# NORTH WEST

# HERITAGE AT

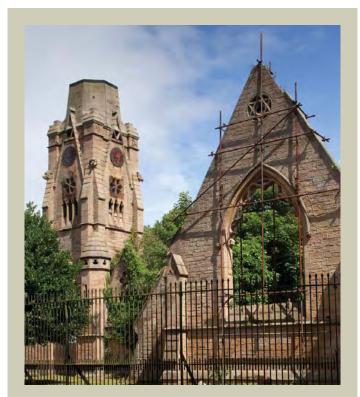
### FLAYBRICK MEMORIAL GARDENS, WIRRAL

First opened in 1864 and now listed grade II\*, the former Birkenhead Cemetery is today used mainly as a public garden. Some of its listed buildings as well as the grounds are in a poor condition; a Friends Group is working with the council to improve the area.
