# SPAB Building Performance Survey 2012

Interim Report October 2012

Dr Caroline Rye, Cameron Scott and Diane Hubbard Society for the Protection of Ancient Buildings Supported by Historic England

# The SPAB Building Performance Survey 2012 Interim Report

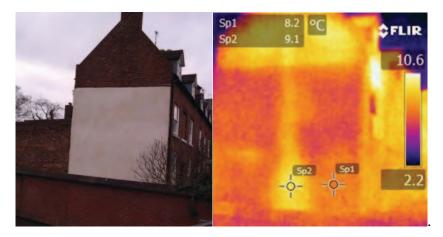
Figure 1a. 116 Abbeyforegate, Shrewsbury – West elevation.

from the living room fireplace was substantially higher than at Riddlecombe and provided an increase in airflow through the property as a whole under the test conditions of 56% (compared to 47% in 2011). This result highlights the fact that as the airtightness of a building improves, air flow relating to remaining flues becomes increasingly important. It should be noted the measured result under the test conditions will not relate directly to the air flows through chimneys, but offers a simple comparison. Evidence of the heat losses being incurred via the flue at Shrewsbury are shown in Figure 1a.

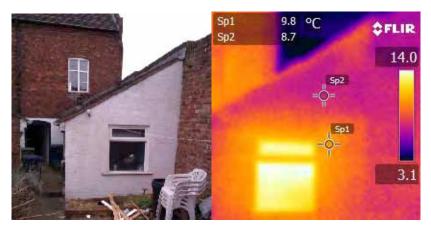
Figure 6. 116 Abbeyforegate, Shrewsbury – Rear elevation (bathroom)

To the rear of the property, it was possible to clearly see the difference between the heated living space and unheated areas. Figure 6 shows the rear elevation of the bathroom, with a temperature difference of just under 1°C between the bathroom and the loft space above.

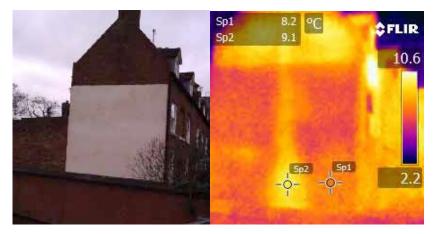
Figure 7. 116 Abbeyforegate, Shrewsbury – West elevation.

On the west elevation of 116 Abbeyforegate, the path of the flue from the open fireplace in the living room can clearly be seen to the top of the building (Fig. 7) indicating this may be a route for substantial heat loss under normal conditions. It must be emphasised the fireplace has not been used by the occupant since he acquired the property. The thermal image also shows an apparent difference in the external wall temperature between the areas of the west elevation between the masonry wall and the insulating render which has been applied. Further investigation of this apparent temperature difference is required due to differences in emissivity between the two surfaces.

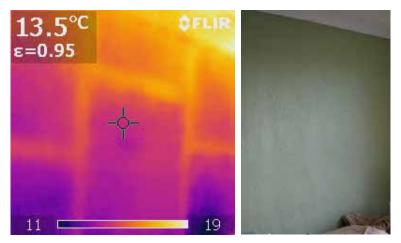
*Figure 15. 116 Abbeyforegate, Shrewsbury 2011 thermographic survey results – ground floor living room, east wall.*

In the 2011 survey, the construction of the living room wall adjacent to the passageway was clearly evident in images shown in Figure 15. The wall has subsequently been insulated and now shows an even temperature.

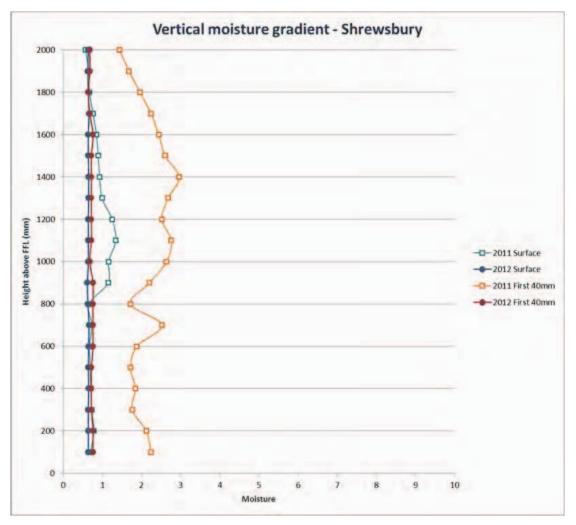
Figure 16. Pre and post refurbishment measurements of surface & subsurface moisture at Abbeyforegate, Shrewsbury, 2011 & 2012.

capacitance reading was taken of conditions at approximately 40mm deep behind the interior wall face. Figure 16 plots these measurements alongside those previously taken in 2011 for the same wall pre-refurbishment, these values are plotted against a nominal moisture scale to a height of 2000mm above finished floor level.

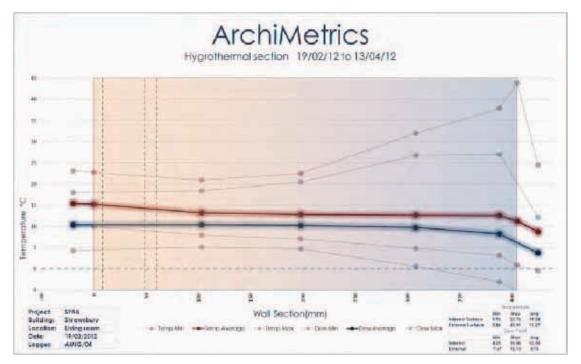
*Figure 18. Temperature and dewpoint gradients for Abbeyforegate, Shrewsbury, 2012.*

What can be observed from Figure 18 is the flattened temperature gradient now found through the masonry element of the 2012 wall following the insulation of its internal face. The steepest temperature drop occurs between the internal surface temperature and the first sensor in the wall and as such is a measurement which spans the insulating woodfibre layer. What is also worthy of note is the temperature gradient plotted by the maximum values on this graph which show temperatures falling across the wall from the exterior to the interior, reversing the trend normally found during the winter months. This is due to the wall's southern aspect which means that on sunny winter days this elevation will be heated by external solar radiation. SPAB Building Performance Survey - Abbeyforegate - C. Rye, C. Scott & D. Hubbard - Oct 2012

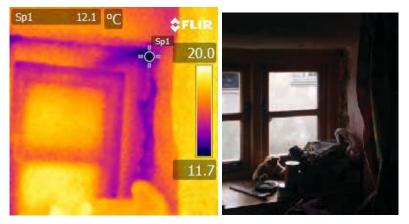
Figure 31. The Firs, Riddlecombe – Bedroom1, south facing wall.

The windows installed prior to the 2011 study showed no evidence of leakage; however there was ingress around the window in Bedroom 1, where plasterwork was still to be completed (Fig. 31). Ingress around beams remained as per the 2011 study.

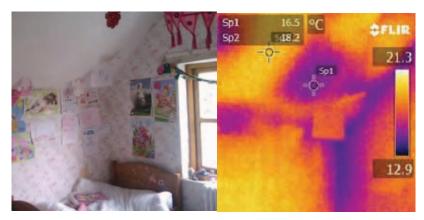
Figure 33. The Firs, Riddlecombe – rear bedroom (Bedroom 2).

33). It is understood that subsequent to this survey this ceiling has been improved.

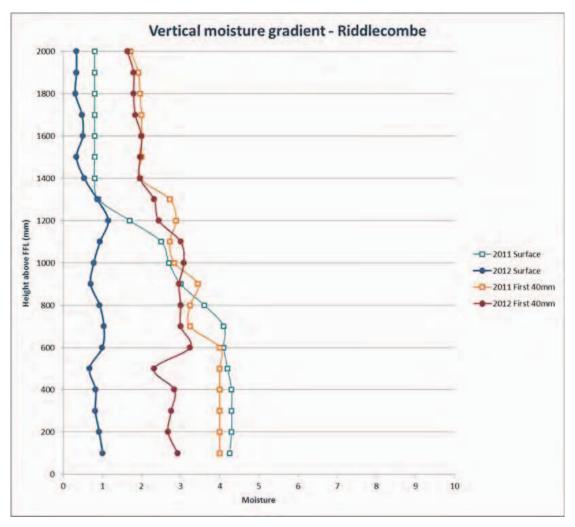
Figure 34. Pre and post refurbishment measurements of surface & subsurface moisture at The Firs, Riddlecombe, 2011 & 2012.

The graph for Riddlecombe, an externally insulated wall, is somewhat different but also shows the general declining trend for surface and subsurface moisture (Fig. 34, p. 63). At this property the moisture permeability of both the internal and external finishes of the walls has, in theory, been increased by the application of lime-based finishes and both the moisture

buffering and evaporation potential of these materials could account for the improvement in moisture readings taken here in 2012. This improvement is particularly pronounced for the lower part of the wall and it should be noted that the stone plinth (300mm) upon which the cob wall sits has received an additional coat of stabilising mortar to both its interior and exterior face which maybe benefitting moisture readings for this part of the wall. Also of note, however, is that above 1400mm readings for sub-surface moisture at Riddlecombe return to those previously recorded, pre-refurbishment, in 2011. This suggests that beyond the internal wall surface moisture conditions deeper within the wall have not really altered as a result of the refurbishment work. This may be of some concern given that high moisture levels within this wall have already been established as a potential problem in the previous 2011 report on this property<sup>5</sup>.

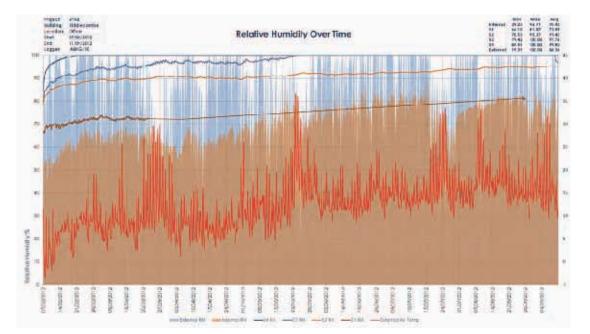
wall indeed it would appear that it is accumulating. Two sensors within the wall (nodes 3 and 4 at 400mm and 580mm deep respectively) now indicate dewpoint/temperature convergence with dewpoint margins of 0.35 and 0.3°C. Overall the average dewpoint margin for the whole wall (taken across all four nodes) has been reduced by 40% from 2.86°C to 1.74°C. The reasons for this change are not obvious and the accumulation of moisture suggests that moisture is becoming trapped within the wall as it is currently configured. During construction and refurbishment processes there is the possibility that moisture will be introduced into building materials from the addition of water used in finishes etc. However, the data presented at Riddlecombe indicates that construction moisture is not the cause of the high moisture content found within the wall not least because this does not explain the *accumulation* of high RH values (calculated as dewpoints) moving back into the centre of the wall. The accumulation of moisture over time suggests an on-going source for this moisture.

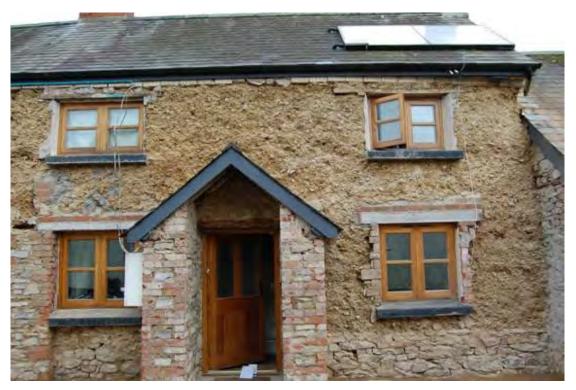
Figure 40. The Firs, Riddlecombe front elevation showing masonry buttress bottom left of frame.

To complicate matters it was discovered, during the course of re-rendering, that the section of the cob wall being monitored was in fact faced with a masonry buttress (Fig. 40). Therefore the presence of this buttress, made in a different material to that of the earth wall may or may not have a bearing on the moisture behaviour that is currently being monitored within the cob. In order to verify the findings at Riddlecombe we are undertaking additional monitoring to measure, through resistivity, the moisture content of the cob 200mm back from the external face (one measurement is taken through and behind the buttress and one above it away from the influence of the masonry (Fig. 41)). These measurements have so far returned indicative moisture content values for these areas of around 3.9 - 4.1% suggesting a raised moisture level which backs up both on-site observations of wet material extracted from the sensor holes when monitoring equipment was re-installed in 2012 as well as the convergent dewpoint readings taken via the interstitial hygrothermal gradient monitors and plots of interstitial RH. Interestingly, these moisture content values were found both above and behind the buttress suggesting that the raised moisture extends beyond the zone of hygrothermal monitoring which is installed in proximity to the buttress.

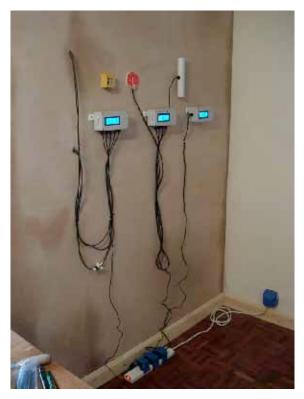
*Figure 50. Interstitial, U-value and IAQ monitoring set up at Mill House, Drewsteignton, 2012.*

been applied to the interior surface of the plasterboard (this can be seen as patches of damp in Figure 50). It is interesting to note the length of time taken for this drying to occur. Also worthy of note is that, following this decline, the level of RH behind the plasterboard tracks that of internal room RH, suggesting that the drylining finish, complete with a coat of emulsion paint, is highly permeable and that the water vapour within the air in the room is easily able to move through the drylining into the air gap behind with the result that room and air gap RH are more or less equivalent. Sensors 2, 3 and 4 however are located adjacent to and within the original masonry part of the wall and these show a different picture where levels of RH are seen to mostly increase during the monitoring period.
