Conserving War Memorials

Case Study: Surface Treatment of Bronze Statuary

First and Second World Wars Memorial, Tottenham, Haringey, London

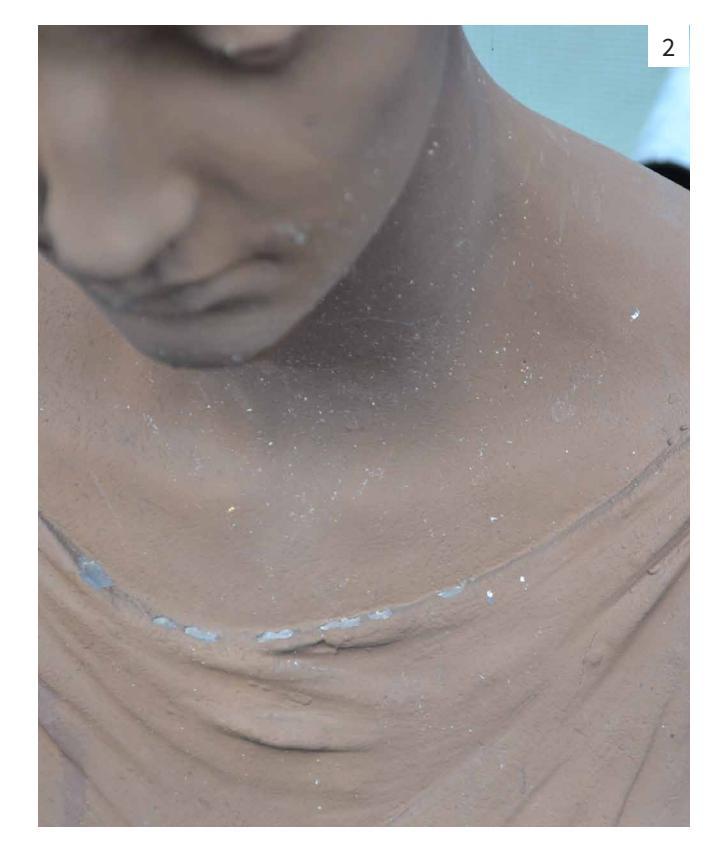
Bronze elements were treated as part of a project to conserve the whole memorial in the 1980's. Although the techniques used were thought to be appropriate at the time, some have proved not to be in the material's long term interest such as the application of a layer of metallic paint which camouflaged any potential deterioration to the original surface. As a result, these elements required substantial conservation work.

2 Paint failure visible on drapery.

Treatment comprised the application of the dichloromethane-based paint remover for a dwell time of one hour or more. This was increased from the trial time to allow the paint remover to work. The surface was covered with cling film to slow evaporation. The residue was removed with a paper towel and the statue was then cleaned using the high temperature steam cleaning system. This removed any residual paint remover and paint. This process was repeated a number of times until the paint was completely removed. Following the removal of the paint, the condition of the surface could be fully assessed. This was essential in order to identify any evidence of active corrosion.

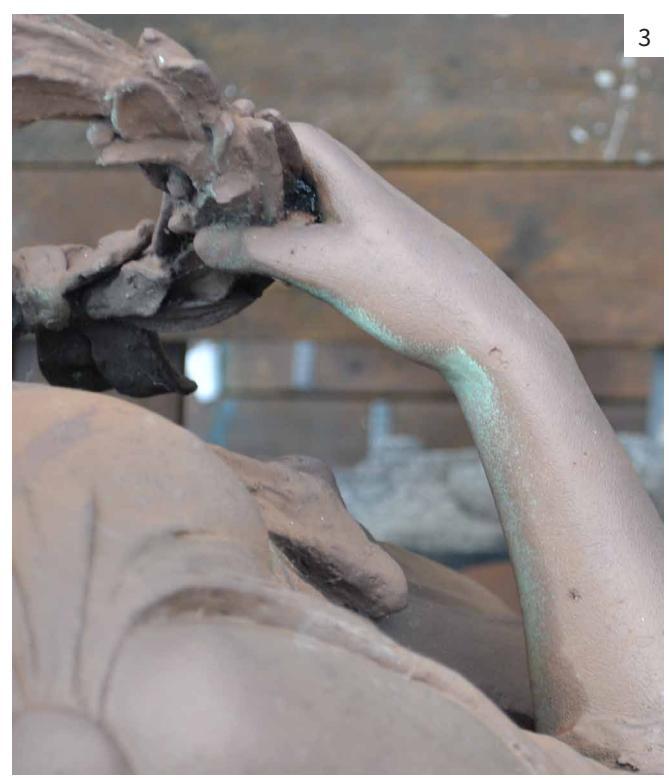
Dirt, areas of paint failure and surface corrosion had given the statue an uneven and disrupted appearance. Some corrosion was observd, but this was deemed stable (non-active).

3 Corrosion present on the inside on the figure's arm.

No active corrosion was found. However, had there been any, these corrosion products would have been mechanically removed by hand using picks and wooden scrapers and rinsed with an appropriate solvents (acetone or Industrial Methylated Spirits).

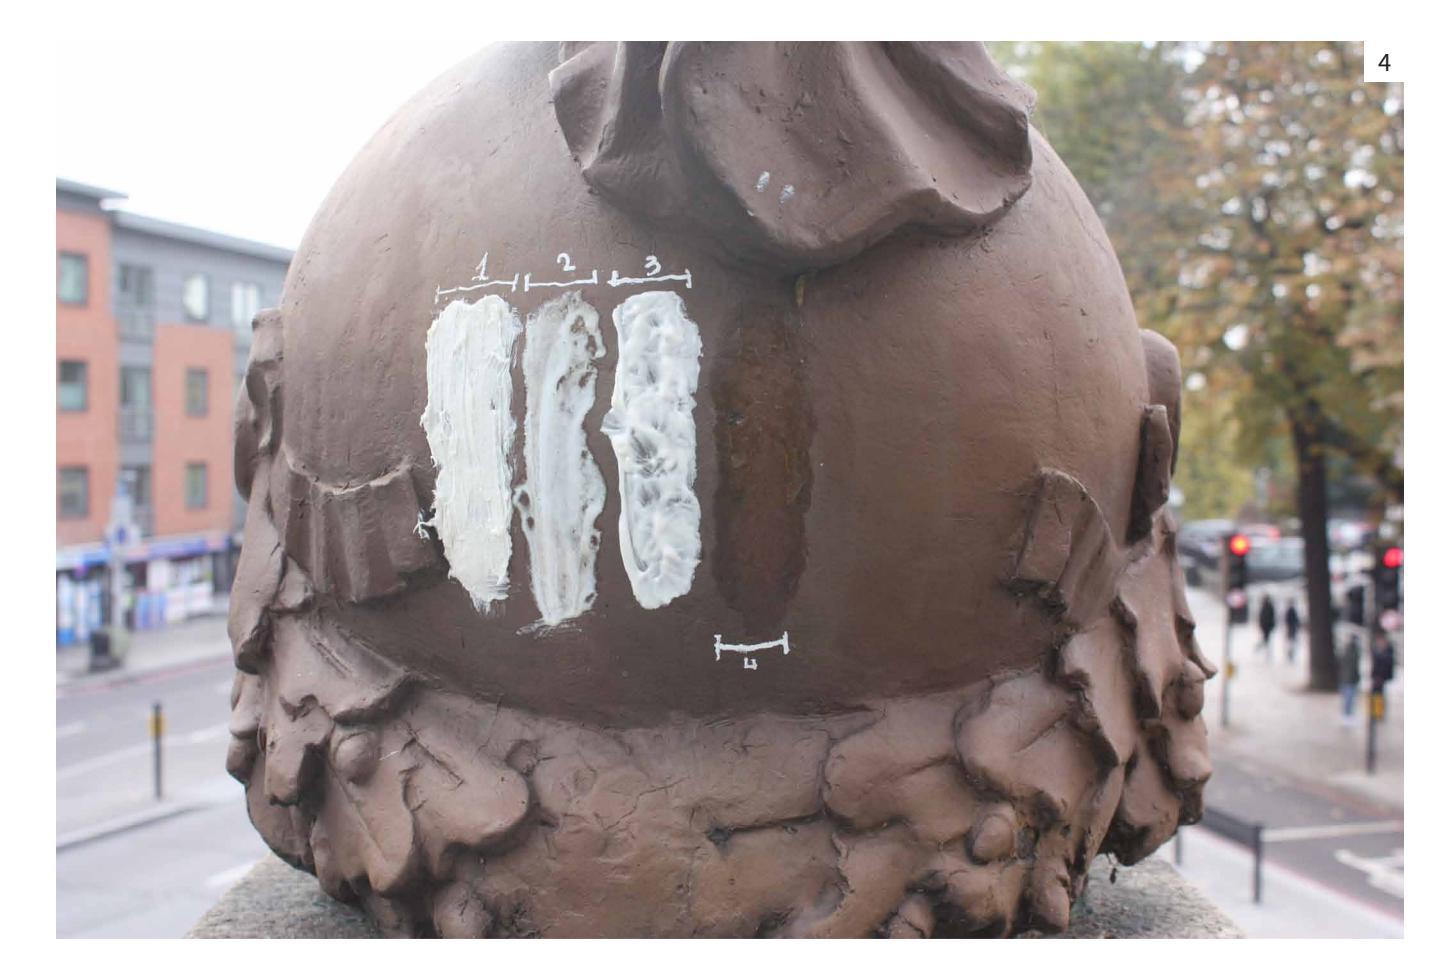
The cleaning trials were carried out on a small area to the rear of the half-globe (500mm x 500mm) that the statue stands on. Four proprietary paint removers containing solvents were tested within this area. The active solvents tested were benzyl alcohol, calcium hydroxide, methanol, and dichloromethane.

4 Paint removal trials: samples applied to the rear of the globe.

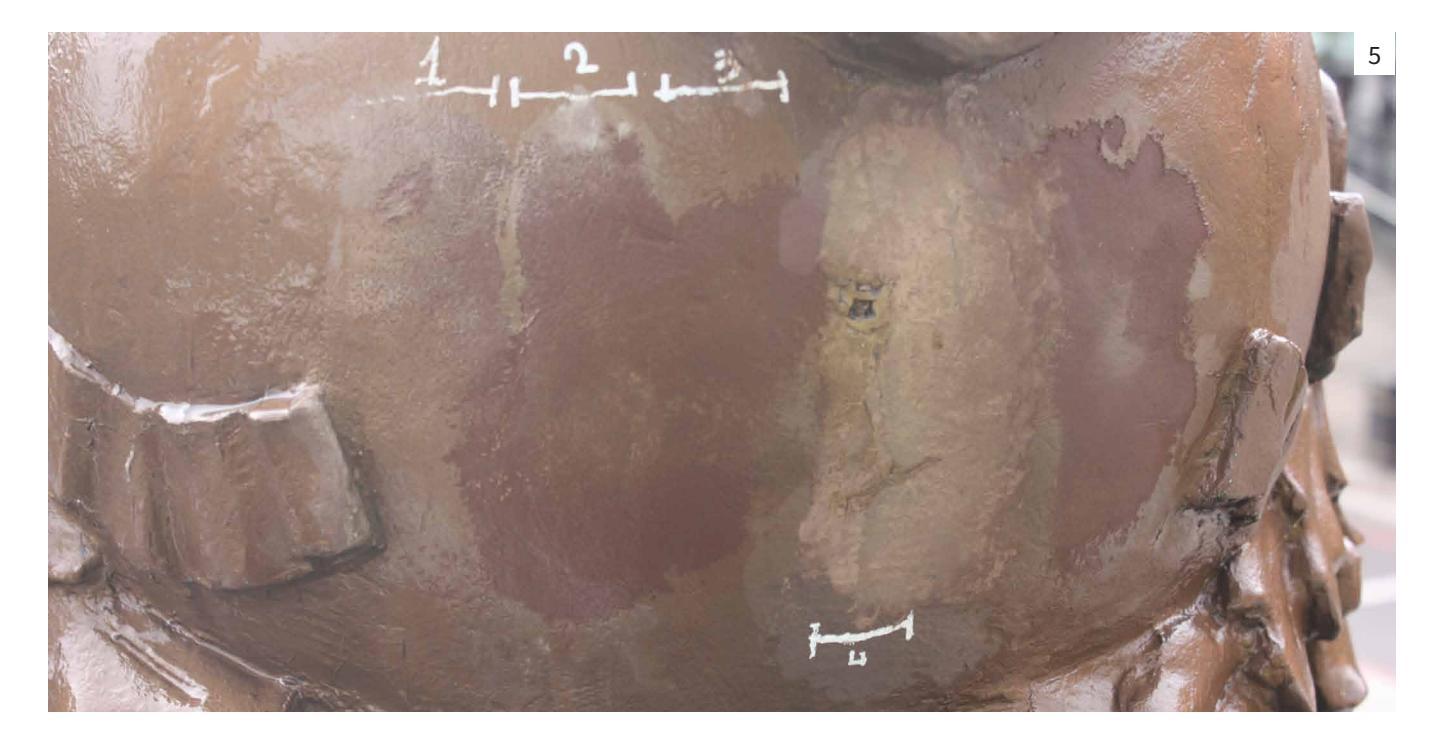
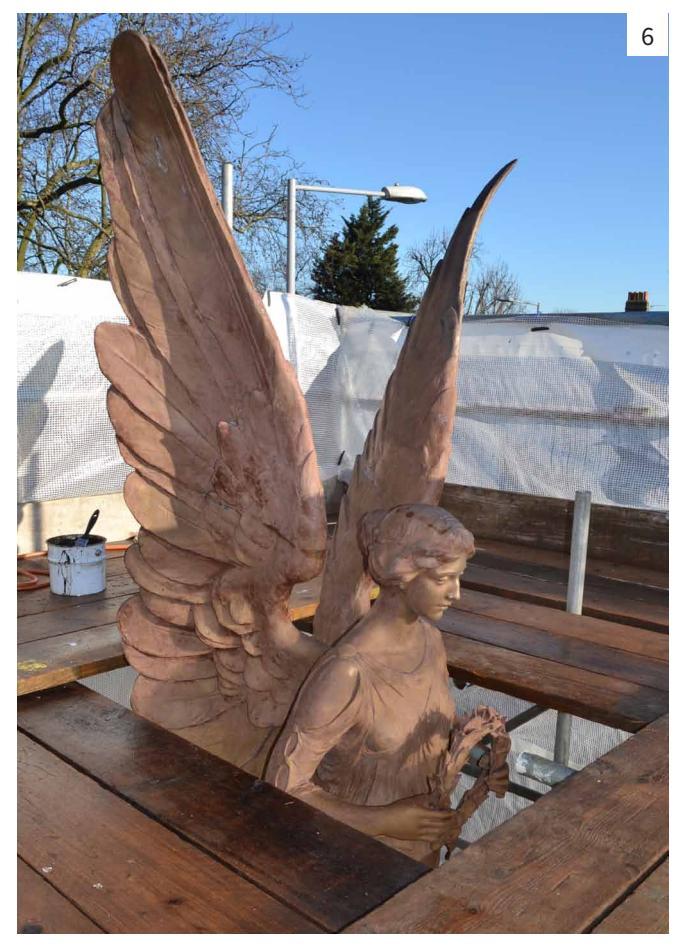
The trials demonstrated that the dichloromethane-based paint remover was the most effective solvent. It also became clear through the trials that the bronze surface had been air-abraded prior to the application of the metallic paint. Although a standard method of surface preparation for applying modern paints, this unfortunately stripped the patina from the surface. As well as permanently damaging the surface finish of the bronze, this removed evidence of its original appearance.

Some of the original surface finish would have been lost through the natural ageing of the bronze, but in this case aggressive abrasive blast-cleaning completely obliterated anything that may have remained, leaving an inert and lifeless finish.

- **5** After 30 minutes' dwell time, the samples were removed and the area washed using high-temperature steam.
- 6 The statue after paint removal.

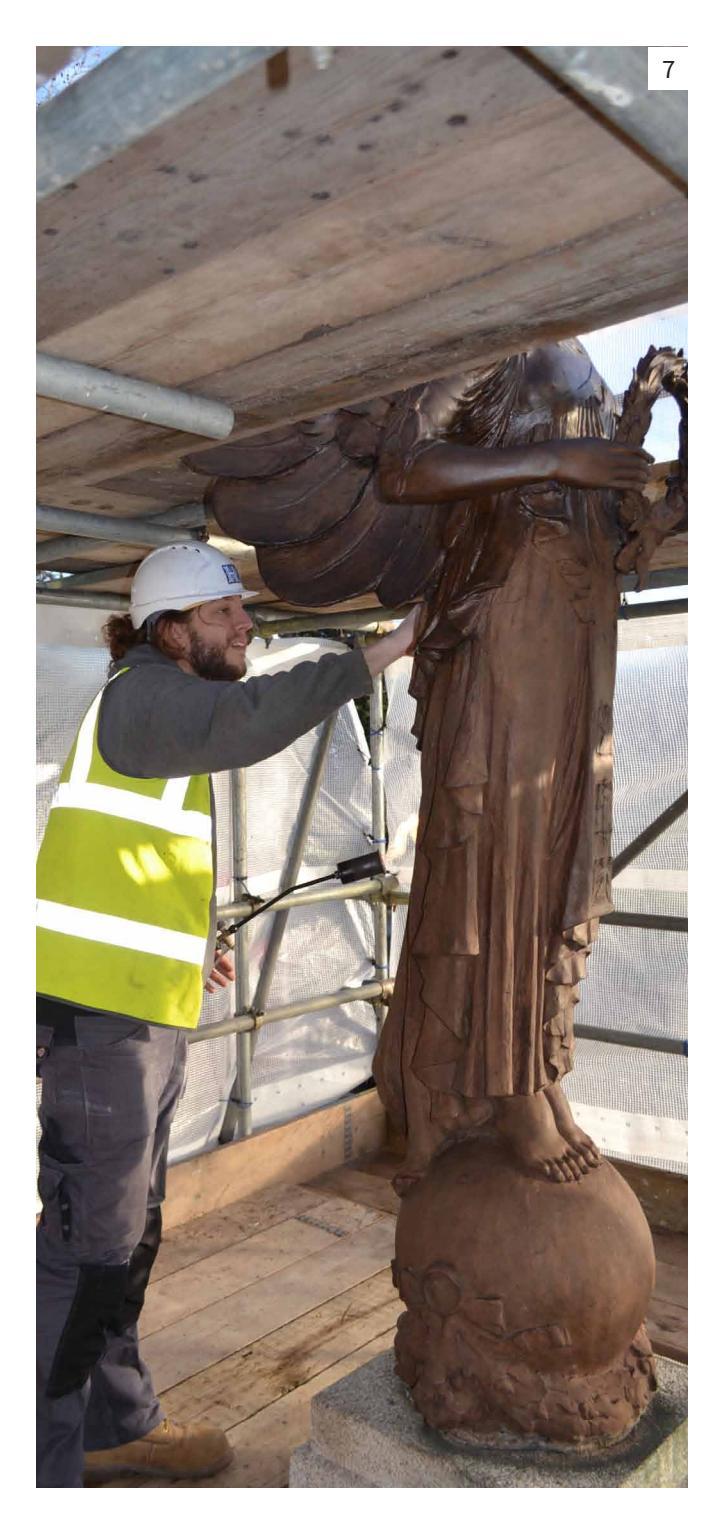
7 Applying the wax coating to the heated surface.

The new wax comprised a first coat of a mixture of microcrystalline and carnauba waxes. This was applied by first heating the bronze close to the melting point of the wax before applying it, then by 'flash' heating over the wax with a broad propane flame afterwards. The use of heat allows the melted wax to fill crevices and flaws, and bond with the bronze surface. This wax mixture can be pigmented with natural earth pigments to give a range of colours required to replicate a patinated bronze surface. It is important that the wax remains translucent and the colour is built up with multiple layers, shading and highlighting. The mixed wax coat is then followed by two coats of microcrystalline wax. These last two coats are sacrificial layers which must be maintained in order to preserve the coloured wax beneath.

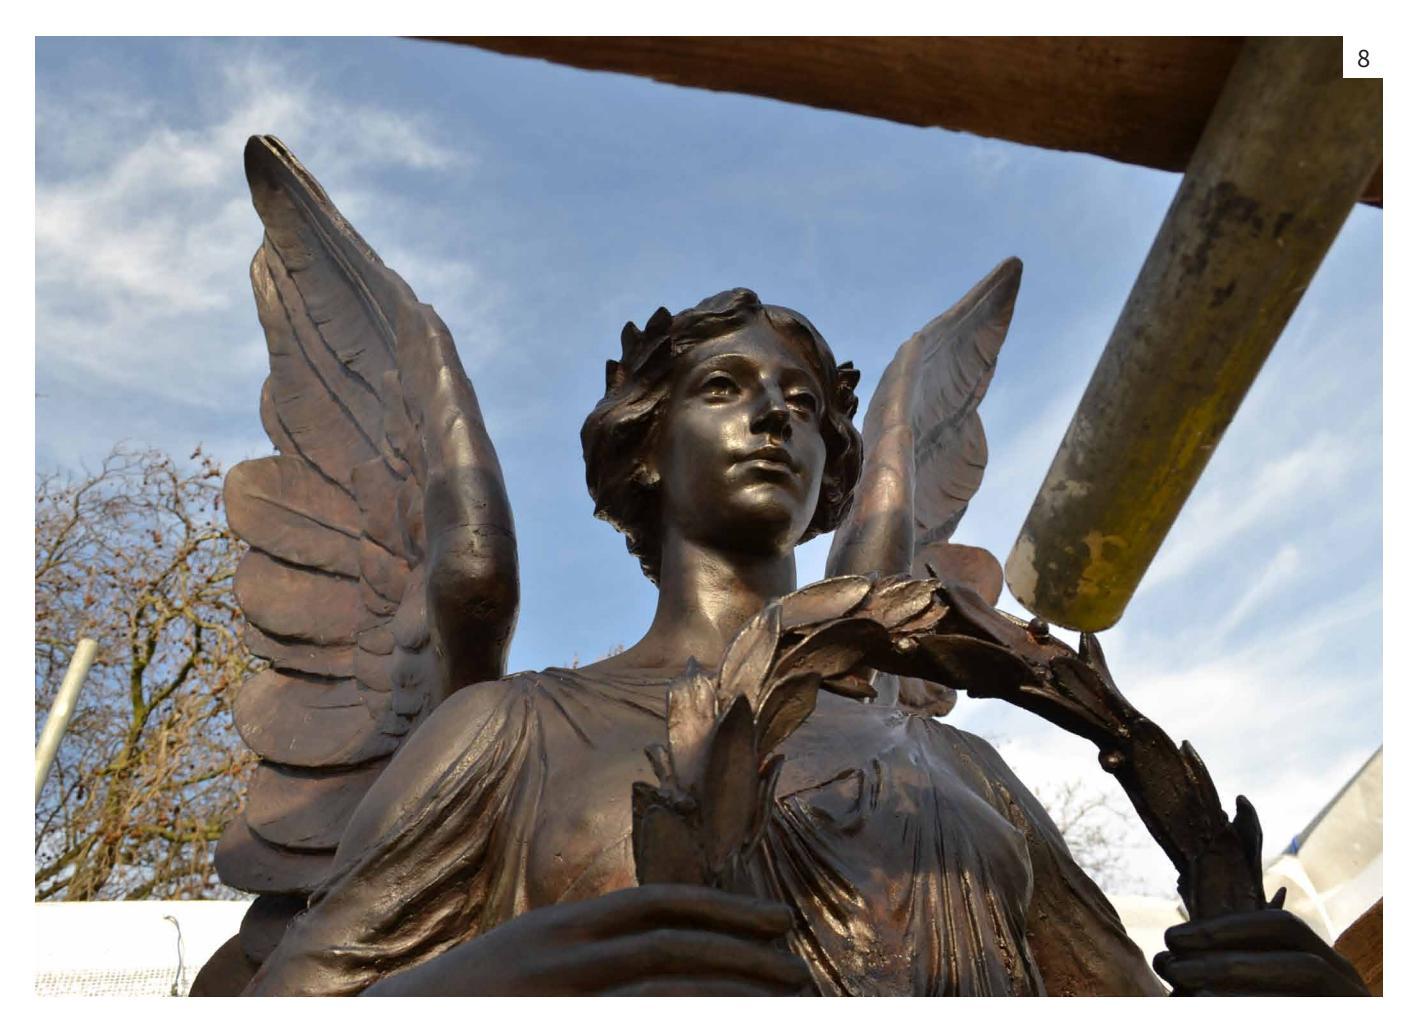
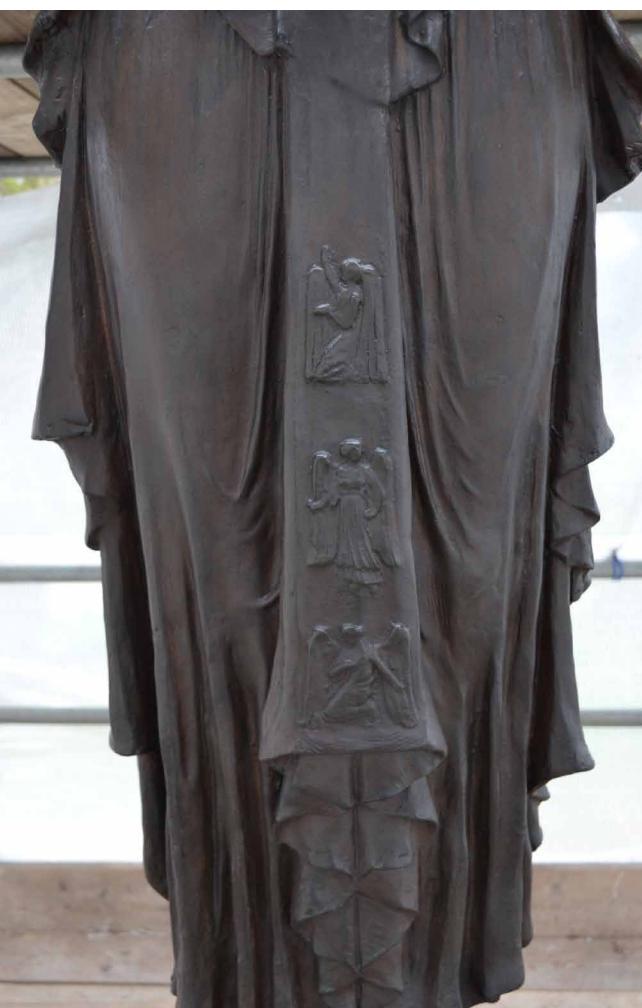
- 8 Statue after the application of the coloured wax.
- **9** Finished detail of the statue's drapery.

Loss of the patination means that some form of re-colouring has to be provided which may be chemical re-patination, paint or coloured wax. In this instance, a coloured wax, pigmented with earth pigments (burnt umber and terre verte) was used.

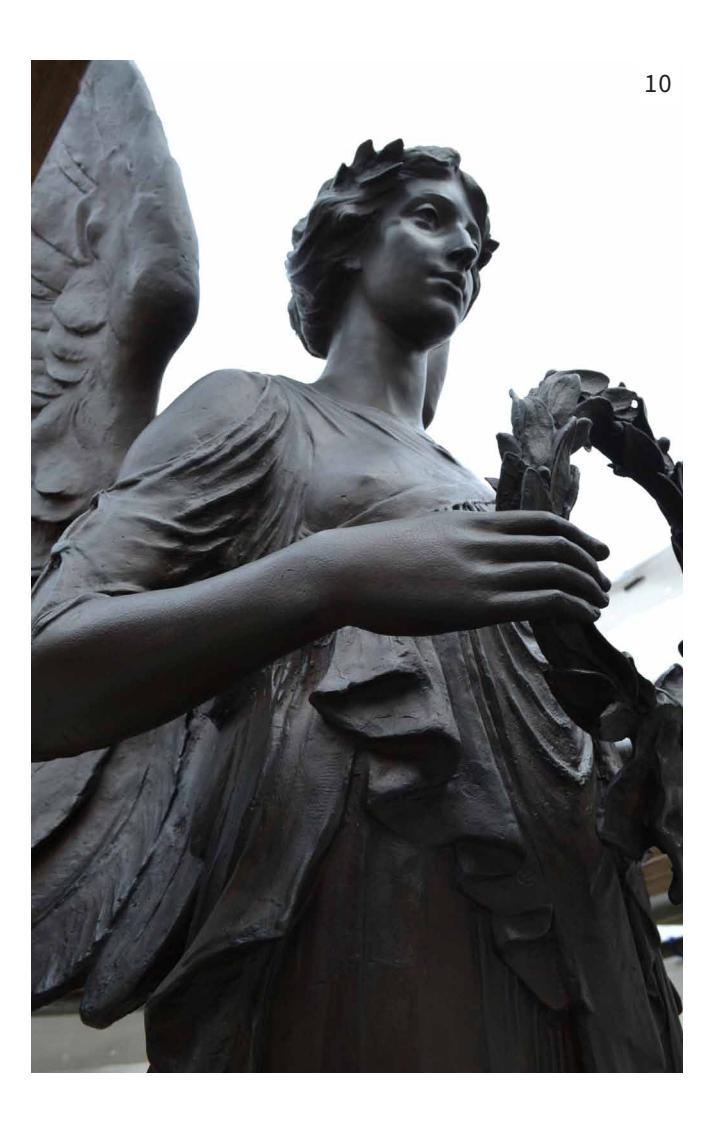
10 The statue after treatment.

A key observation is the potential loss of original significance through unsympathetic restoration procedures and lack of regular maintenance. Annual conservation maintenance for the metal elements and five-yearly maintenance of the stone elements is recommended to ensure the continued stability of this memorial.
