FIRE RISK

Geraldine O'Farrell

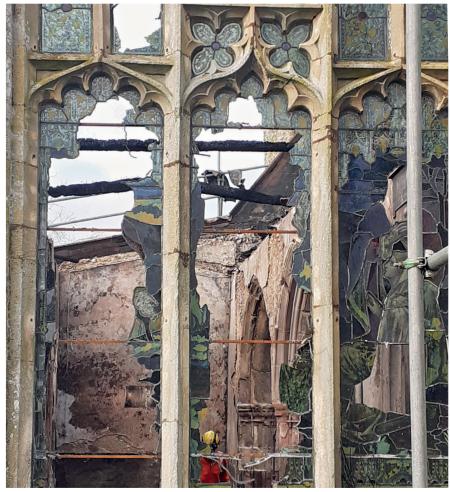
The aftermath of the fire at St Mary's Beachamwell (Photo: Domenico D'Alessandro)

A spark from welding caused the blaze at St Mary's church in Beachamwell, Norfolk (Photo: Norfolk Churches Trust)

All projects involving what is known as 'hot works', such as the use of a blowtorch in lead working, must be risk assessed as a minimum and a hot works permit issued daily before any work is carried out. Historic England has produced an advice note – see http://bc-url.com/hc23-gf4 – and the Lead Sheet Association and other bodies have introduced a policy of removing hot works from buildings wherever possible.

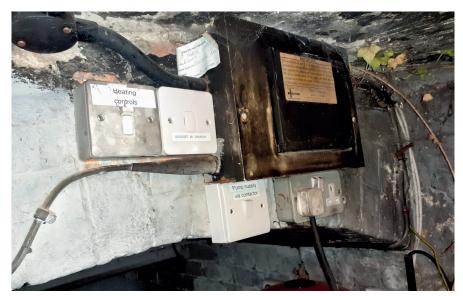
A smoke-blackened consumer unit in the parish church of Bibury, Oxfordshire (Photo: Dan McNaughton)

Unfortunately, a lot of churches still have wiring installations that contain very old cabling, accessories and switchgear, which are still in use. This along with a lack of system maintenance and inspection is a disaster waiting to happen.

An electrical installation condition report (EICR) ought to be produced at least every five years and any faults actioned according to the categorised severity:

- **C1** means that there is a danger present, a risk of injury and immediate remedial action is required
- **C2** means this part of the installation is potentially dangerous and further investigation is required without delay
- **C3** means that improvement is recommended.

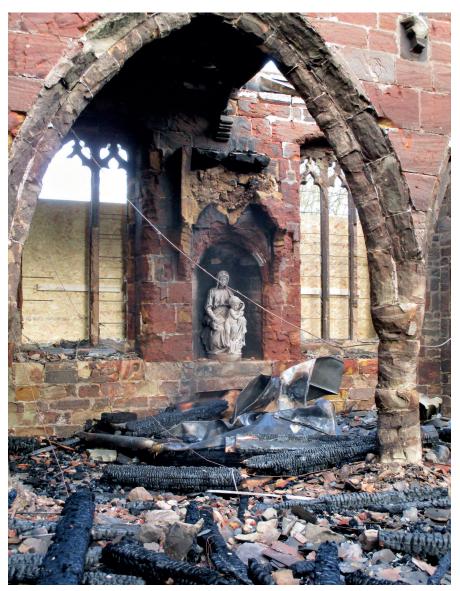
All Saints' in Mackworth, Derby which was almost completely destroyed by arson in 2020 (Photo: Leon Walsh)
