BUILT TO LAST?

The Buildings of the Northamptonshire Boot and Shoe Industry

Kathryn A Morrison with Ann Bond

Based on a survey directed by Adam Menuge

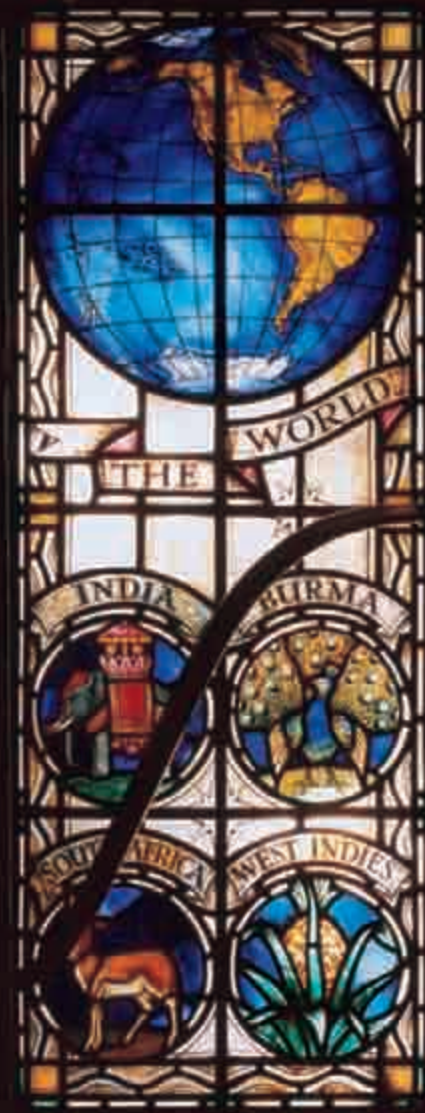
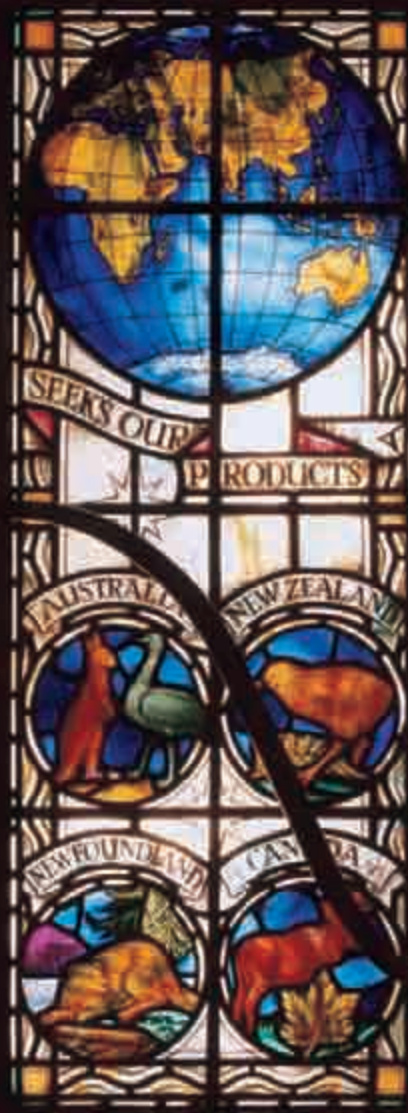
Fig 1 'The World Seeks our Products': these stained-glass doors in Fred Hawkes's shoe machinery factory on Portland Road, Rushden, built in the 1920s, illustrate the international importance of Northamptonshire's boot and shoe industry. [AA044187]

This international reputation is of long standing (Fig 1). Northampton was exporting boots and shoes as early as the 17th century, and the industry had spread to other parts of the county by 1850. At the zenith of the British Empire, Northamptonshire manufacturers despatched huge cargoes of boots and shoes – footwear for all climates and terrains – to the colonies. Periodically, the demands of war, from the Civil War (1642–8) to the Second World War (1939–45), spurred production to new heights and created new markets. In the First World War (1914–18) alone, Northampton manufacturers supplied the staggering number of 23 million pairs of boots and shoes to the Allied forces, while the rest of the county provided another 24 million pairs. To put this in context, other footwear-manufacturing areas of Great Britain produced only 23 million in total.

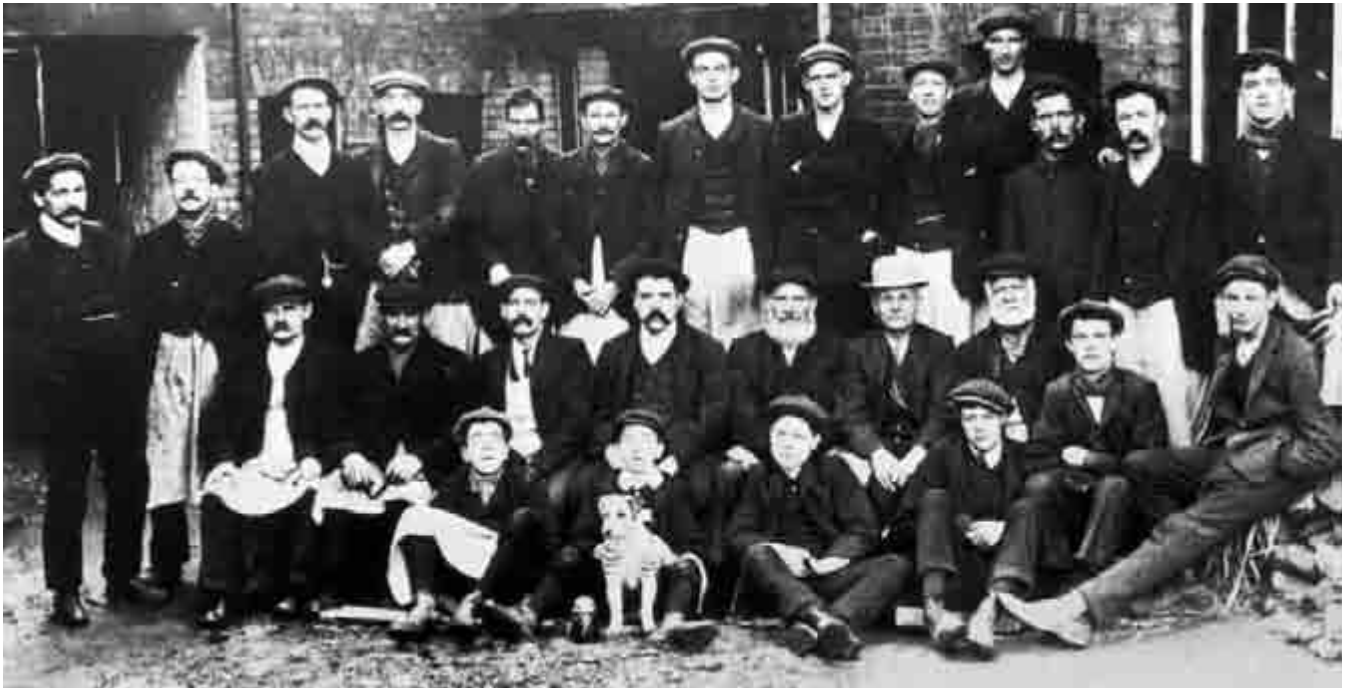
Fig 2 Boot and shoe workers pose with a dog for the photographer in the factory yard at Parker & Howe's, 33 High Street, Long Buckby, about 1913. The village of Long Buckby specialised in the manufacture of long boots. [Northampton Museums and Art Gallery]

This thriving industry provided skilled employment for hundreds of thousands of people in Northamptonshire, generation after generation (Fig 2). It created wealth that enabled towns such as Kettering, Wellingborough and Rushden to expand at an unprecedented rate. New streets lined with factories and houses took the place of green fields, and it was impossible to escape the sights, sounds and smells of footwear manufacture.

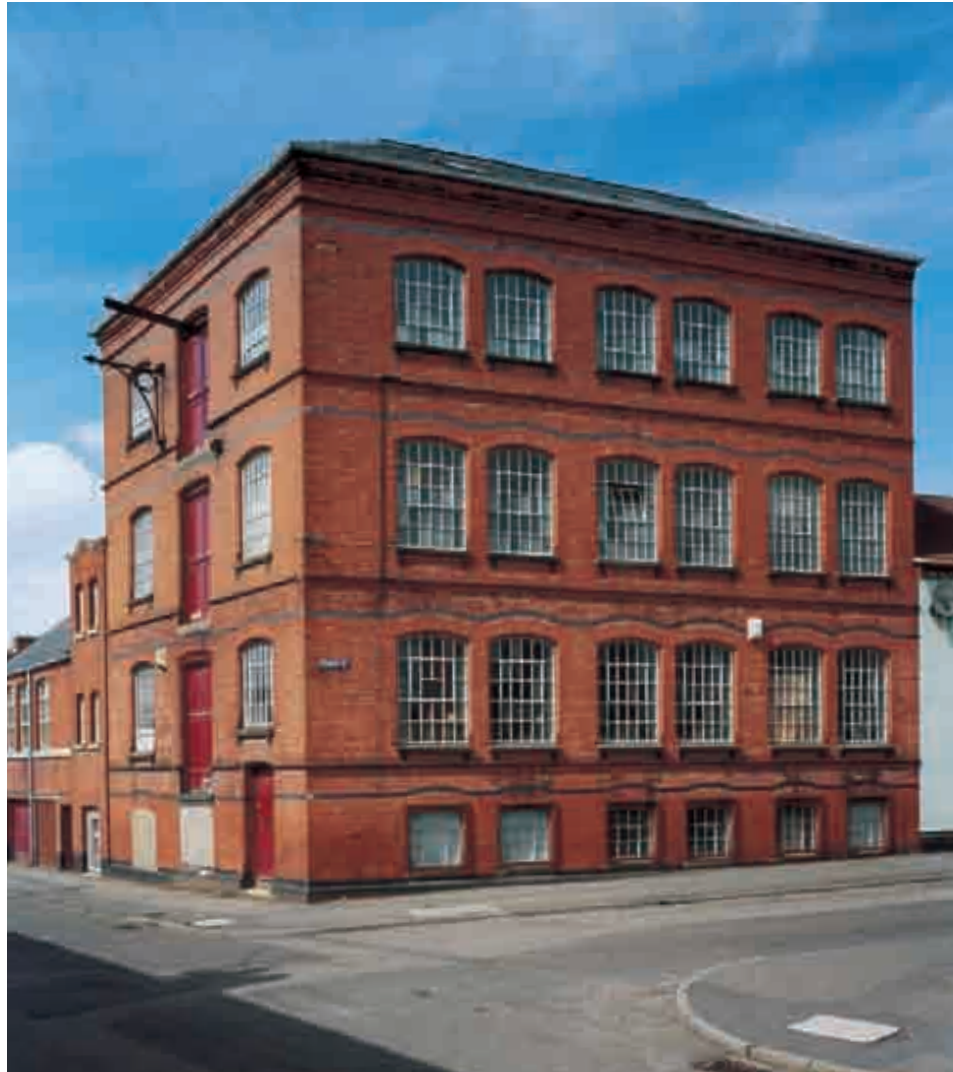
Fig 3 Although no longer used for its original purpose, this factory on Crabb Street in Rushden is well cared for and retains most of its original features, including its crane, loading doors and windows. It was built about 1887. [BB013242]

The architectural inheritance of the boot and shoe industry (Fig 3), which defines the character of so many Northamptonshire towns, has been threatened for some time by the decline of the manufacture of mass-produced footwear in this country. Competition from the Continent and the Far East has accelerated since the end of the Second World War. This has affected not just Northamptonshire, but also other shoe-manufacturing centres, such as Leicester and Norwich. Although many well-known firms still produce high-quality footwear in

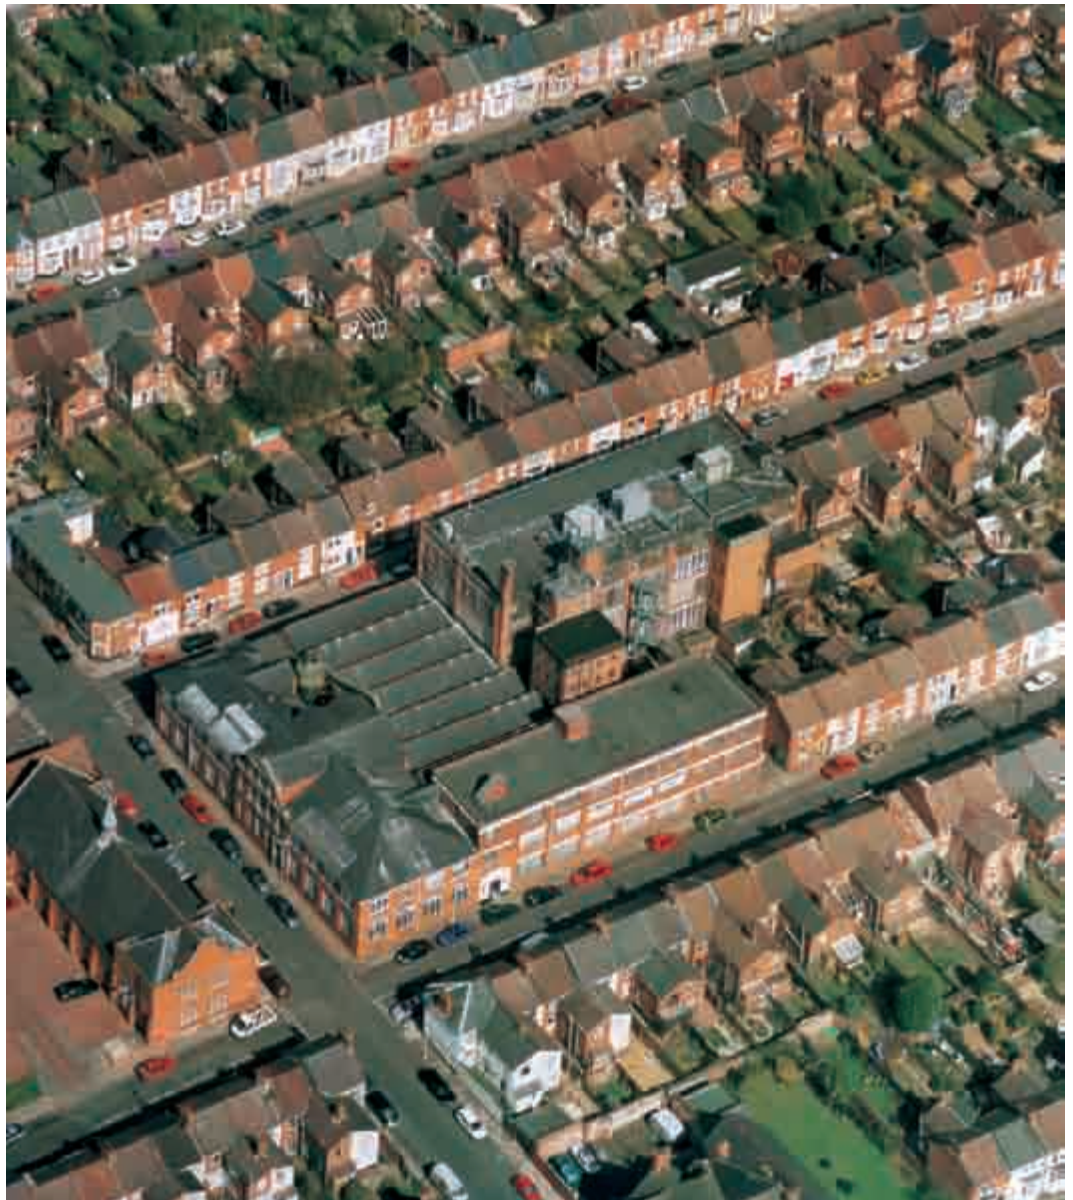
Fig 6 *The district shown in this aerial photograph, to the north-east of Northampton town centre, was built in the 1880s and 1890s. The large factory in the centre, belonging to Crockett & Jones, dominates the neighbourhood. Characteristically, the buildings were erected in regimented rows, and the predominant building material is red brick. [NMR 23031/07 SP 7661/33]*

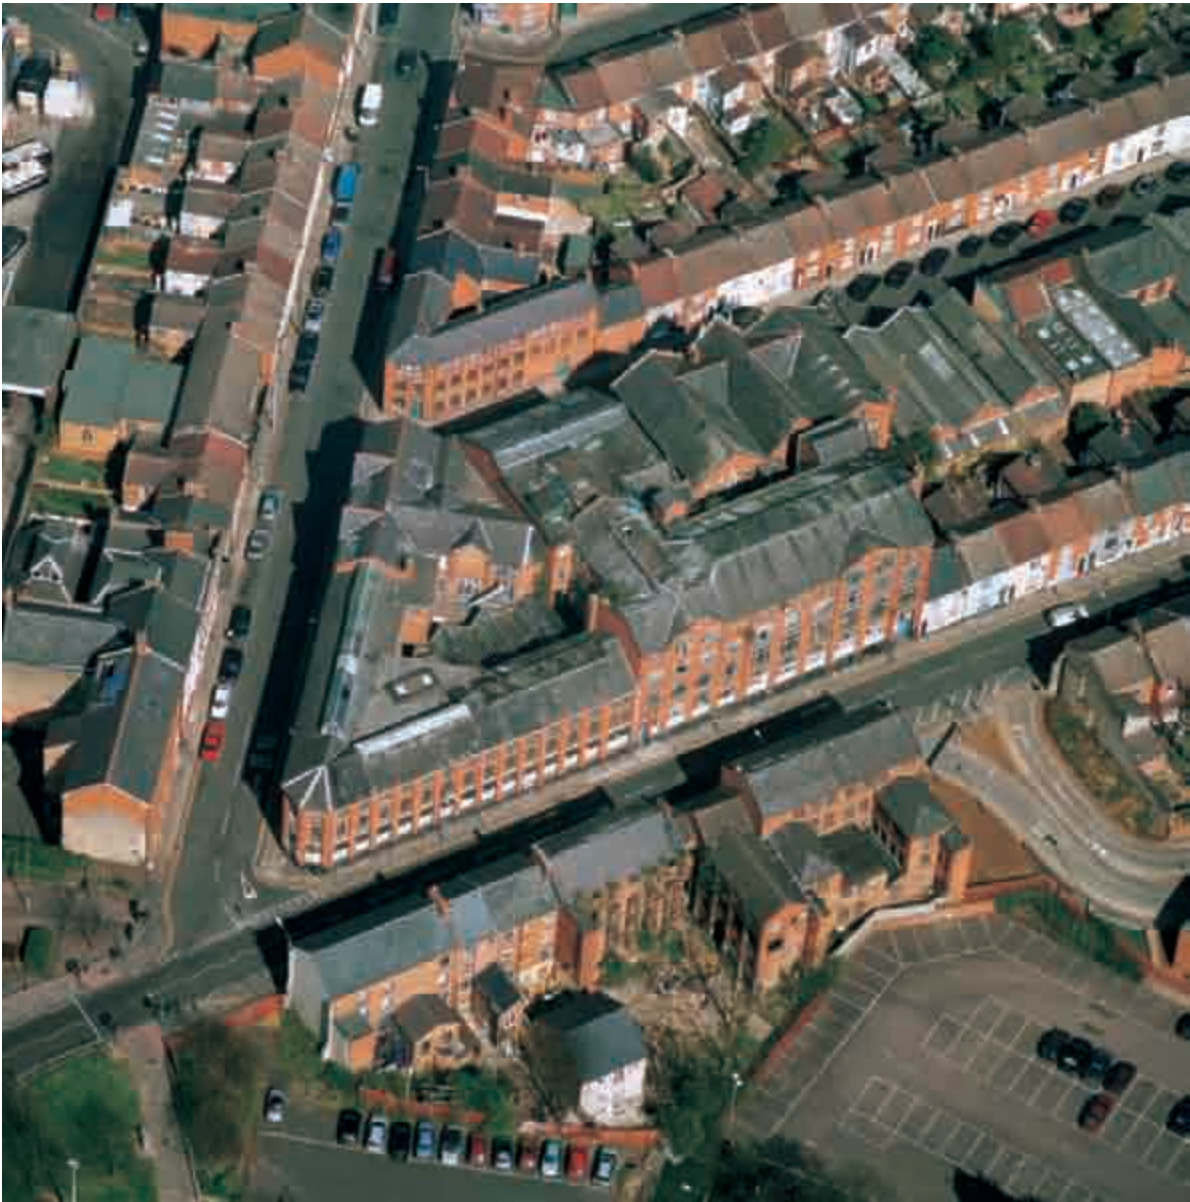
Fig 7 *This aerial view shows a dense cluster of factories at the junction of Overstone Road (left), Dunster Street (top) and St Michael's Road (bottom) in Northampton. Originally, these factories – built between the mid-1870s and late 1890s – belonged to Hornby & West, G T Hawkins and Collier's. A modern road, bottom left, runs through the site once occupied by Cove & West, whose factory was one of the most important in the town. [NMR 23032/08 SP 7560/58]*

clusters, or along one side of a street, creating industrial canyons: this can be observed most impressively on Henry Street, St Michael's Road (Fig 7) and Duke Street. At the end of the 19th century these red-brick streets must have presented a strong contrast to the historic core of the town, where most streets were lined with façades dating from the 18th and early 19th centuries, constructed in mellow local stone.

Fig 26 Hornby & West's factory was built on the corner of Overstone Road and St Michael's Road, Northampton, in 1876, and extended in 1883 and 1893; it was taken over by its neighbour, G T Hawkins Ltd, about 1912. The building was used for shoemaking into the 1990s. (See also Fig 7.) [BB001586]

Fig 29 (left) *G T Hawkins's Northampton factory was designed by Charles Dorman and erected in 1886 on the corner of Overstone Road and Dunster Street (see Fig 7). It had a rough-stuff shop and riveters' shop on the ground floor, with clickers' rooms and a small closing room on the upper floors. The name of the factory's most famous product, 'Waukerz' footwear, is displayed over the office doorway.*

Fig 46 This former currier's, at 1 Dunster Street, Northampton, was built by G Heap for Collier's in 1877, and extended shortly afterwards. Despite hosting a variety of occupants during the 20th century, the building – now an upholstery works – retains many original features. (See also Fig 7.)

We know that the surviving buildings represent only a small sample of the chronological, geographical and typological range that once existed. For example, there is little surviving evidence of buildings erected before 1870, and the currier's on Dunster Street (*see* Figs 7 and 46) and Miller's last works on Arthur Street, Northampton, are among the few remaining examples of once-common types.

- 5 Junction of Overstone Road and St Michael's Road. Two footwear factories: Hornby & West's of 1876 (extended 1883 and 1893) and G T Hawkins's of 1886 (extended 1888, 1893 and 1914). (See Figs 7, 26, 29, 37 and 55.)

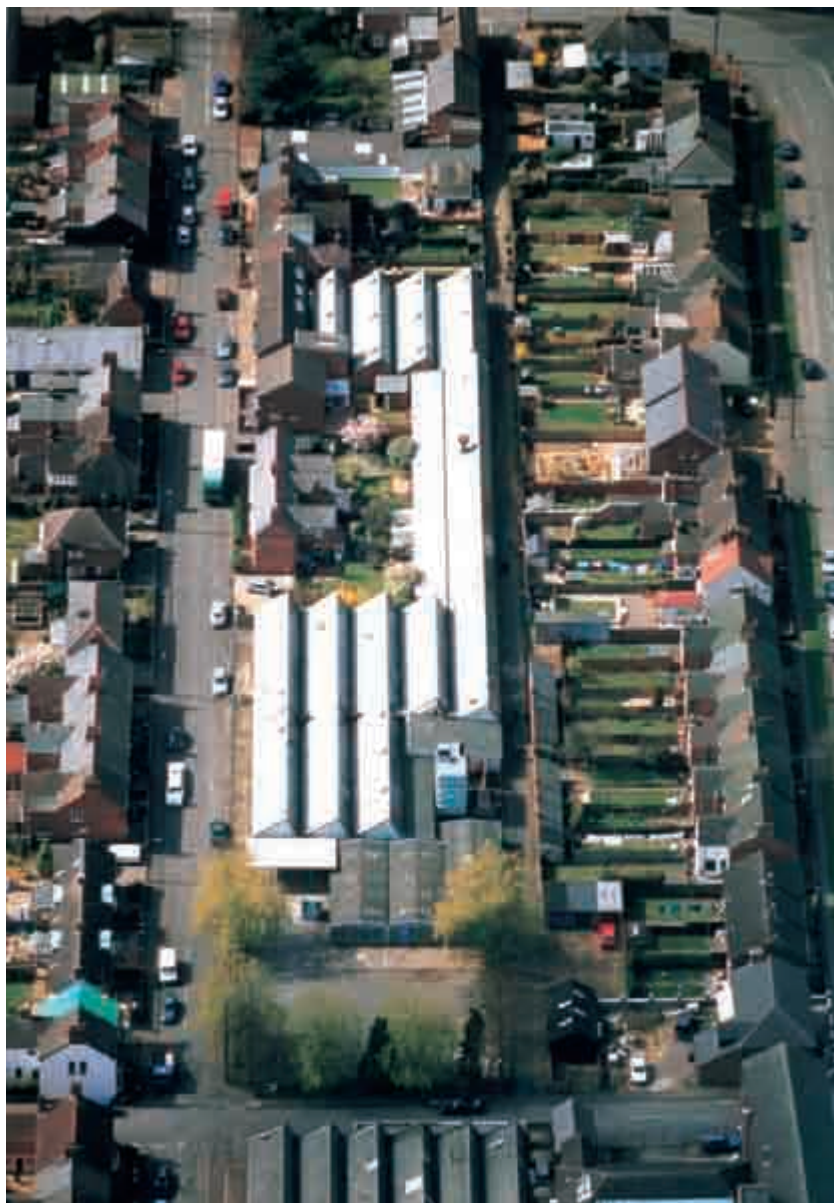
Fig 8 A mixture of factories, houses and small workshops can be seen in this aerial view of Wollaston. The factories range in date from the Sheldon Factory of about 1900 (bottom right) to the Austin Factory of the 1920s (centre). To the north of the Austin Factory is Septimus Rivett's factory of 1915. [NMR 21992/07 SP 9162/8]

the main street, and similar developments can be seen in Bozeat. Back lane factory development, running parallel to the main street, was erected in Irthlingborough (Victoria Street), Higham Ferrers (Midland Road) and Raunds (Park Road). More intricate boot and shoe suburbs, with a grid-plan of streets containing a mixture of factories and terraced houses, were built at New Barton (a suburb of Earls Barton), Wollaston (Fig 8) and Burton Latimer.

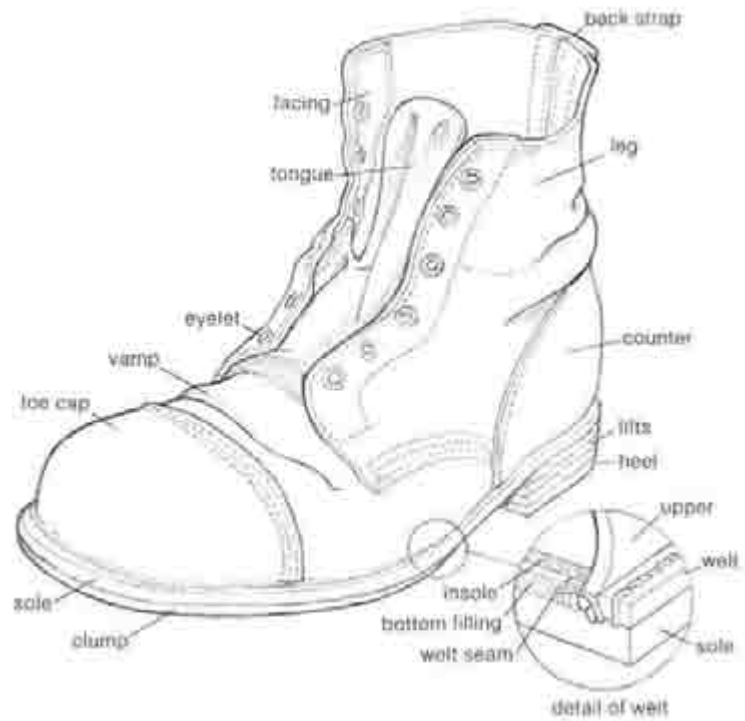
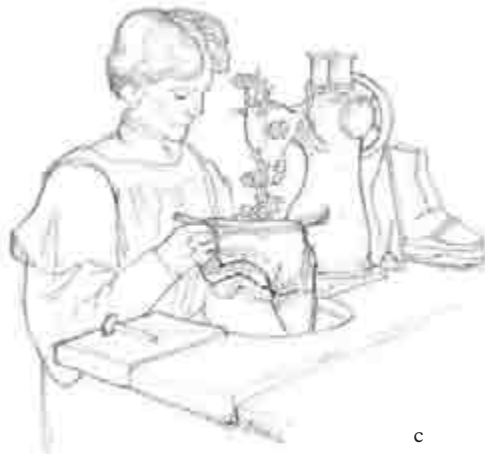
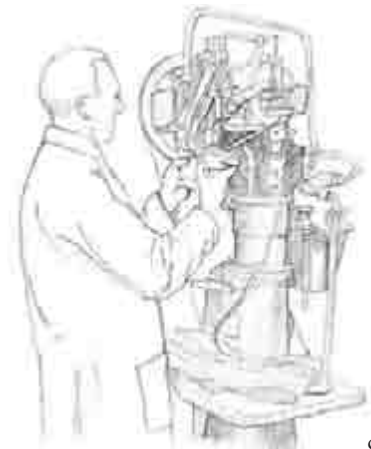
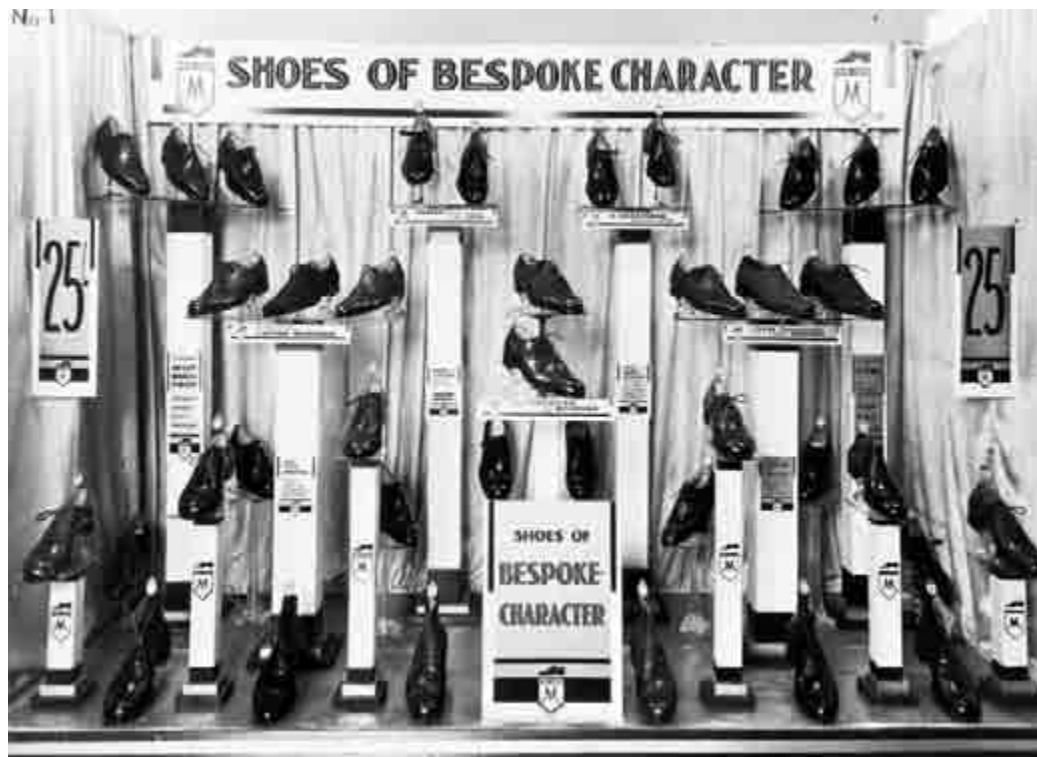
Fig 11 *This diagram identifies the principal parts of a man’s boot, made of welted construction. It is surrounded by illustrations of machines used in the boot and shoe industry:*

overtaken by machinery (Fig 11) – notably by the Blake Sole Sewer, the Goodyear Welter and the Standard Screw Machine – and brought into the factory. By the end of the century lasting (pulling the closed upper over the last in preparation for sole attaching) and finishing (trimming, colouring, buffing and polishing the finished article) had also been mechanised and brought ‘indoors’ (into the factory). In this way, outworking declined as factories expanded. By the early 20th century outwork was largely restricted to the most skilled shoemakers, who continued to make considerable quantities of high-quality bespoke and orthopaedic footwear by hand. Ironically, many of those who abandoned their workshops for the factory floor were compelled to do so by the factory hands’ union. In 1894 it brokered an agreement with manufacturers, stipulating that no processes were to be undertaken outside factories, except closing.

forces was enormous, including Russian Cossack boots, rope-soled boots for the tank corps, submarine deck boots and mosquito boots, as well as the standard B5 British infantry boot (similar to the boot depicted in Fig 11).

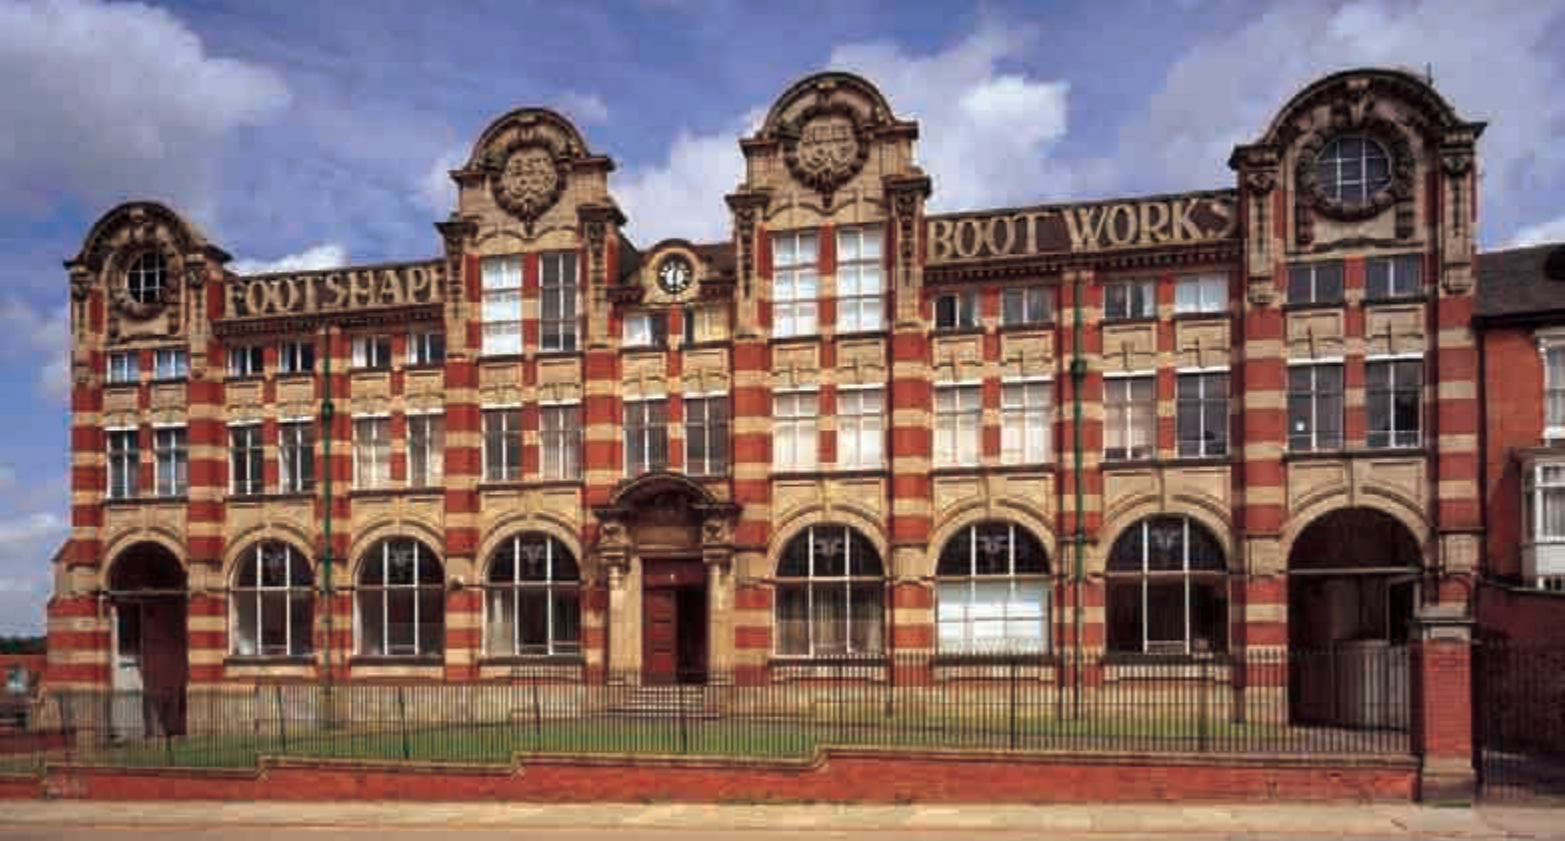
Fig 13 Barratt's Footshape Boot Works in Northampton was designed by the specialist shoe-factory architect Alexander Ellis Anderson and opened in 1913. The lettering on the neo-baroque front range, which served as a conspicuous advertisement for the company, was inspired by Castle Ashby, a country house 17.5 kilometres from Northampton. Barratt's closed in 1997, and the single-storey factory, located behind the front range, was demolished following a serious fire. [BB001829]

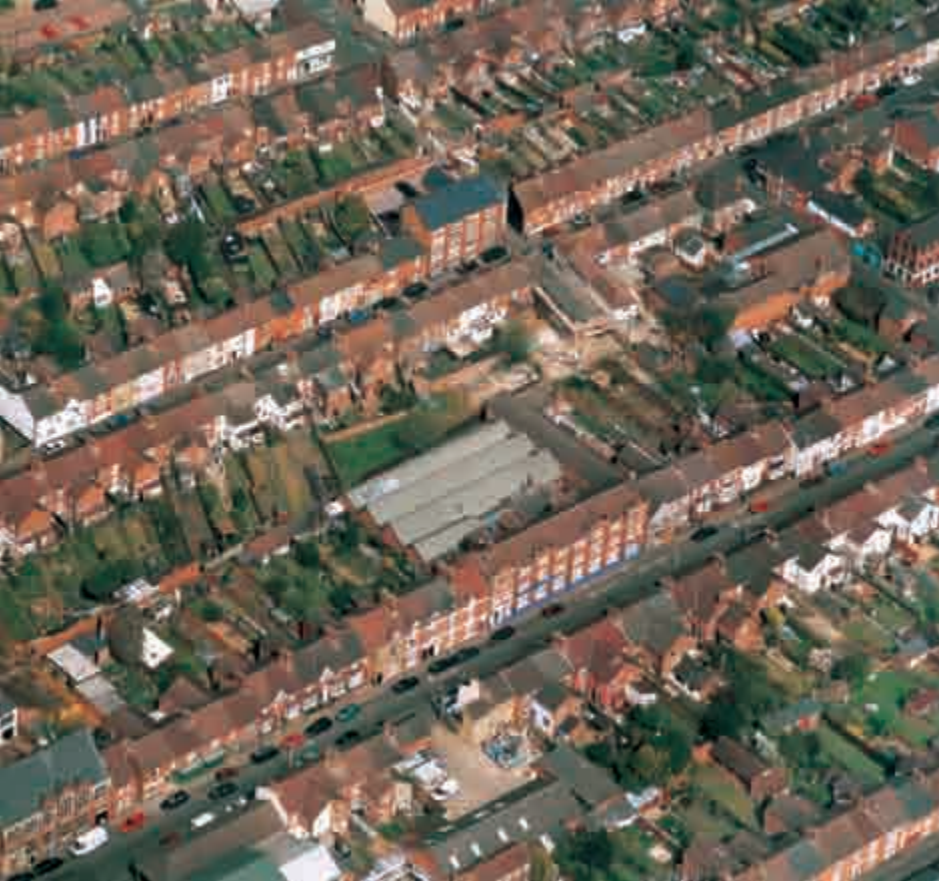
Fig 15 *An aerial photograph of Wood Street and Havelock Street in Kettering, showing late 19th-century factories interspersed with terraced housing. Outworkers' workshops can be seen in many of the narrow gardens. [NMR 23034/19 SP 8679/3]*

In contrast to Northampton, individual outworking was common in Kettering, which specialised in cheap riveted boots for labourers. As many as 2,000 small, detached workshops survive in the town, with a particular concentration in the Havelock Street and Wood Street district (Fig 15), which was largely developed by the local manufacturers William Meadows and John Bryan between 1876 and 1883. There, back

Fig 58 *This building at 37 Regent St, Kettering (see Fig 15), exemplifies the successful reuse of a former factory as a retail unit, in this case a bedding showroom. This is an ideal 'loose-fit' solution, requiring few internal or external alterations. The factory, with its attractive original windows, still forms an integral part of a characteristic urban street scene: industrial and domestic buildings sit together in harmony, creating an unbroken line, extending right up to the pavement. Scenes such as this, which encapsulate the unique character of the Northamptonshire boot and shoe industry, can be protected by selectively designating conservation areas. [AA044169]*

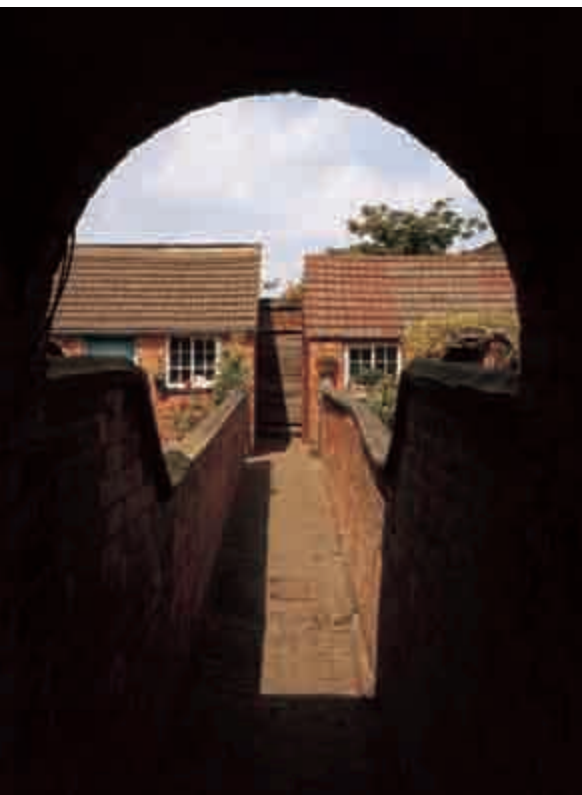
Fig 16 (above, left) Kettering workshops viewed through a 'jitty', or 'tunnel', running through a row of terraced houses. [AA044198]

alleys and 'tunnel-back' terraces (Fig 16) enhanced communications between garden workshops and factories. The single-storey brick workshops abut the rear walls of gardens behind the terraced houses. They usually have a monopitch roof, a corner or rear-wall fireplace or stove, and a large timber-framed window overlooking the garden. Most of the Kettering workshops date from the 1880s, although some are clearly older. The outworking system entered a decline in the 1890s, but garden workshops continued to be built in Kettering until at least 1913 – much later than in comparable industries such as wool and cotton – and many were still being used for their original purpose in the 1960s.

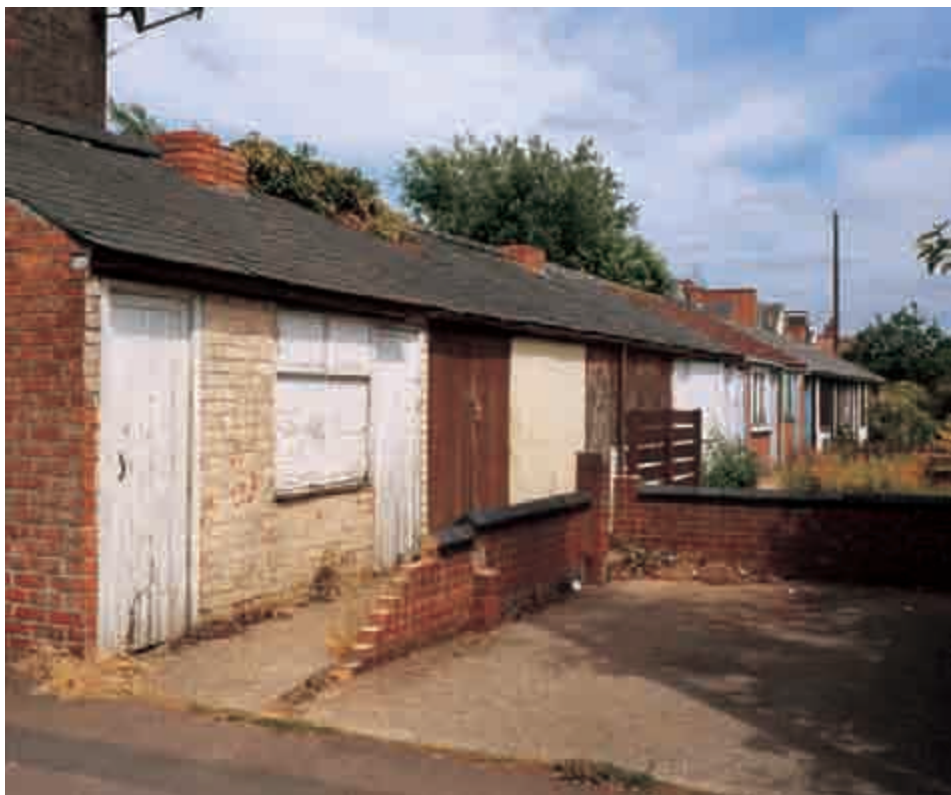
Fig 17 (above, right) This row of workshops lies behind a terrace which sits at right angles to New Street in Rothwell. The houses and workshops are served by separate footpaths. Most of these workshops are now used simply as garden sheds, but notice the remains of the brick chimney stacks. [AA044165]

Single-storey, detached workshops like those in Kettering can be found throughout the county (Fig 17), although not in such a dense concentration. Another distinct type of workshop was built over a store and/or privy. The main benefit of this arrangement was that the first-floor workshop admitted more light than a ground-level one.

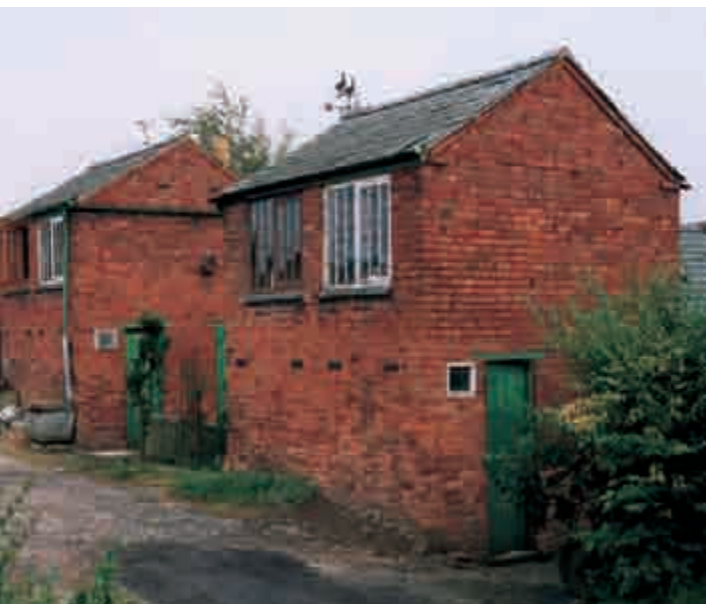
Fig 18 (above) These two-storey outbuildings are arranged in pairs behind terraced houses on East Street, Long Buckby. Each unit comprises a first-floor workshop over a store and water closet. A single-storey outbuilding in the same row is depicted in Fig 14. [BB013371]

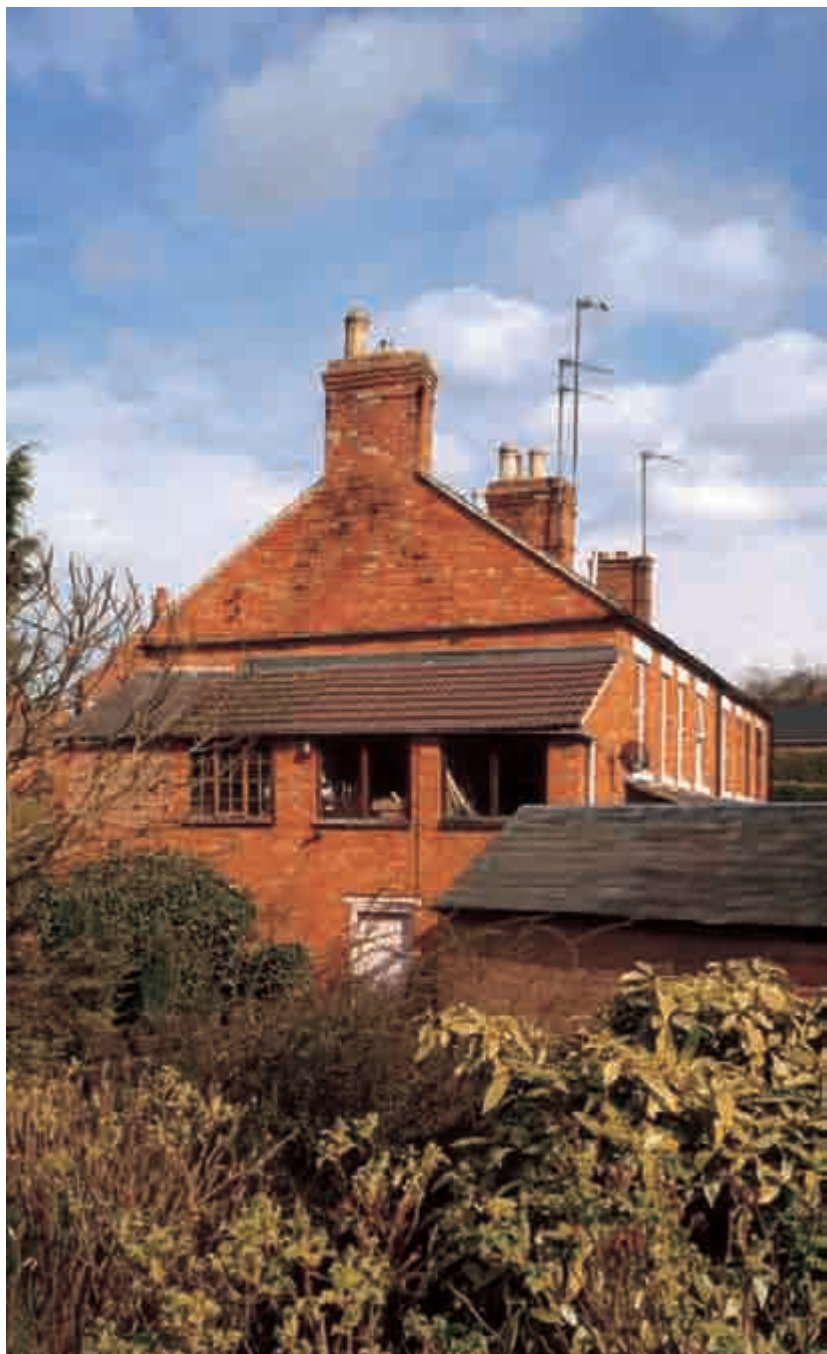
Fig 19 (right) At Rotton Row in Raunds, a set of four tiny workshops, originally with identical windows, occupies the first floor of a lean-to, built against the gable end of a short terrace. Each workshop had its own entrance and ladder stair. [AA026814]

Particularly well-preserved examples behind East Street in Long Buckby (Fig 18) were built by a local co-operative society about 1890, and extended in 1898. While most workshops of this type were detached, a row of four first-floor workshops in Raunds (Fig 19) was built against the end of a terrace. Single-storey workshops attached to individual houses, yet another variation on this adaptable building type, were more common. In the village of Walgrave, for example, workshops usually abutted the sides or backs of houses. Those behind Crispin Cottages (Fig 20), a four-house terrace on Baker's Lane, were built in 1895, but after 1900 it became increasingly rare for new houses to incorporate working space in this manner.

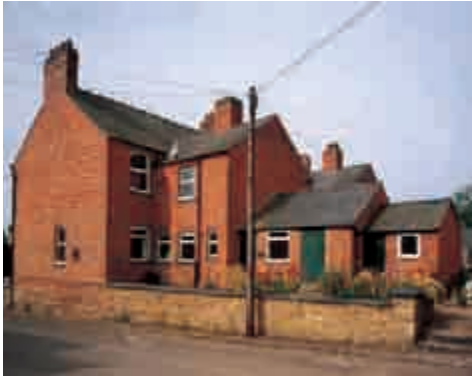
Fig 20 *Crispin Cottages in Walgrave were named after St Crispin, the patron saint of shoemakers. The terrace bears a datestone reading 'SW 1895'. The initials belonged to Stephen Norton Walker, whose shoe factory on Walker's Acre – recently converted into flats – was the only one in the village. Undoubtedly, Walker employed outworkers who worked in the 'cottage shoe shops' attached to the rear of the houses. [AA044182]*

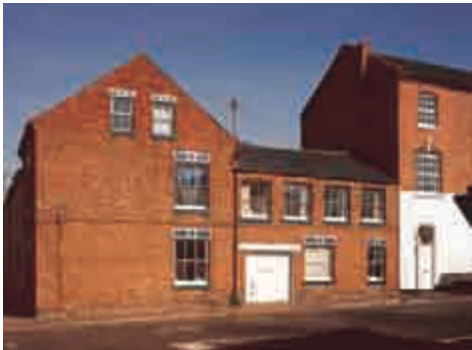
Fig 21 *A rear-range workshop at 20 Bailiff Street and Robert Street, Northampton, probably built for a machine closer about 1870. The house lies to the left. The three-storey building to the right was erected as a factory in 1869, but has been converted to residential use. [AA026830]*

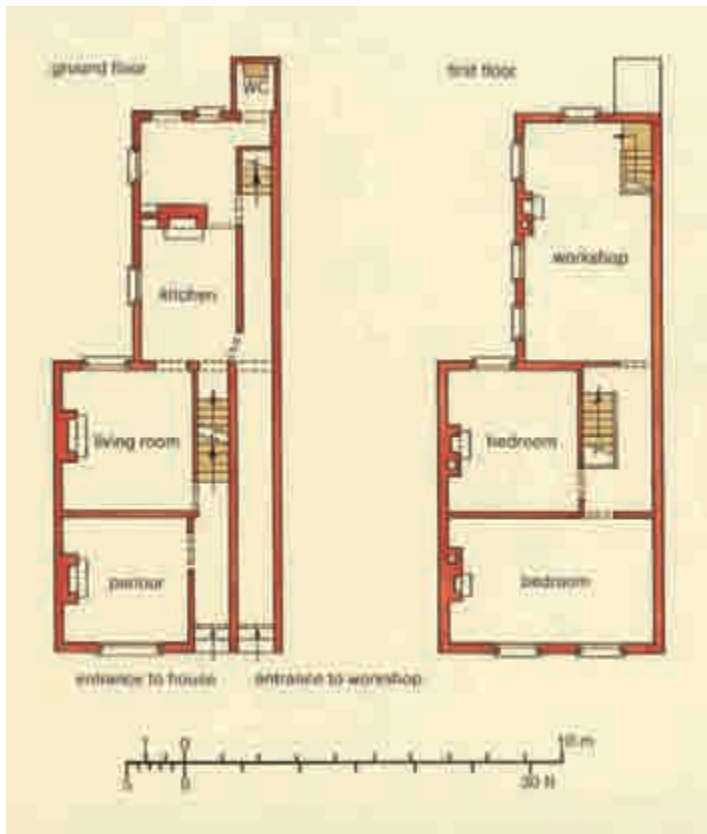
Fig 22 (above) A small first-floor workshop formed part of 53 Alcombe Road, Northampton, which is a mid-terrace house. The workshop had its own staircase, approached through a separate entrance and a passage that ran along the side of the property. This has now been incorporated within the house. [Redrawn from a survey by Brian Giggins]

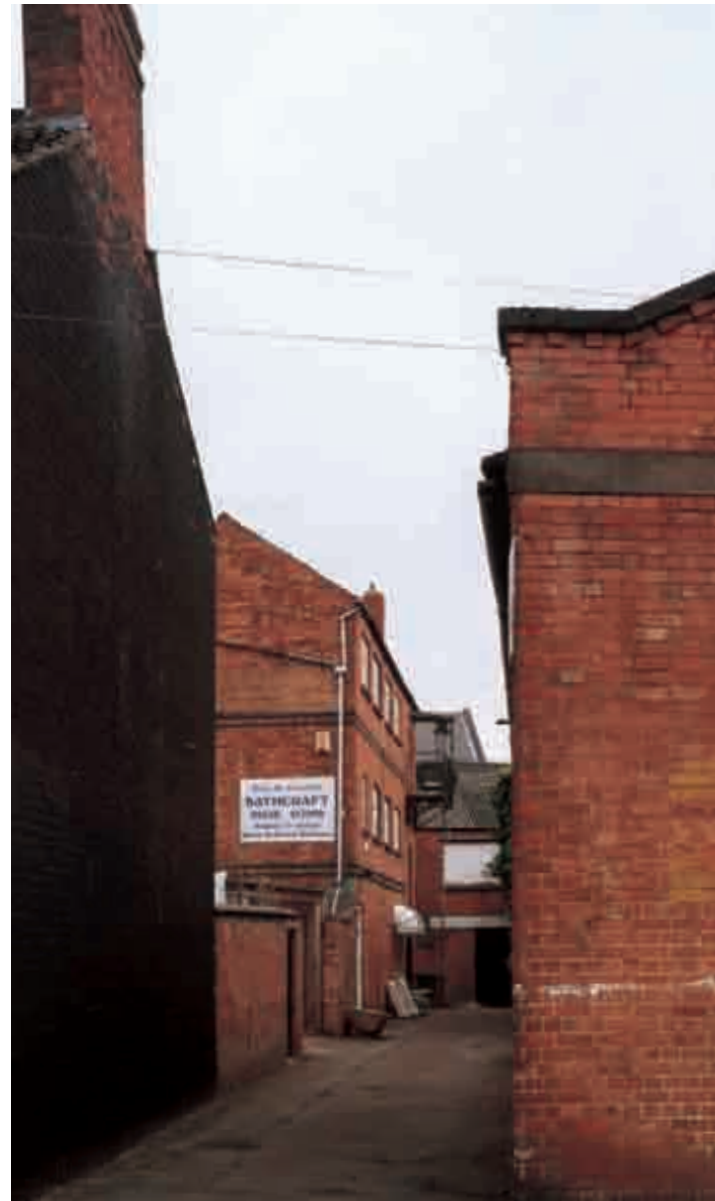
Fig 23 (right) A small, detached factory of the 1860s or 1870s hides behind an end-of-terrace house at the west end of Havelock Street, Kettering. [AA044173]

A number of large workshops and small factories took the form of detached buildings (Fig 23), erected on gardens behind houses rather than being incorporated within their footprint. These were usually, but not inevitably, in the same ownership or occupation as the house. Some achieved a considerable size, but, as part of the local streetscape, they remained less visible than the stand-alone factories of the wholesale boot and shoe manufacturers.

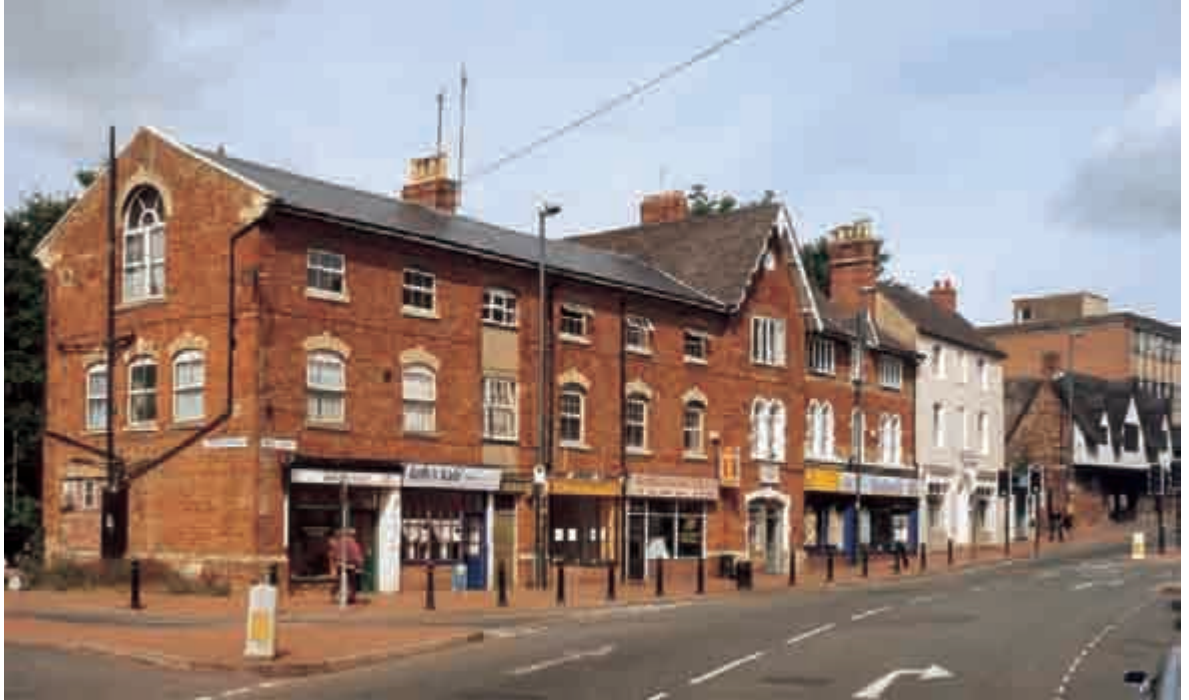
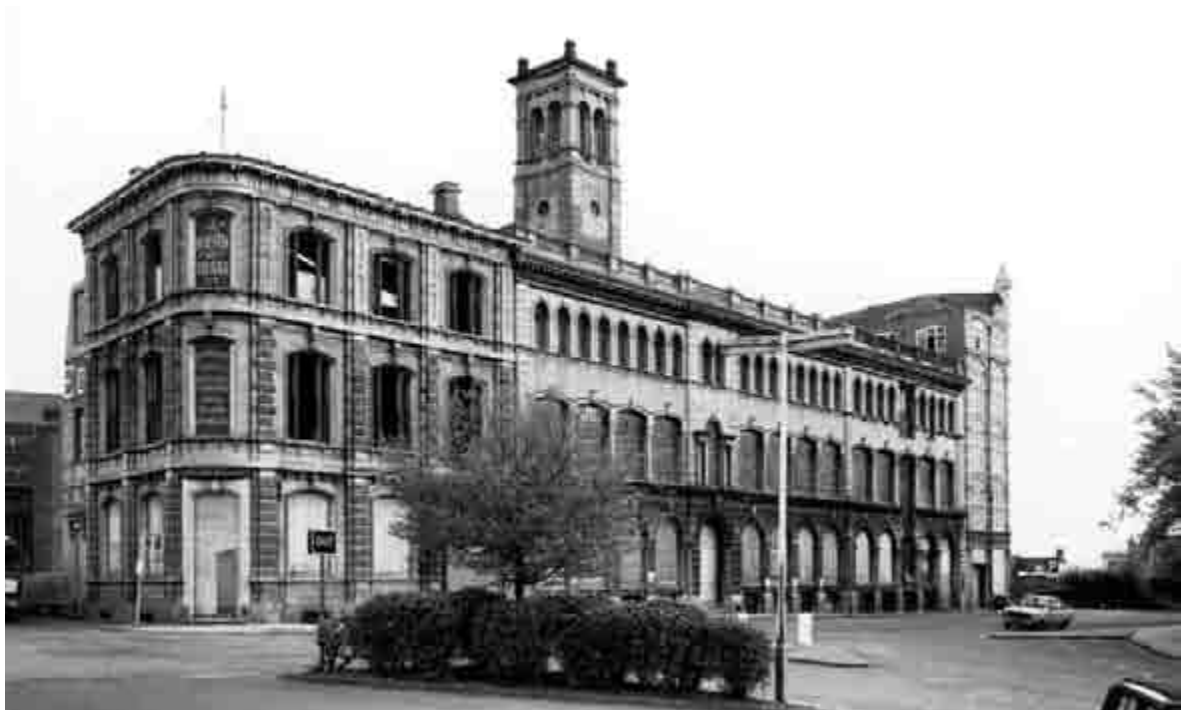
Fig 24 Sharman’s shoe factory (left) and house (right) of about 1850, on Sheep Street, Wellingborough. Unlike most later factories, this building is of stone, and originally had sash glazing. [AA044212]

Fig 25 The demolition of the Northampton factories of Isaac, Campbell’s (left, on corner) and Manfield’s (right, with ‘campanile’) in 1982 is a matter of regret. Our understanding of the boot and shoe industry has improved immeasurably in the last twenty years, and we have learnt to appreciate this kind of industrial landmark. [BB82/7720]

Factories dating from the 1850s and 1860s are rare and of considerable interest. They include the former Trafalgar Works (Fig 24) on Sheep Street, Wellingborough, which shares the street frontage with the house of the owner, Nathaniel Pearce Sharman. A similar arrangement can be seen at 3 New Street, Daventry, premises belonging to John Line (later Line & Cattell), where a double-pile warehouse or factory was built alongside an earlier house. These two sites represent a new departure, since maps of the period suggest that most factories were situated behind houses, lying at right angles – rather than parallel – to the street. This latter pattern of development can still be seen in other industrial towns, such as the Jewellery Quarter of Birmingham.

Isaac, Campbell’s and Manfield’s factories (Fig 25) both opened in 1859. They were located side-by-side on Campbell Square and were demolished in 1982. The huge factory belonging to Isaac, Campbell & Co was designed by William Hull. It had an ornate office block on the corner of Campbell Square and Victoria Street, and much plainer rear ranges. In this factory, both closing and (more unusually) making were brought indoors. The women employed to operate closing machines had their own separate workrooms, entrances, staircases and water closets. Initially, much of the men’s work was unmechanised. In what appears to

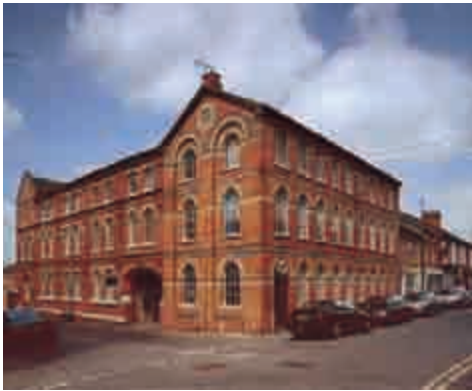
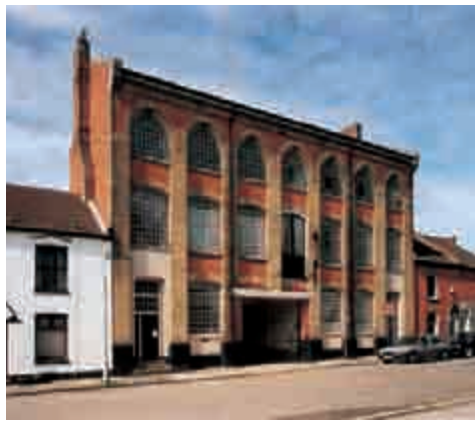
Fig 27 (top) In Kettering, several purpose-built footwear factories of the 1870s adopted a distinctive Italianate style. These included Spence & Page's Compton Works, erected on Field Street in 1878 and later extended to the left. The building has been converted into housing. [BB018467]

Fig 28 (bottom) This mid-Victorian factory on Palmerston Road, Northampton, has an unusual elevation in a reduced version of Venetian Gothic, with a giant order carrying pointed arches. The particularly large windows were retained when the building – now Palmerston House – was converted into flats. [BB018419]
