BUILT TO LAST?

The Buildings of the Northamptonshire Boot and Shoe Industry

Kathryn A Morrison with Ann Bond

Based on a survey directed by Adam Menuge

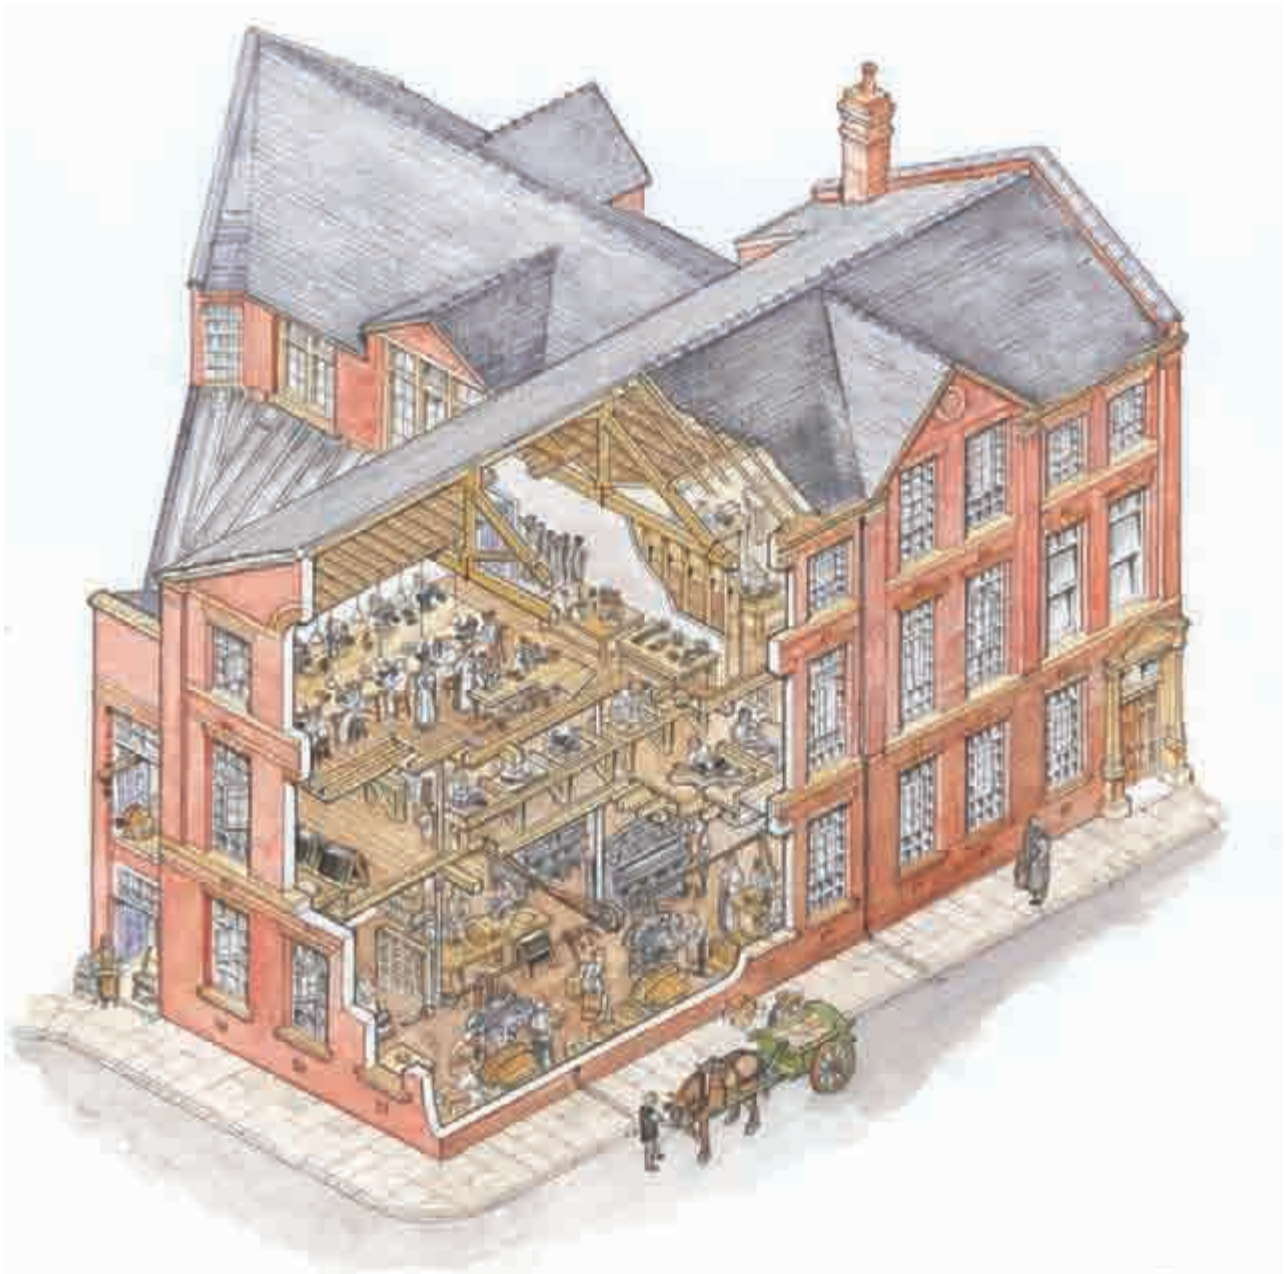
Fig 29 (left) *G T Hawkins's Northampton factory was designed by Charles Dorman and erected in 1886 on the corner of Overstone Road and Dunster Street (see Fig 7). It had a rough-stuff shop and riveters' shop on the ground floor, with clickers' rooms and a small closing room on the upper floors. The name of the factory's most famous product, 'Waukerz' footwear, is displayed over the office doorway.*

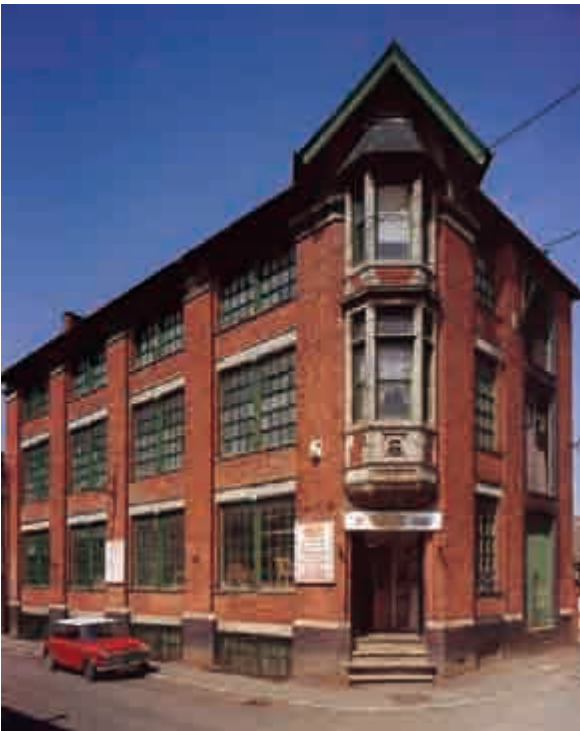
Fig 30 *The Havelock Works of Kettering Co-operative Boot and Shoe Manufacturing Society was built in 1890: note the relief and motto on the oriel window. Factories often occupied corner sites to obtain maximum lighting. In such cases it was common for the corner bay to contain a prestigious entrance leading to offices, which is the arrangement here.* [BB001992]

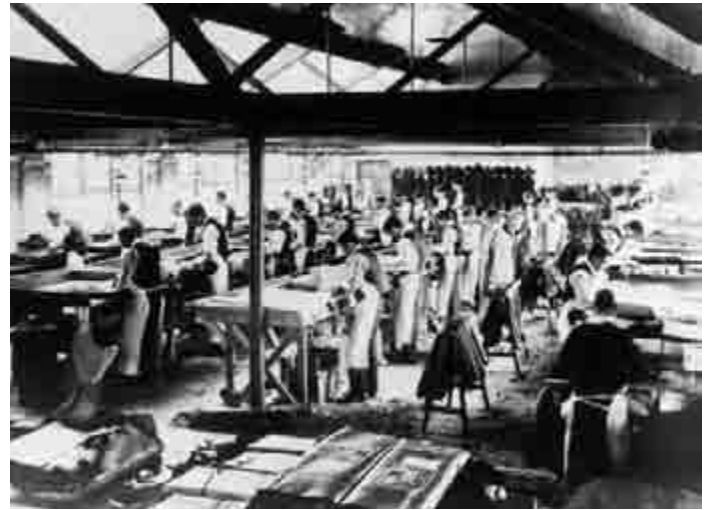
Fig 31 (above, left) Manfield's rough-stuff department, with revolution presses for bottom-stock cutting, in the 1920s. At this stage, the different components of boots and shoes were carried around the factory in wicker baskets, which can be seen in the foreground. Pattern racks can be seen against the far wall. [Northampton Museums and Art Gallery]

The main processes carried out on factory floors were rough-stuff cutting and clicking. Rough-stuff cutters (Fig 31) were positioned in the basement or on the ground floor because they used heavy presses. Clickers (Fig 32), who cut leather by hand, were generally accommodated on upper floors, since their main requirement was copious light. Some buildings were laid out with small open areas or yards on all sides, just so that clickers could benefit from as many windows as possible. The clickers stood at benches facing the windows, with storage racks or tables arranged behind them.

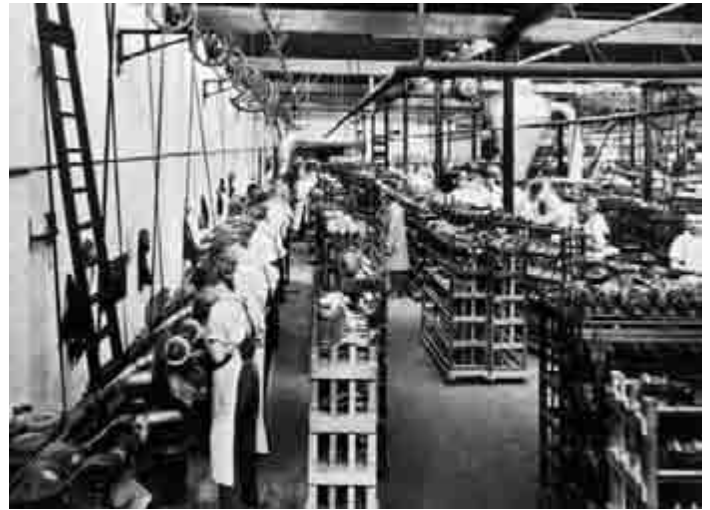
Fig 34 (above, right) The finishing room of Manfield's Northampton factory in the 1920s, with men buffing shoes in the foreground. Note the large dust extractor in the background. Once shoes were fully assembled they were transported around the factory in wheeled racks rather than baskets. [Northampton Museums and Art Gallery]

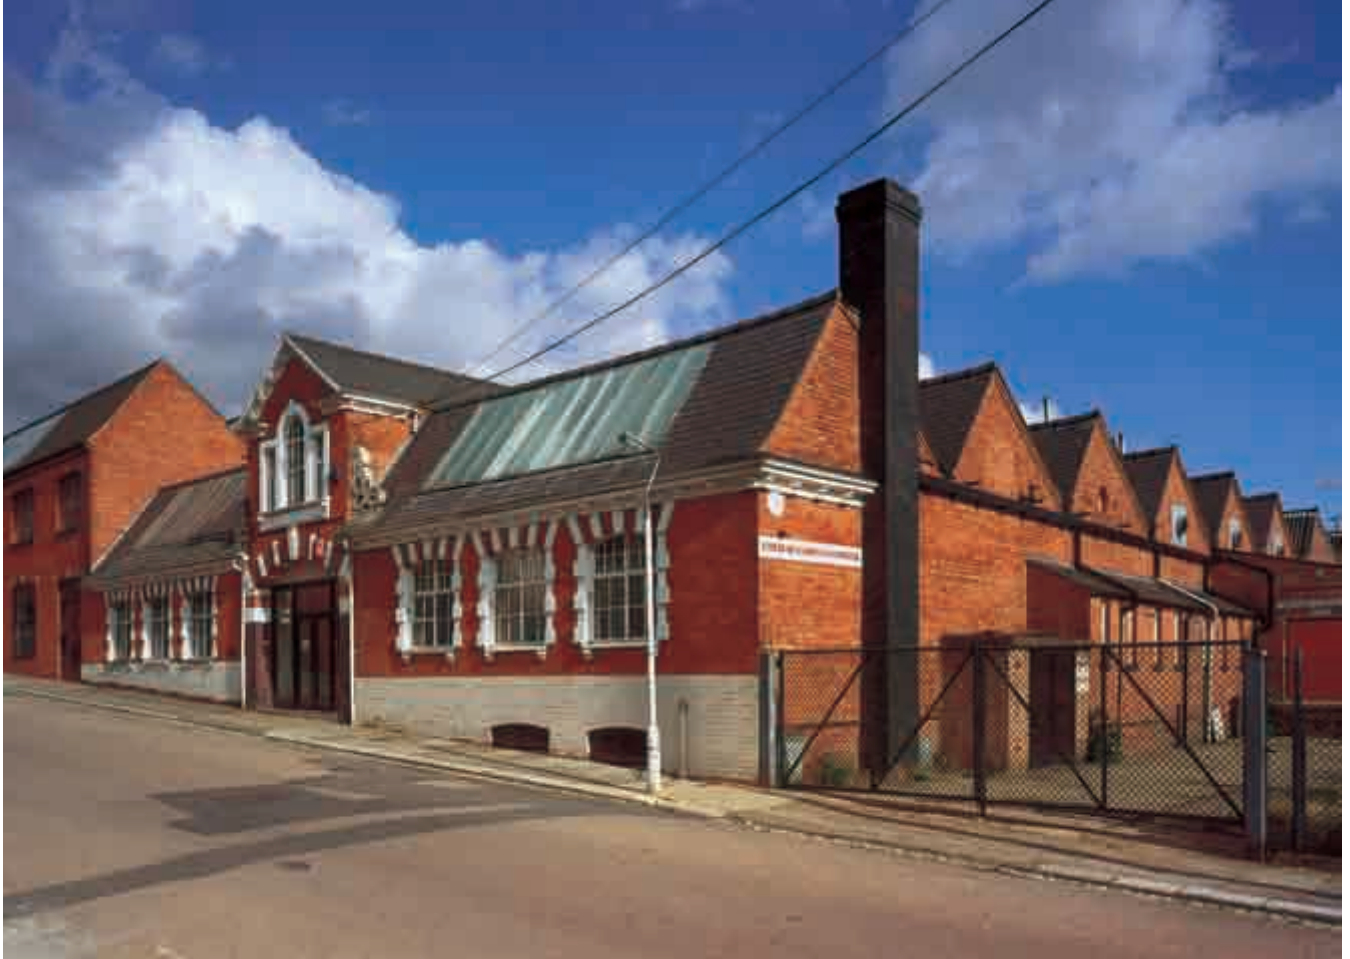
Fig 35 *A Lee's Enterprise Factory was built on Bective Road, Northampton, in 1902. The north-facing slopes of the sawtooth roofs contain skylights.* [BB013273]

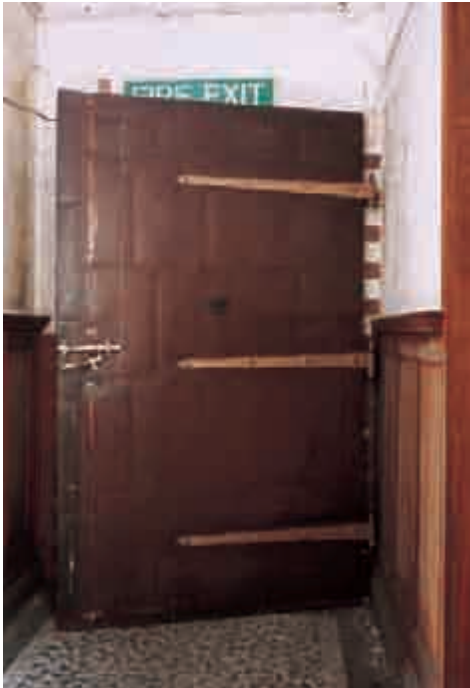
Fig 37 *A Mather & Platt fire door in G T Hawkins's Northampton factory, separating the office suite from the production floor. It was installed in 1915.*
[AA044154]

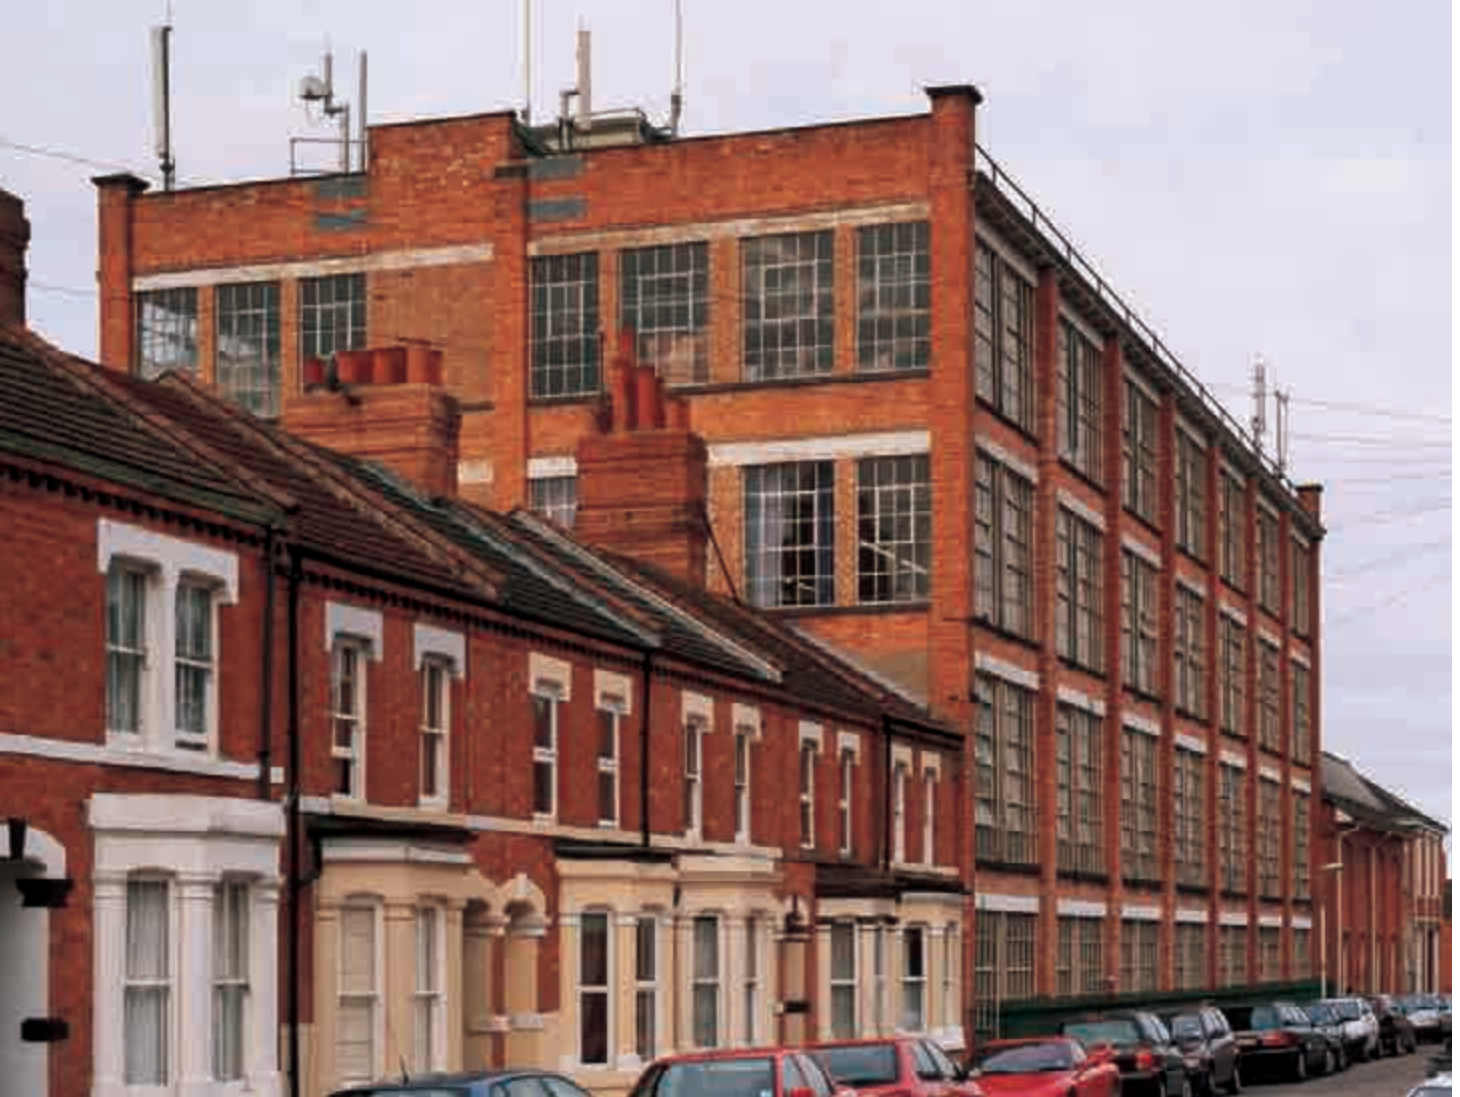
Fig 38 *The premises of Crockett & Jones were built in a number of phases between 1889 and 1935. This four-storey block with basement, which dominates adjoining terraced housing on Turner Street, Northampton, was designed by Brown & Mayor and built in 1910. It was probably the first steel-framed building in the town. [AA044180]*

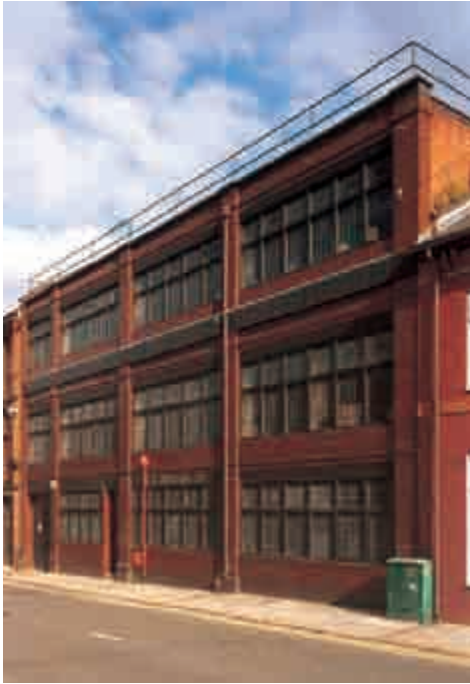
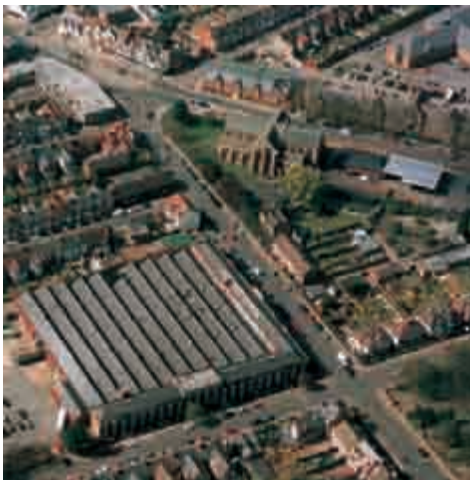
Fig 39 (right, top) *Tricker's originated in London, but moved to Northampton in 1903. The factory at 54–60 St Michael's Road has an unusual glazed brick façade, erected in 1924. The firm still employs about 70 people who make 700 pairs of shoes a week. It supplies the Royal Household and is entitled to use the coat of arms of the Prince of Wales. [AA044206]*

Fig 40 (right, bottom) *This aerial photograph shows (to bottom left) the CWS factory on Christchurch Road, Northampton, built in 1923–4 and now successfully reused for a range of light industrial businesses. All three CWS shoe factories in Northamptonshire were designed by the CWS architect, L G Ekins. Top right, the surviving front range of Manfield's Wellingborough Road factory of 1892, one of the first factories in the town to be listed, can be glimpsed. [NMR 23033/01 SP 7761/26]*

In comparison with previous decades, very few new factories were erected in the 1920s (Figs 39 and 40). The most notable single-storey factories of the decade were built in Northampton and Wellingborough by the Co-operative Wholesale Society (CWS), which had already erected a large factory in Rushden before the First World War. The CWS produced good footwear at reasonable prices, and had a dependable market in the shops of co-operative retail societies, while other manufacturers struggled to find an outlet for their goods. After the Depression, some factories were built in an impressive Modern style. The most outstanding of these was erected in 1938 for John White (Impregnable Boots) Ltd on Higham Road, Rushden (Fig 41). It was designed by Sir Albert Richardson, and may have been the first and only footwear factory in the county to be floodlit at night. Factories built since 1945 – ranging from Barker's hutted extension of 1950 to

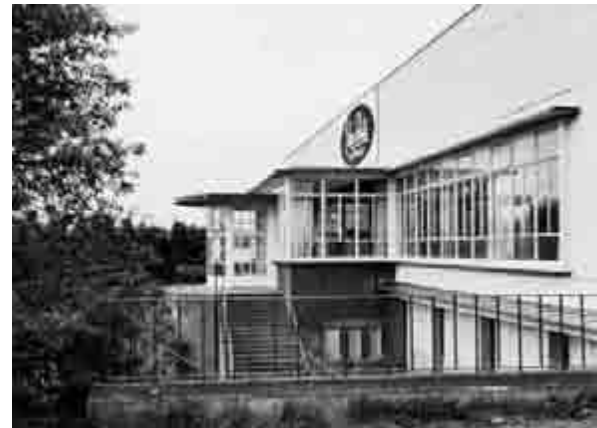
Fig 41 *John White's Rushden factory was built in a garden setting in 1938. White considered it to be the most beautiful factory in the shoe trade and was upset when the authorities removed the railings to help the war effort. The factory closed in the 1990s and has been converted into apartments. [BB97/05800]*

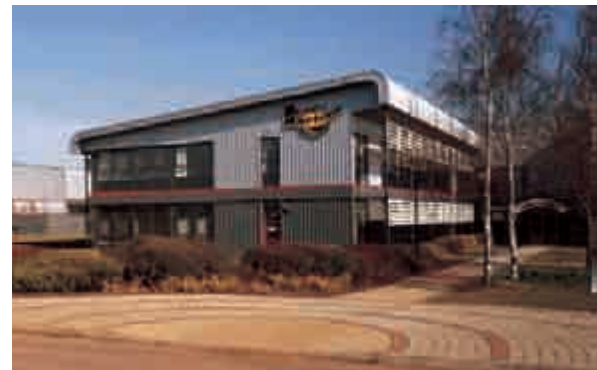
Fig 42 *R Griggs & Co's factory was built on the outskirts of Irthlingborough in 2000. It is in a modern hi-tech style, reflecting the image of the company's Dr Martens footwear. Although superior to the average out-of-town industrial unit, it is already redundant. It closed following the firm's announcement, in 2002, that it was moving all of its production to China, with the loss of more than 1,000 jobs. [AA026817]*

R Griggs & Co's hi-tech building of 2000 (Fig 42) – are essentially utilitarian and seldom exhibit the panache of their predecessors.

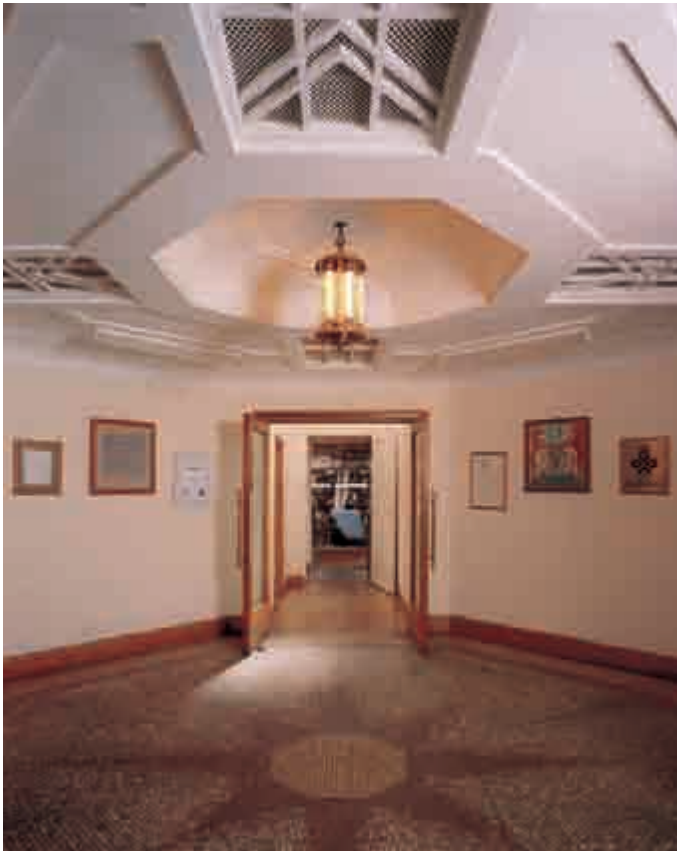
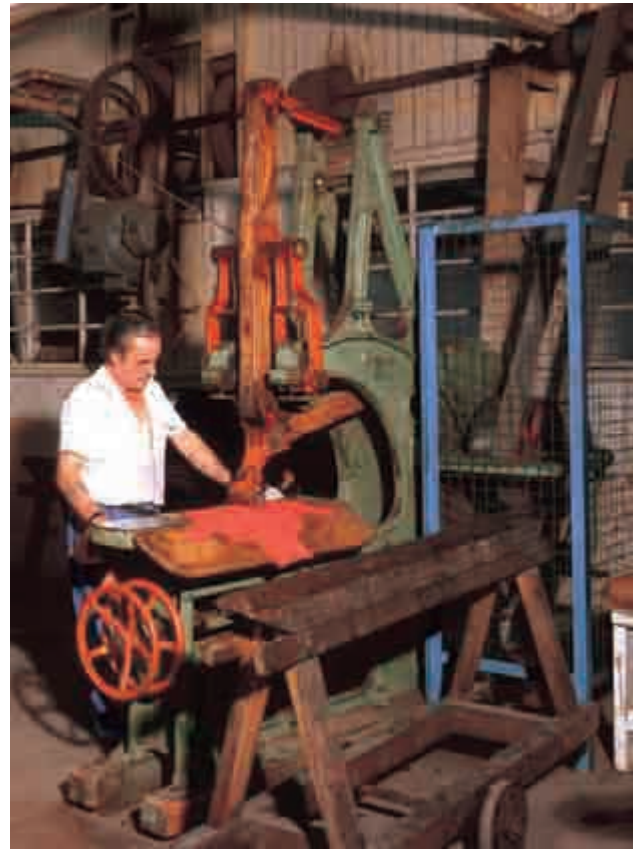
Figs 43 and 44 *W Pearce's tannery was designed by Wilfrid Lawson Carter and built in the years 1937–9 in spacious landscaped grounds at Billing Park, outside Northampton. These photographs show the stylish interior of the administration block lobby (with a view through to the production floor), and glazing machinery inside the factory. Although the building is listed, its future is uncertain. [BB018400; BB018411]*

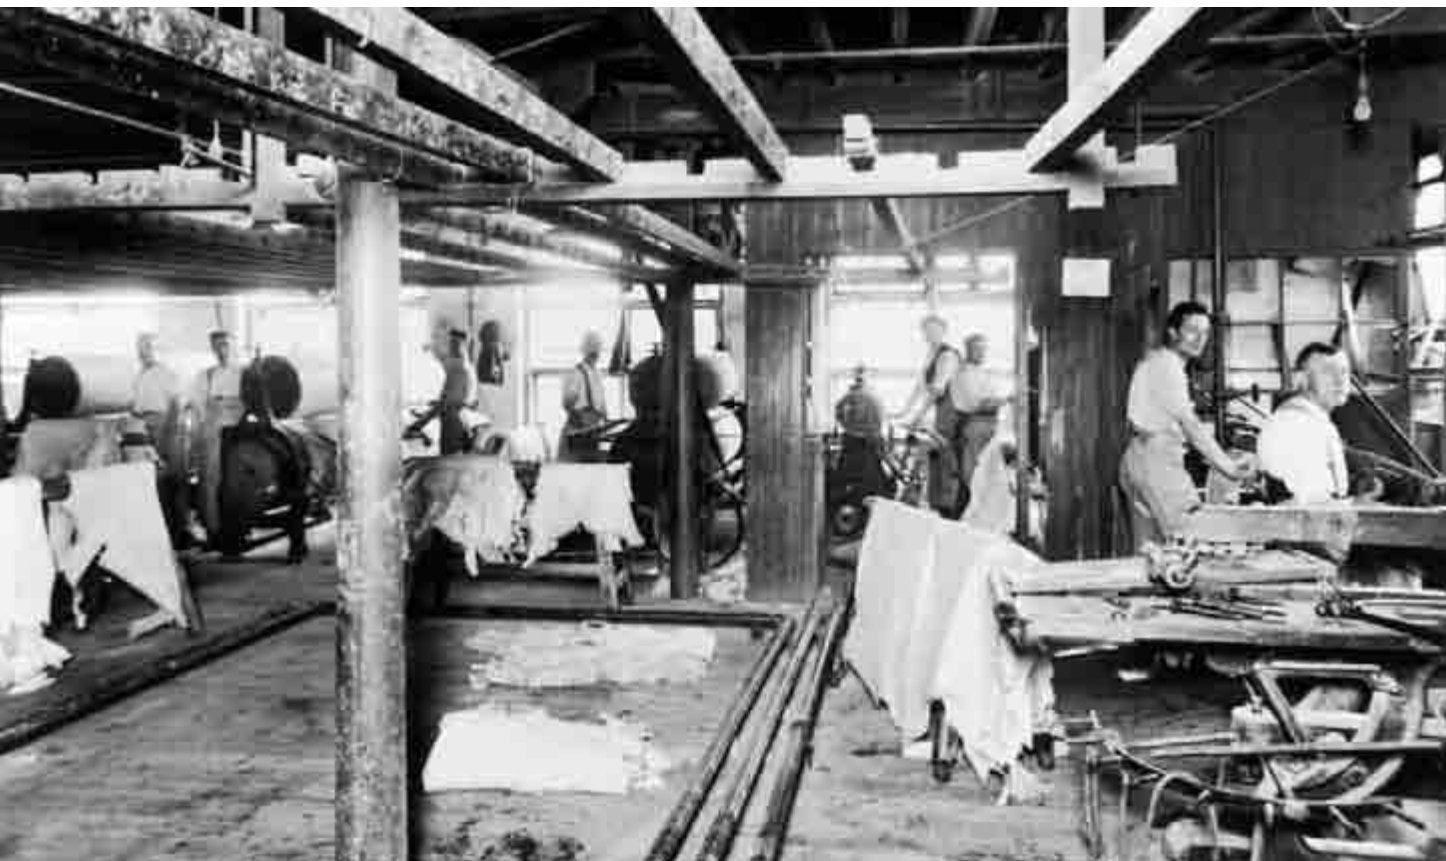
Fig 45 In 1899 the currying firm of Dickens Bros moved into a very simple four-storey factory, built by the local firm of A P Hawtin, on Kettering Road, Northampton. This photograph of 1929 illustrates the first floor of the factory. [BB99/05290]

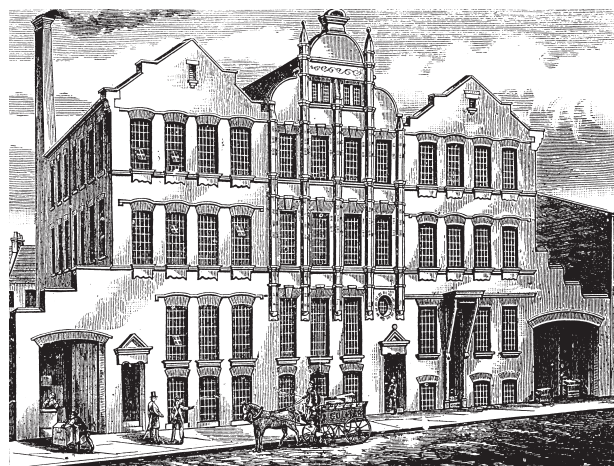
Fig 47 The Jacobean-style Globe Leather Works was built at 4-6 Dunster Street, Northampton, for Collier's in 1887 and extended in 1889. The building is currently empty, but has planning permission for conversion to flats. [From The Boot and Shoe Trades Journal, Supplement, 7 March 1891; Northampton Museums and Art Gallery]

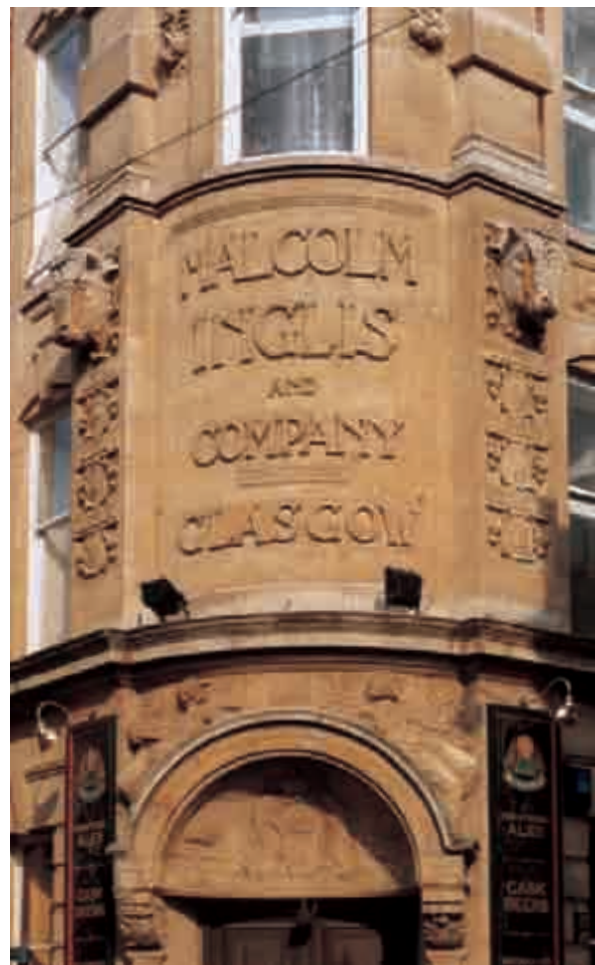
Fig 48 *The Northampton premises of the Glasgow-based leather merchants Malcolm Inglis & Co, designed by Alexander Ellis Anderson, are decorated with bulls' heads. This building at 50 Fish Street has recently been converted into apartments after a spell as a public house. Built in 1900, it stands opposite the firm's earlier warehouse, which was by the architects Mosley & Anderson. [AA044176]*

Wholesale leather merchants from all over the country opened establishments in Northampton. From impressive town-centre premises (Fig 48), equipped with offices and sample rooms, they sold leather to the commercial travellers or buyers who flocked to Northampton, as well as to local manufacturers. Several of these firms, such as Brice's, also had their own leather works.

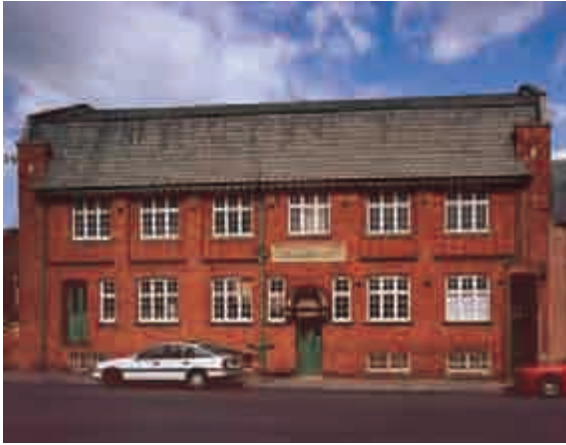
Fig 49 (above, left) *The deceptively domestic-looking Perfecta Works in Kettering was built in 1904 to a design by Timson, Bullock & Barber. A wide variety of boot and shoe machinery was manufactured in this building. [BB029378]*

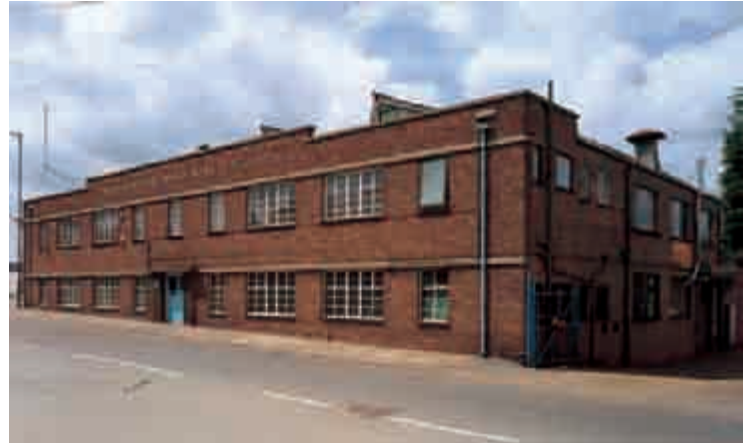
Fig 50 (above, right) *The Northamptonshire Machinery Co Ltd factory on Balfour Road, Northampton, was designed by Sir John Brown & A E Henson and built in 1937. It has recently been demolished. Lt Gen Sir John Brown was articled to Charles Dorman in the 1890s and designed an innovative extension for Crockett & Jones (see Fig 38) with his first professional partner in 1910. [BB001827]*

Northamptonshire abounds in industrial buildings that owe their existence to the boot and shoe industry, but were not actually used to process leather or to manufacture footwear. In particular, a great deal of shoe machinery was made in the county. The oldest machinery works included Henry Mobbs's Lion Foundry and Vulcan Works in Northampton (Cow Lane and 34–8 Guildhall Road respectively), Owen Robinson's Champion Works in Kettering (Victoria Street) and Salmon & Co's Victoria Works, also in Kettering (Victoria Street). In 1888 the Northampton Shoe Machinery Co was founded by seven major manufacturers, first to market American lasting machines, then to manufacture them under licence. It erected new premises on Earl Street in 1888–9, comprising an office, showroom and machine store to the front, and a single-storey workshop to the rear. Later machinery works included the Arts and Crafts style Perfecta Works (Fig 49) on Catesby Street, Kettering, and the recently demolished Northampton Machinery Co Works (Fig 50) on Balfour Road, Northampton.

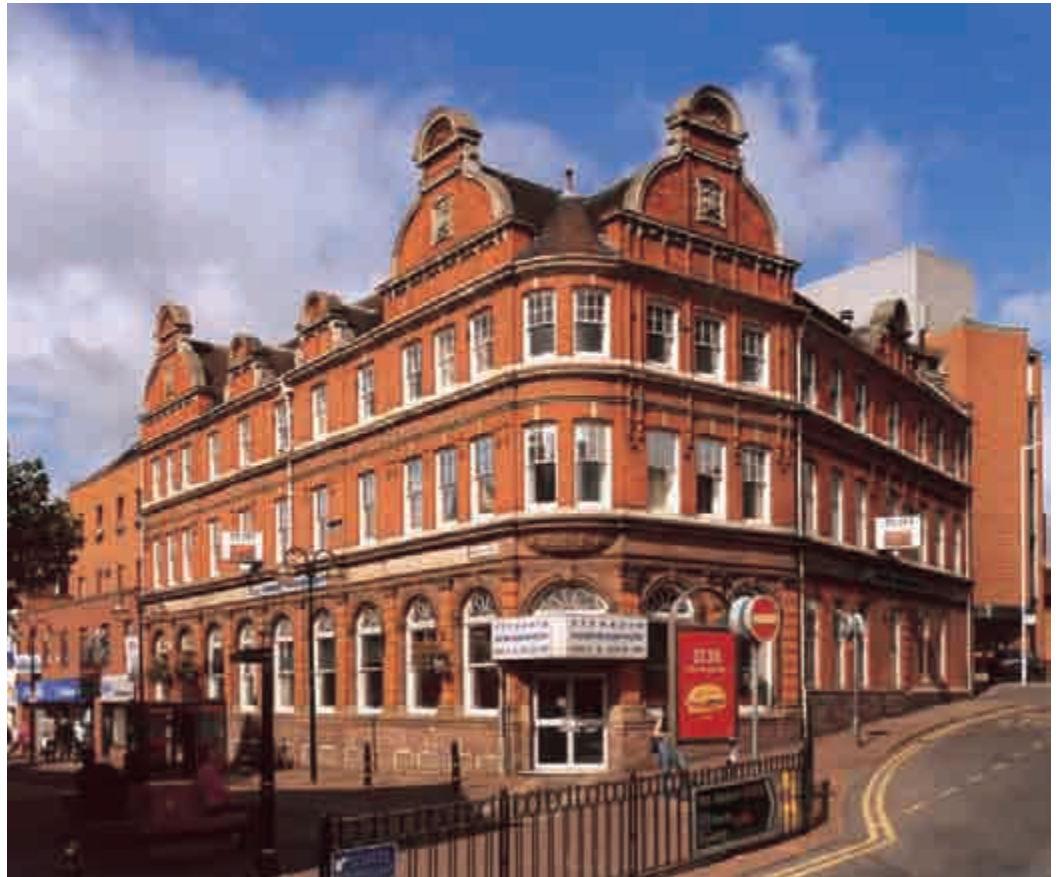
Fig 51 (right) *Goodyear Chambers, Abington Street, is a landmark building in the centre of Northampton. It was built as a machinery warehouse in 1891, to designs by the local architect Edmund Law, and was extended in 1931 in a matching style. [BB013406]*

The most prominent commercial machinery warehouse in Northampton was Goodyear Chambers (Fig 51), a dignified building on the corner of Abington Street and Lower Mounts. Goodyear was one of three companies that amalgamated in 1899 to form the British United Shoe Machinery Company, which leased machinery – produced in the firm's works in Leicester – to manufacturers. The company erected several repair depots throughout Northamptonshire, including premises in Kettering (1910, School Lane), Rushden (c 1910, Midland Road) and Northampton (1923, Upper Mounts).

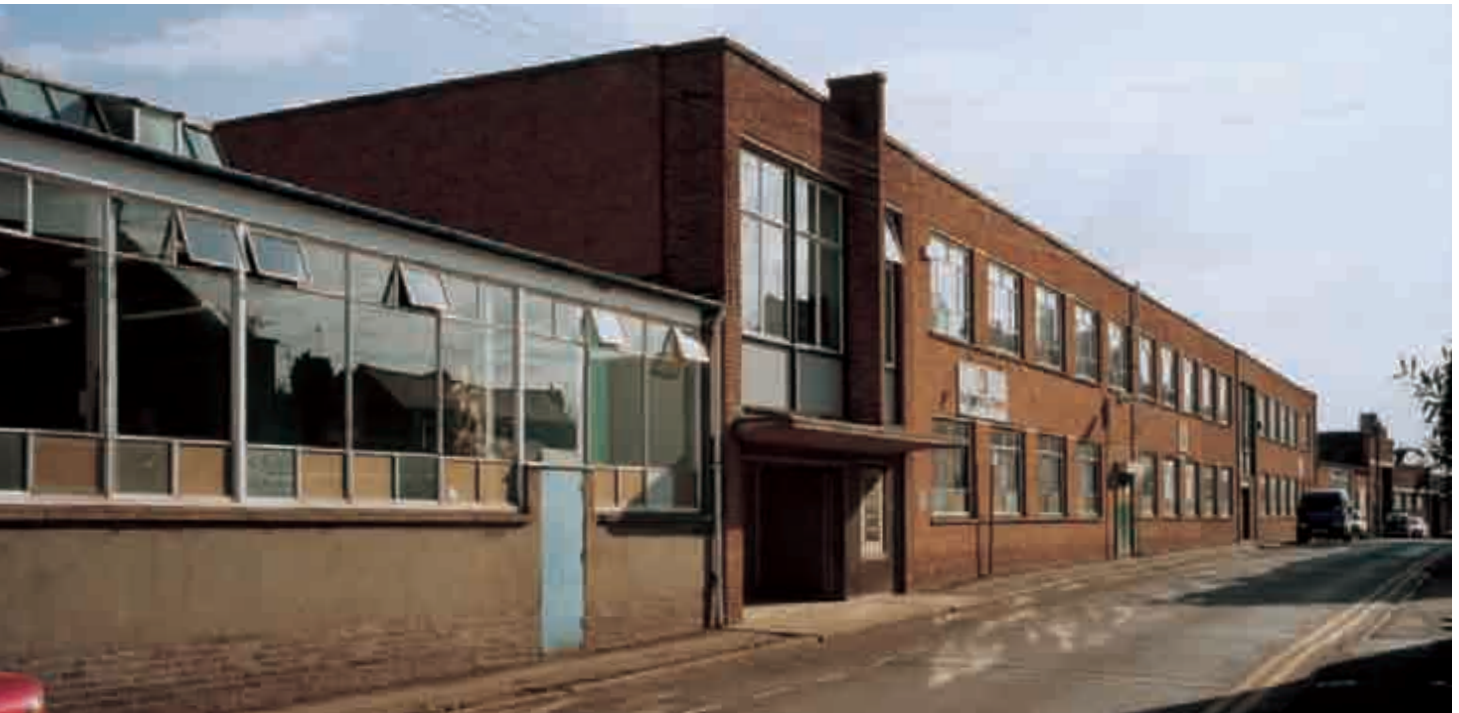
Fig 52 The last works of Mobbs & Lewis (from 1964 Mobbs Miller) in Kettering was built in the years 1961–3, and was one of the largest post-war manufacturing plants serving the boot and shoe industry. It has now closed. [AA044209]

Once the components of shoes were made up, they were assembled over lasts to give them their shape. The last factory of O A Miller – an American manufacturer – was built on Arthur Street, Northampton, in 1896 and is now a shoe factory. Another important last manufacturer was Mobbs & Lewis. The firm's 'Easy-Exit' last, produced from 1885, prevented the back seam bursting when the last was extracted from the finished shoe. The Mobbs & Lewis factory (Fig 52) in Carrington Street, Kettering, was entirely rebuilt between 1961 and 1963, at a time when the company was switching from Canadian maple to plastic. One year later, in 1964, the O A Miller Last Co Ltd merged with Mobbs & Lewis to become Mobbs Miller. Another very important last works was R Whitton's, built at 21 St James's Road, Northampton, in 1932, and currently empty.

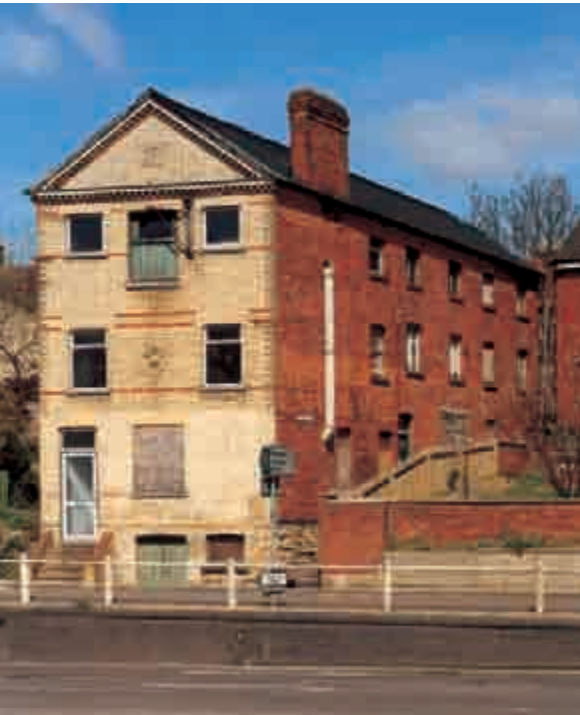
Fig 53 *The boot and shoe factory at 83 High Street South, Rushden, was built in 1874. A two-storey house at the front of the building, served by a broad stack, is sandwiched between the basement and upper floor of the factory. This ingenious idea, prompted perhaps by the steeply sloping site, does not seem to have caught on. The entire building is now in residential use. [BB001997]*

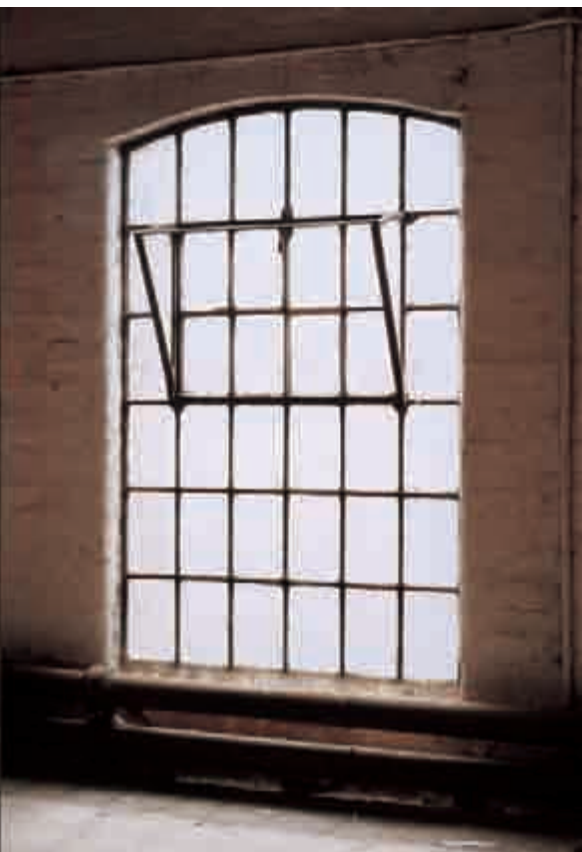
Fig 55 A typical cast-iron window which says 'factory' to us all, lighting the first floor of the former Hawkins's factory on St Michael's Road, Northampton. One of the most effective ways of safeguarding the character of factory and workshop buildings is to retain these original windows. Note the low sill, the opening hopper and the hot-water heating pipes. [AA044156]

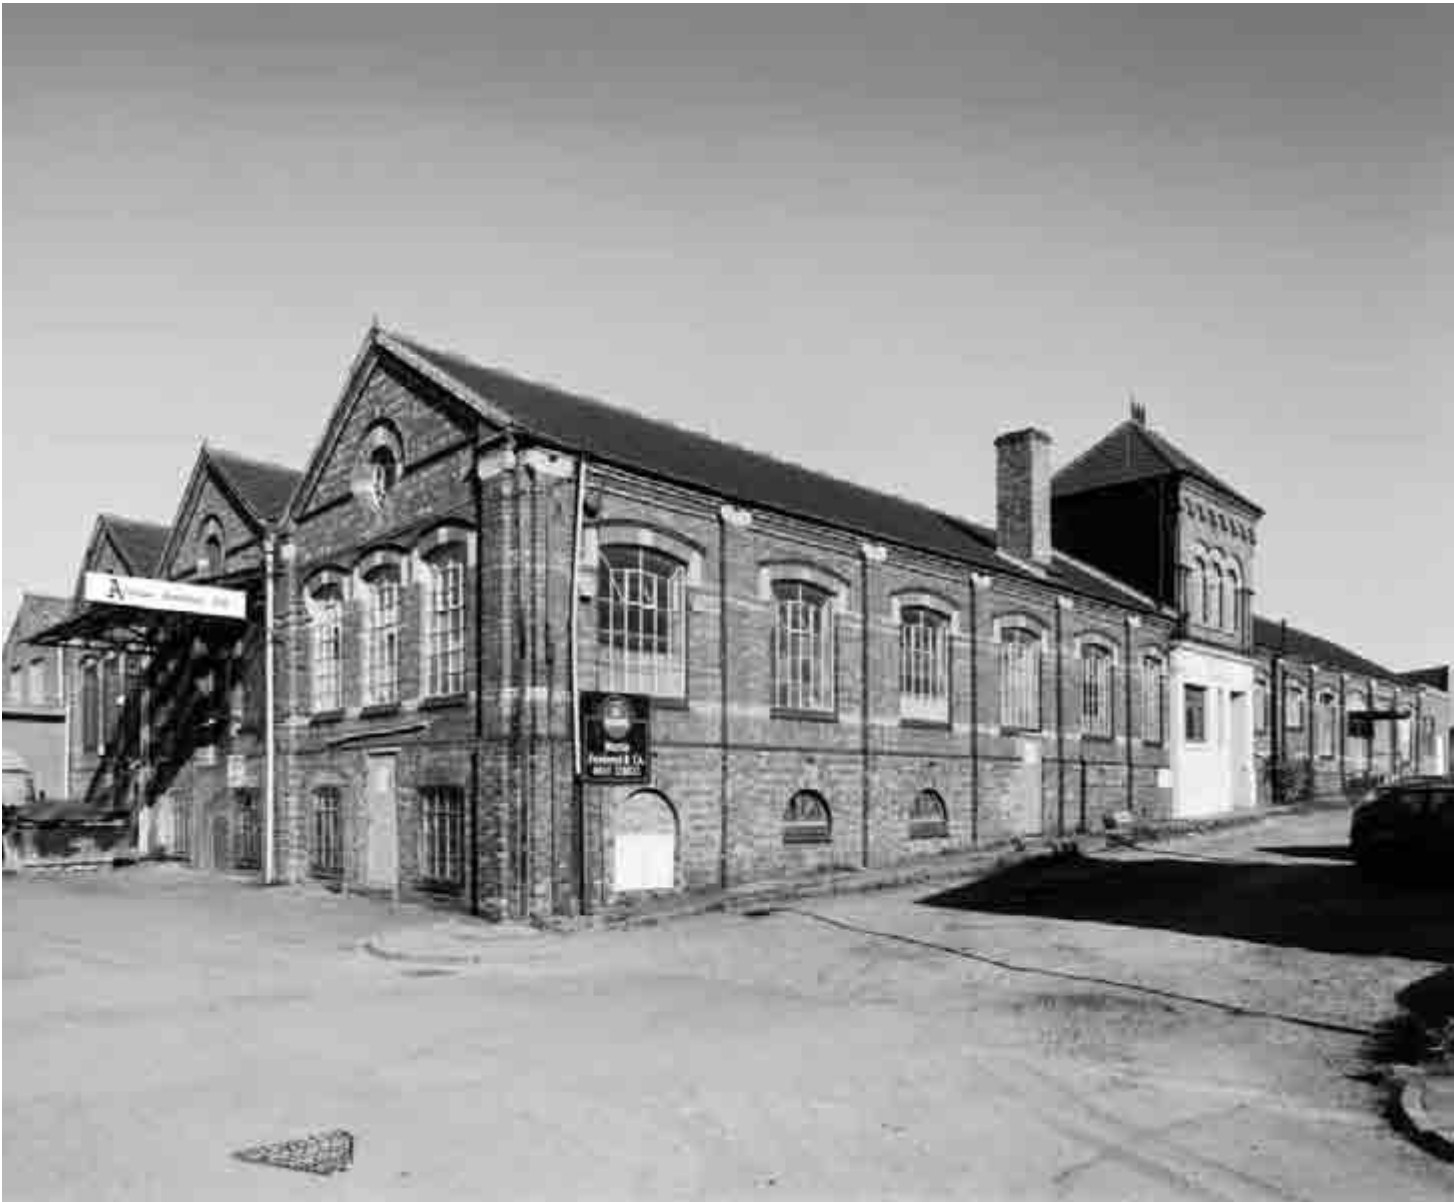
Fig 56 *The Britannia Slugging Machine Works, Oak Street, Rushden, demonstrates the vulnerability of boot and shoe buildings. It was built in 1899 as an engineering works producing riveting machinery for the footwear industry. It was constructed in a charming Italianate style with surprisingly elaborate detailing. Adapted to footwear production by Artisans Footwear Ltd, it remained in production until the 1990s. Despite its potential for reuse, it was demolished in 2002, and the site redeveloped for housing. [BB001748]*

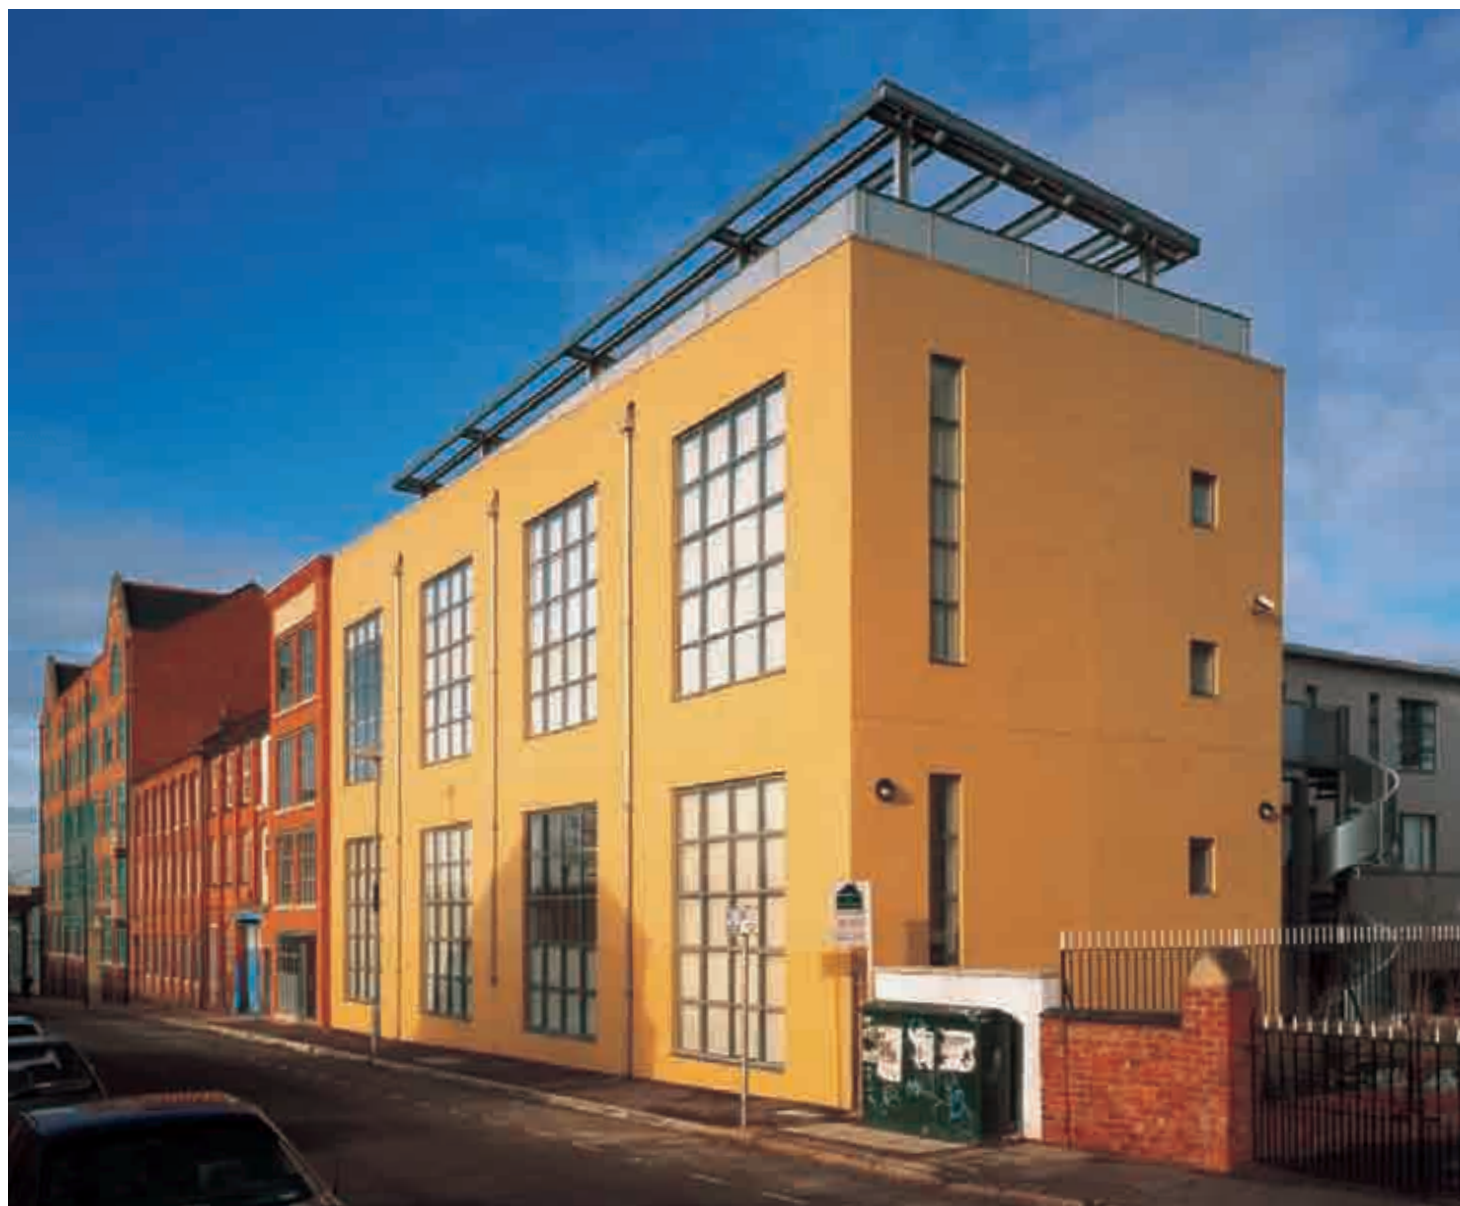
Fig 57 A combination of redevelopment and reuse has regenerated Duke Street in Northampton, which was home to Church's main factory until the late 1950s. This view, taken in December 2003, can be compared with the frontispiece image of this book, shot in 1999. The building in the foreground, an apartment block called the Lightbox (2001), occupies the site of Heggs's curriery, which was damaged by fire in 2000. [AA044240]

There is a growing recognition that the successful reuse of historic buildings can be a major factor in bringing about the regeneration of historic areas (Fig 57). As well as ensuring that the character of particular buildings and whole areas is not eroded, it can contribute in a positive way to a more sustainable future. Not only is it sensible to reuse buildings on account of the 'embodied energy' costs (the real costs of producing and transporting the materials of which they are made), but reuse that encourages the integration of home and work need not depend so heavily on environmentally damaging transport. This approach is particularly applicable to the former footwear-producing areas of Northamptonshire, where the relationship between factories, workshops and homes was always intimate.

- 17 Duke Street. Church’s former factory was built in 1877 and was extended in 1893. (*See* Frontispiece and Fig 57.) Walking west along Louise Road and Lorne Road several other small factories of the 1870s and 1880s can be seen.

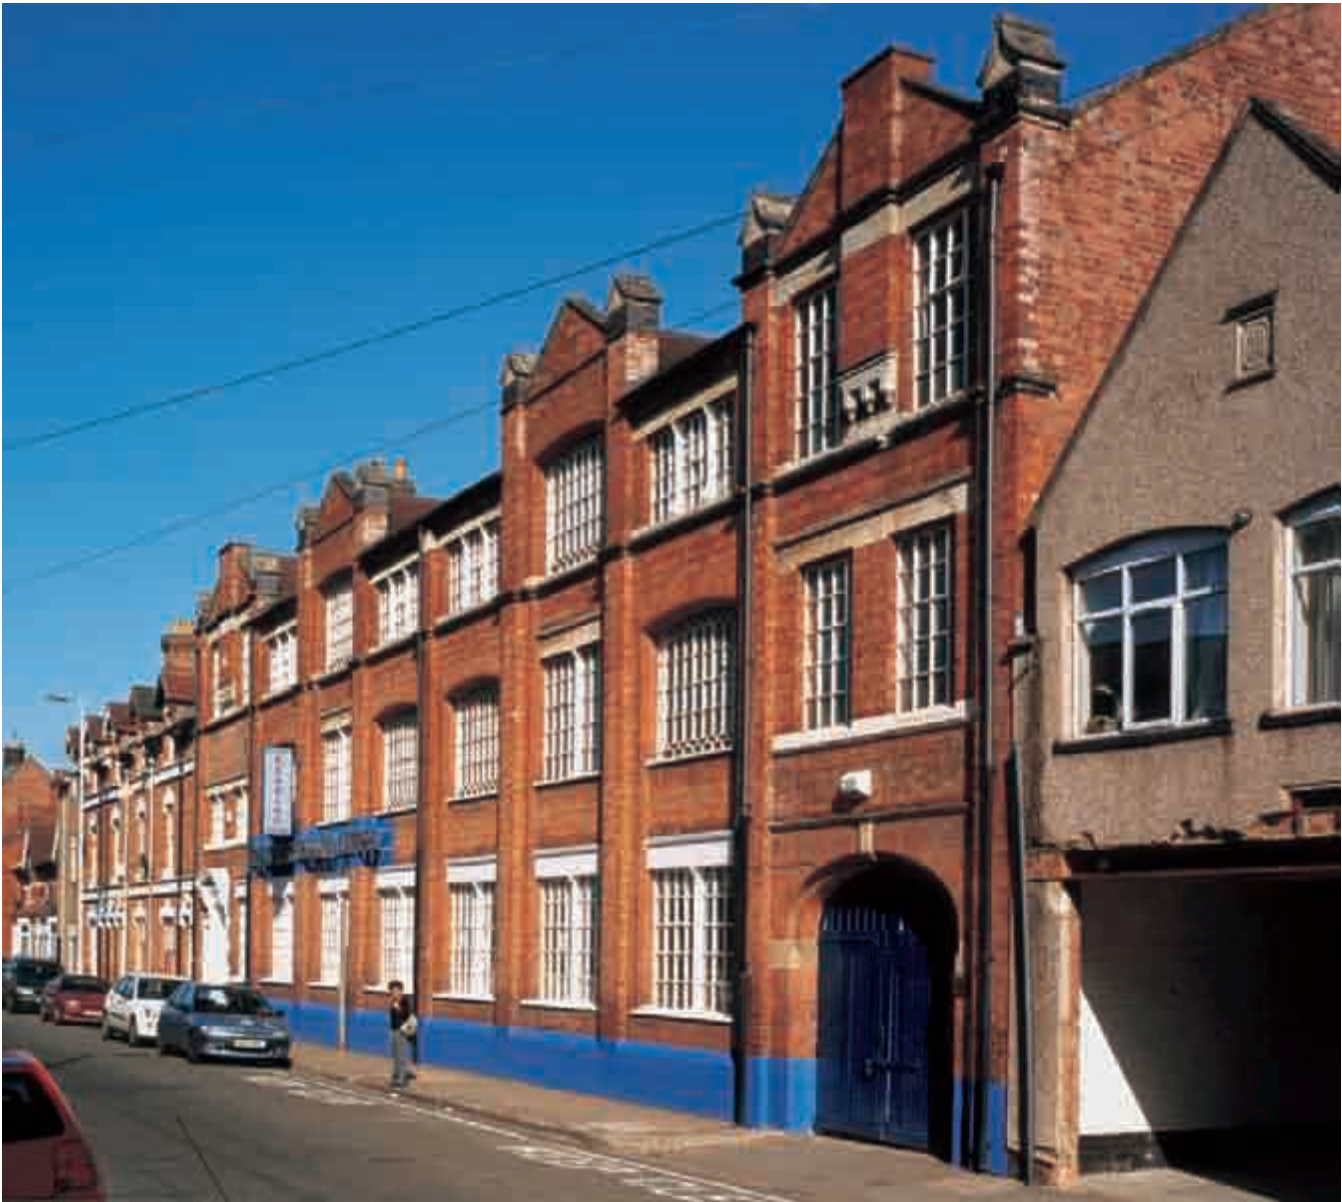
Fig 58 *This building at 37 Regent St, Kettering (see Fig 15), exemplifies the successful reuse of a former factory as a retail unit, in this case a bedding showroom. This is an ideal 'loose-fit' solution, requiring few internal or external alterations. The factory, with its attractive original windows, still forms an integral part of a characteristic urban street scene: industrial and domestic buildings sit together in harmony, creating an unbroken line, extending right up to the pavement. Scenes such as this, which encapsulate the unique character of the Northamptonshire boot and shoe industry, can be protected by selectively designating conservation areas. [AA044169]*

Fortunately, most of the surviving buildings relating to the industry can be adapted to new uses, including retail, light industrial or office use (Fig 58). Given a sympathetic and flexible approach, most can have a continuing economic future and still retain their special interest, character and historic fabric. Today the greatest pressure is for housing. This often requires more extensive alterations, and consequently greater loss of character, than other uses. The key to revitalising such historic
