Heritage at Risk

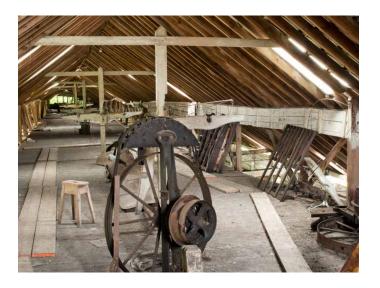
It was added to the Heritage at Risk Register this year because the listing was upgraded from Grade II to Grade II*. Ageing and weakness of joints, the collapse of surrounding banks and water running through the building have made it a very fragile structure.

Historic England, South Somerset District Council and one of the owners are working on a temporary solution involving propping and tying to support the structure. This should allow time for permanent repair and reuse solutions to be developed.
