Historic England

East of England Register 2016

East of England Summary 2016

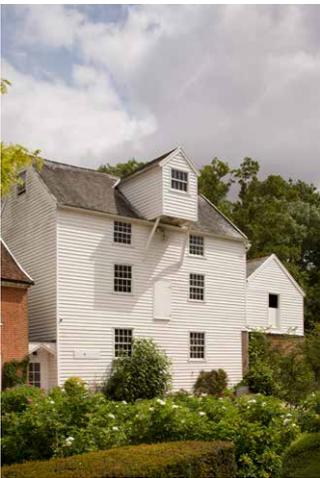
Kersey Mill **Ipswich, Suffolk**

Kersey Mill is a grade II* building which was added to the Heritage at Risk Register in 2014, after being in a deteriorating condition for many decades. New owners acquired the building in 2012 and immediately sought for a positive and sustainable solution to the structural issues and overall condition faced by the mill.

John Whitmore and Sons built the original section of the mill in 1810. It was later enlarged in 1868 with the introduction of a steam engine, large bolters (or sieve) and an elevator. This sophisticated array of equipment minimised the need for manual handling and produced fine white flour. The mill has over time been adapted to three main sources and phases of power: water, steam

and then gas. The milling machinery is still virtually complete and capable of sensitive repair and restoration to enable milling once again. The mill also has a fine iron waterwheel and the wheel pit has already been carefully repaired and rebuilt by the current owners.

The building is still substantially original, despite being subject to repairs and renewal over the years. However, a structural survey in summer 2015 discovered that two full-height principal posts, one axial beam and substantial areas of flooring were severely rotted and at risk of collapse. A leaky valley gutter and poor roof covering contributed to the rate of decay. The mill required urgent repair and replacement of these structural elements in order to reinstate structural integrity. A grant of £80,000 towards eligible costs of £101,760 was offered and accepted. The main elements of structural work were completed this summer to a high standard, resulting in a nomination for a Historic England Angel Award. The mill is now open to the public on selected open days.
