ENGLISH HERITAGE  
PRACTICAL BUILDING CONSERVATION

# METALS

## EXAMPLES OF WHAT TO LOOK FOR WHEN SURVEYING FERROUS METALS

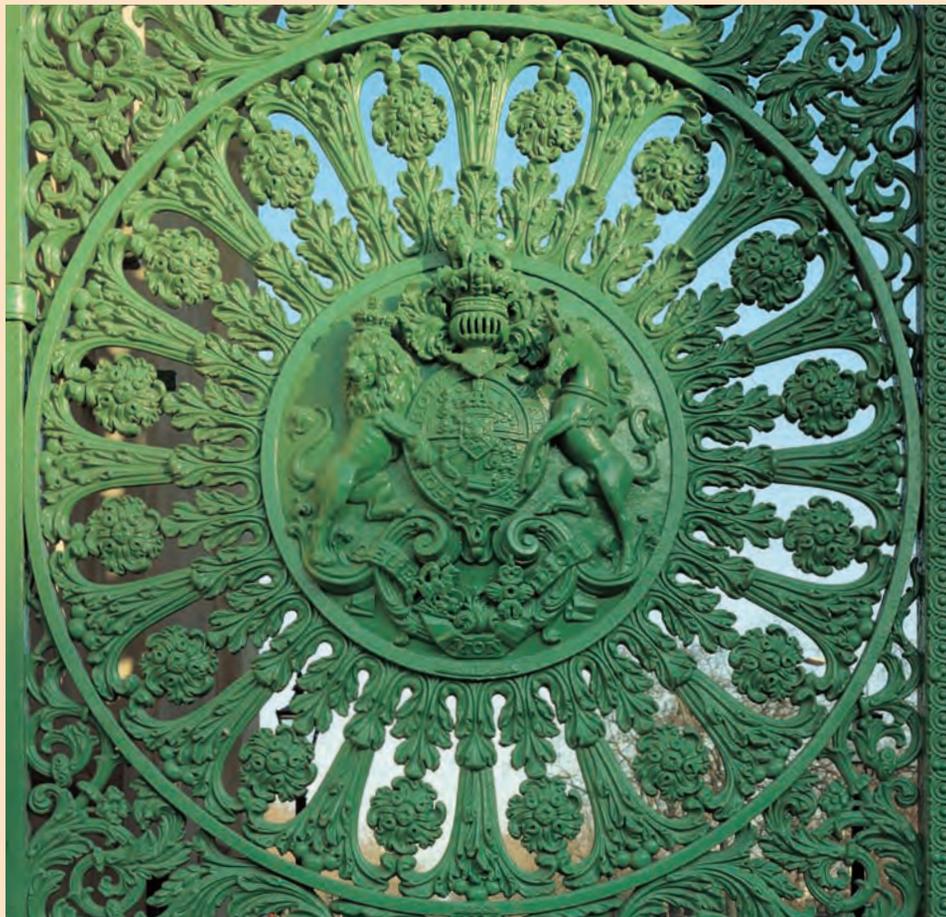
In the Victorian period, railings were most often painted green (as here on the Wellington Arch in London).

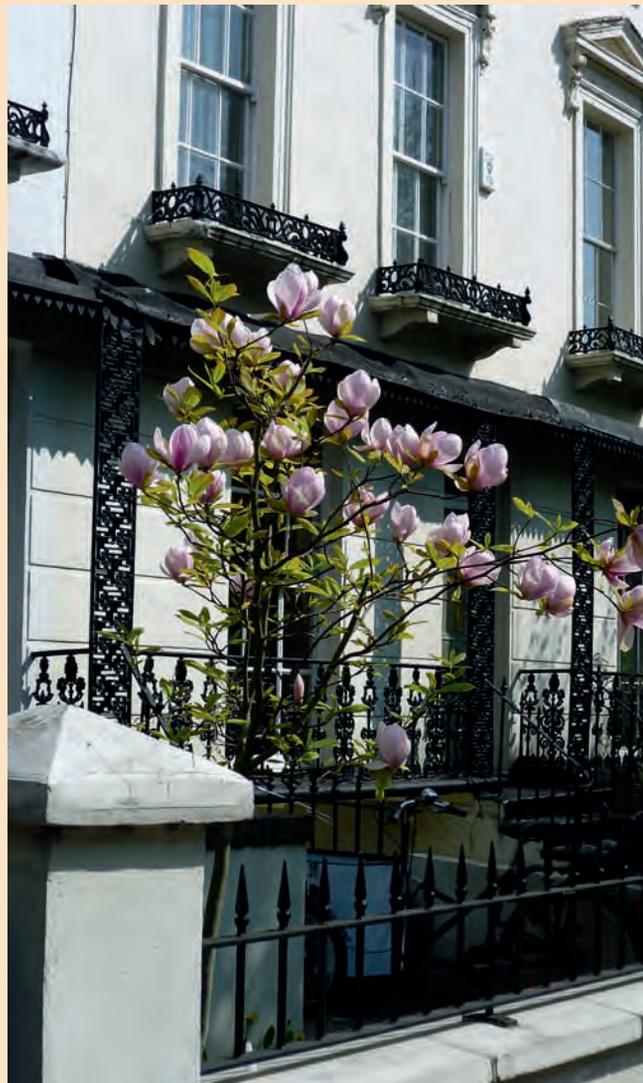
Victorian awnings and railings in London and elsewhere in England are now commonly painted black.

It is very often said that the painting of ironwork with the now ubiquitous black began at the death of Prince Albert in 1861, but in truth it is rarely encountered before the 1960s. Fast-drying black paints became a possibility only with the introduction of alkyd binders in the 1930s, and the disruption caused by the Second World War meant it was adopted only slowly, with dark greens continuing to see great use. Nonetheless, in some circles black became highly desirable, with Basil Ionides in the 1930s insisting: *“...all ornamental ironwork on the outside of a house should be black, or as nearly black as it can be.”*

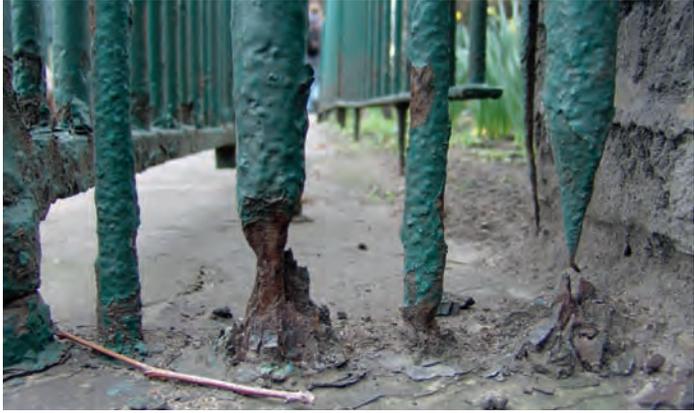
Corrosion at footings and bases	Common position for water to pool, and maintenance to be poor

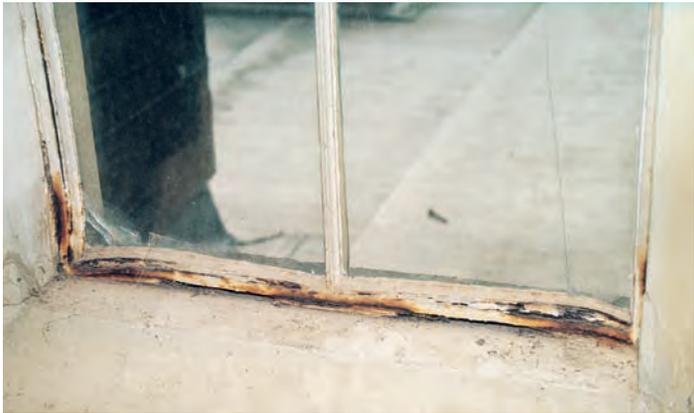
Corrosion of base of metal window frame	Common position for water to pool, and maintenance to be poor

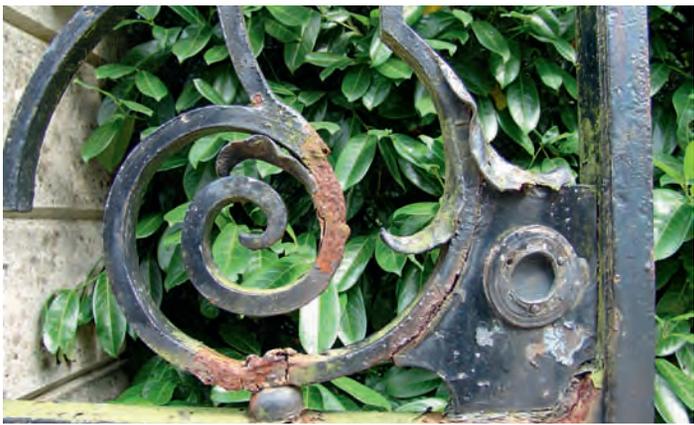
Crevice corrosion: rusting where water is trapped in small cracks and cavities	Common position for water to pool, and maintenance to be poor

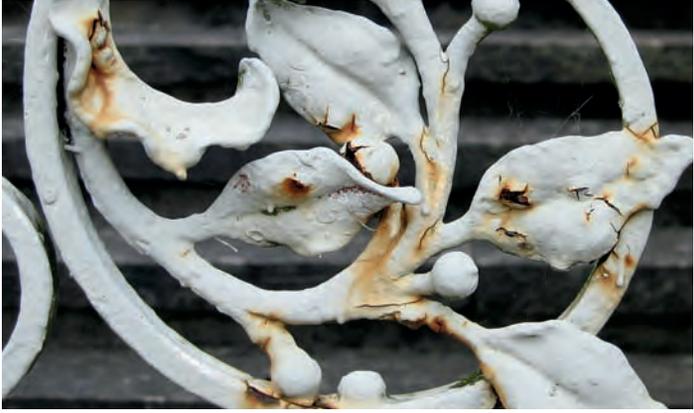
Corrosion in areas where paint is not well maintained	Common at the back of downpipes, especially those that are inset into the wall

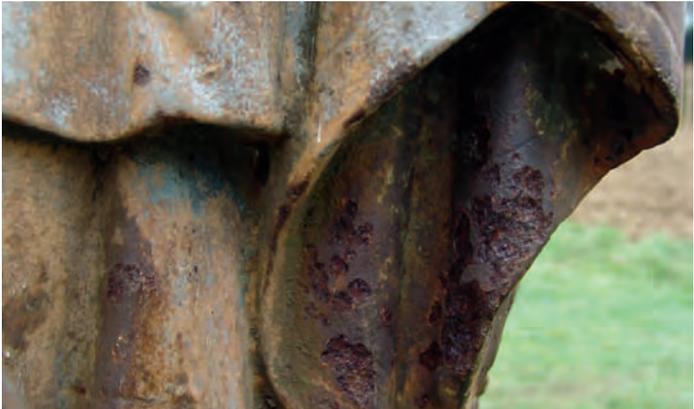
Corrosion in areas not washed by rain	Salts, pollutants and other dirt can attract enough moisture to initiate corrosion

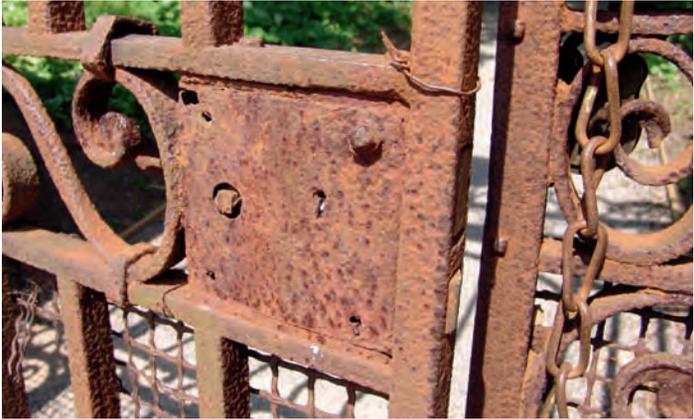
<p>Failure of working parts; for example:</p> <ul style="list-style-type: none"> <li>• Corroded locks and hinges on gates</li> <li>• Gates unable to open or close correctly</li> <li>• Windows or doors that do not open or close correctly</li> </ul>	<p>Failed locks and hinges can lead to distortion as the gates are used</p> <p>Often locks are replaced by chains and padlocks, but these can strip paint from the gate, leading to more corrosion</p> <p>Raising of ground levels and seizing of quadrant wheels are both common reasons for gates to be unable to operate correctly</p> <p>Complicated moving parts such as hinges and locks have many crevices in which water can be trapped; if maintenance is not meticulous, rusting can soon cause these to seize</p>

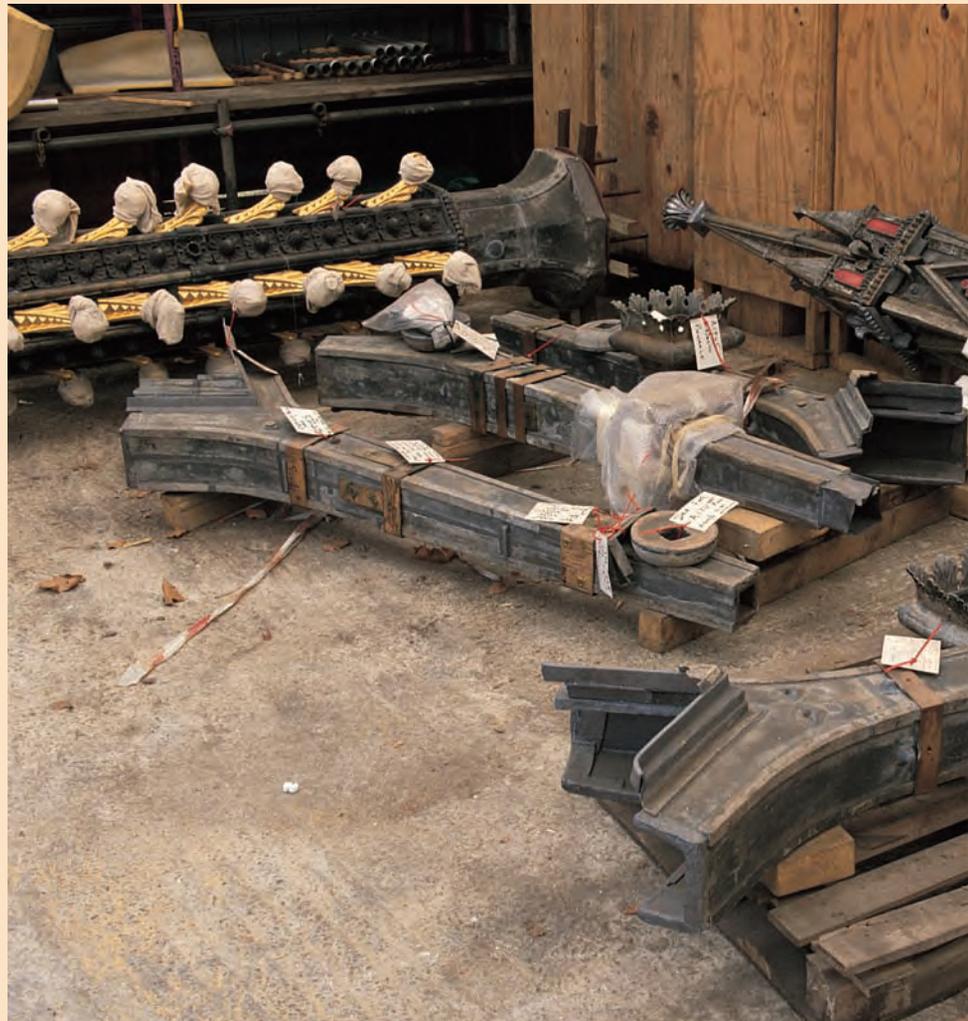
Parts from the Albert Memorial in London, being stored during conservation works

Storage can be an important issue, particularly when dealing with extensive architectural metalwork such as railings. Here, these dismantled sections of the Albert Memorial have been labelled with robust metal tags, and stored flat on wooden palettes.

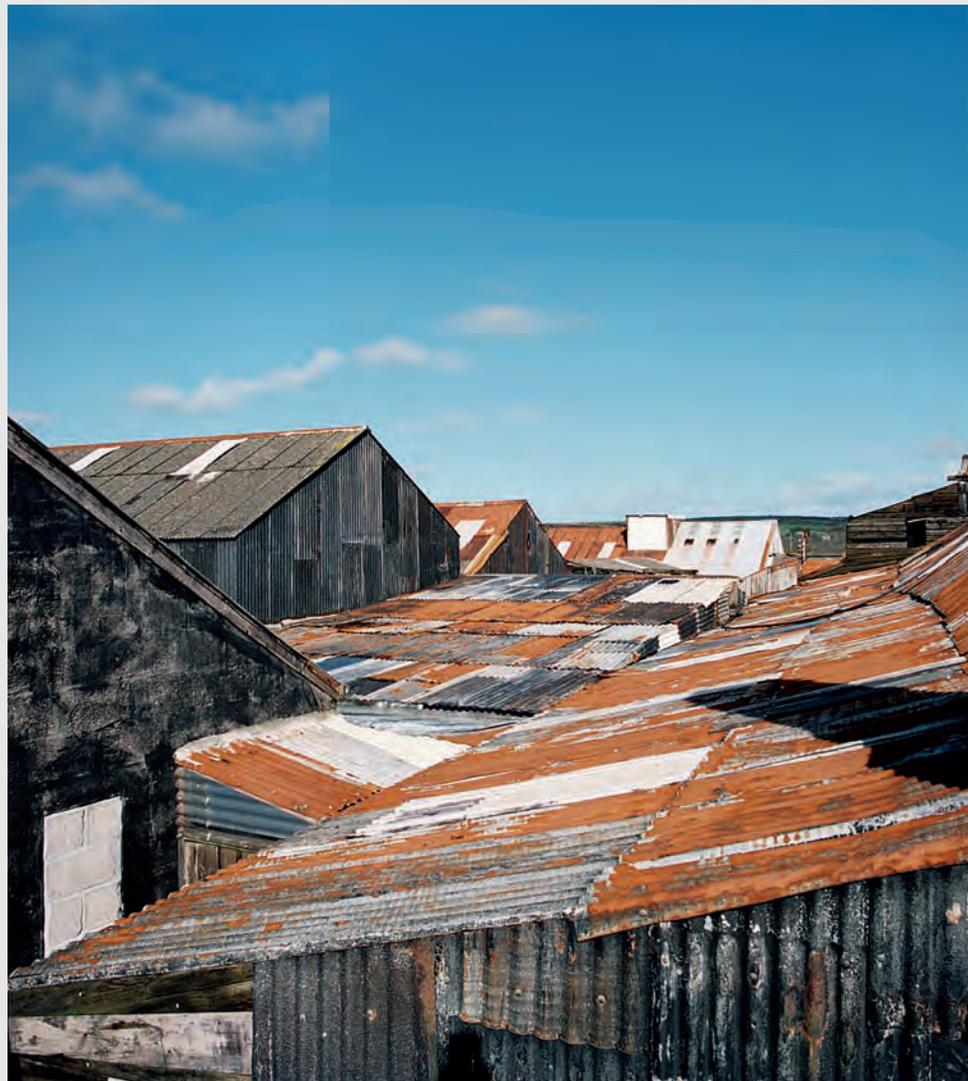
The checker-board patterns that resulted from using small sheets with uneven coatings cannot be replicated with modern corrugated-iron sheet.

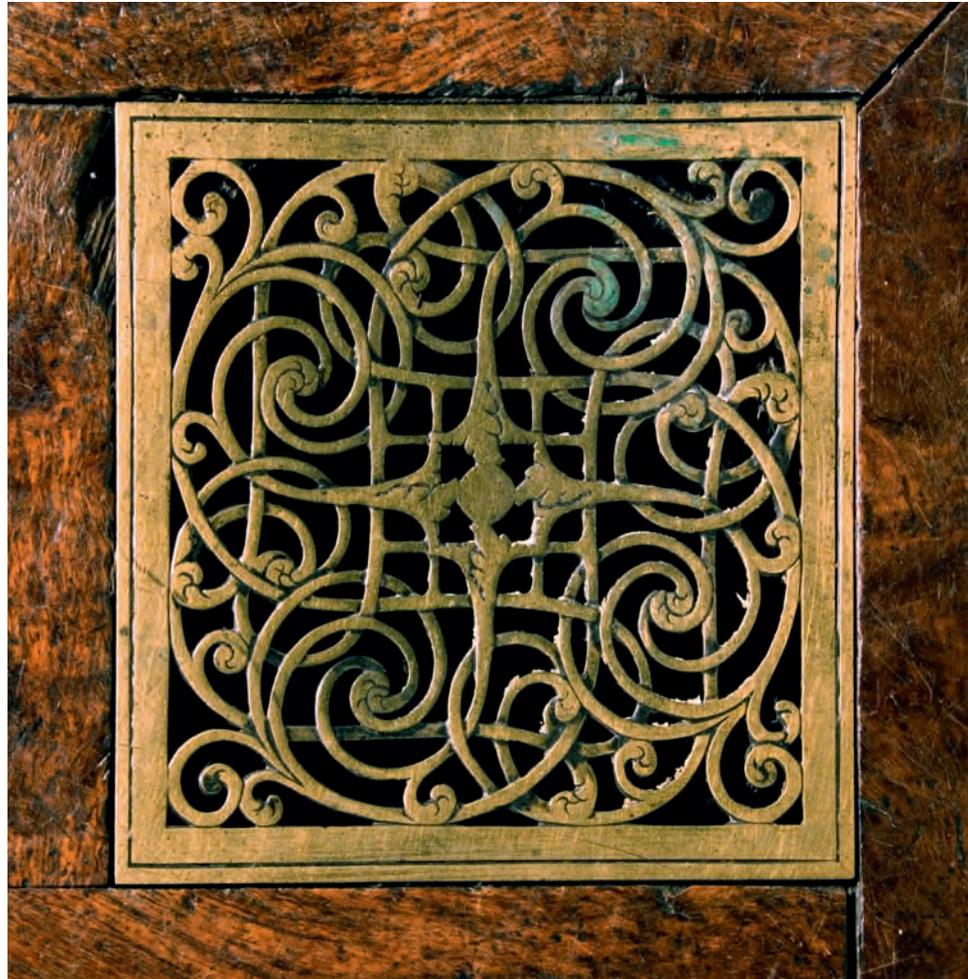
Wear and tear on architectural elements made from metals such as brass often incorporates damage to the metal and its surroundings from repeated polishing.

Polishing can also cause problems for surrounding materials: it is very common to see that the stone around a brass plaque has been stained by metal polish.

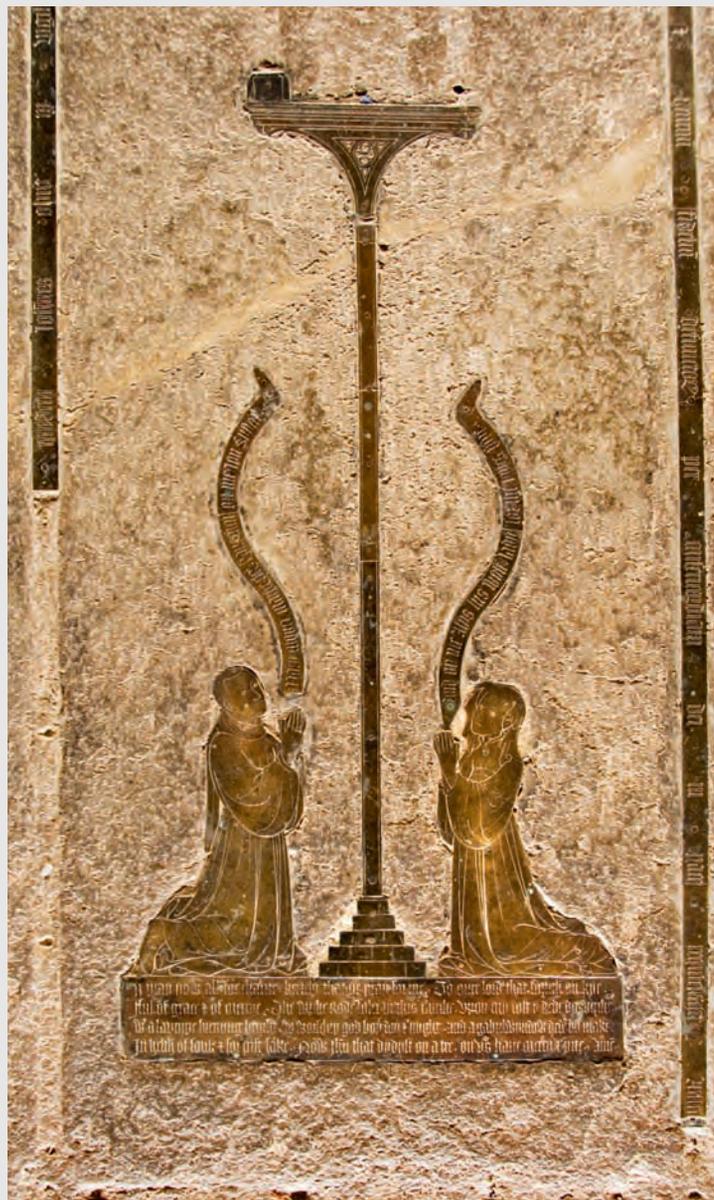
## Monumental Brasses

For four centuries, monumental brasses were the most important form of tomb decoration in English churches, and the practice was briefly resurrected in the 19th century. Most seem to have been made by a handful of specialised workshops, and their manufacture survived not just the Black Death but the Reformation.

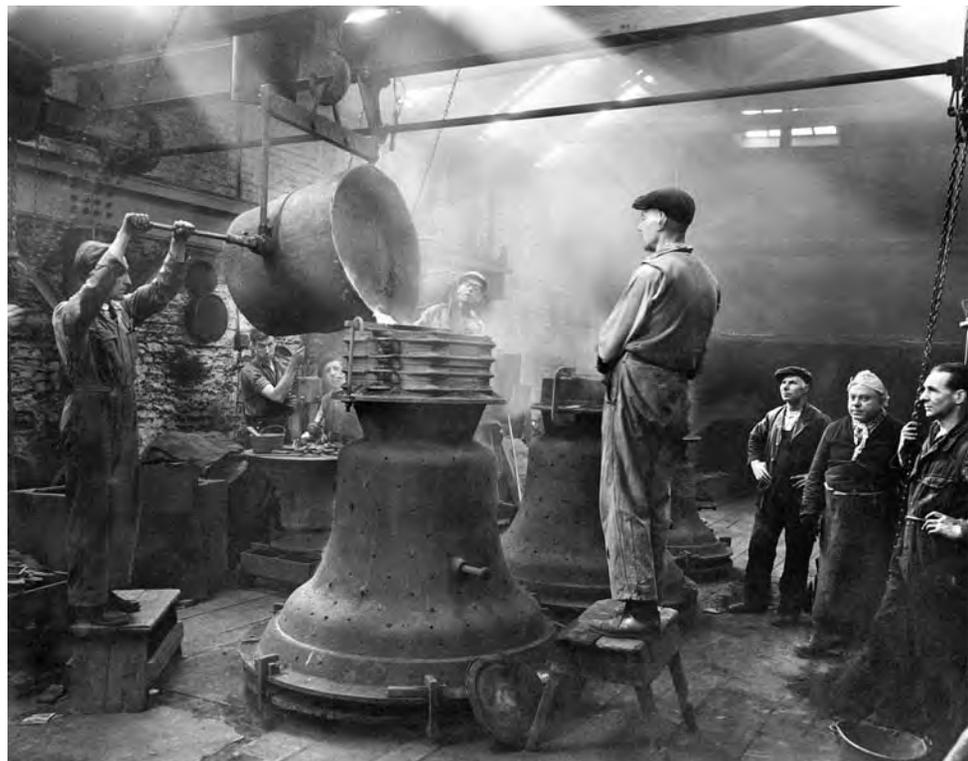
Casting bells, in an undated antiquarian image.

To cast the bell, the assembled mould was lowered into a casting pit mouth downwards, packed round with sand, and the molten metal was poured into the void using a header box. Before transport systems improved, large bells were sometimes cast in the ground near the church for which the bell was destined.

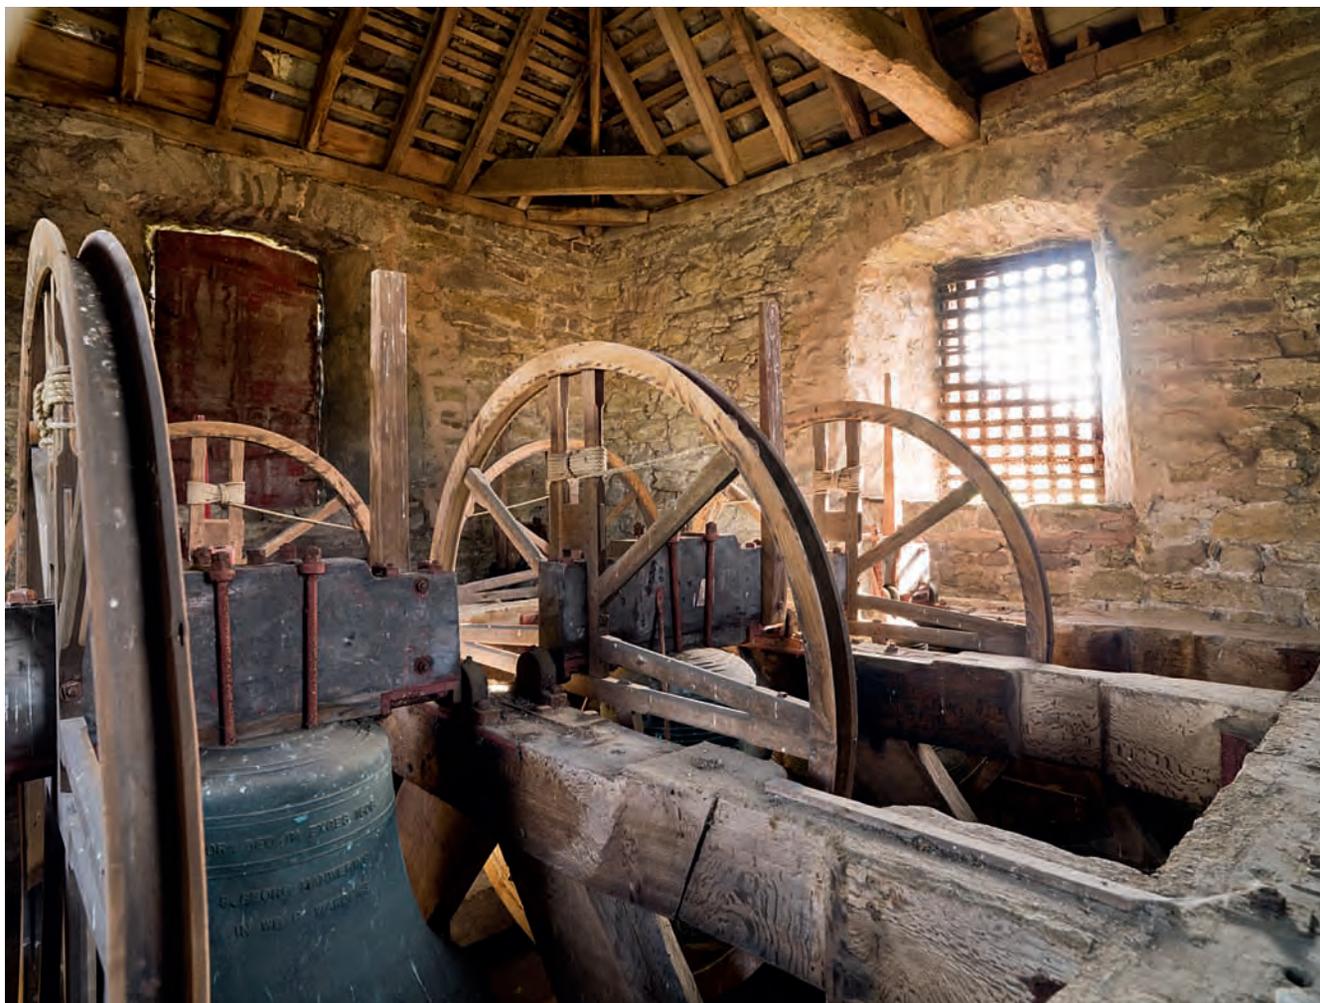
The belfry of St John the Baptist at Stokesay in Shropshire, where the bell frame is wooden, but the bells have been suspended in the modern manner with bell bolts.
