ENGLISH HERITAGE
PRACTICAL BUILDING CONSERVATION

ROOFING

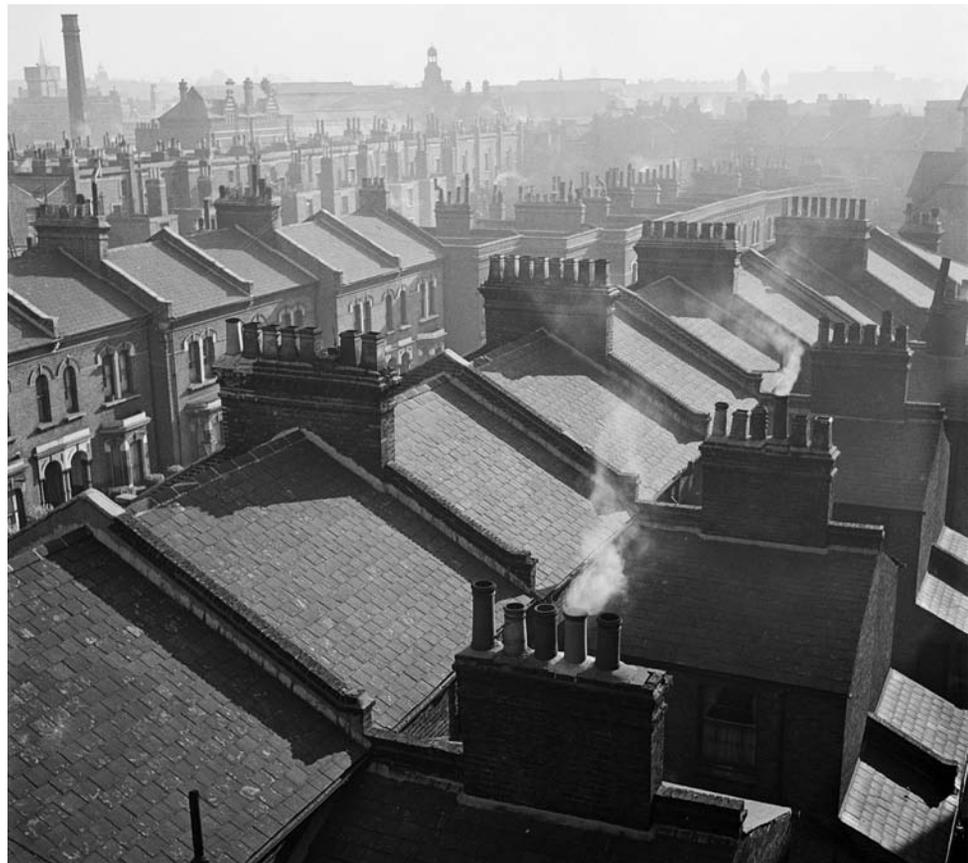
Victorian terraced housing, London. As transport links with North Wales improved from the mid-19th century, Welsh slate found a ready market in new areas where the demand was growing rapidly for cheap materials for urban working- and middle-class housing.

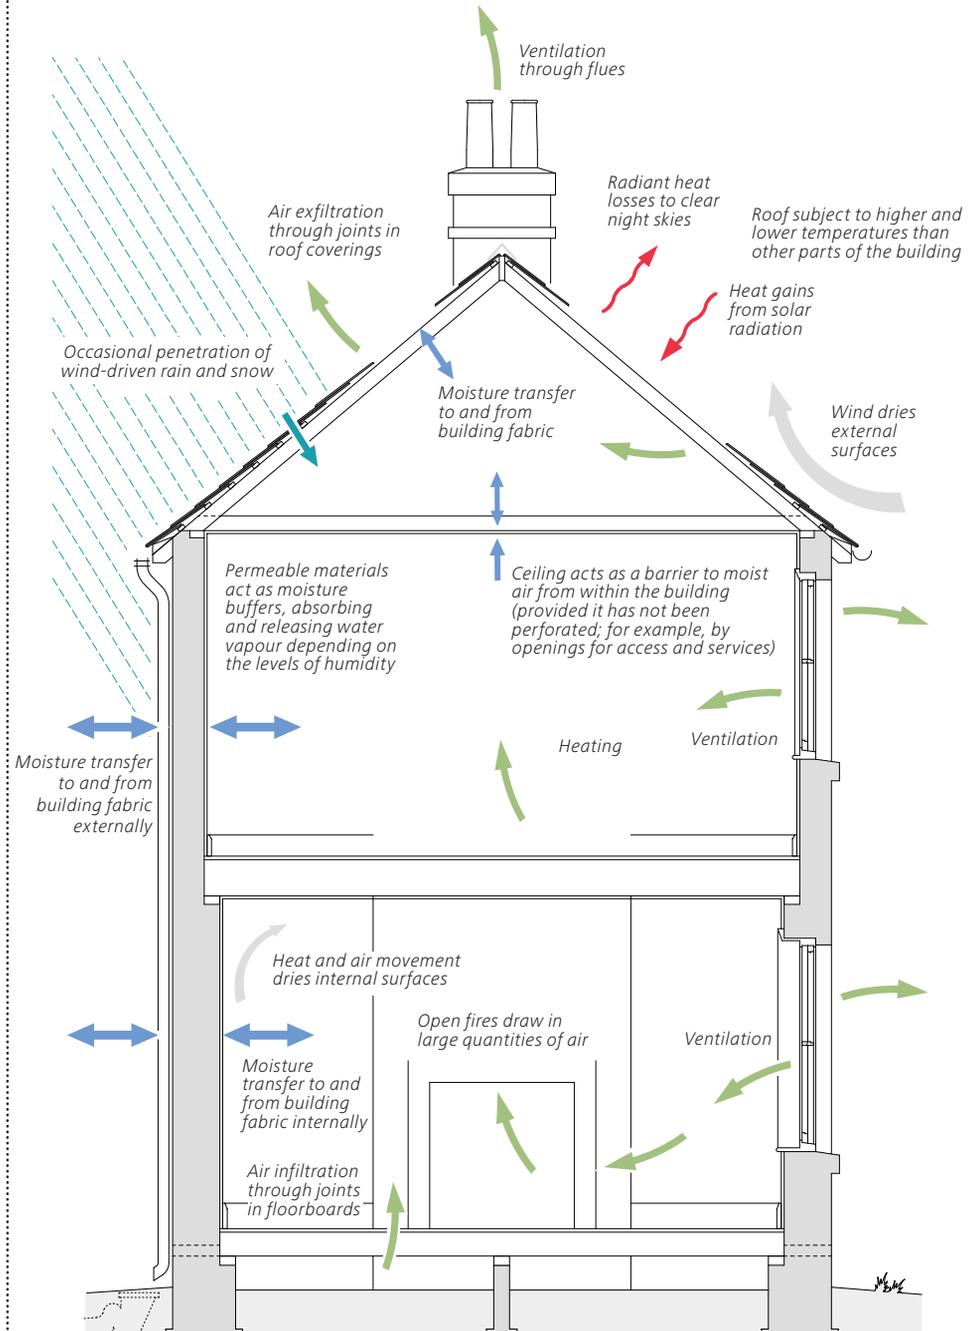
AIR & MOISTURE MOVEMENT IN TRADITIONAL BUILDINGS

With simpler lifestyles and an absence of plumbing, less water vapour was generated internally, while ventilation rates would have been higher, particularly when fires were lit

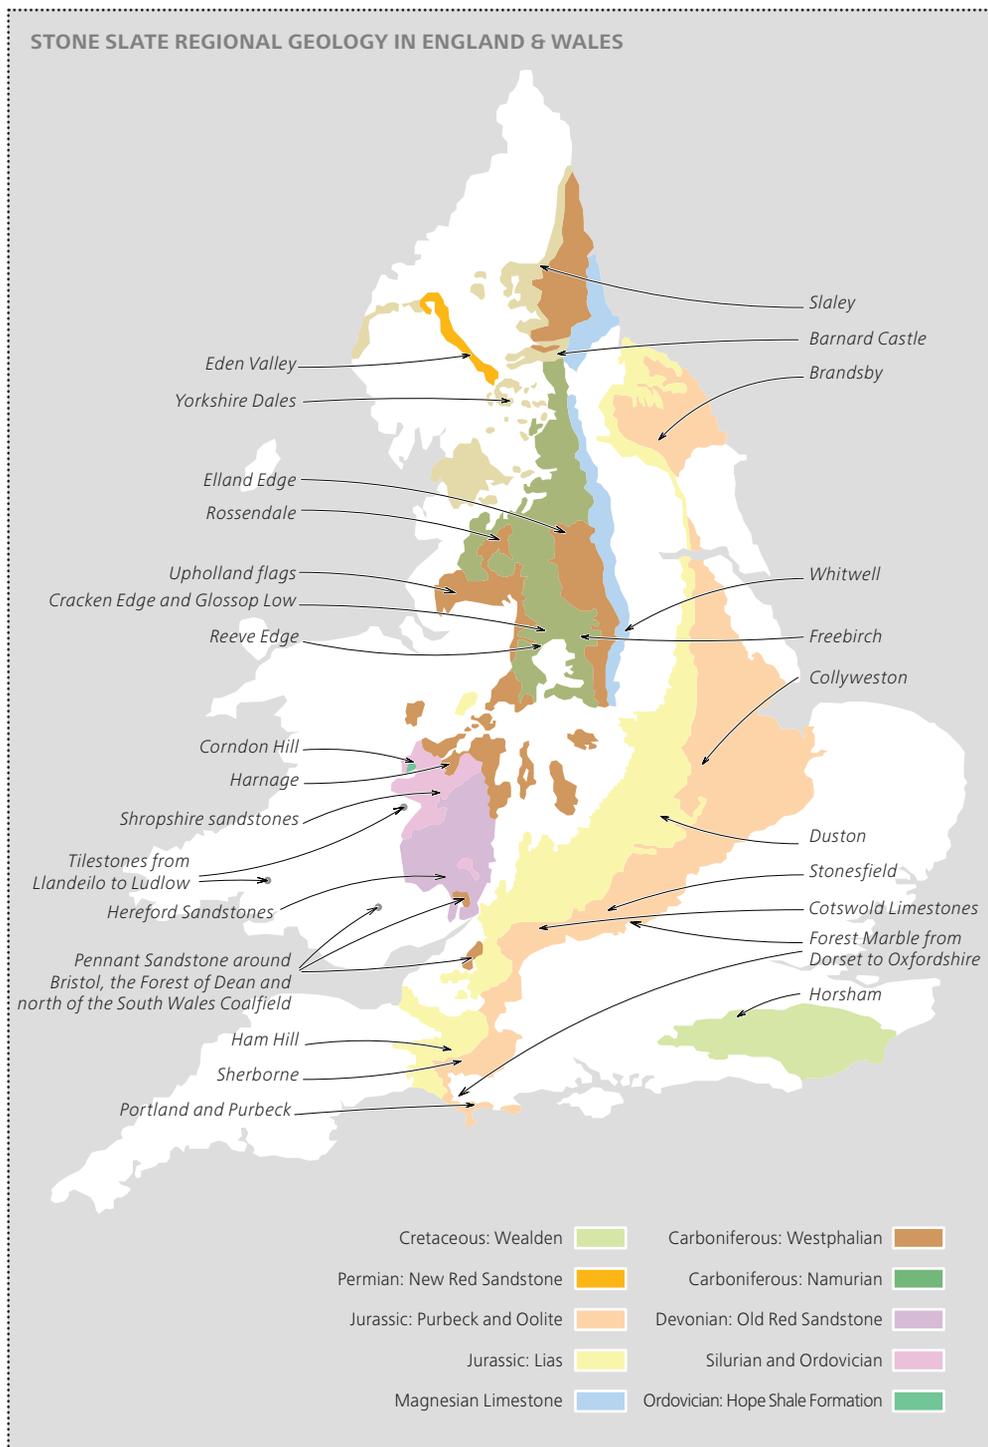
Geological formations important for stone slates in England and Wales, and some historic locations of production and use.

SOURCES OF STONE SLATES USED IN ENGLAND	
REGION OF USE	GEOLOGICAL SOURCES
Dorset and Somerset	Purbeck Limestone, Forest Marble, Upper & Lower Lias Limestone
Wiltshire, Gloucestershire, Oxfordshire	Purbeck, Corallian, Forest Marble, Hampen Marly Beds, Taynton and Trougham tilestones, Stonesfield Slate, Chipping Norton Limestone, Lower Fullers Earth Rock, Inferior Oolite, Marlstone
Northamptonshire, Rutland, Lincolnshire	Blisworth Limestone, Rutland Formation, Collyweston Slate, Duston stone (Northampton Sand Formation)
Surrey, Sussex, Kent	Horsham Stone, Charlwood Stone
Gloucestershire, Bristol region, South Wales	Pennant Sandstone, Tilestones (Murchison), Old Red Sandstone, Lower Lias Limestone
Welsh Marches including Gloucestershire, Herefordshire, Worcestershire, Shropshire	Old Red Sandstone, Tilestones (Murchison), Cheney Longville Flags, alternata limestone, Chatwall Sandstone, Harnage slates (Hoar Edge Grit), Grinshill Flagstones, Hope Shale (Corndon Hill)

Staffordshire, Cheshire, Derbyshire, Lancashire, Yorkshire, County Durham, Northumberland	Carboniferous Millstone Grit and Coal Measures sandstones
East Derbyshire, Nottinghamshire	Magnesian Limestone
North Yorkshire	Carboniferous Millstone Grit and Coal Measures sandstones, Jurassic limestones, Brandsby & Boltby slates
Cumbria	Carboniferous Millstone Grit and Coal Measures sandstones, Permian (New Red) Sandstone

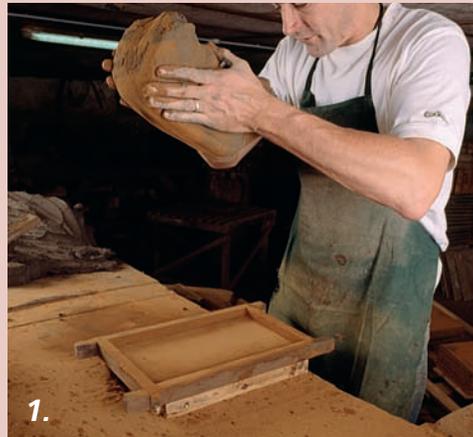
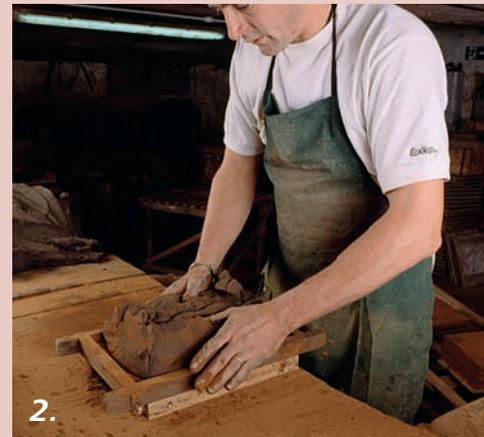
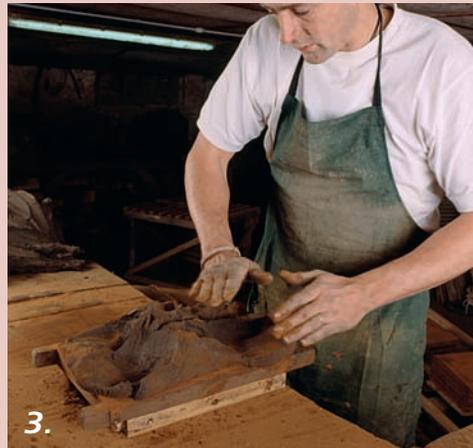
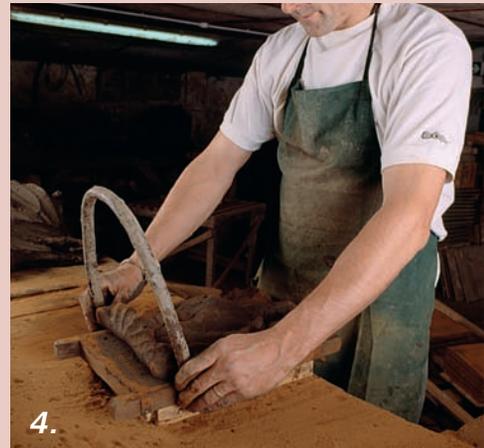
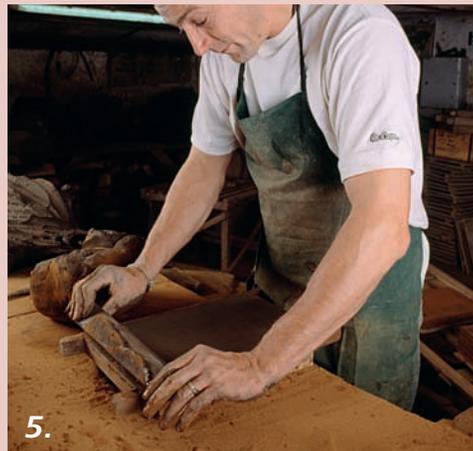
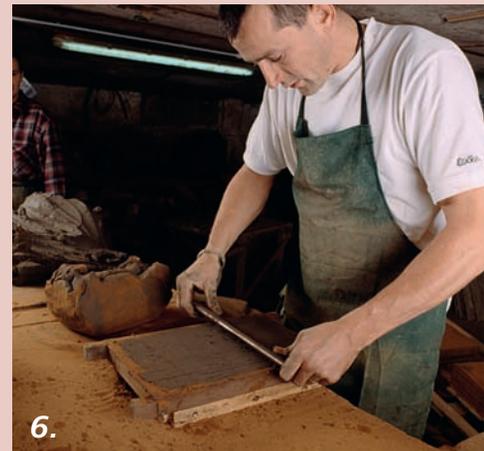
Moulding a Tile by Hand

These pictures were taken at the Bulmer Brick & Tile Co on the Essex-Suffolk border. The processes and their names vary from region to region.

1. The tile-maker works at a bench, with prepared clay in a heap to one side, and the mould in front. The mould comprises a wooden base or stock, which is fixed to the bench, and a loose wooden frame placed over it. The frame is slightly larger than the required size of the tile, to allow for shrinkage. Fine sand is lightly sprinkled into the mould to help release the finished tile and provide a textured appearance (the face of the tile is on the underside). A handful of stiff clay is taken from the pile and rolled into a 'warp' (also known as a wedge, clod or clop).

2. The clay is thrown into the mould.

3. The clay is compressed into the corners of the frame. Although this work looks straightforward, it has resulted in many tilers suffering from repetitive strain injury, which is a principal reason why many of these operations are now mechanised.

4, 5. Excess clay is cut or struck off with a bow and the surplus lifted off.

6. A steel or wet timber strike is used to give the underside of the tile a smooth finish.

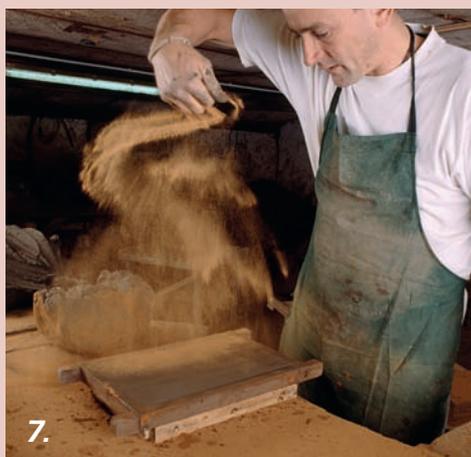
7. Sand is evenly thrown across the tile to ensure that the tiles do not stick together when stacked.

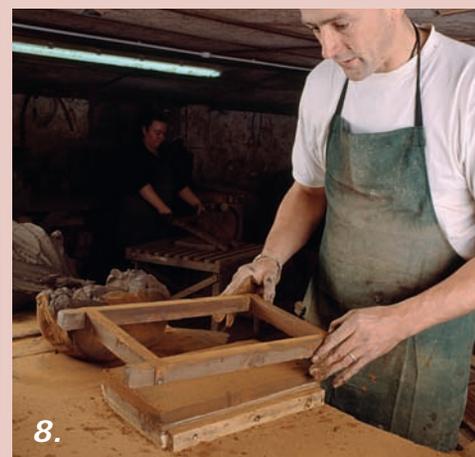
8. The frame is lifted away from the stock.

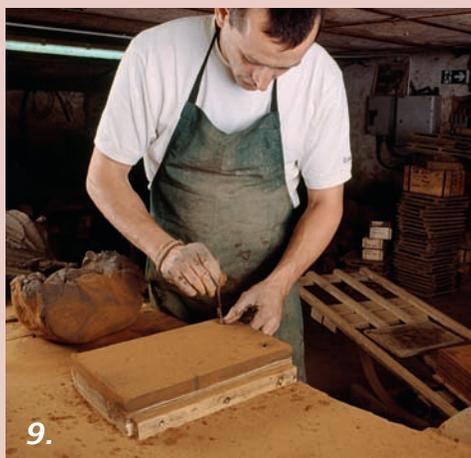
9. For peg tiles, a stick or a metal spike is used to make the holes. Historically, pegs were usually tapered, but they varied in shape and size from square to round, and were anything from 6-mm to 16-mm wide. Behind the tiler is the bearing-off barrow, which is used to wheel the wet tiles to the drying sheds.

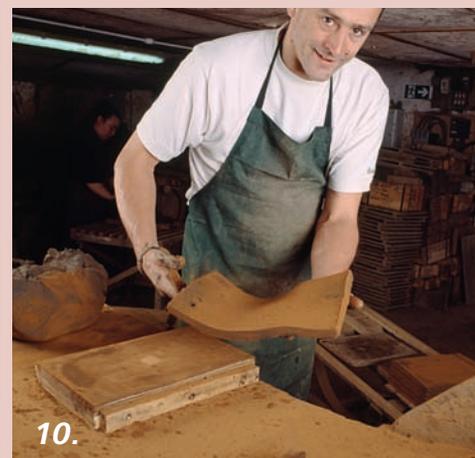
10. The soft tiles are transferred to a wooden pallet to dry to a 'green' state so that they can then be stacked. Stacking the green tiles must be done with great care. Nibbed tiles must be placed alternately so as not to damage the nib. The top tile in the stack dries first, and as shrinkage takes place the tile will try to bend, giving it a natural camber. It is then taken off to expose the next tile, so that too developed a camber.

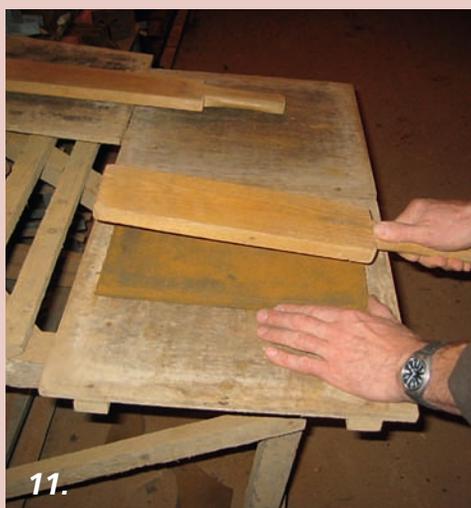
11. Some clays shrink on drying by up to 12%. When they are leather-hard they are placed on a curved board and beaten to give each tile the correct camber, so that on the roof they fit edge-to-edge to avoid capillary draw. Other tile-makers place their 'leather hard' tiles onto long, slatted cambered-shaped racks so that they adopt that shape. Pating to shape is then normally confined to hips and ridges placed over a wooden horse. Gault clays only shrink by 10% and are not normally beaten.

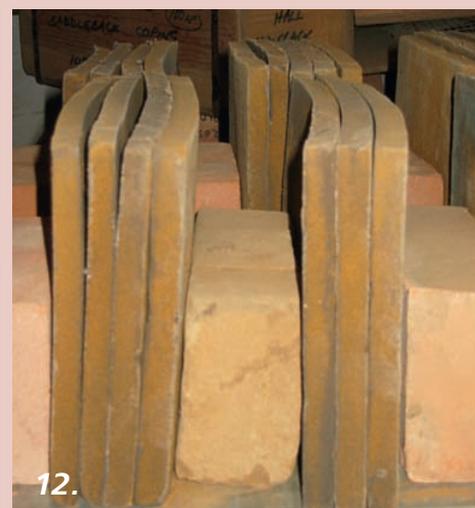
12. The tiles are stacked on their ends to continue drying. When dry, they are fired in a kiln to vitrify the clay, and permanently fix their shape and size.

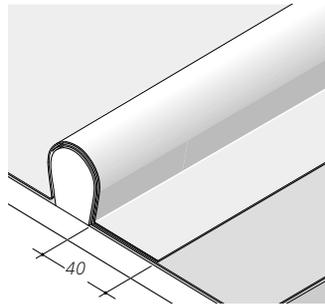
WOOD-CORED ROLL

For vertical joints in lead sheets, hollow or wood-cored rolls, standing seams or welts can be used. For joints across the fall, laps or drips are used. Cross welts are not used for horizontal joints in lead.

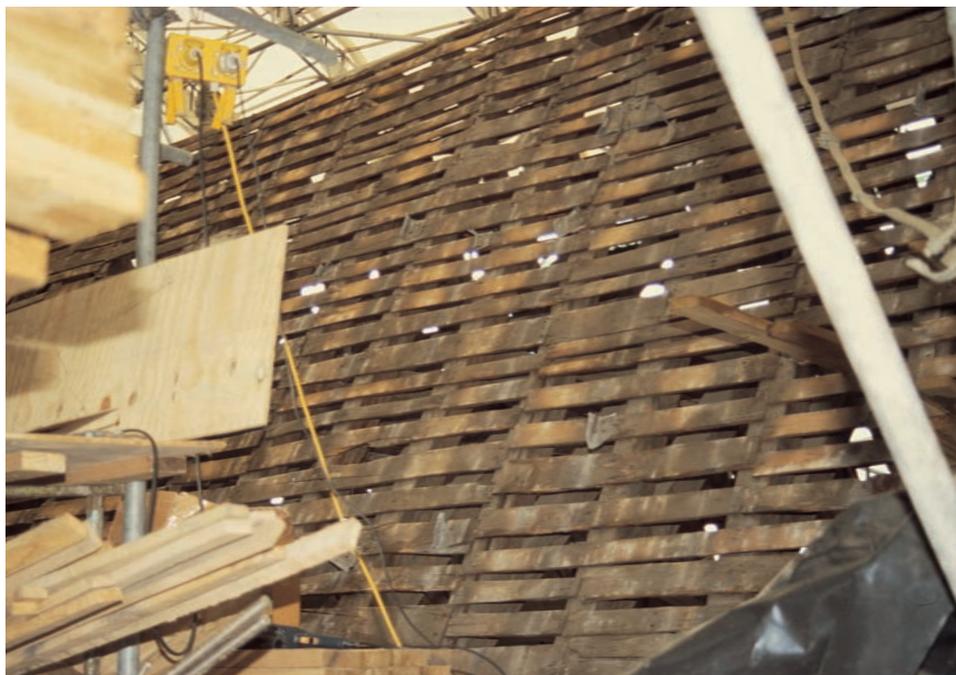
Medieval oak boards on the north nave triforium roof, Salisbury Cathedral, Wiltshire.

At Salisbury Cathedral, the north nave triforium is 200-m long, and extends from the west front to the tower crossing. Beneath the lead are oak boards measuring 12–20-mm thick and 100–150-mm wide. Most of the roofs of the cathedral were rebuilt during the mid-18th century, and although the north nave triforium roof was only subject to minor repairs, it was assumed that most of the boards had been replaced at that time. However, when re-leading was being undertaken in 2003–5, tree-ring dating (dendrochronology) confirmed that the oak for the boards was felled in 1251–52, and therefore they dated from the original construction in the mid-13th century. Their survival for over 750 years suggests that boarding on other buildings may be considerably older than the lead they support. In the case of medieval buildings that were re-roofed in the 18th or 19th century, it should not be assumed that original boards were replaced at the same time. The medieval boards at Salisbury were over-boarded with new softwood boarding, laid diagonally, to support the lead, during the repairs of 2003–5.

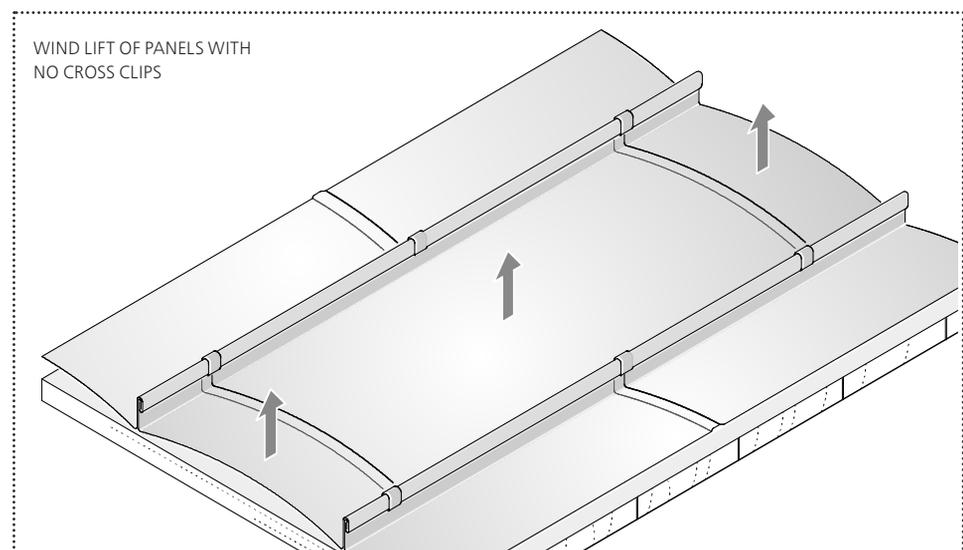
Wind damage to standing-seam copper panels

Wind lift can cause drumming of the sheet on the substrate, and can create stress in the copper that may lead to the formation of cracks.

Wind damage is a major cause of failure. Strong winds can produce highly variable air pressure across a roof. Where turbulence creates negative pressure above part of a copper roof, the internal pressure may force a copper sheet off the roof. This exposes adjacent sheets to the wind which may lift them from beneath, so once one sheet is removed, adjacent sheets frequently follow. Wind can also initiate vibration of the copper on the substrate, which causes a loud drumming noise within the building.

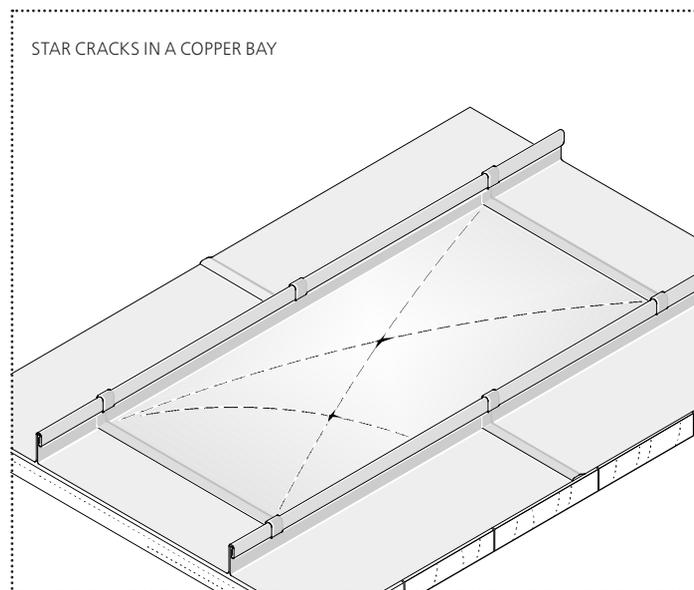
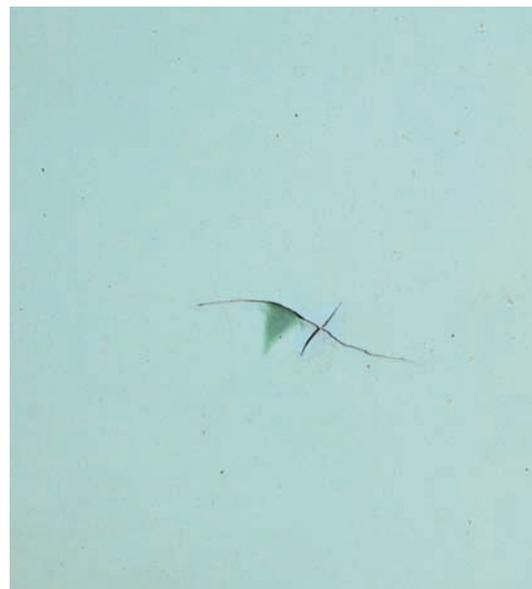
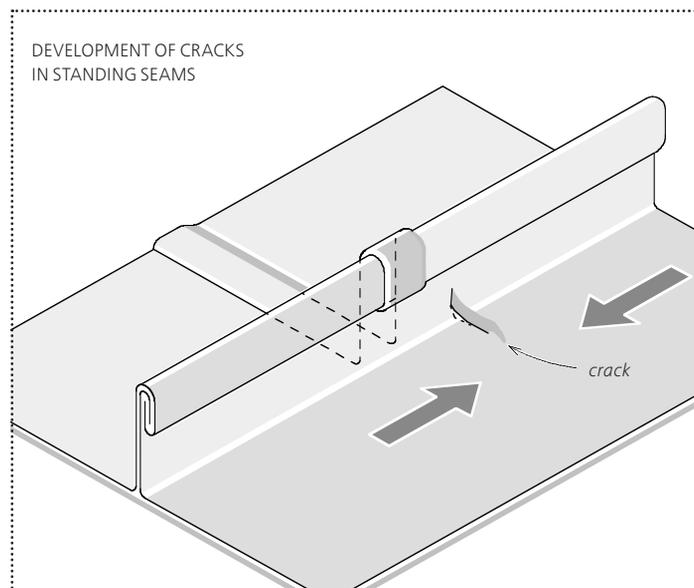
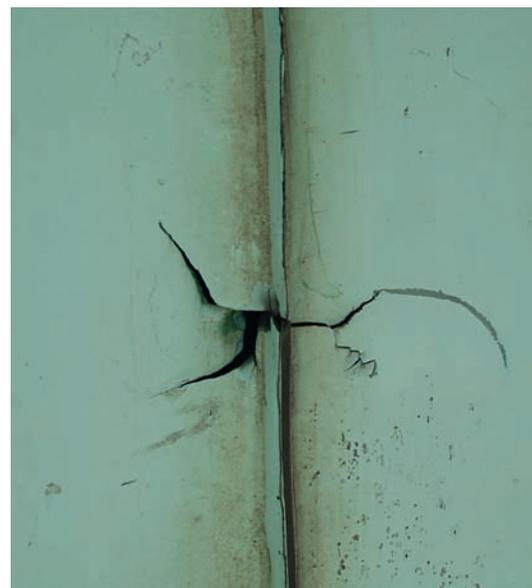
Top: Wind loading or thermal stress can cause a rectangular copper sheet, which is securely fixed at the edge to flex along the lines of folds which tend to be diagonal. Where the lines cross, additional stresses result in the star crack.

Bottom: Cracks in a standing seam. Where a number of copper sheets have been folded over to form a seam, the area is subject to work hardening. The sheets are restrained by copper clips fixed to the decking and may not have room to expand laterally when subject to solar heating. This can create stress in the joint, eventually resulting in cracking. It is fairly normal to find this sort of problem on roofs over about 70 years old.

Copper can also suffer damage as a result of flexing due to wind loading or thermal movement. When copper sheet is deformed it undergoes changes to its crystal structure, known as 'work hardening'. Repeated movement makes it very brittle and can eventually lead to cracking. 'Star cracking' is a characteristic failing in copper sheet, caused by repeated flexing of a sheet due to wind or thermal movement, and is normally confined to localised areas, usually the verge, ridge or eaves. Failure to repair star cracks results in their enlargement, and the risk of water ingress into the roof and wind damage. Long sheets of copper may buckle due to thermal movement if they are too long, and this can also eventually lead to cracking.

Work hardening of copper also occurs due to folding the sheet to form seams and joints. Work-hardened joints are more susceptible to cracking due to thermal or wind movement, especially as the copper ages. Cracking of welts and seams due to age hardening, especially when three or more sheets are folded together, is also a major cause of failure. Annealing (heating) copper relieves this inherent stress, and is usually required to avoid cracking when seams or joints are opened up.

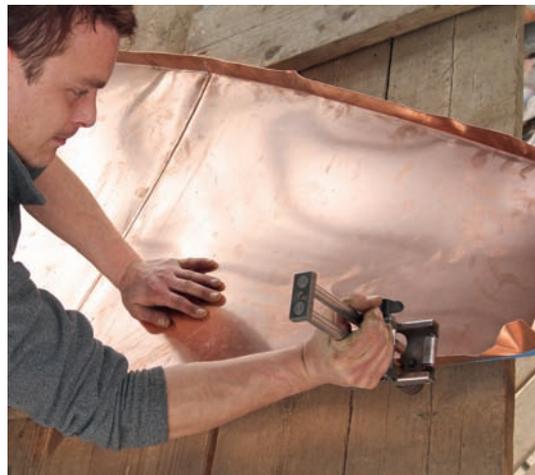
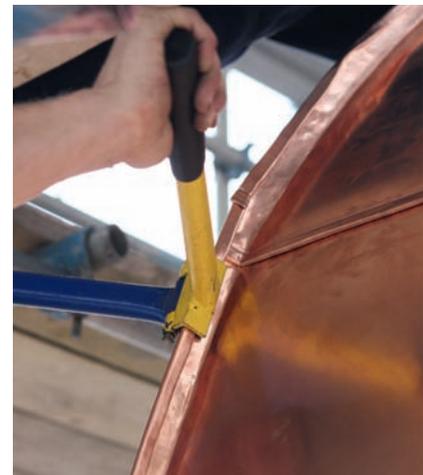
Left: Traditionally, copper sheet was dressed by hand to form the seams, but nowadays the edges of the sheets are often pre-formed in the workshop using a profiling machine. However, for complicated shapes the seams must be hand-formed on site.

Right: For traditional copper roofing, the seams must be finished by hand, as, in most cases, they need to accommodate the cross welts. For long-strip copper roofing, which does not have cross welts, an on-site seaming machine can complete the joint.

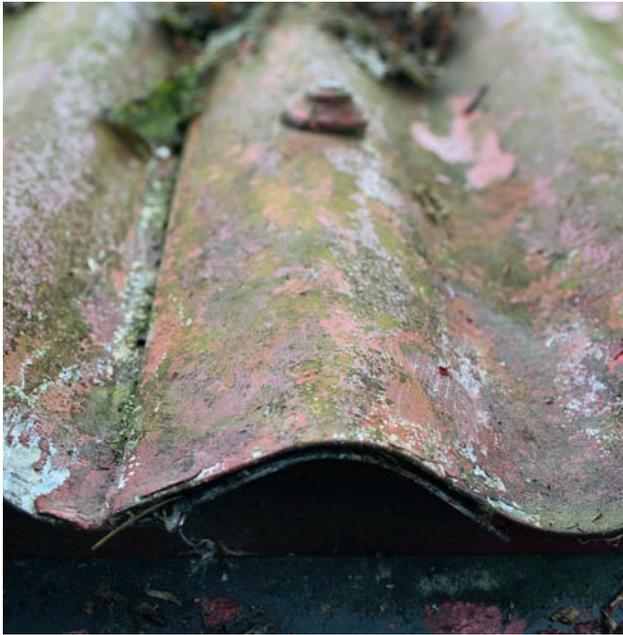
<p>DISCOLOURATION OF COATING Exposure to ultraviolet light and/or poor-quality coating</p>	<p>Coating will eventually fail, allowing corrosion to start</p>

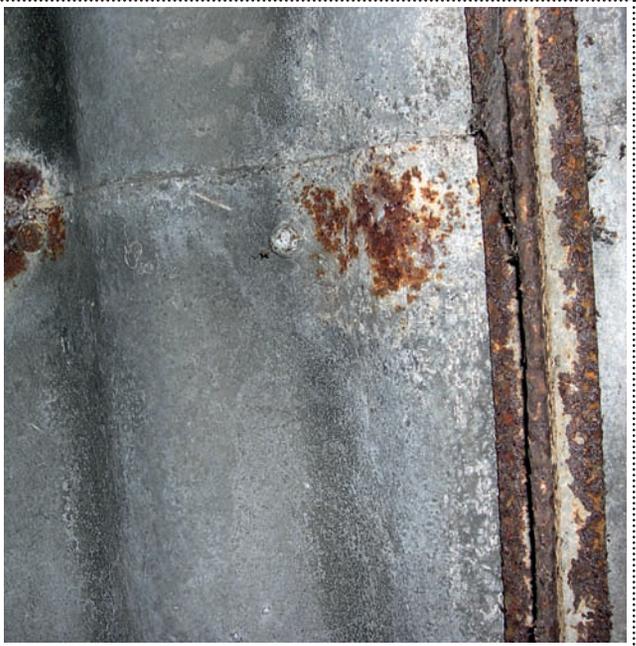
<p>RED COLOURATION ON SHEET SURFACES</p> <p>Deterioration of polymer or zinc coating, and corrosion of ferrous substrate</p>	<p>Need to clean up and repair coating or replace sheets, depending upon availability</p>

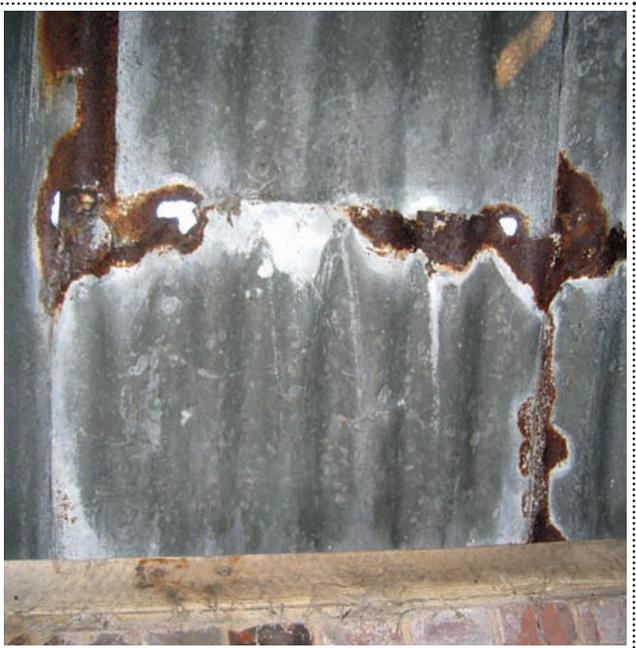
<p>HOLES PENETRATING THE SHEETS</p> <p>Widespread corrosion due to total failure of the coating</p>	<p>If damage is localised, patch repair may be possible</p> <p>If damage is more extensive, replacement of sheets may be the only option</p>
