### 3. ARCHAEOLOGICAL SURVEY RESULTS: MERSEYSIDE

#### 3.1 Introduction

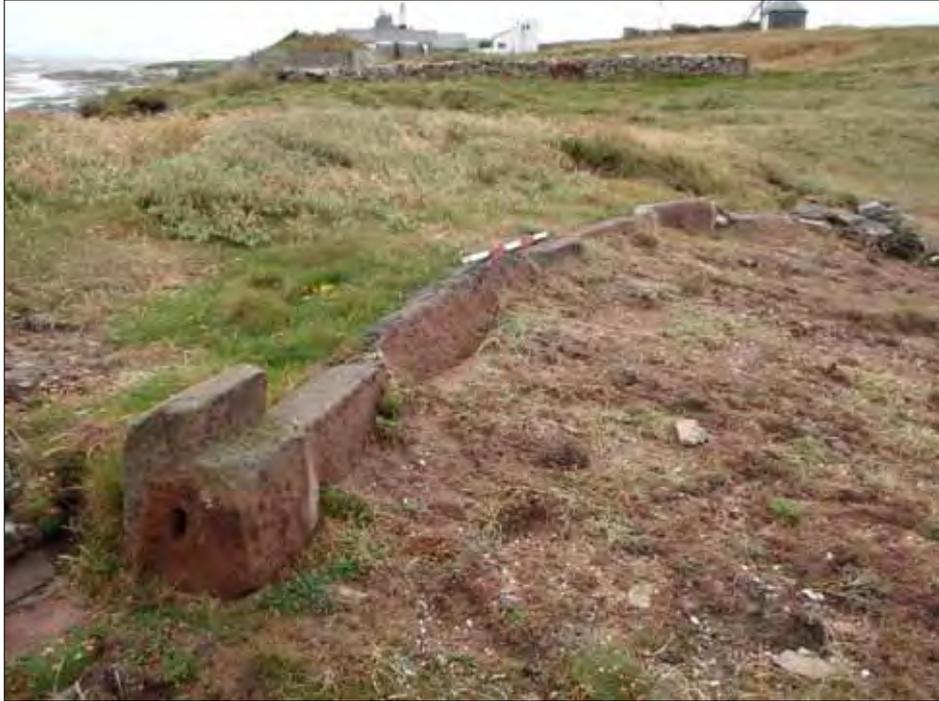
A series of re-used cut sandstone blocks (146) forming edges to footpaths and land bridges were recorded to the north of the supposed site of St Hildeburgh's Chapel. These appear to be parts of a door jamb and punch-dressed window sills (Figure 3.2). The masonry is not diagnostic in terms of date, however the blocks are mostly hand-crafted and differ from the sandstone blocks used in the construction of the nearby 19<sup>th</sup> century lifeboat station (see Section 3.2.8). It is possible therefore that they relate to an early medieval or medieval site on the Island and could be re-used remains of the aforementioned chapels, though such an association remains only speculative.

Figure 3.3 Re-used punched-dressed sandstone masonry with part of a door jamb in the foreground. (scale=1m).

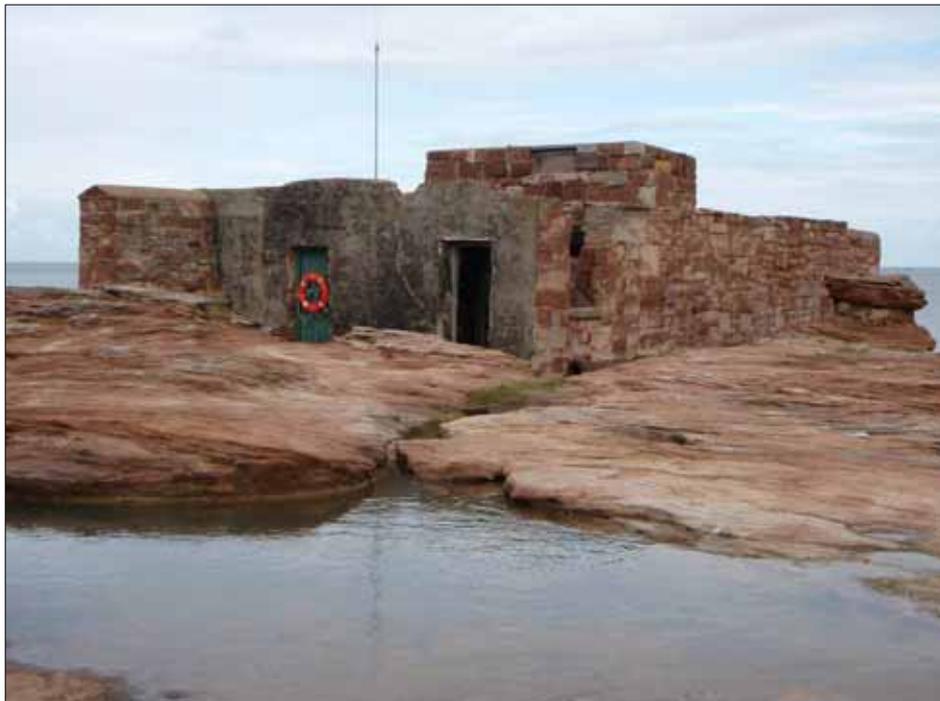
The field survey recorded the remains of the station as consisting of the main red-sandstone station building, a slipway, a tide gauge and set of iron steps (145). The station building is constructed of well-coursed red sandstone and is currently derelict and unroofed, though a bird hide has been established above one section of the station at first-floor level (Figure 3.4). This is for the exclusive use of members of the Hilbre Bird Observatory. The condition of the building is generally satisfactory, with localised weathering of the sandstone, but it is maintained as much as possible by the Friends of Hilbre who carry out re-pointing work when necessary (Friends of Hilbre 2007). Roofing the structure would probably be the next necessary step in its preservation for the future.

Figure 3.4 Remains of red sandstone, 19<sup>th</sup>-century lifeboat station.

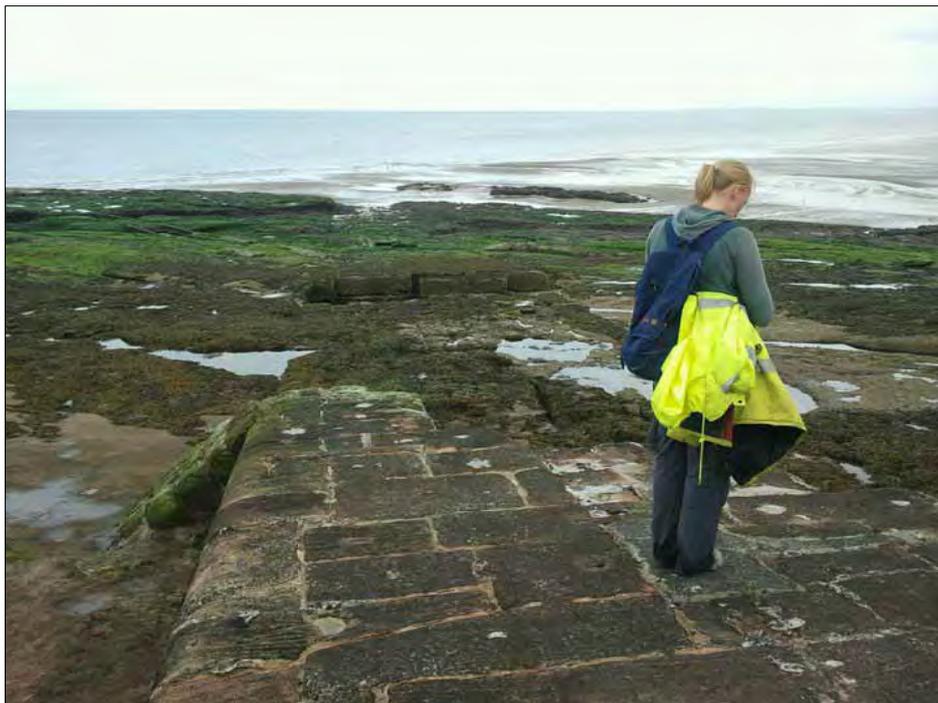
The slipway associated with the station runs for 116m north-east of the station down to the shore and is constructed of large sandstone blocks. The Friends of Hilbre newsletter in 2006 reports that stormy conditions over the previous few winters had dislodged several stones on the slipway outside the station. This damage is evident at the site today (Figure 3.5), however, the Friends of Hilbre carried out temporary repair works (funded by Wirral Borough Council) in 2004 to help counteract further erosion (Burnett 2006; Burton 2009). This provided a concrete capping, but, as yet, a more permanent solution has not been put in place.

Figure 3.5 Slipway running north-east of the lifeboat station. Showing damage caused by storm action in the early 2000s.

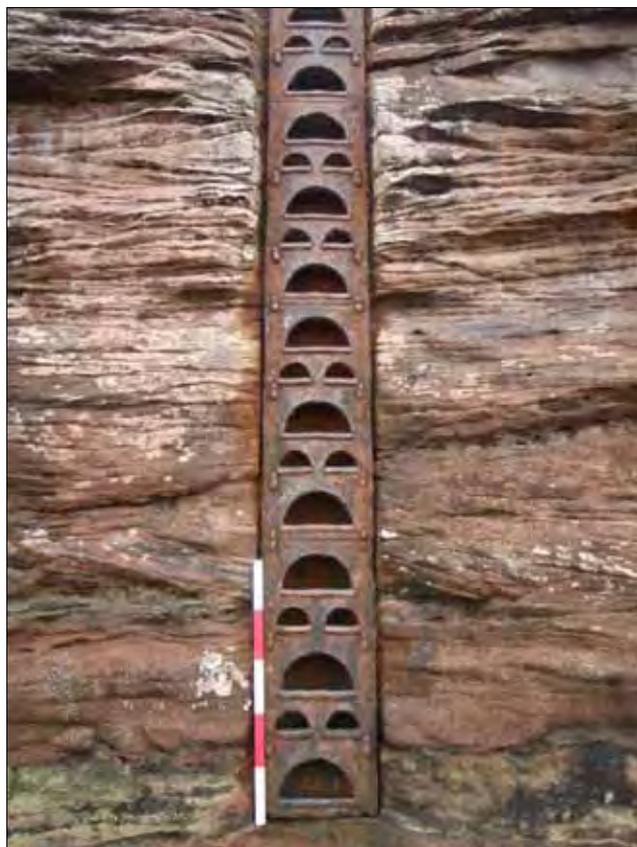
The tide gauge and iron steps are located to the west of the station and are attractive features in the red sandstone cliffs and shelves that dominate this side of the island. The iron steps are recessed into the rock face and consist of a series of half-moon shaped foot and hand holes (Figure 3.6). They are constructed of jointed iron panels, each containing three sets of foot holes and two sets of hand holes. The steps are generally in very good condition maintained by the Friends of Hilbre (Friends of Hilbre 2009), though some rust is evident. It does not appear that they are or were ever partially submerged.

Figure 3.6 Iron steps recessed into the cliff-face to the east of the lifeboat station (scale = 1m).

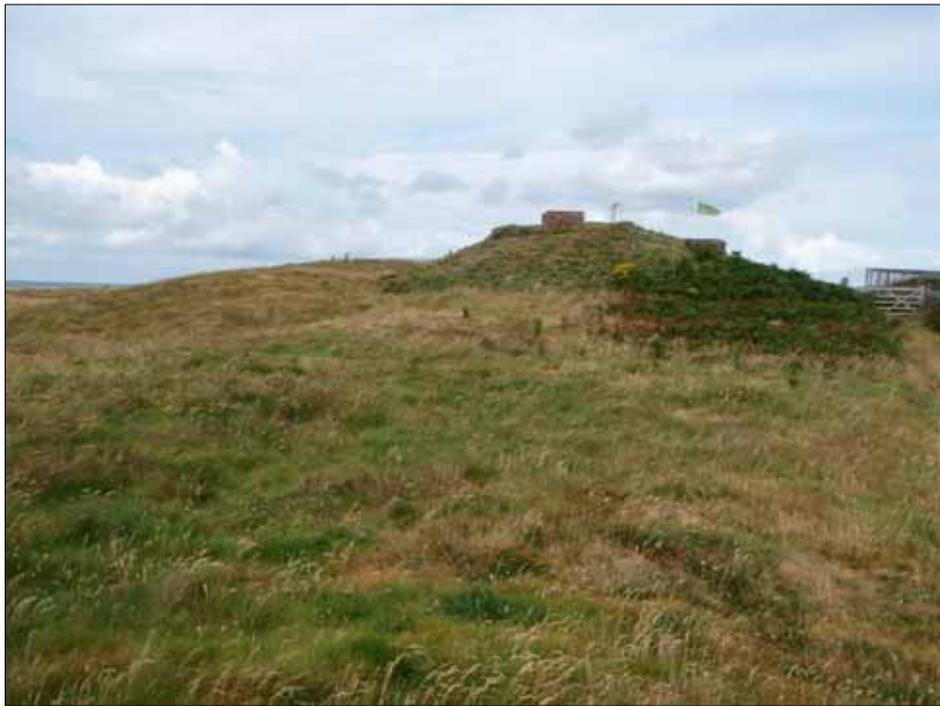
The shelter is located at SJ 18516 87096, an amendment to the recorded location in the Merseyside HER which lies  $\approx 17\text{m}$  south-east of its actual position.

Figure 3.7 View of Second World War, partially sunken, air-raid shelter, looking north.

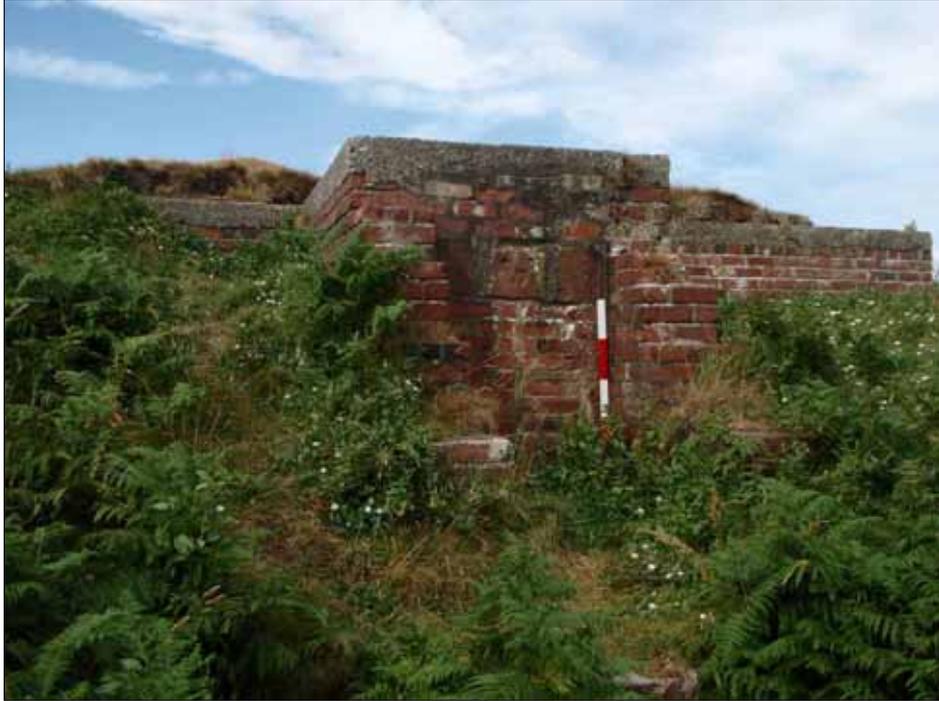
Figure 3.8 Blocked entrance into Second World War air-raid shelter (scale = 1m).

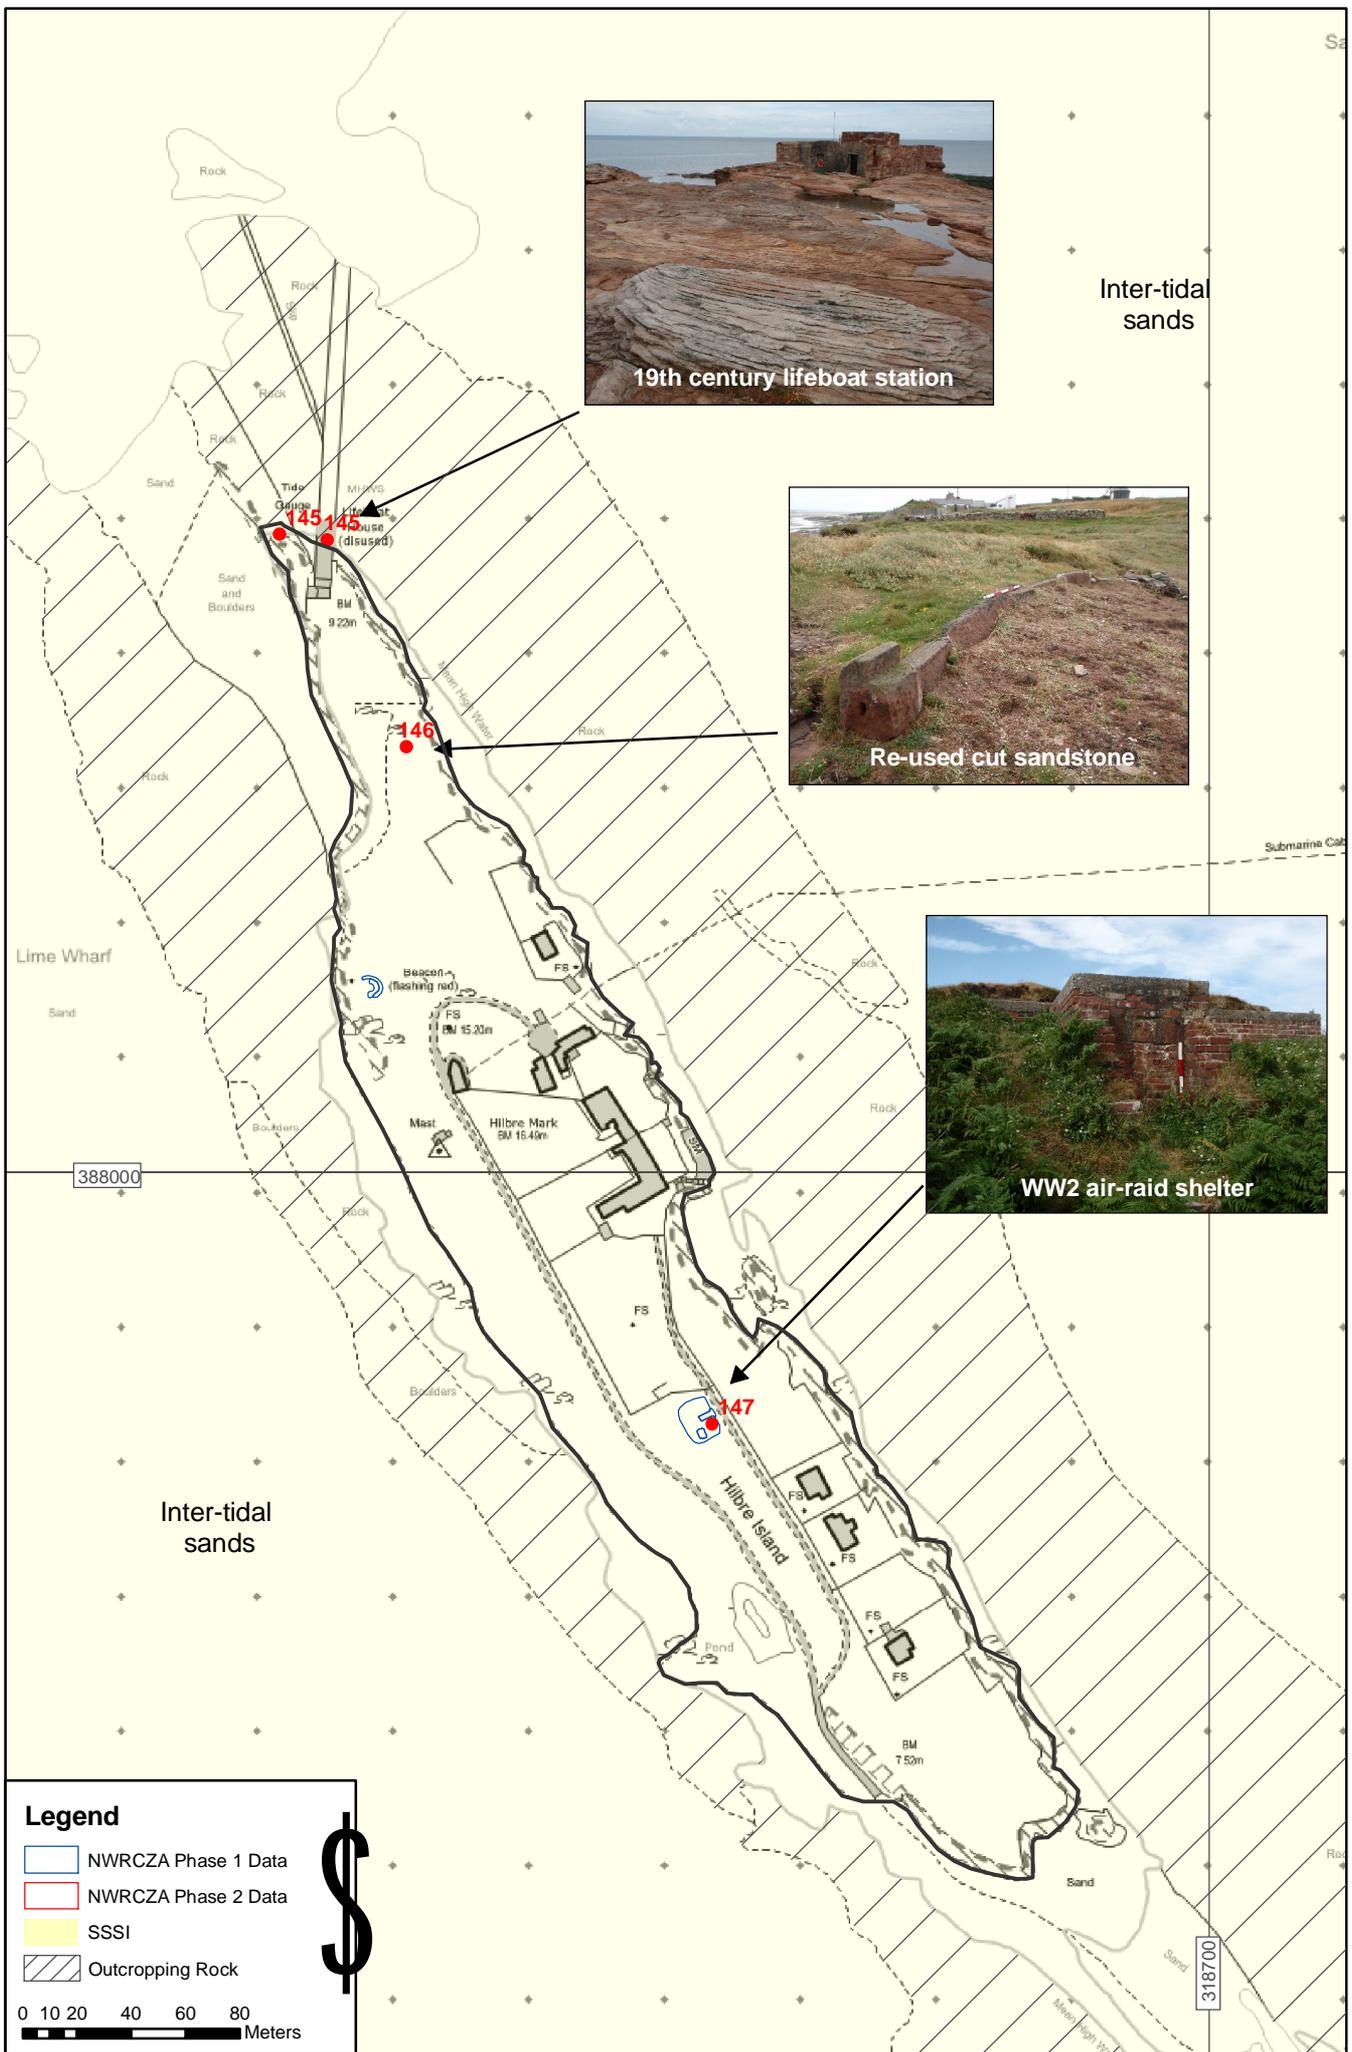
Based on these predictions (Figure 3.9) two of the sites recorded at Hilbre Island (the re-used cut sandstone masonry (146) and the World War II air-raid shelter (147)) are not considered to be at immediate, or longer term, threat from coastal erosion. This is due to the proposed construction of new seaward defences and/or the maintenance of older defences which should mitigate against erosion without causing damage to the monuments themselves. The lifeboat station (145), however, is considered to be at risk of coastal erosion, since its slipway lies in the inter-tidal zone where it will not be afforded the protection of the aforementioned defences. Stormy conditions in the early 2000s have already caused major structural damage to this feature (Figure 3.5) and only temporary repair works have been conducted. No remains of the prehistoric midden sites (HER: 1888-001), or St. Hildeburgh's Chapel (HER 1887-001), were recorded during the Phase 2 survey, however, unknown buried remains of these features may still be at risk of damage during the construction of sea defences or through coastal erosion.

Figure 3.9 Location of sites surveyed on Hilbre Island.

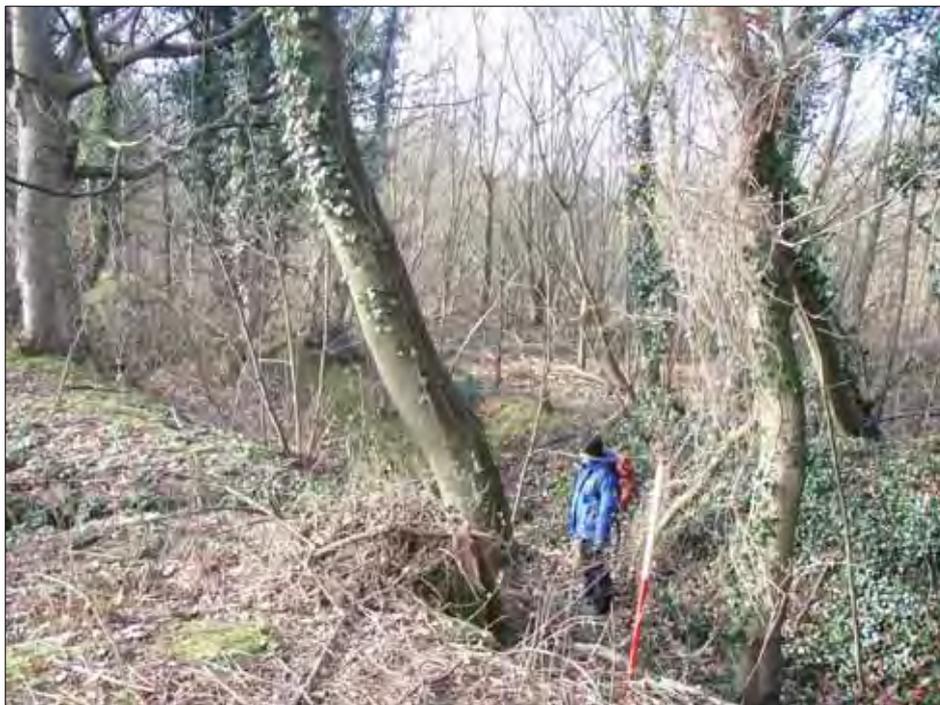
Figure 3.11 Western stretch of the moat at Bromborough (scale = 1m)

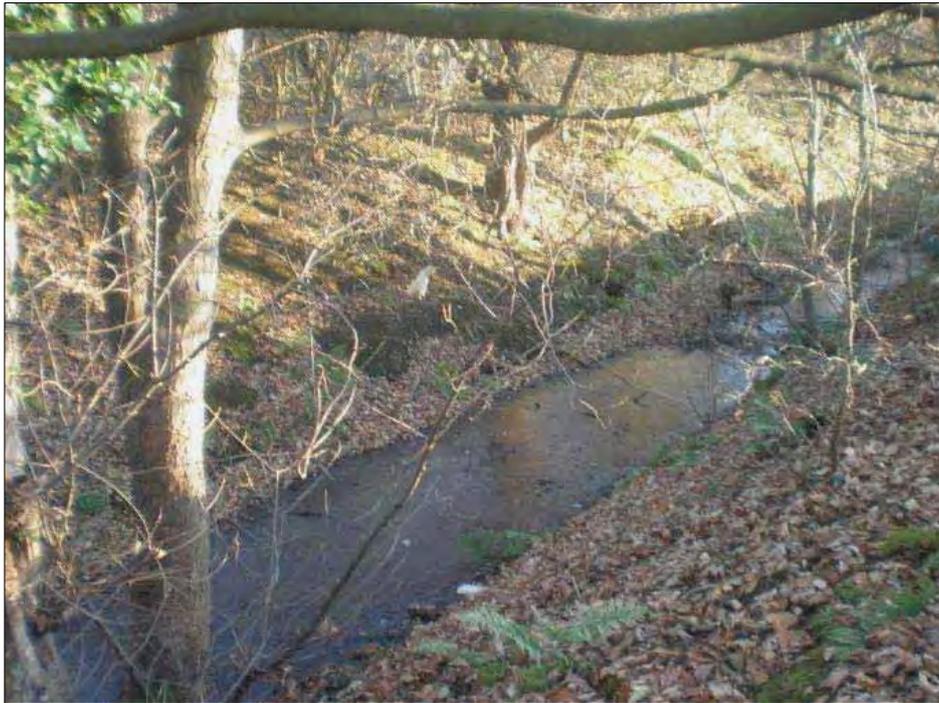
Figure 3.12 Southern section of the moat filled with water.

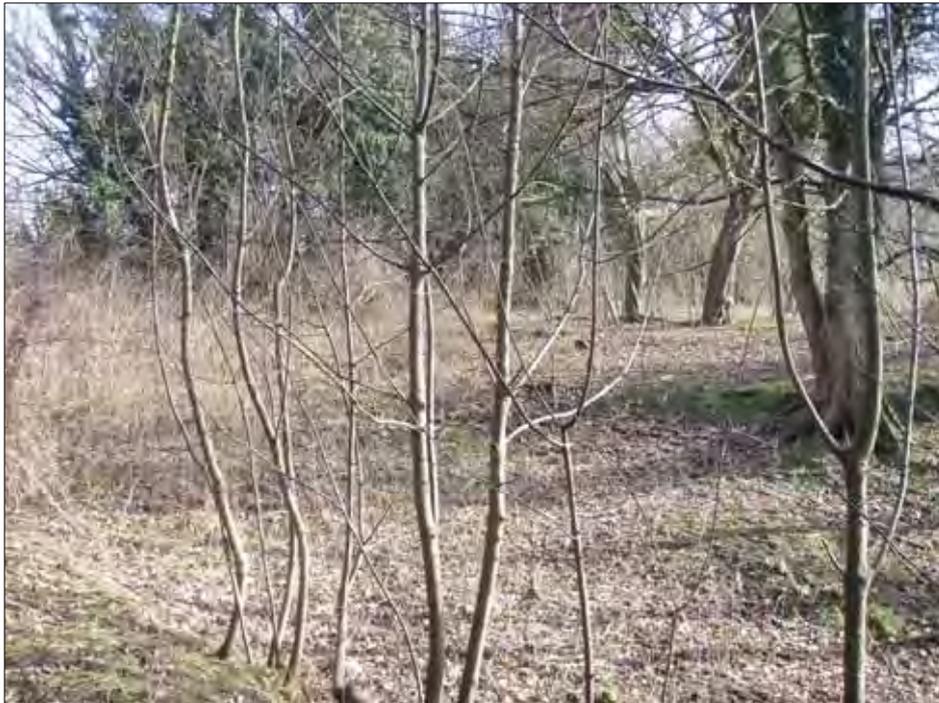
The site is significantly overgrown (Figure 3.13), preventing a detailed analysis of remains within the enclosed area. Several patches of ruined masonry were noted, however, possibly marking the remains of the post-medieval court house known to have occupied the site. No evidence of a building platform associated with the medieval manorial building was noted during the survey, though this is described in the scheduling information.

Figure 3.13 Interior of Bromborough Moated Site showing the level of tree cover.

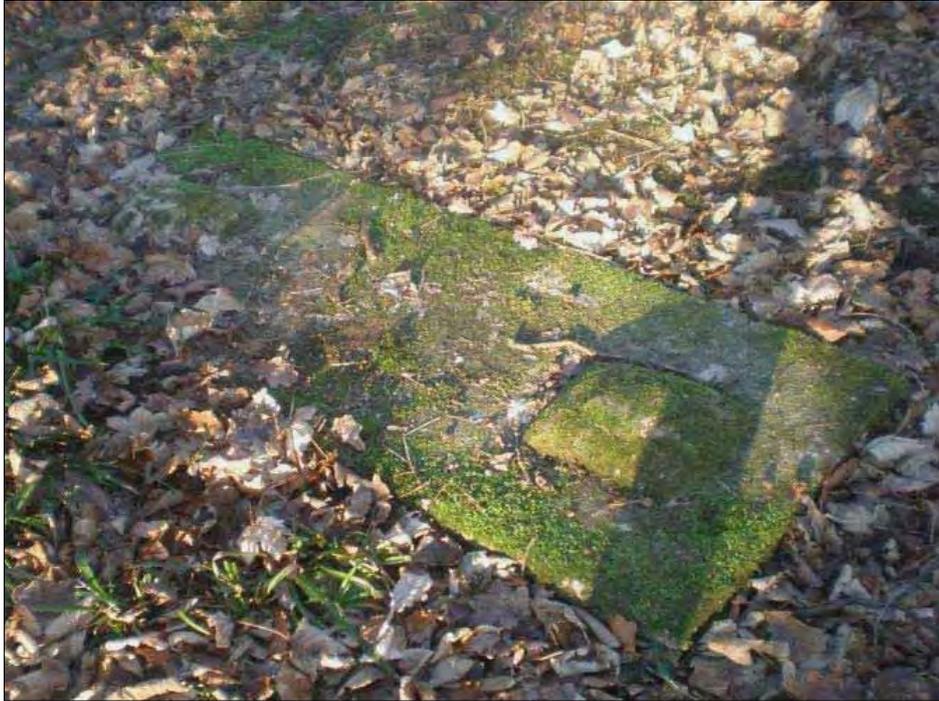
Several concrete blocks associated with an over-ground pipe network were noted during the course of the survey, though the pipework has now been removed (Figure 3.14). These are partially buried and may have disturbed buried archaeological deposits. They are spread over a large area of the north and east of the site.

Figure 3.14 Example of a concrete footing for the (now removed) over-ground pipe network. These are located throughout the north and east of the enclosure.

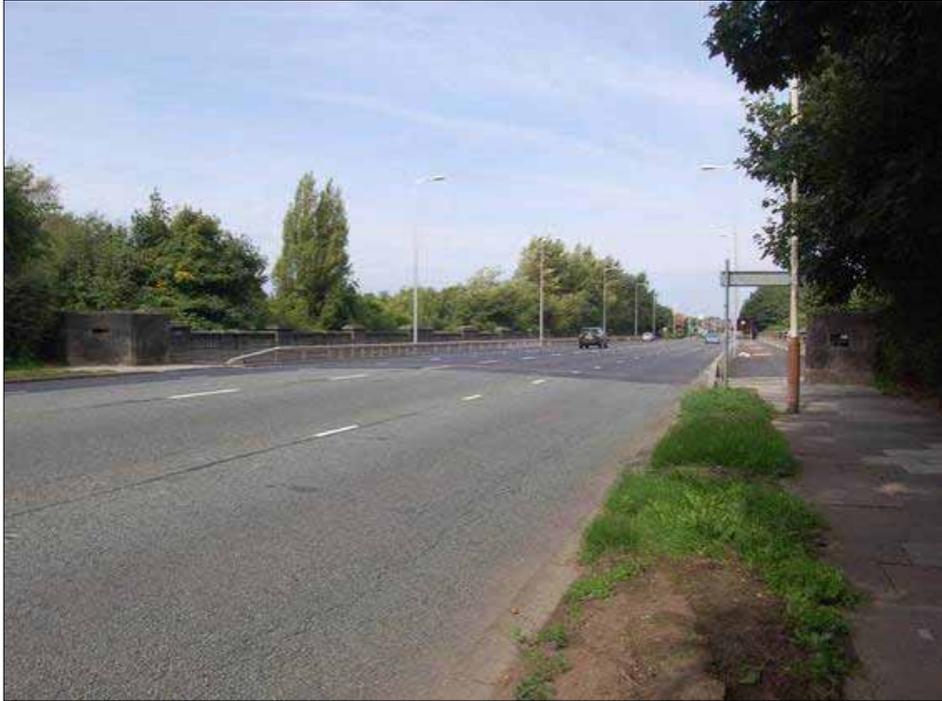
The pill boxes are Type 22 or FW3/22 which was the most common form of pill box in the country consisting of a regular hexagon with gun ports on each side except for the one that had the entrance (Lowry 1996, 82). The examples recorded at Bromborough Pool are constructed of concrete with brick-lined gun ports and are  $\approx 20\text{m}^2$  in area (Figure 3.15).

Figure 3.15 Pill boxes either side of the A41 at Bromborough Pool.

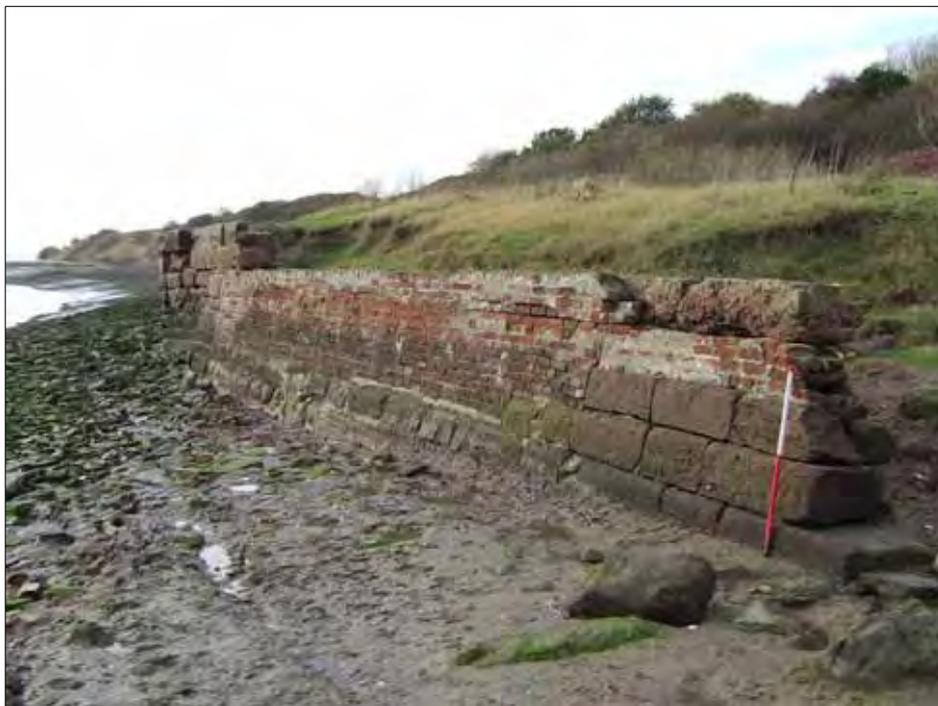
The survey of the wharf conducted by the MIHS provides a stone-by-stone record of the structure and also a detailed assessment of its erosion characteristics. This uses the following headings 'dressing still on stone face', 'slight erosion to stone face', 'considerable erosion with even wearing', 'erosion resulting in change of shape of the stone', 'missing pointing leaving voids' and 'uneven erosion', and as such it provides a basis by which future erosion of the wharf can be measured. Forshaw also draws attention to the sites of old navigational aids along the wharf and various iron fittings (Forshaw 1998, 4).

Figure 3.19 Remains of red sandstone and brick wharf looking west (scale = 1m).

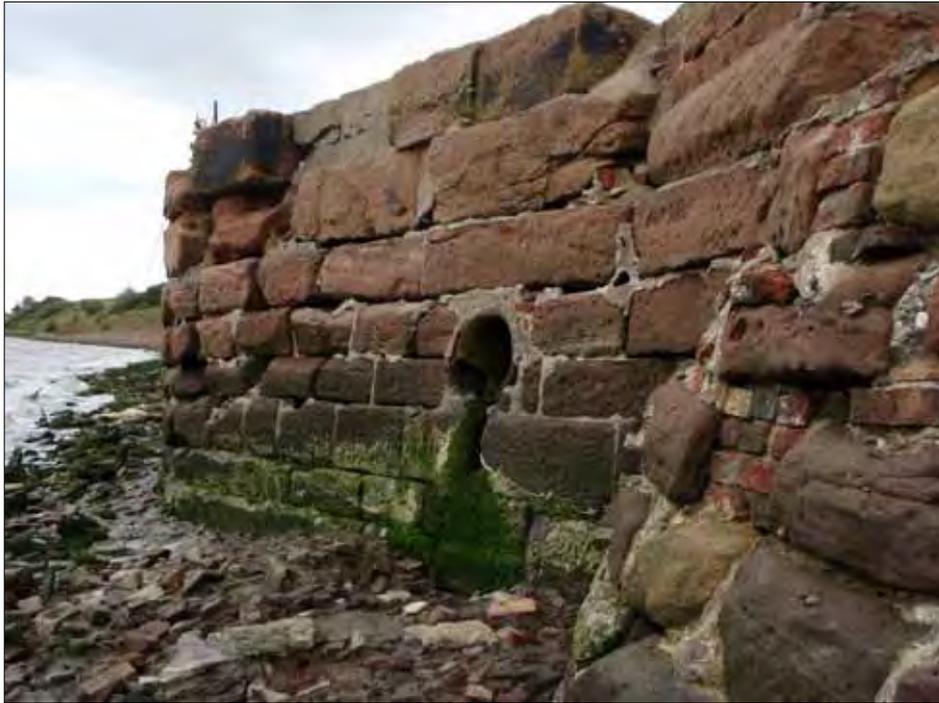
Figure 3.20 Dogleg in the course of the wharf, possibly indicating the juncture between two phases of construction. Looking west

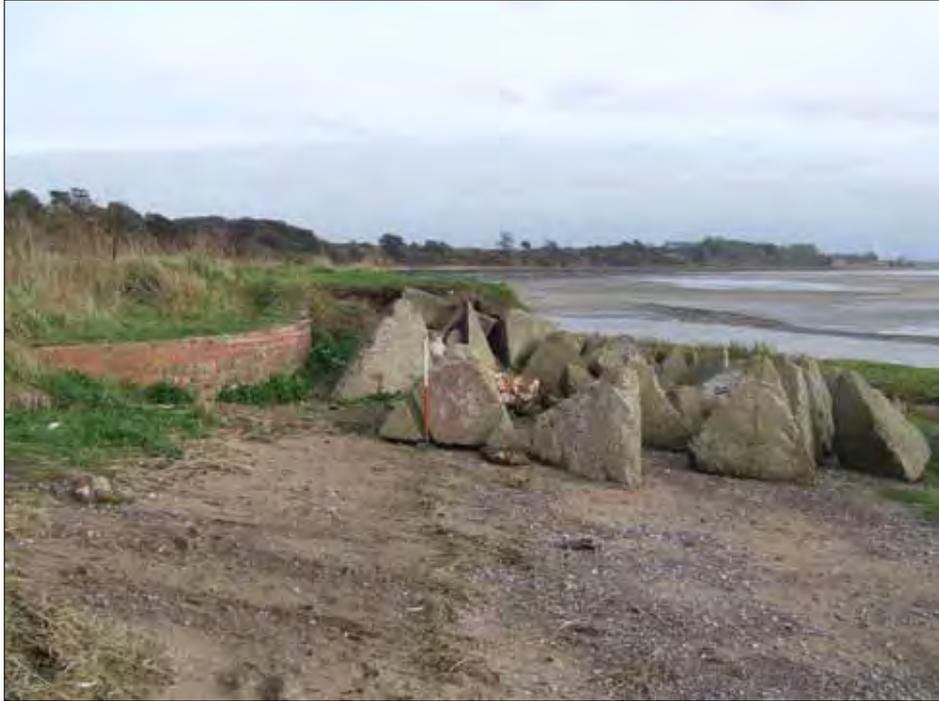
The circular underground saltchamber (198) is only partially exposed and its original lower portions are constructed of handmade bricks laid to English bond (Figure 3.21). Again these bricks can be said to pre-date the brick tax of 1803 (see above). More modern repair work is evident in the upper courses, probably attributable to the MIHS who consolidated the chamber against further erosion in 1991 (Forshaw 1998, 1). The remainder of the chamber is grassed over and a man-hole cover protects the entrance.

Figure 3.21 Partially exposed, circular brick-built salt chamber on the left of the photograph with World War II anti-tank blocks ('dragon's teeth') re-deposited in front to protect it from erosion. Looking east (scale = 1m).

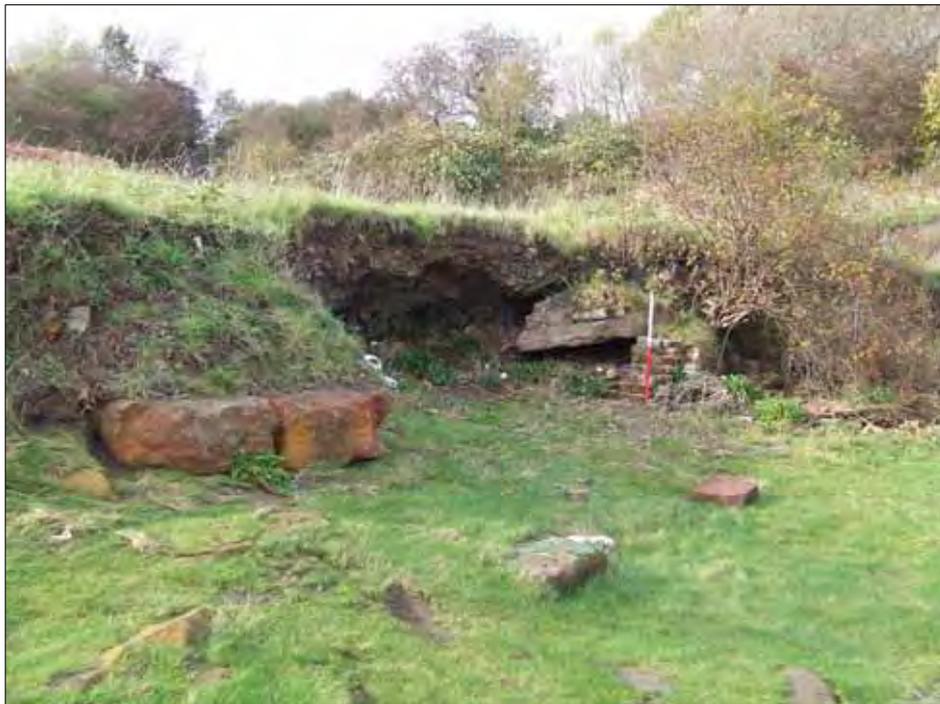
Coastal erosion has already caused heavy damage to the remains at Dungeon Saltworks and the associated Hale Cliff Wharf, as shown in Figure 3.23. Based on the predicted levels of future erosion (Figure 3.22), the wharf (148) and anti-tank blocks (197) are considered to be at immediate threat from coastal erosion, whilst the salt chamber (198) and building remains (198) are considered to be under long-term threat (i.e. damage will occur within the next 100 years). The preferred policy of No Active Intervention will see further erosion of these features.

Figure 3.23 Eroding remains of sandstone quay and brick buildings, looking north-west (scale = 1m).

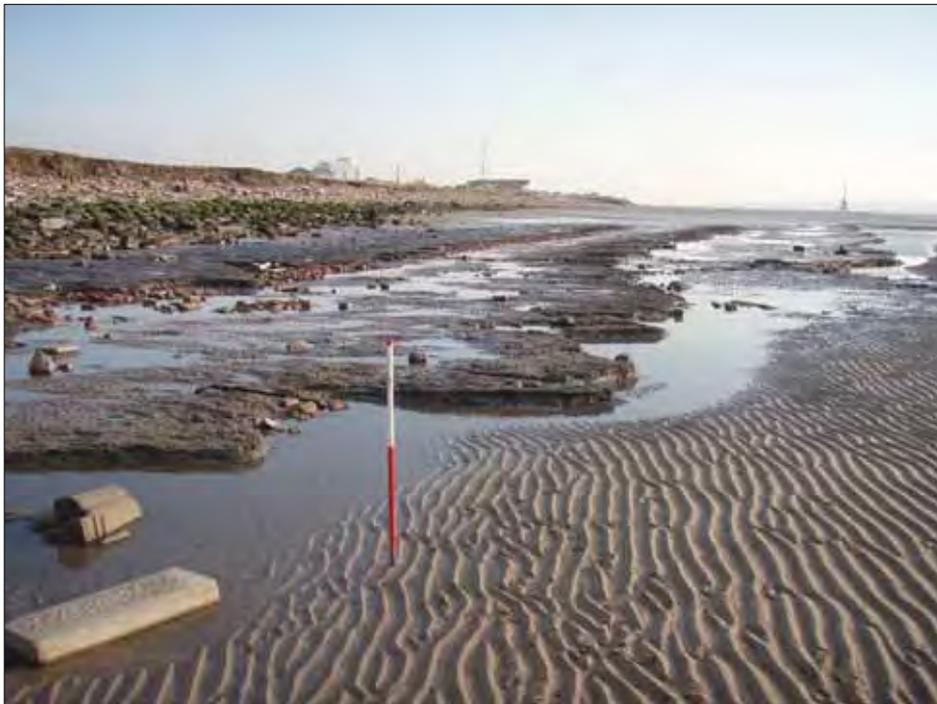
Figure 3.26 Exposed silts on Crosby beach, looking south (scale = 1m).

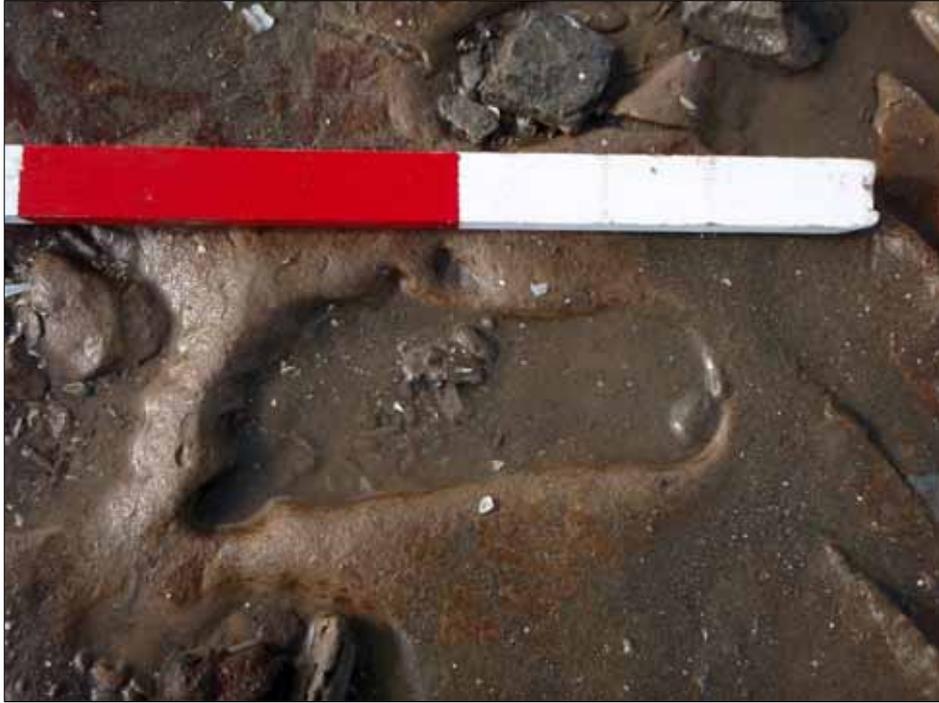
The first recorded exposure of silt (149) containing potentially prehistoric footprints was a narrow band measuring 162m x 12m. This contained one very well-defined human footprint (Figure 3.29), showing the characteristic pointed toes interpreted as the drag caused by unclipped toe nails (Roberts 2009). Further imprints in the silt may have been the remains of more eroded human footprints and several well-defined ungulate tracks were also identified (Figure 3.30). There was a significant amount of damage to this exposure of silt caused by 4x4 vehicles and this represents a further threat to the remains

Figure 3.29 Very well defined human footprint on exposed silt at Formby Beach (scale = 0.2m graduations).

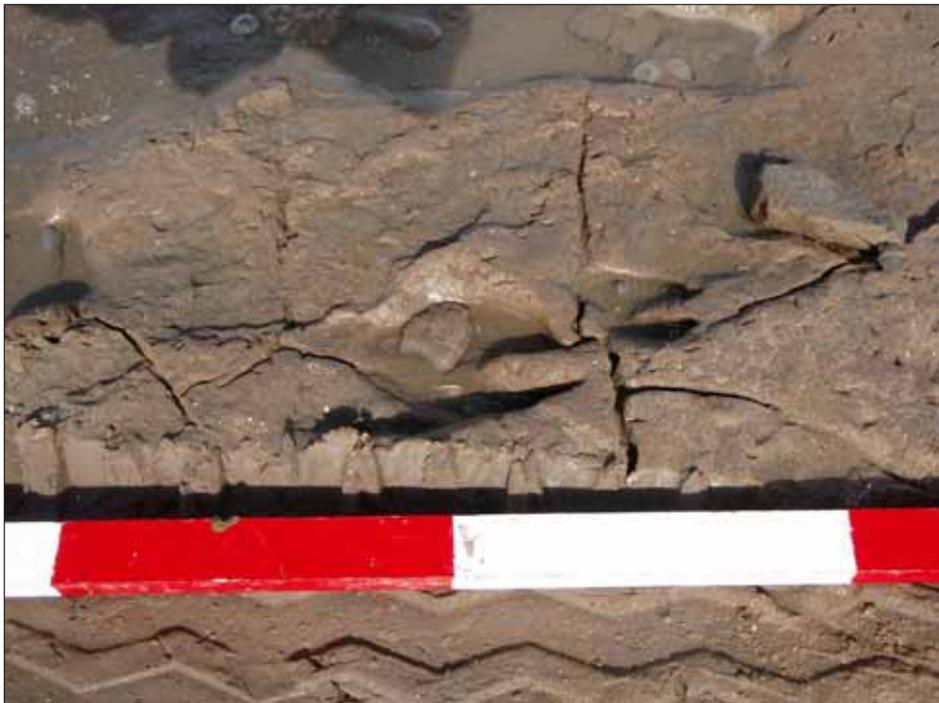
Figure 3.30 Ungulate footprints on exposed silt at Formby Beach (scale = 0.2m graduations).

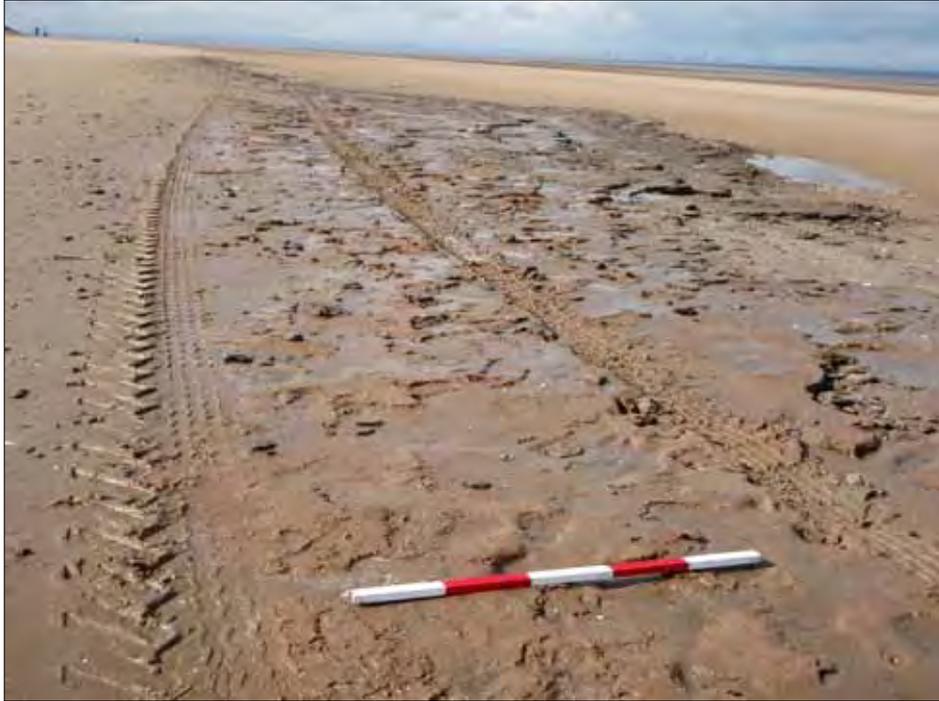
(Figure 3.31). This exposure was initially recorded in July 2011 and by October 2011 it had been re-covered with wind-blown sand.

Figure 3.31 Vehicular damage to exposed silt containing prehistoric human and ungulate footprints at Formby Beach. Looking south (scale = 1m).

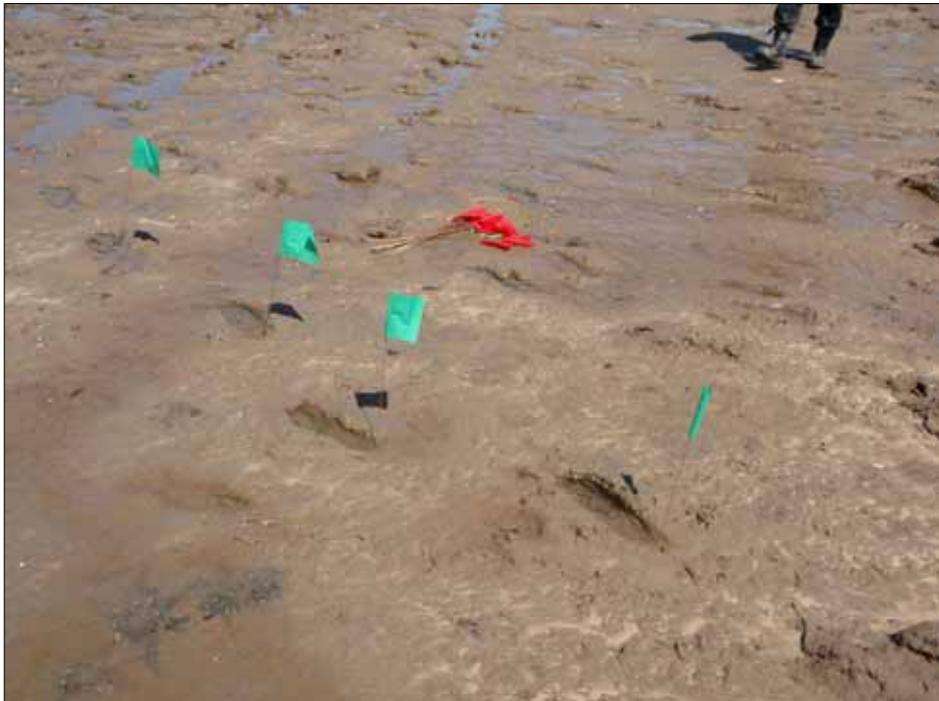
Figure 3.32 Recording of exposed human trails under the Sefton Coast Partnership Scheme.

The second recorded exposure of silt (150) containing potentially prehistoric footprints was a larger area, measuring 283m x 24m. This contained several well-defined tracks of human footprints which were in the process of being recorded by undergraduate student,

Ronan Mooney, as part of the Sefton Coast Partnership Scheme. This involved marking the footprints using different coloured flags (Figure 3.32), completing pro-forma record sheets, recording their location on a handheld GPS unit and undertaking a photographic record (equipment supplied by the Partnership Scheme). This detailed record will be provided to the Merseyside HER and will allow for the future analysis of the footprints, should they be destroyed by erosion or re-covered by wind-blown sands.

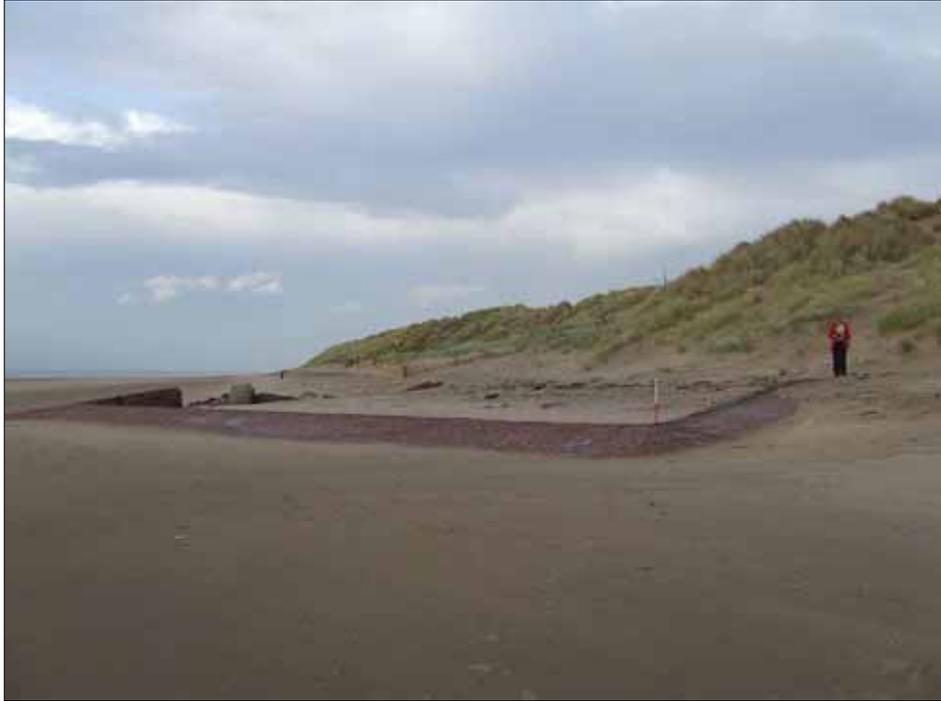
Evidence of this maritime history was recorded during the Phase 2 survey as the remains of the lifeboat house (199) and three shipwreck sites (151, 152 and 153). The lifeboat house has been reduced to foundations following its demolition 1965. These consist of a sloping base of handmade bricks with keyed-in red sandstone blocks, measuring *c.*10m x *c.*20m (Figure 3.33). The remains are partially buried in sand and some damage is apparent on the northernmost corner. An interpretation panel by Sefton council, next to the remains, gives an explanation of the feature.

Figure 3.33 Foundations of the 18<sup>th</sup> century Formby lifeboat house looking north-east (scale = 1m).

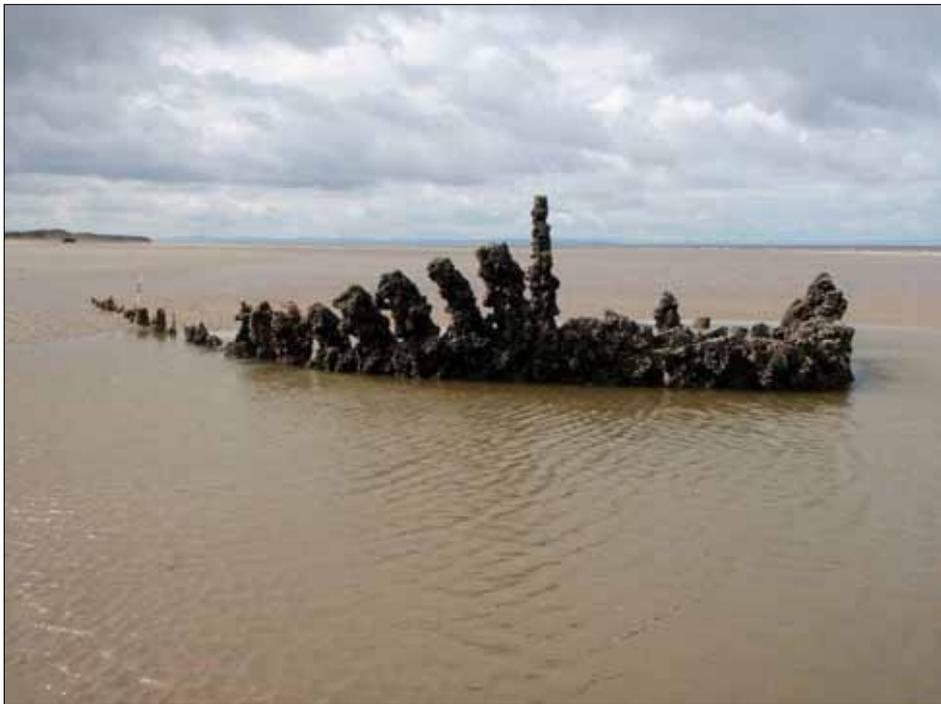
The best-preserved shipwreck recorded as part of the survey (151) consists of the bow or stern of a timber sailing vessel with a single mast surviving (Figure 3.34). The remaining sections measure *c.*26m x *c.*11m and stand at varying heights up to 2m at the mast. The timbers are degraded and covered in mussels, but are still recognisable as a possible schooner-type vessel.

Figure 3.34 Bow or stern of a timber sailing vessel looking south-east (scale = 1m).

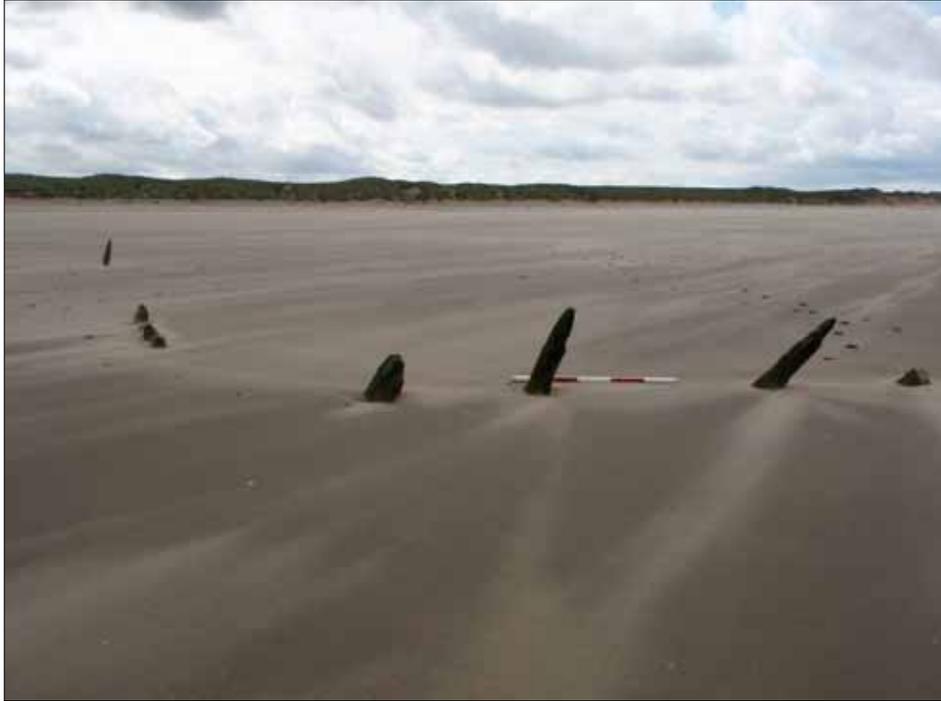
The second shipwreck recorded (152) consists of eight remaining timbers, covering an area of  $\approx 2.3\text{m} \times \approx 5\text{m}$  and is almost fully buried in sand. The morphology of the vessel is no longer recognisable (Figure 3.35).

Figure 3.35 Remains of a timber vessel. Looking south-east (scale = 1m).

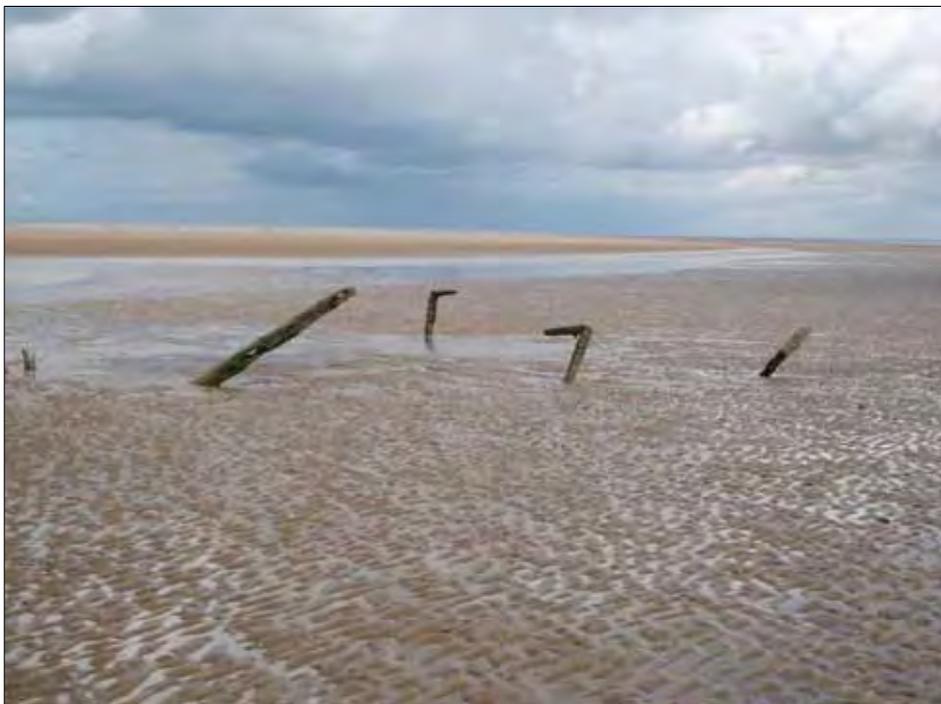
The third shipwreck recorded (153) consists of three iron L-shaped brackets and a single timber baulk. The remains cover an area of  $\approx 9\text{m} \times \approx 8\text{m}$ . The morphology of the vessel is no longer recognisable (Figure 3.36).

Figure 3.36 Remains of an iron and timber vessel or structure looking west.
