## **5.12 Barrowmouth and Saltom Bay (Map Figure 5.129)**

### *5.12.1 Location and geology*

#### *5.12.3 NWRCZA Phase 2 Archaeological Investigation*

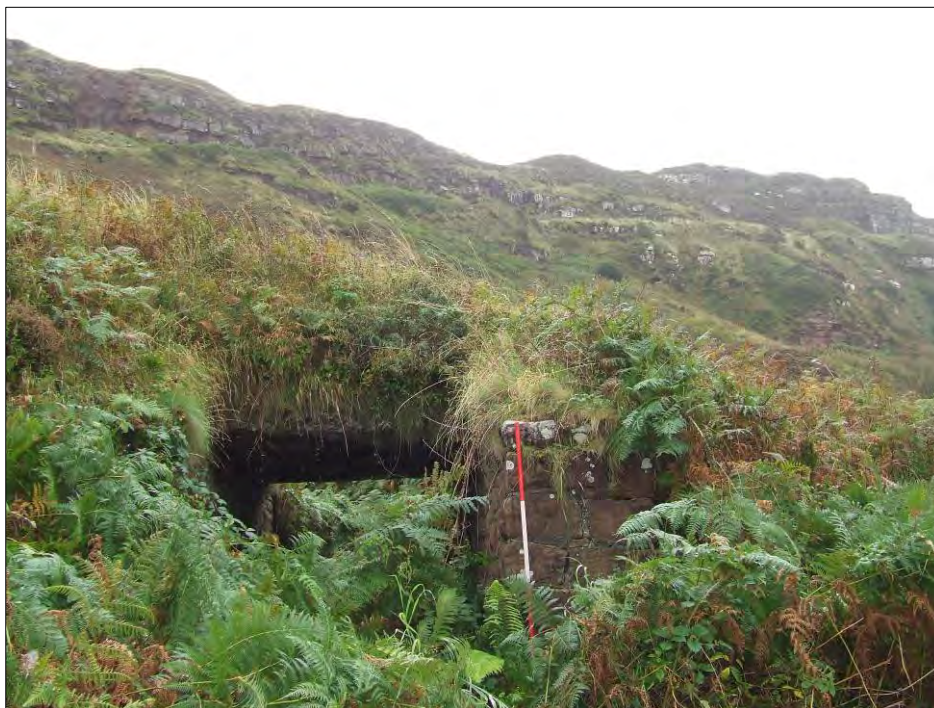
The wagonway on an incline plane (132) would have been used to haul mined products up the side of the cliff face, from the pit head to Croft Wagonway at the top of the slope (Cranstone 2007, 63). It survives as a visible earthwork running for a length of c.0.25km and crosses what must be an original trackway by means of a stone-built bridge (Figure 5.119). Cranstone notes that that wagonway now has a slight dog-leg due to damage from land slips (Cranstone 2007, 115).

Figure 5.119 Stone-built bridge carrying the wagonway on an incline plane looking south (scale = 2m).

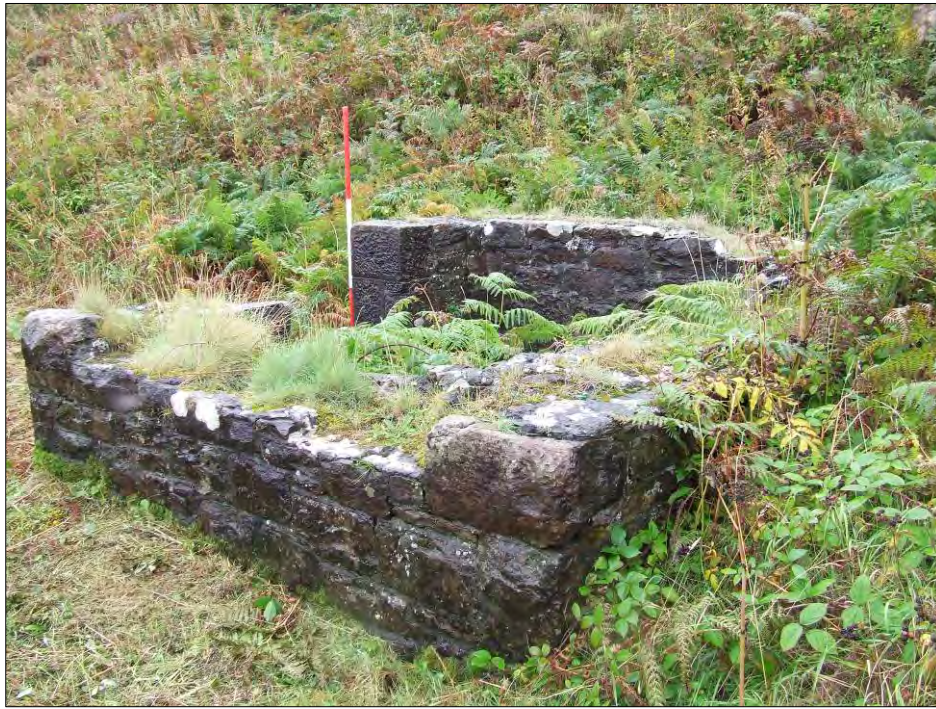
Three buildings were recorded alongside the wagonway (133-135). These were roofless, square structures which had been reduced in height, in what appeared to be deliberate destruction rather than ruination. Each structure contained the partial remains of an entrance doorway, sometimes fitted with iron hinges for a door rebated to open outwards (Figure 5.120). Each measured  $\approx 5\text{m} \times \approx 3\text{m}$  and the southernmost building (135) was interpreted as a possible gunpowder store as its floor was lower than the surrounding ground, giving it the appearance of a pit-like storage location. Gunpowder stores were usually located in remote locations, however, due to the risk of explosion so this interpretation is open to debate.

Figure 5.120 Remains of three structures at Barrowmouth; top (135), left (133), right (134) (scale = 2m).

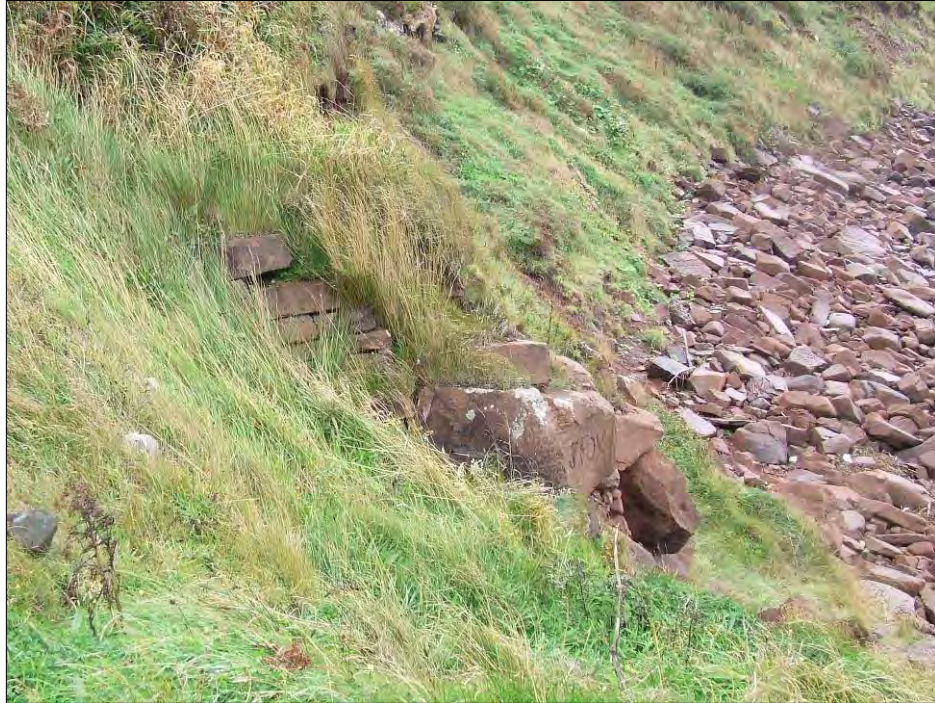
A further section of walling was recorded to the southwest of the possible gunpowder store (136). This was undergoing active erosion and access could not be gained to the structure for the purposes of more detailed investigation (Figure 5.121). This may be the remains of a further building or it could be the remains of an old sea wall or boundary wall for the mining operation. There appeared to be lettering on the face of this walling which may give an indication of its date or purpose, but this could not be assessed at the time of survey.

Figure 5.121 Remains of a further structure or walling at Barrowmouth, looking south.

The remains of walling (136) recorded at the Barrowmouth Alabaster and Gypsum Mine were undergoing active erosion, and in light of Halcrow's predictions of shoreline retreat, further features associated with the mine will be at risk of coastal erosion. The remains are therefore considered to be at immediate and longer term threat of coastal erosion that will see the loss of a third of the site in the following 100 years.

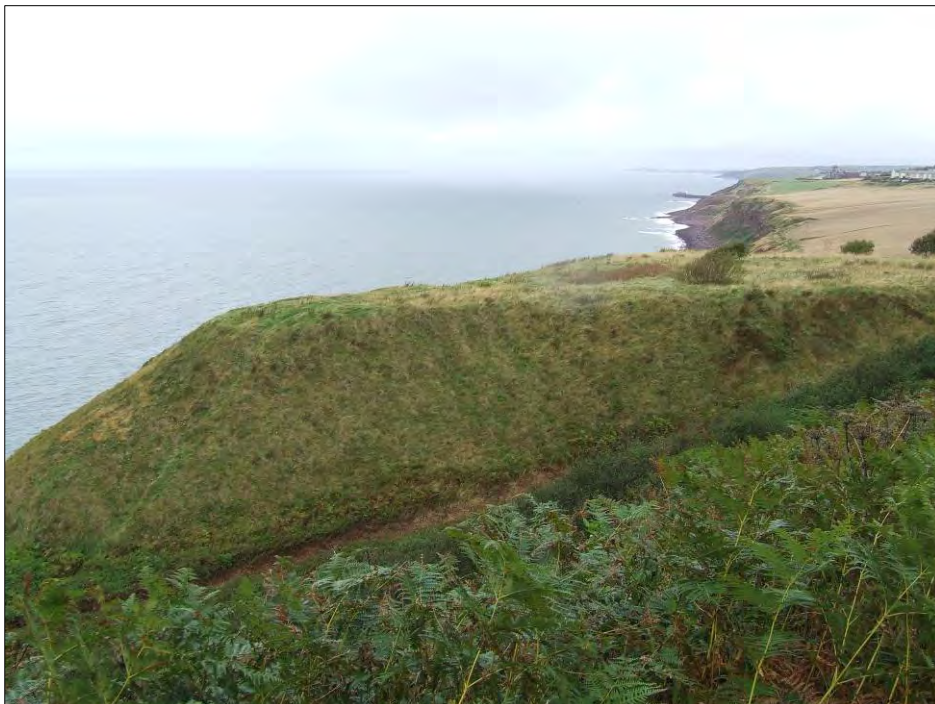
A large, flat-topped tip of mining spoil was also noted to the north of the mining remains, it is a very prominent feature in the landscape of this area (Figure 5.122). Cranstone interprets this mound as spoil from Haig colliery to the north and describes this area as an interesting 'landscape of disposal' which should be retained if possible (Cranstone 2007, 94).

Figure 5.122 Remains of a large mining spoil tip at Barrowmouth, looking north.

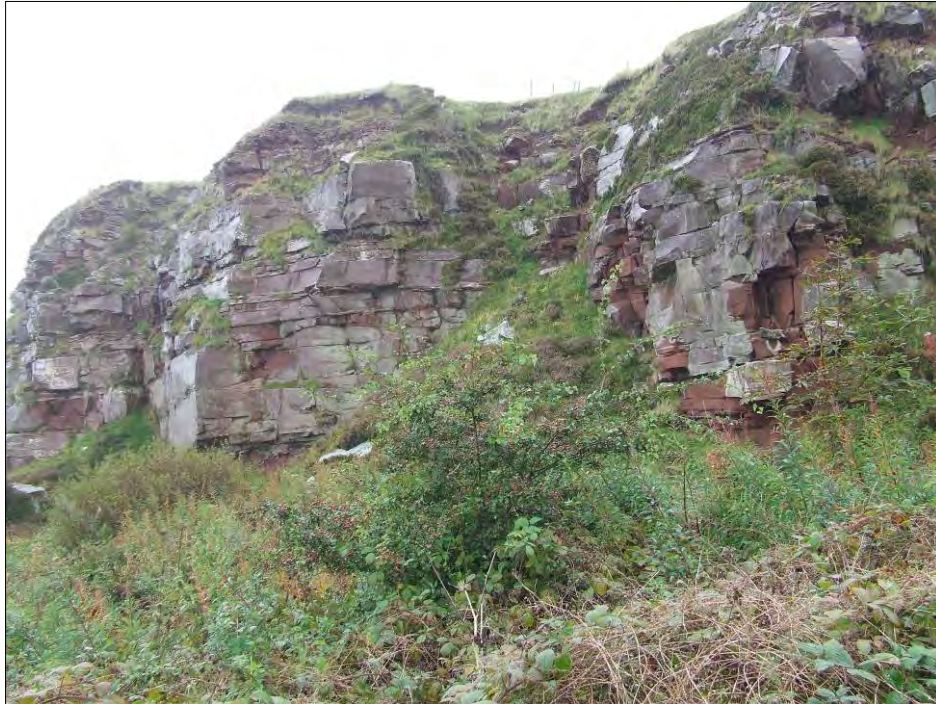
Aikbank Quarry: East of the mining operation in the cliffs that back on to the site, there are extensive remains of post-medieval quarrying activities. One such site was recorded as part of the survey at Aikbank Quarry (131) c.160m east of the mine. This site is recorded in the Cumbria HER (HER: 11981) and it was recorded during Phase 2 in order to characterise the remains in this area. The site consisted of a man-made cliff face where past red sandstone extraction would have taken place (Figure 5.123). The quarry is depicted on the First Edition Ordnance Survey Map of 1863 as being rectilinear in plan and accessed from the west. By the Second Edition Map of 1899 it had been enlarged and perhaps abandoned as it is shown as being the same size but disused on the 1925 mapping.

Figure 5.123 Remains of Aikbank Sandstone Quarry at Barrowmouth, looking east.

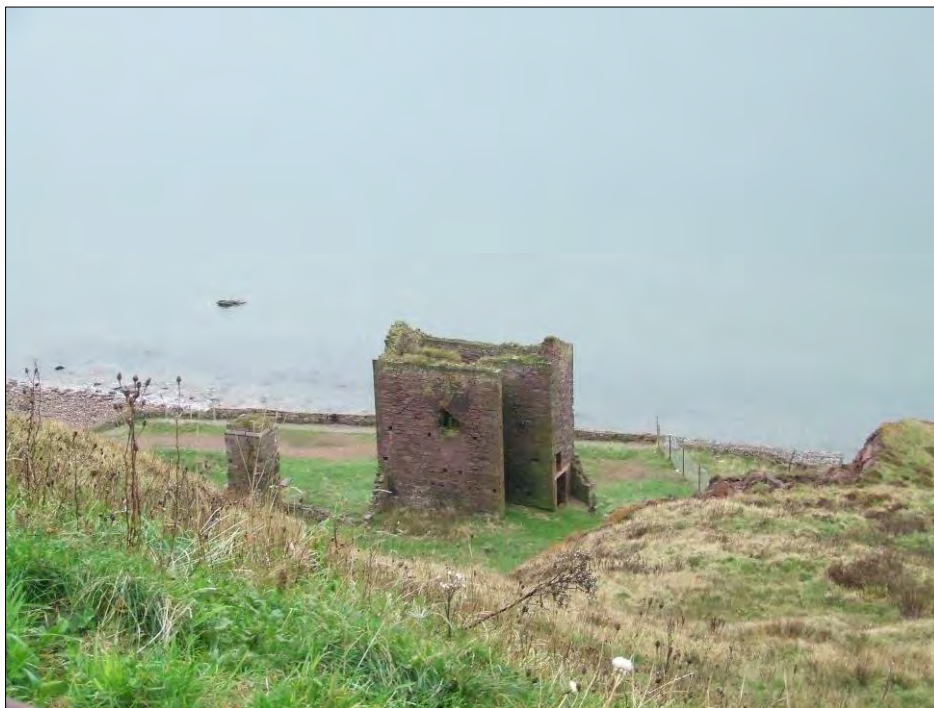
The Phase 2 survey recorded the remains of the colliery (187) as consisting of the engine house, chimney, seawall and remains of the horse gin (Figure 5.124-126). Further buildings were mapped to the east of these remains as part of the Phase 1 aerial photography transcription (NRHE: 8484), however no remains of these structures were recorded during the Phase 2 survey. Significant land slip and waste tips from the nearby Haig colliery were noted to the east of the site and these may be obscuring earlier colliery remains.

Figure 5.124 Standing remains of winding engine house and chimney, looking west.

A further cause for concern at Saltom Pit Colliery is the danger of landslips from above the standing remains. Recent landslips were noted at the time of survey as the cliffs backing on to this site are composed of mining spoil, most likely derived from Haig Colliery to the north (Figure 5.128). Landslips from above could cause major damage to this Scheduled Monument.

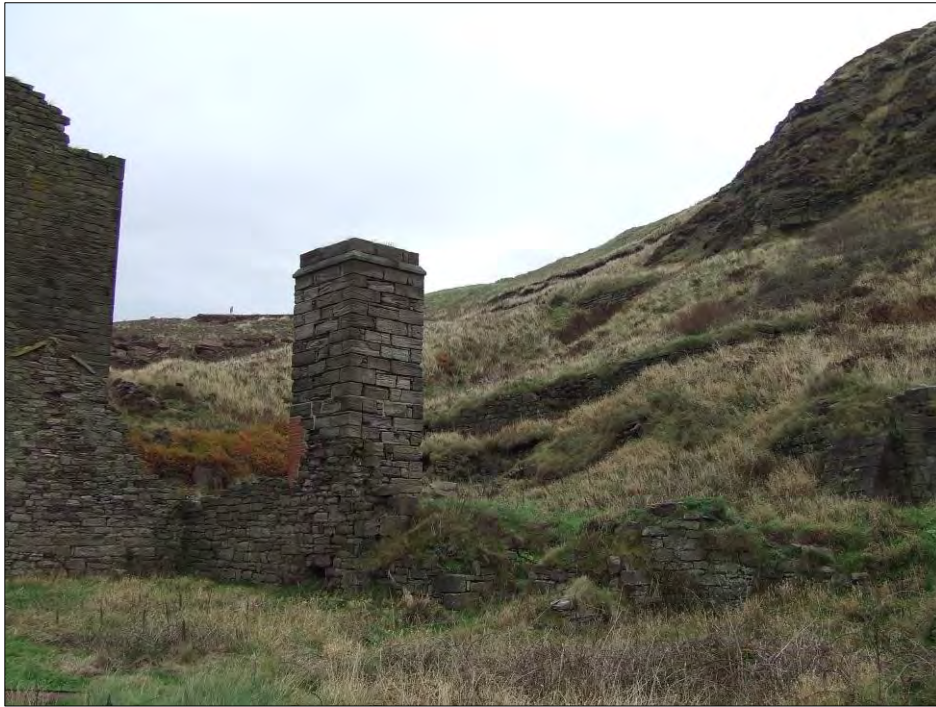
Figure 5.125 Standing remains of the chimney with retaining wall and remains of horse gin in the background, looking east.

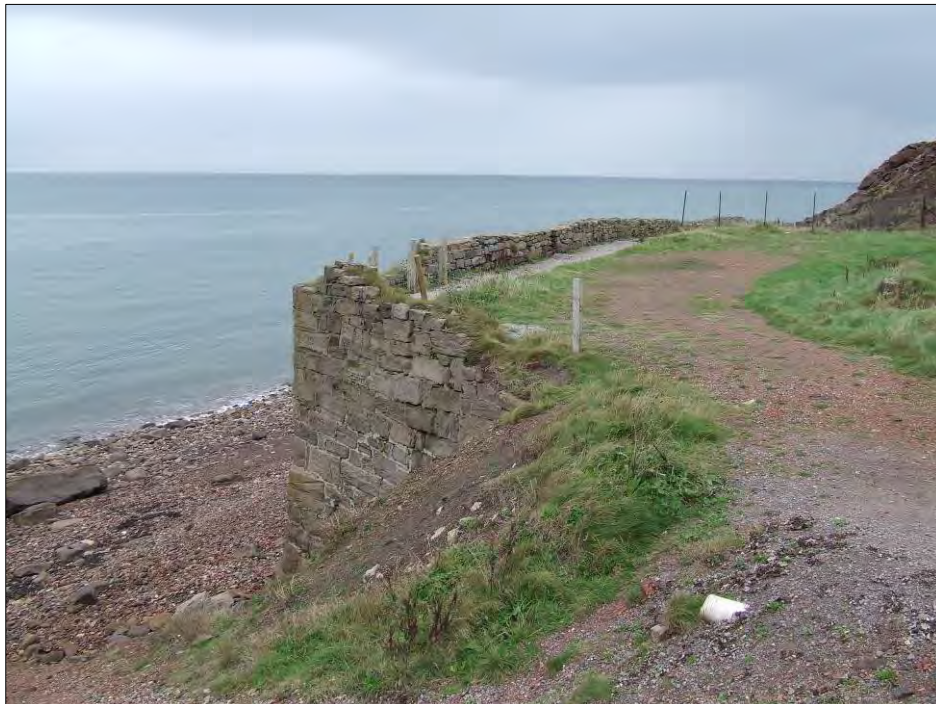
Figure 5.126 Remains of 18<sup>th</sup> century sea wall erected to protect Saltom Pit Colliery, looking north.

At Saltom pit to the north of Barrowmouth, the shoreline defences will be maintained for the following 50 years, after which time a 'No Active Intervention' policy will be adopted. Halcrow state that maintenance of the seawall at Saltom Pit Colliery will continue until such time as it is deemed technically difficult or not affordable to do so. 'The economic viability of the policy in the short and medium terms may depend on

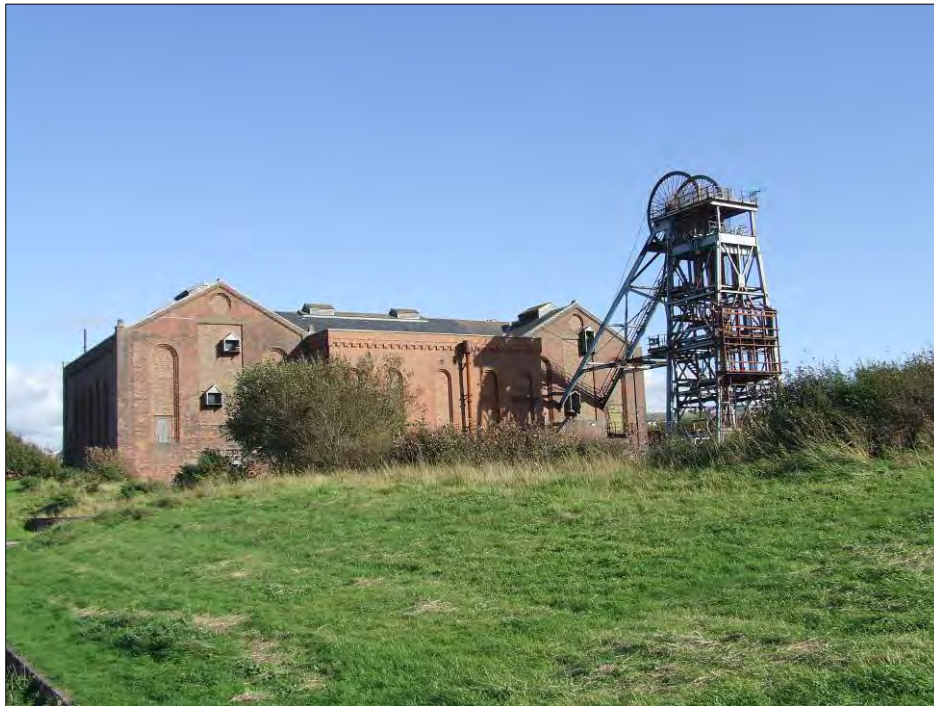
The survey recorded the colliery buildings (140) as being in a good state of repair. It is a prominent feature in the surrounding landscape and is clearly visible from the alabaster and gypsum mine to the south. Only one of the original external winding gears survives and the surrounding area has been landscaped (Figure 5.127). The colliery is not considered to be at risk of erosion.

Figure 5.127 Scheduled and Listed Engine houses and power station at Haig Colliery, looking east.

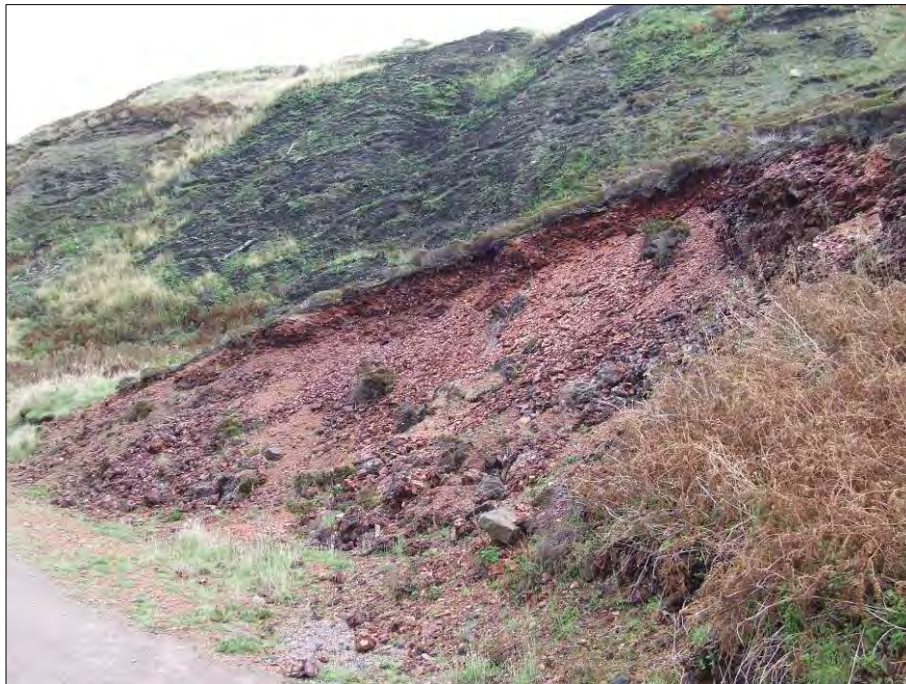
Figure 5.128 Mining spoil backing on to the remains of Saltom Pit Colliery, looking northeast.

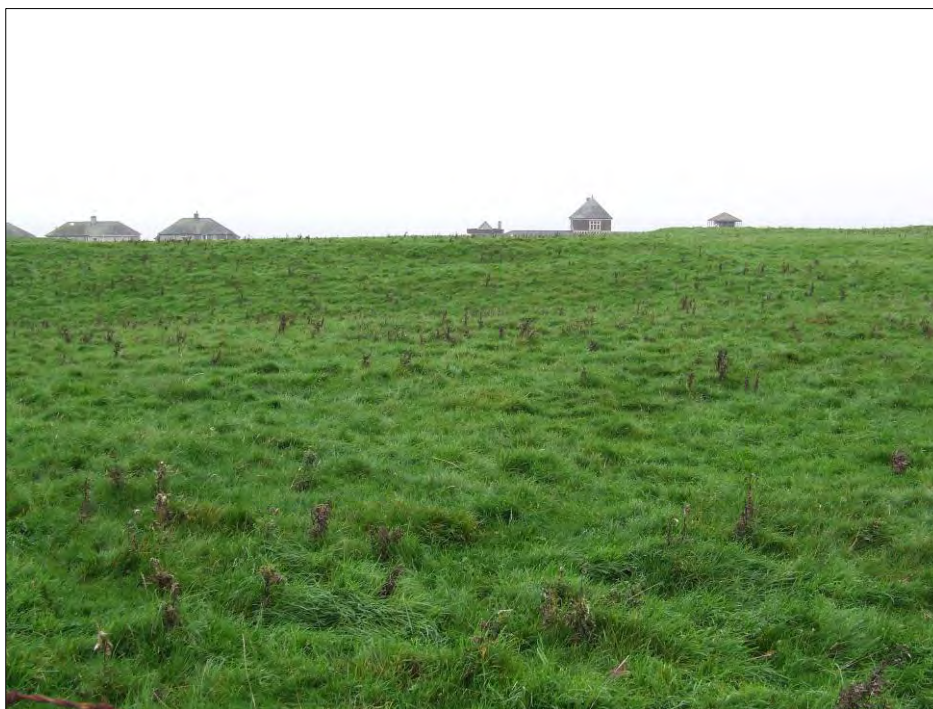
The Phase 2 survey recorded the remains of a second road (186) running east in the immediate vicinity of the southeast side of fort. This road is recorded in the Cumbria HER (HER: 12410), and was mapped as part of the Hadrian's Wall NMP (NRHE: 1326393). It survives as a visible earthwork running from the fort towards Camp Road (Figure 5.131). It is truncated by the road and housing along the east side of the street, however the NMP data records the extension of the road beyond the housing, curving round to the north. This was also revealed during the geophysical survey of the area and coincides with the Ordnance Survey projected route (Biggins and Taylor 2004, 123).

Figure 5.131 The southeast side of Maryport Fort with reconstructed watchtower at the Senhouse museum in the background, looking northwest.

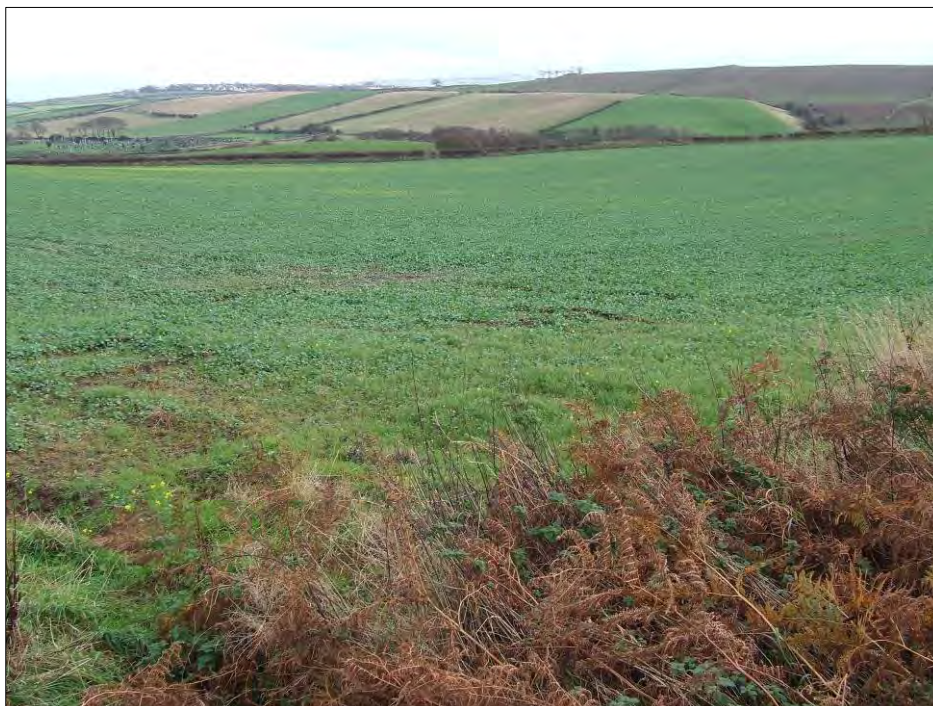
The survey recorded the remains as consisting of a slightly raised area of ephemeral earthworks adjacent to an apparently stable cliff face (Figure 1.132). The remains were

bisected by a modern field boundary. The Scheduled Monument description for this site states that it 'will retain undisturbed archaeological deposits and will contribute to any further study of the Roman frontier defences along the Cumbrian coast' (Scheduled Monument Description). However, the location of the site on the edge of the cliff may mean that the site has been partially lost through quarrying activities or erosion/landslip.

Figure 5.132 Slight earthwork remains of Milefortlet 23 bisected by field boundary in the foreground, looking northeast.

In light of this information the remains of the Roman road running eastwards from the fort site is not considered to be at immediate or longer term threat of coastal erosion as it begins c.320m from the shoreline. Milefortlet 23 is however considered to be at risk of coastal erosion in the longer term (i.e. within 100 years). This is due to the potential for increased rock falls and land slips on the cliff face following erosion of the foreshore at the foot of the cliffs. The cliffs presently appear to be stable, however their future response to cliff foot erosion has not been formally modelled.

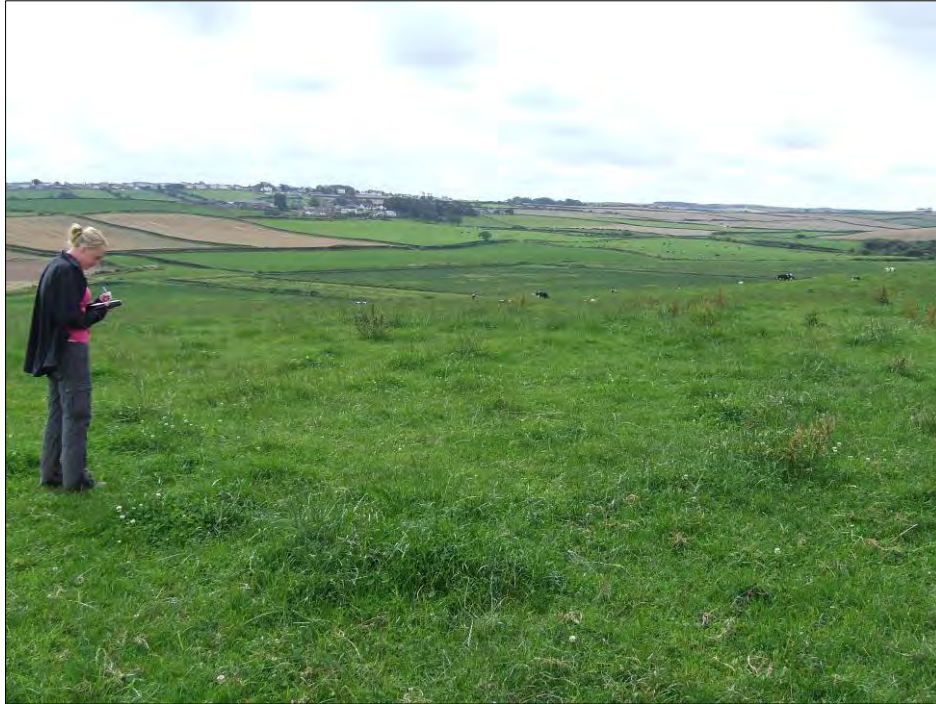
Excavations on the hillfort did not recover any artefactual remains, however the form of all three enclosure ditches was established, the outer two measure c.3m wide and 0.8m in depth, and the inner ditch measuring 5m in width and 1.3m in depth. There was also evidence for banks on the internal face of all three ditches (Bewley 1992, 40-2). The fill of the inner ditch was rich in charcoal and produced a radiocarbon date of 601-394 Cal BC (Bewley 1992, 39). Bewley states that geophysical survey was not possible at the site, and that he thought it unlikely that any internal features survive at the site (Bewley 1992, 37-8). No explanation for this statement is provided, but it may be related to the fact that the site has been ploughed almost continuously since the 1940s. Nevertheless the scheduling states that 'further evidence of the monument's defences and the nature of settlement within the hillfort's interior will survive (Scheduled Monument Description). The Phase 2 survey recorded the remains of the hillfort (107) as consisting of a very slight raised area nearing the crest of Swarthy Hill (Figure 5.35. The ditches did not have

any convincing surface expression, although a slight depression was noted that may coincide with the location of the inner ditch. The cliff face on the northwestern side of the monument appeared relatively stable and showed dense vegetative growth. However a moderately sized section of subsidence was noted at the top of the cliff at the time of survey, indicating that landslips are a risk to this monument (Figure 5.136).

Figure 5.135 Recording the remains of Swarthy Hill Hillfort, looking southeast.

The fate of the Iron Age (107) and Roman (87) remains on Swarthy Hill will be largely dependant upon the maintenance of the seawall for the Crosscanonby saltworks, since this would also protect the B5300 road and the Swarthy Hill cliff face from direct wave action. Nevertheless small scale landslips were noted at Swarthy hill at the time of survey and past erosion of the cliff face was noted during excavation of the hillfort (Bewley 1992). Swarthy Hill Hillfort (107) and Milefortlet 21 (87) are therefore considered to be at risk of coastal erosion in the long term (i.e. within the following 100 years), although Swarthy Hill hillfort is also currently undergoing active erosion in the form of landslips. Halcrow's assessment of the risk of erosion at Swarthy Hill hillfort states that 'the monument is at risk of further coastal erosion' (Halcrow 2011)

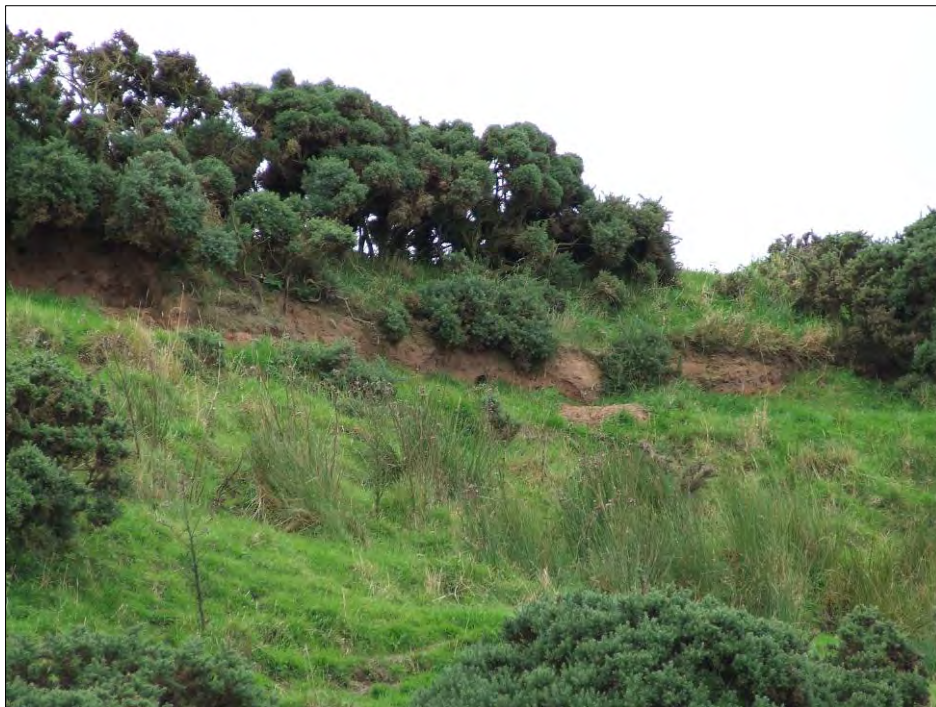
Figure 5.136 Subsidence at the top of the cliff on which Swarthy Hill Hillfort sits, looking southwest.

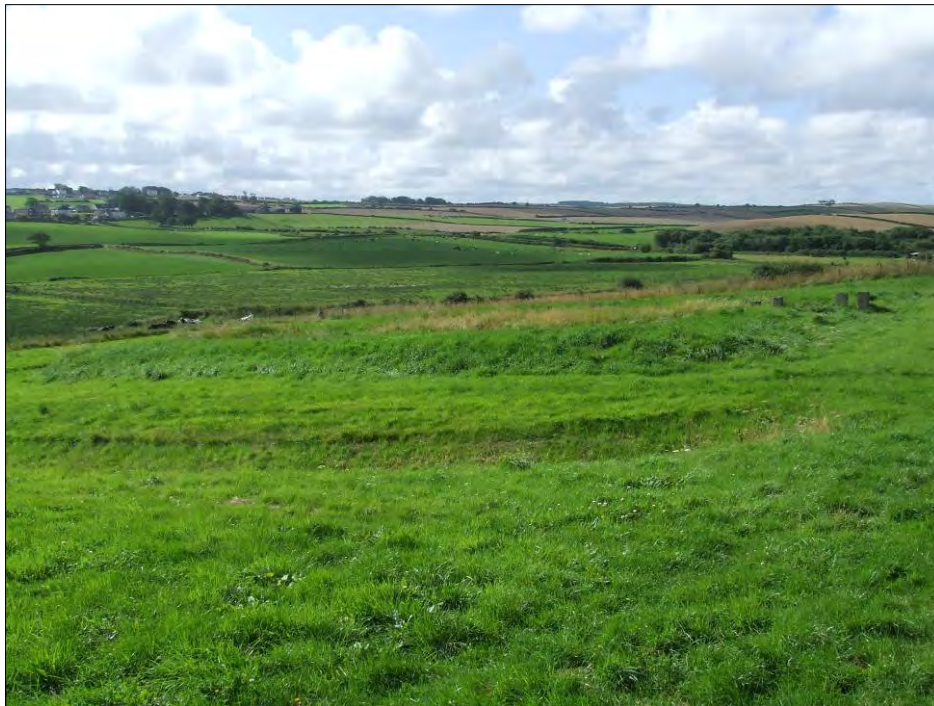
The Phase 2 survey recorded the remains of the Milefortlet 21 (87) as consisting of the well-maintained, partially reconstructed earthwork remains of a Roman milefortlet measuring c.45m x c.40m externally (Figure 5.137). The excavation of the site showed that the rampart was constructed of turf revetting a sand bank (Turnbull 1998, 68-9) and these remains have been reconstructed at the site inside the perimeter ditch which has been emptied of all fill. The entrance to the site is marked by timber posts which mirror the excavated evidence of sleeper beams constructed to carry a timber structure of a gateway (Turnbull 1998, 71).

Figure 5.137 Partially reconstructed remains of Milefortlet 21, looking south. Around 1.3km southwest of Milefortlet 21 the survey recorded the remains of Tower 21B (90), known as Brownrigg North Tower. This site is a Scheduled Monument (27717)

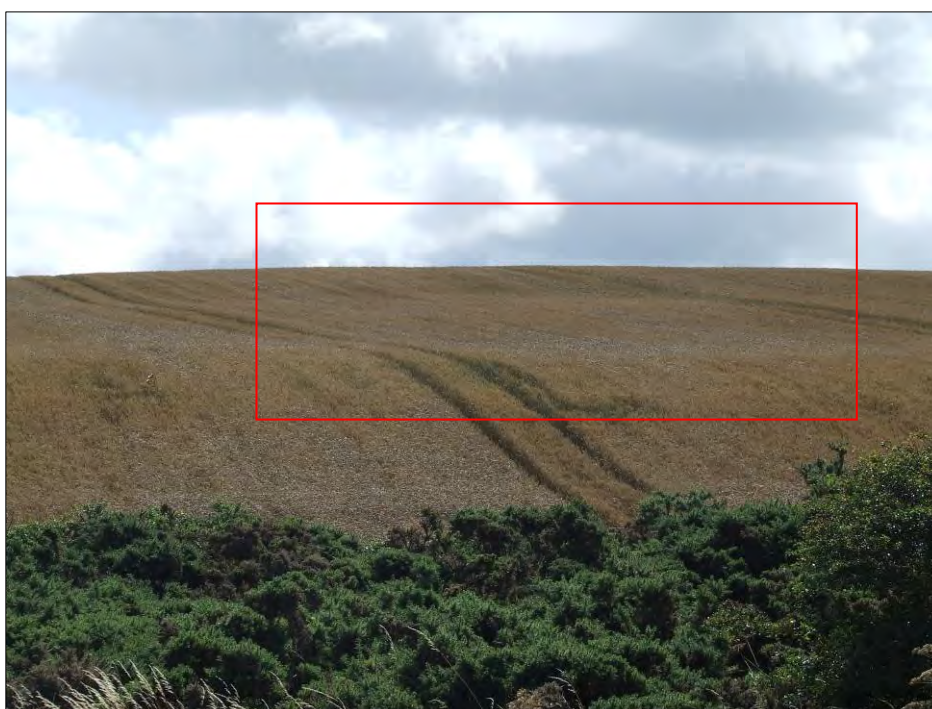
The Phase 2 survey recorded the remains Tower 21B (90) as consisting of a slightly raised earthwork platform lying on a natural ridge, on the seaward facing slope of Brownrigg Hill (Figure 1.138). The site is located on private land, under crop, and was not accessed for the purposes of detailed survey, however the ephemeral nature of the remains would most likely not repay further earthwork survey.

Figure 5.138 Ephemeral earthwork remains of Roman Tower 20B, looking east.

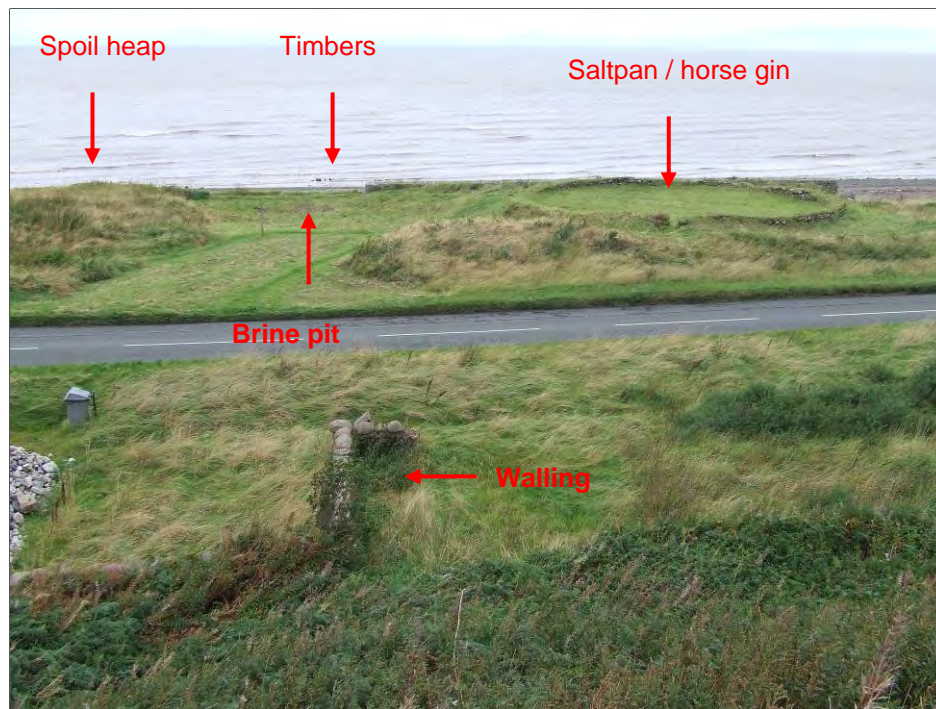
The Phase 2 survey recorded the remains of the saltworks (86) as consisting of a large saltpan or horse gin, spoil heaps, a possible brine pond or pit, the foundations of a cistern or water pump and walling associated with workers cottages and stables (Figure 5.139).

Figure 5.139 View of Crossscanonby saltworks taken from Swarthy Hill, looking northwest.

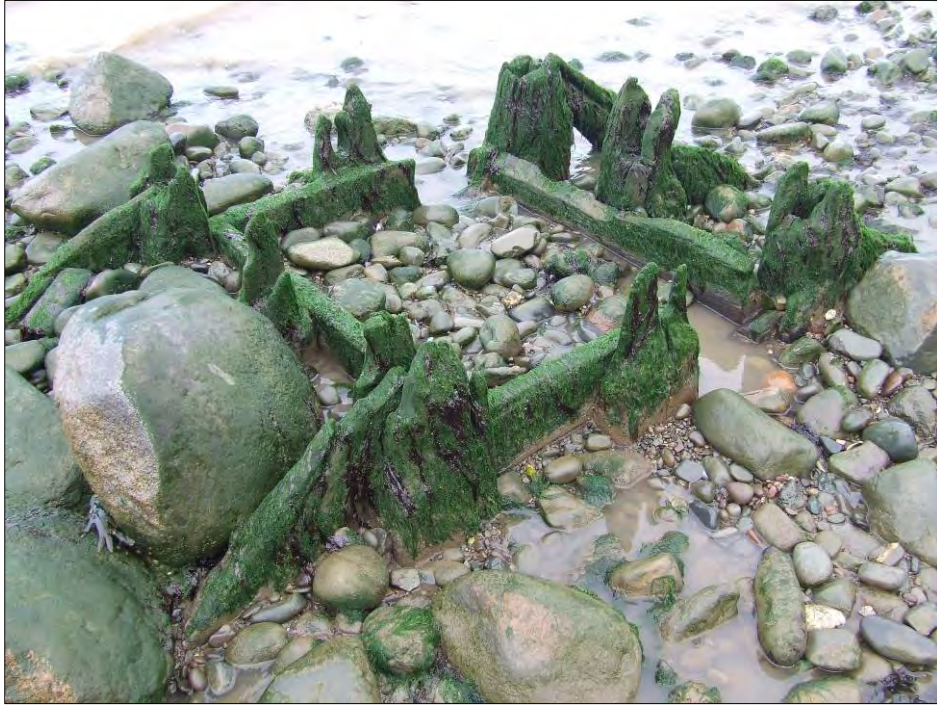
Figure 5.140 Timber trough associated with a cistern or pump for Crosscanonby saltworks, looking northwest.

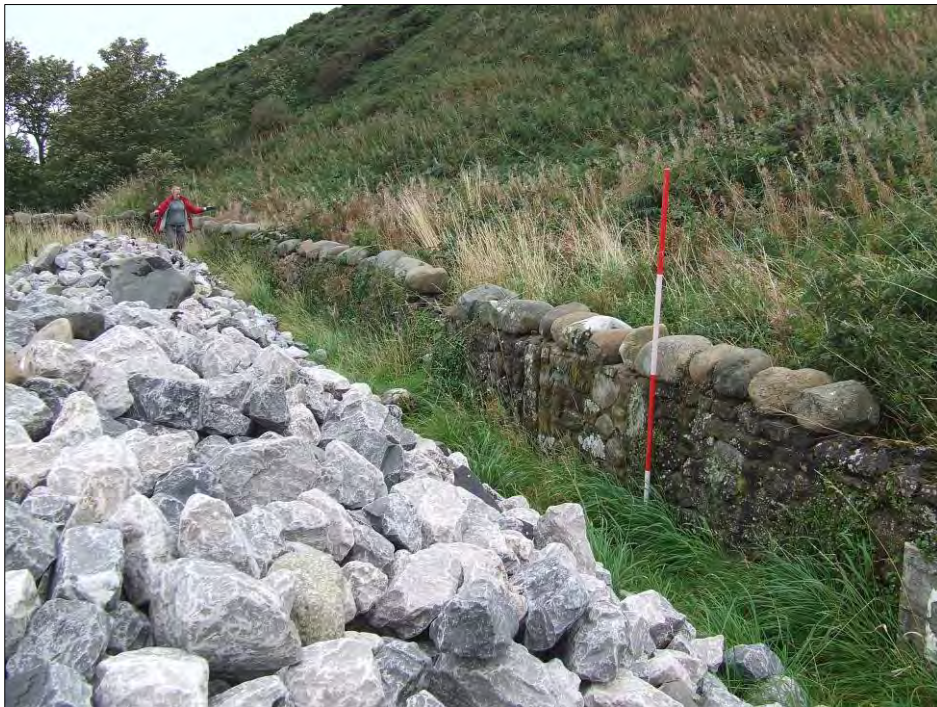
Further evidence of a sea water pump or cistern was recorded in the inter-tidal zone in front of the saltworks. This took the form of a timber trough-like feature measuring  $\approx 1\text{m}^2$  (Figure 5.140). Evidence of the presence of horses at the site is attested by the presence of stables next to workers cottages. These were situated at the base of Swarthy Hill, across the B5300 from the site, and were demolished in the 1970s due to dereliction (Martin 1975, 73). The survey recorded the remains of stone walling possibly associated with the gardens or yards of these cottages, running for a length of  $\approx 60\text{m}$  at the base of Swarthy Hill (Figure 5.141).

Figure 5.141 Recording the remains of walling associated with workers cottages for Crosscanonby saltworks, looking northeast (scale = 2m).

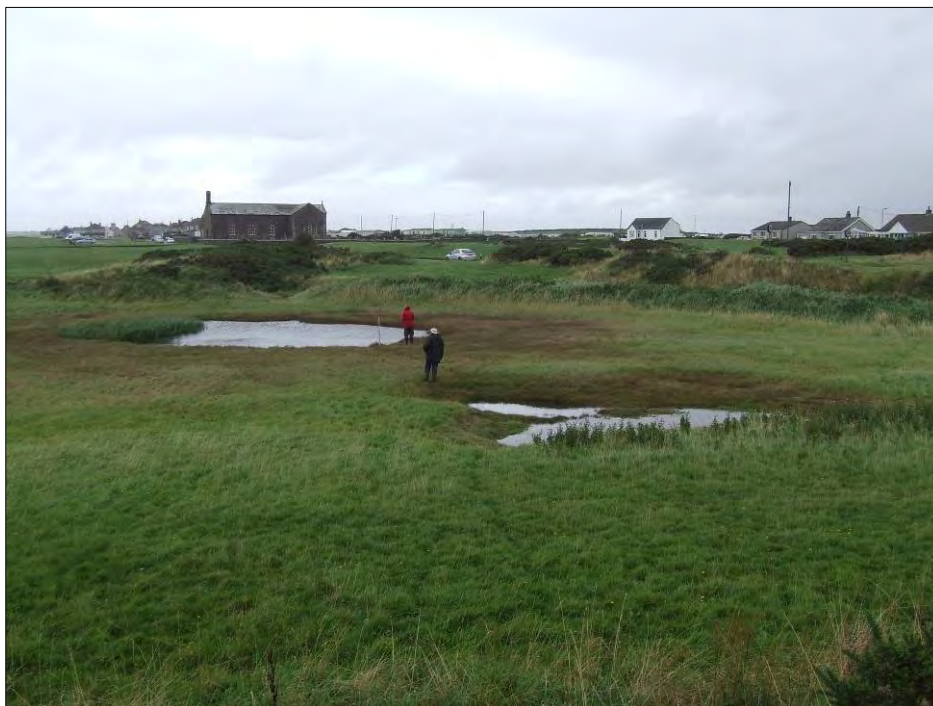
The remains of the possible saltworks included two large circular water-filled depressions and possible spoil heaps, next to a water channel that appeared to have been trained and embanked (Figure 5.143). The circular depressions each had diameters of  $\approx 19\text{m}$ , making them a similar size to the large salt pan or horse gin at Crosscanonby. The features did not appear to be natural and owing to their coastal location and proximity to the successful saltworks of Crosscanonby they have been interpreted as a post-medieval

Figure 5.143 Recording the remains of a possible post-medieval saltworking site at Allonby, looking south.

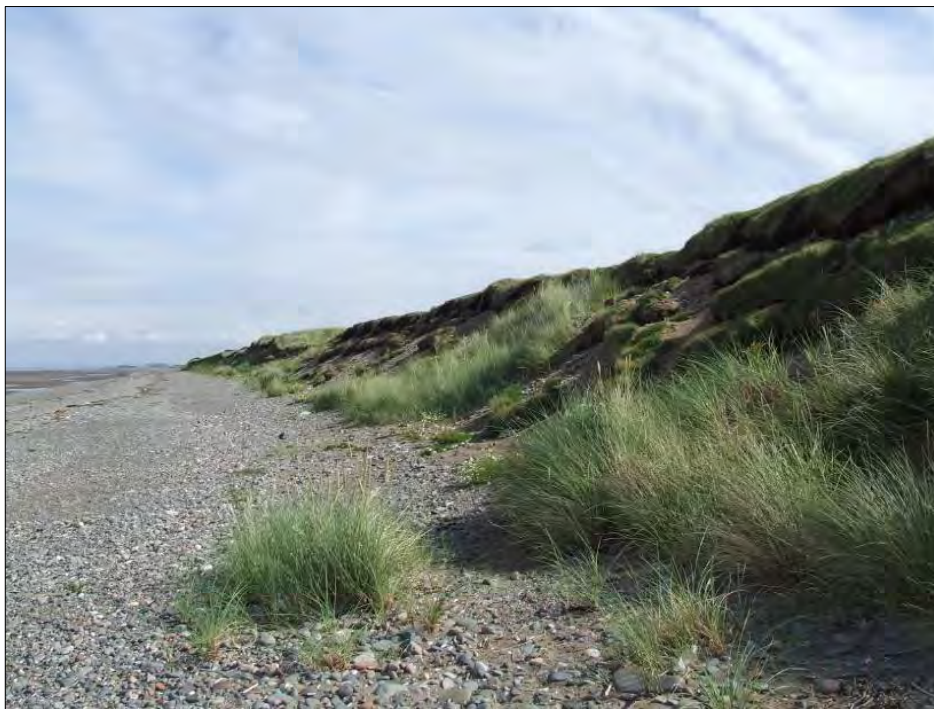
In August 2011 the dune face at Beckfoot showed signs of active coastal erosion and slumping of material from the top of the cliff face to the base. There were moderate levels of vegetative growth (Figure 5.146).

Figure 5.146 Dune face erosion at Beckfoot August 2011, looking north.

The changes that have taken place at Beckfoot cemetery (100) over the course of the present project show how much change and damage can occur at such a monument in a single year, both through natural and human processes. This serves to highlight the level of risk to these sites going forward. The cemetery site (100) and possible remains of Milefortlet 15 (103) are of national significance and these will suffer increased damage as each year passes. The construction of temporary gabion walling at the cemetery site, may arrest coastal erosion for the following 25 years, however there is a danger of the exacerbation of erosion at either end of the defences. This is due to be monitored by English Heritage.

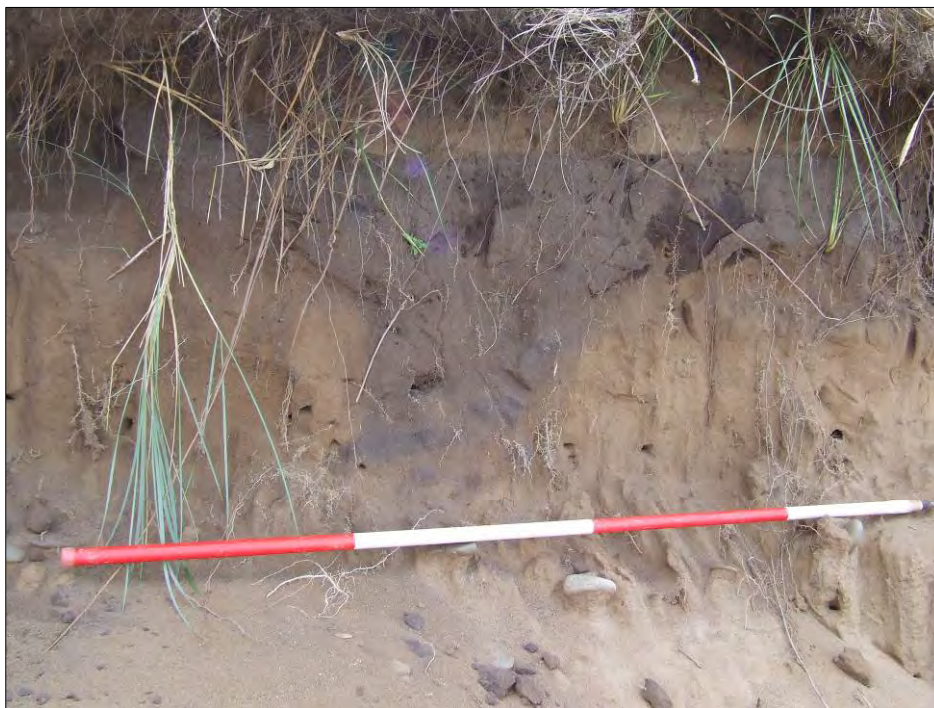
5.147 Cut feature in the eroding dunes at Beckfoot (99), looking west (scale = 2m).

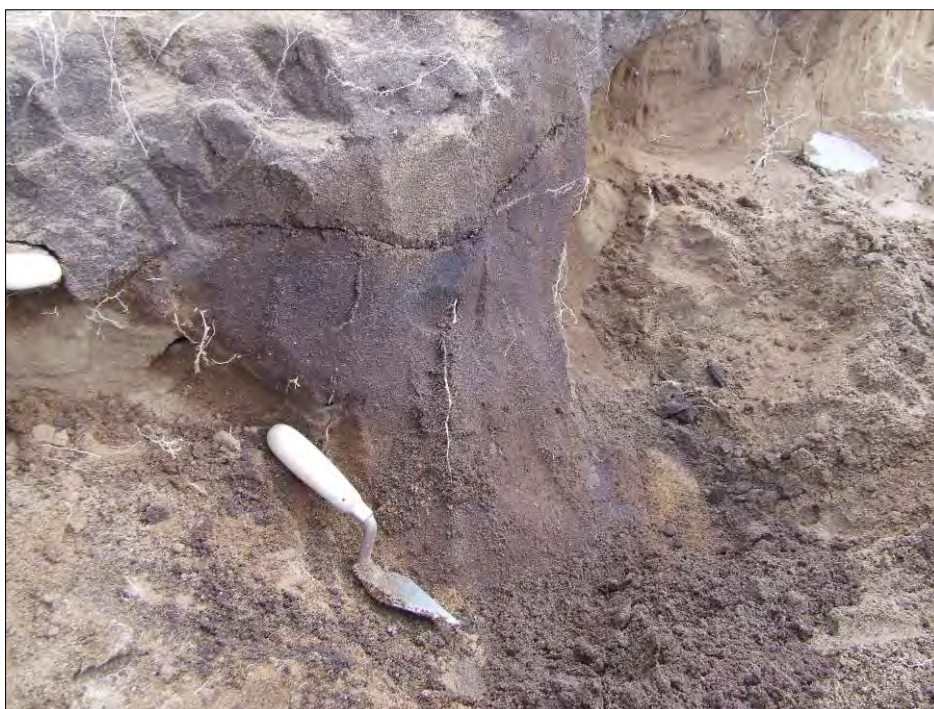
The second feature (125) had the appearance of a possible pit or post hole measuring 0.47m across with a depth of 0.38m (Figure 5.158). The fill of this feature was a fine silty sand, darker than the palaeosol above which appeared to overlie the feature. This feature lay  $\approx 10$ m outside the southern boundary of the scheduled area of Milefortlet 15 and was therefore sampled for dating evidence. This was subjected to flotation in a 500 $\mu$ m sieve by Archaeological Research Services Ltd. (ARS Ltd), however no datable residues were recovered.

5.148 Cut feature in the eroding dunes at Beckfoot (125), looking southwest.

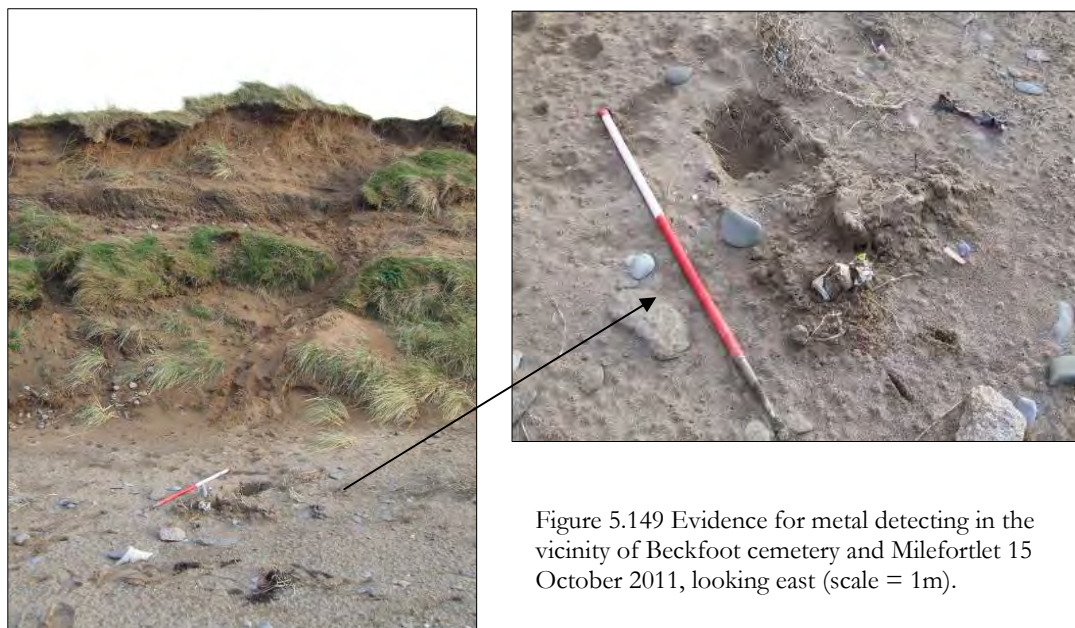
In October 2011 the dune face had a similar appearance, but with less vigorous vegetative growth. Evidence of recent metal detecting and footprints leading up to the exposed dune face were noted (Figure 5.149).

Figure 5.149 Evidence for metal detecting in the vicinity of Beckfoot cemetery and Milefortlet 15 October 2011, looking east (scale = 1m).

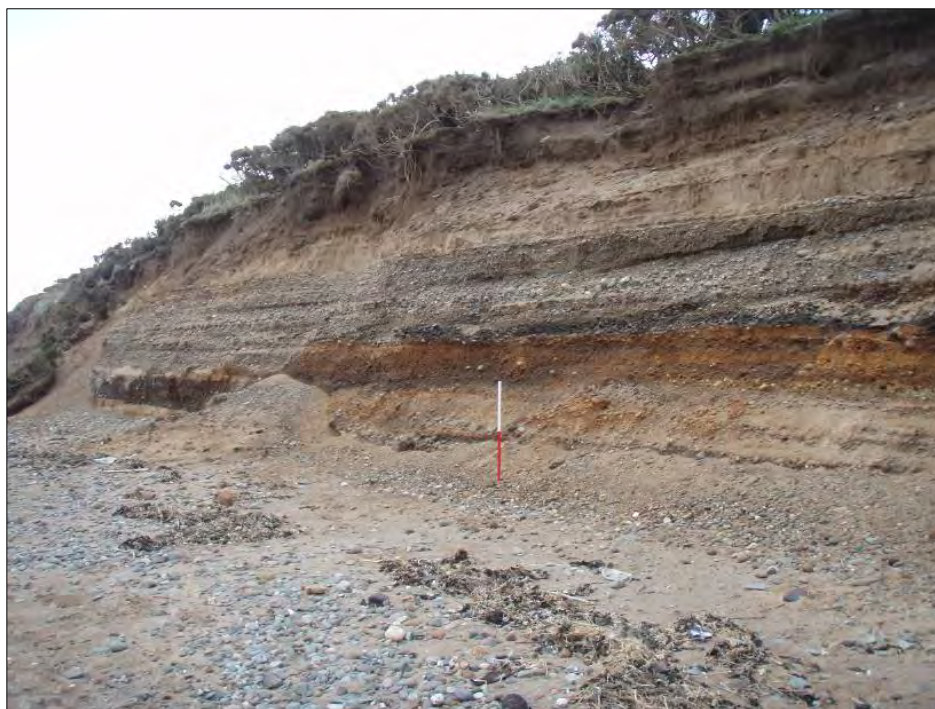
5.150 Machine scoured, vertical dune face March 2012, looking northeast (scale = 1m).

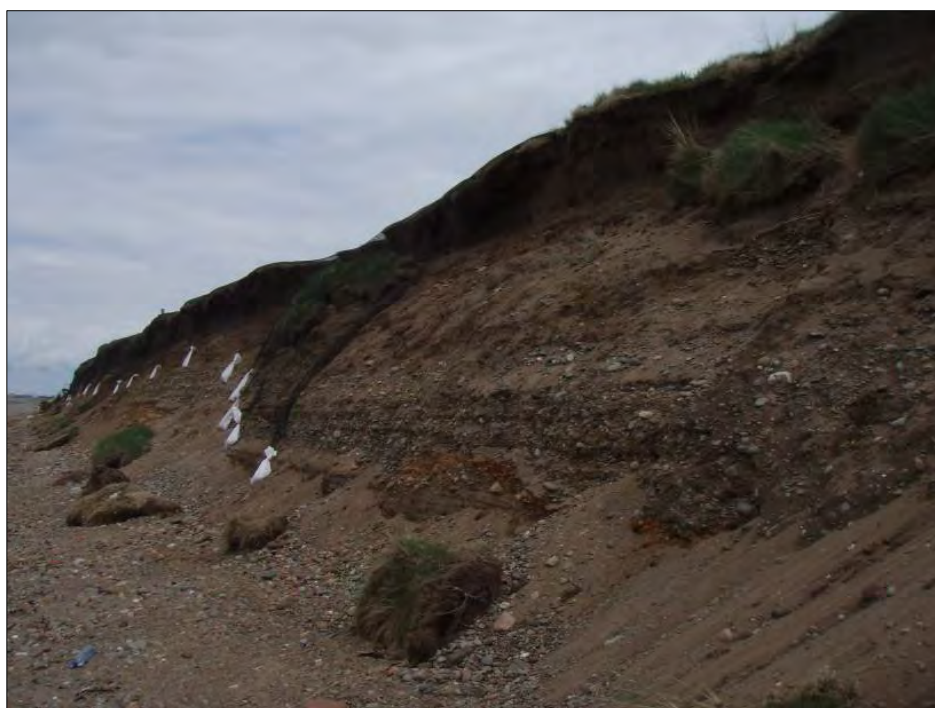
In April 2012 netting was installed to deter nesting birds from the freshly exposed dune face. The exposed area showed signs of significant slumping of material from above the raised beach deposits (Figure 5.151). This is the level where the archaeologically sensitive remains of the Roman cemetery are generally found and the loss of this material, without a formal archaeological monitoring system in place, is a cause for concern. Although the installation of gabion walling is said to directly affect only the lower beach deposits, it is clear from site photography that the work has caused the slumping of material from above that level in archaeologically sensitive areas. It is recommended that any further works in relation to the development will be subject to archaeological monitoring.

5.151 Machine scoured dune face April 2012, showing significant slumping of material from above the raised beach deposits, looking northeast.
