## **5.12 Barrowmouth and Saltom Bay (Map Figure 5.129)**

### *5.12.1 Location and geology*

#### *5.12.3 NWRCZA Phase 2 Archaeological Investigation*

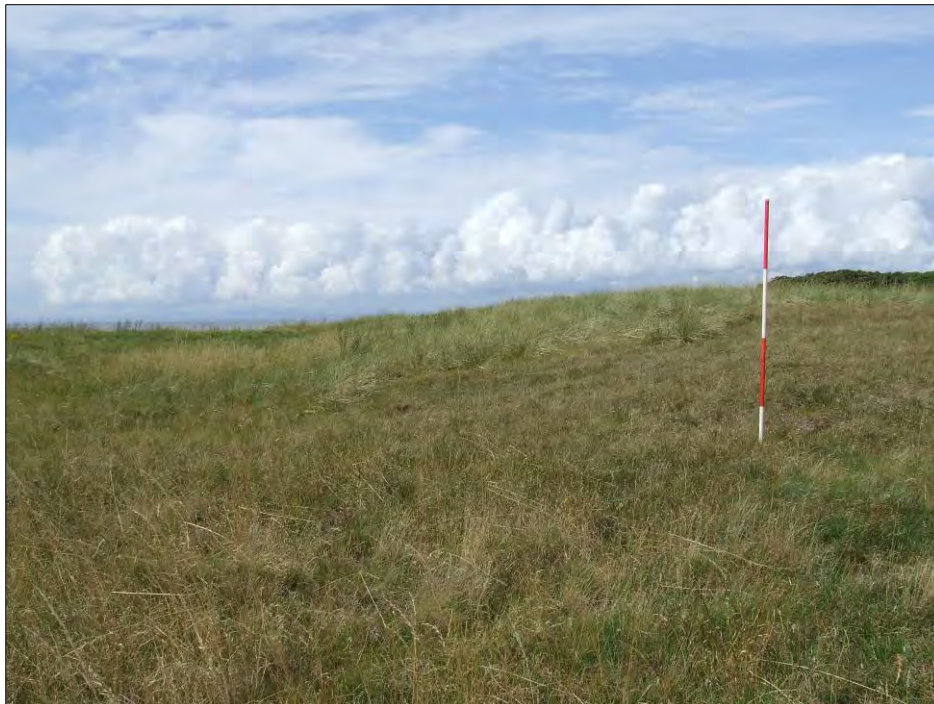
The earthwork remains identified as the milefortlet consisted of a rectilinear raised area in the dune system demarcated by a possible ditch on the south side and the possible Roman road or trackway on the east side. The raised area (103) measures c.60m north-south and c.30m east-west, where traceable (Figure 5.152). The site of the milefortlet was visited by Keith Blood and Colin Lofthouse of RCHME in 1993 with a view to surveying any remains, however they did not locate any remains that they interpreted as the milefortlet. The raised area recorded may therefore be a natural feature, but its location within the scheduled area of the milefortlet and its condition as a partially eroded rectilinear area, implies that this was the feature originally observed by Bellhouse in 1954.

5.152 Possible remains of Milefortlet 15 showing the possible east-west aligned ditch to the left and the raised area to the right, looking west (scale = 2m).

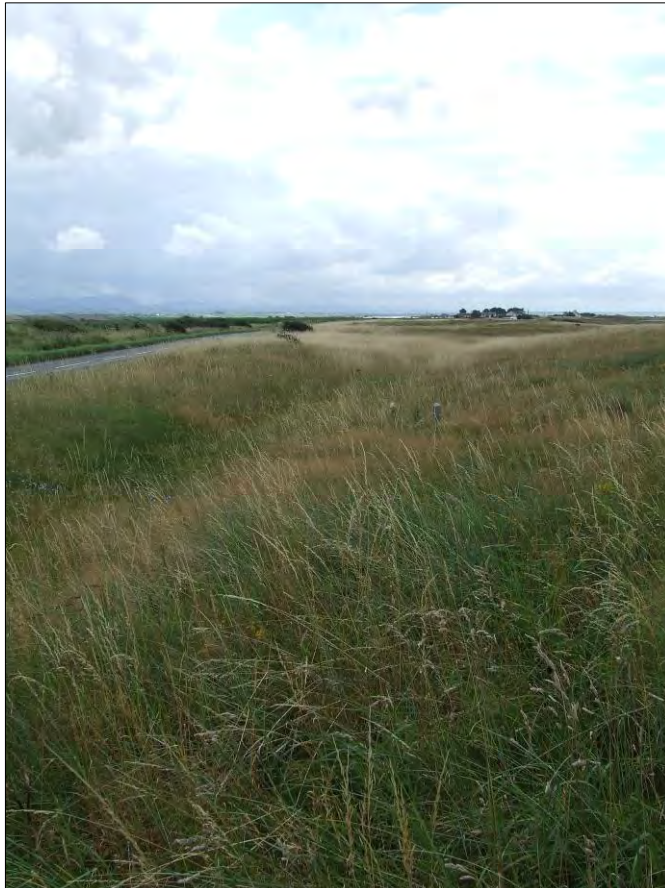
The remains of a possible Roman road or trackway (104) were recorded defining the eastern side of the raised area, between it and the modern B5300 road (Figure 5.153). This feature was recorded for a length of 100m, but extended beyond this recorded section to the south. It was a prominent feature that may have been artificially emphasised by the build-up of the adjacent modern road. Again, this feature was noted in the geophysical survey of the site which states ‘a linear area of raised readings runs to the east of the above mentioned anomalies and may correlate with a topographic depression in the dunes...it may be evidence of a route or track-way here’ (Martin 2005, 4).

5.153 Possible Roman road or trackway looking south.

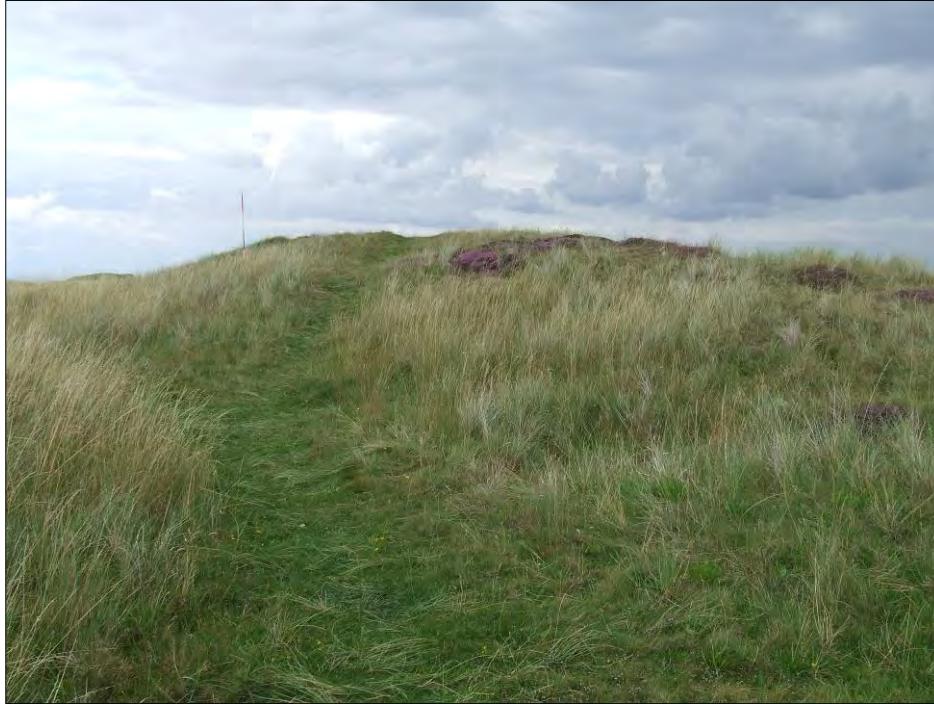
The Phase 2 survey recorded the location of the tower (105) as the highest point in the surrounding dune system (Figure 5.154). This was a natural sub-circular mound of consolidated sand with a diameter of c.50m at the base. The tower was located on the top of this prominence, however no remains of the tower were observed at the time of survey. As with the nearby cemetery site, the tower is at risk of metal detecting and active detecting was observed at the time of survey.

5.154 Site of Roman Tower 15A (scale = 2m).

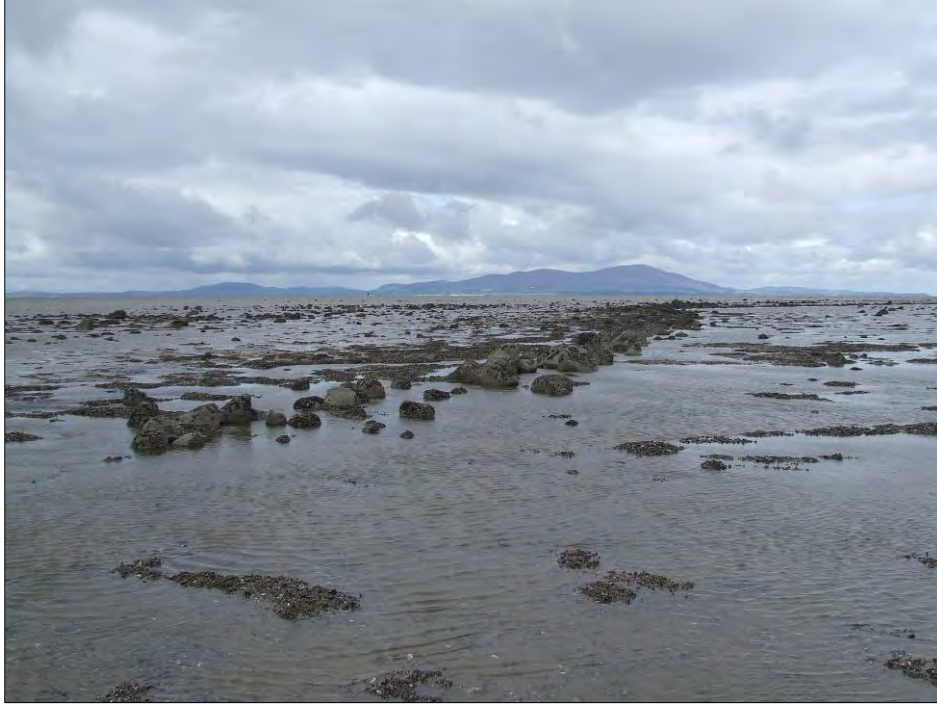
The Hadrian's Wall NMP mapped the remains of a medieval/post-medieval fish trap (120) at Mawbray, south of Beckfoot (NRHE: 9066). The Phase 2 survey recorded these remains as a degraded stone-built, wide V-shaped fish trap, extending into the inter-tidal zone (Figure 5.155). The remains were only visible at extreme low tide and were not accessible for the purposes of detailed investigation. The trap is similar to those recorded at Nethertown and St Bees and is therefore interpreted as medieval in date.

5.155 Medieval fish trap at Mawbray, looking northwest.

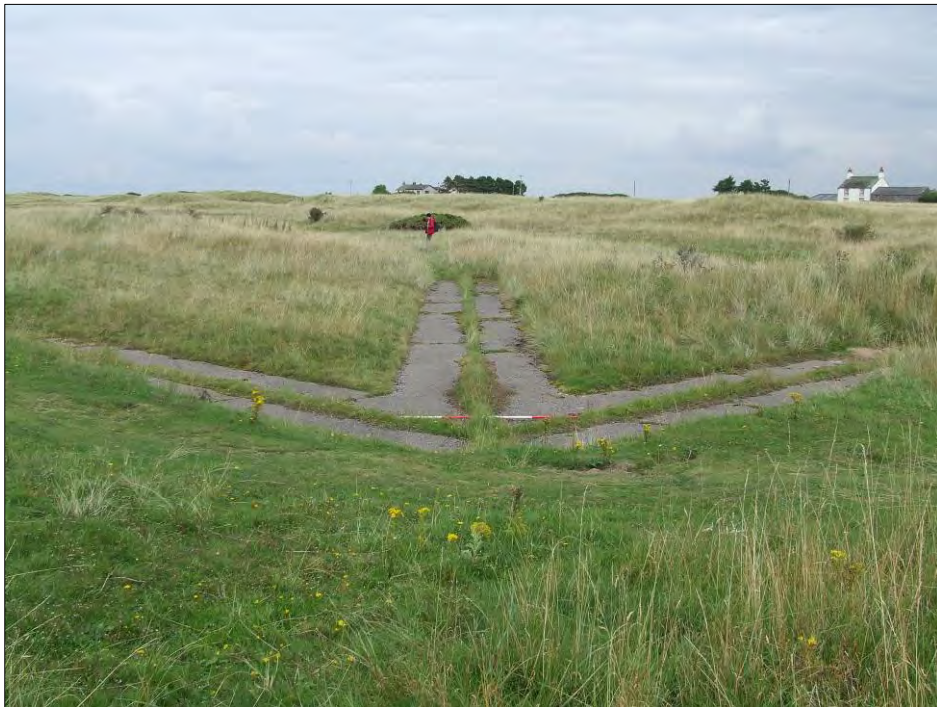
The bombing range markers were constructed of concrete, laid out to form an arrow when viewed from above. Each arrow has three concrete circles laid out on their nodal points and two rectangular concrete bands to the rear. The northernmost arrow (116) was smaller than that to the south. It measured 10m in length as opposed to the southernmost arrow (117) which measured 25m in length. The remains of these features were relatively well-preserved with limited intrusion of vegetation (Figure 5.156).

5.156 Bombing range marker arrow (117) in the dunes south of Beckfoot, looking northeast (scale = 2m).

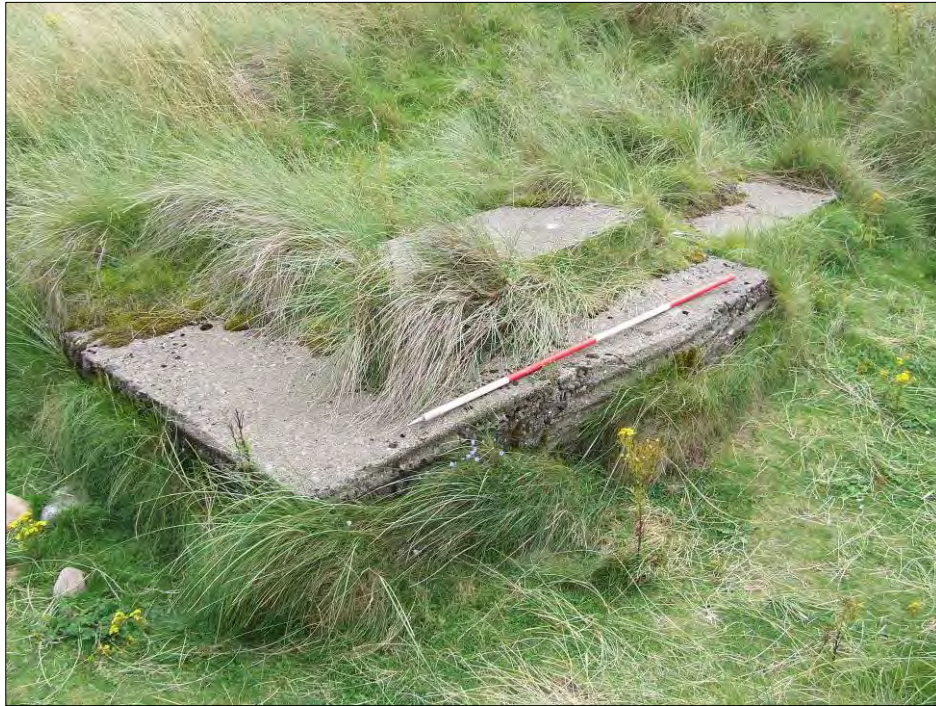
The remains of a possible ruined pillbox (115) were also recorded  $\approx 30\text{m}$  to the west of the bombing range markers. This was most likely to be a feature associated with the range markers, but its exact purpose is not known. The remains consisted of a concrete base for a structure measuring  $\approx 3.5\text{m} \times 2\text{m}$  (Figure 5.157).

Figure 5.157 Base of a Second World War structure south of Beckfoot, looking southwest (scale = 2m).

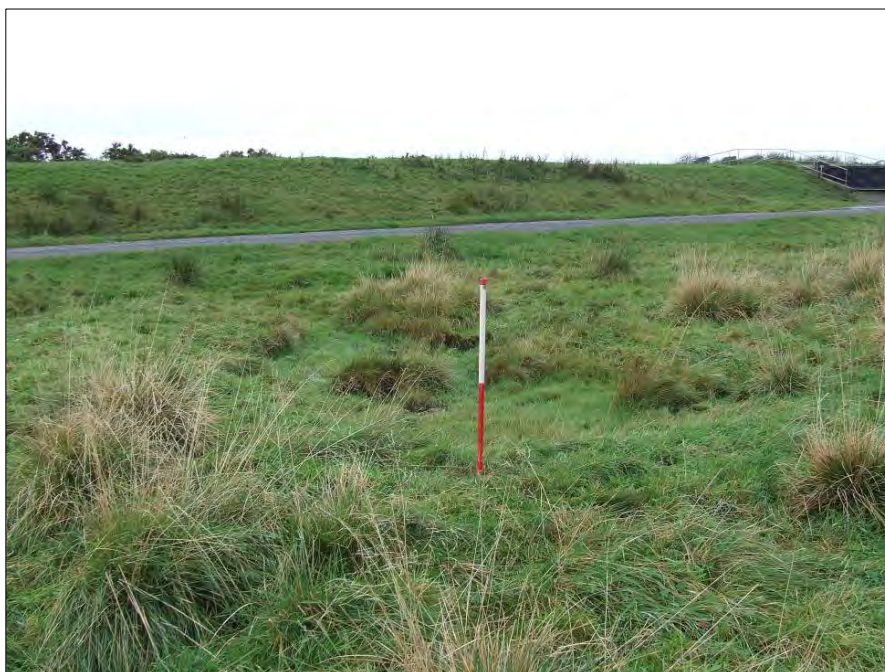
Figure 5.159 Shoreline at Skinburness Marsh showing the earthen sea dyke of medieval origin in the background (scale = 1m).

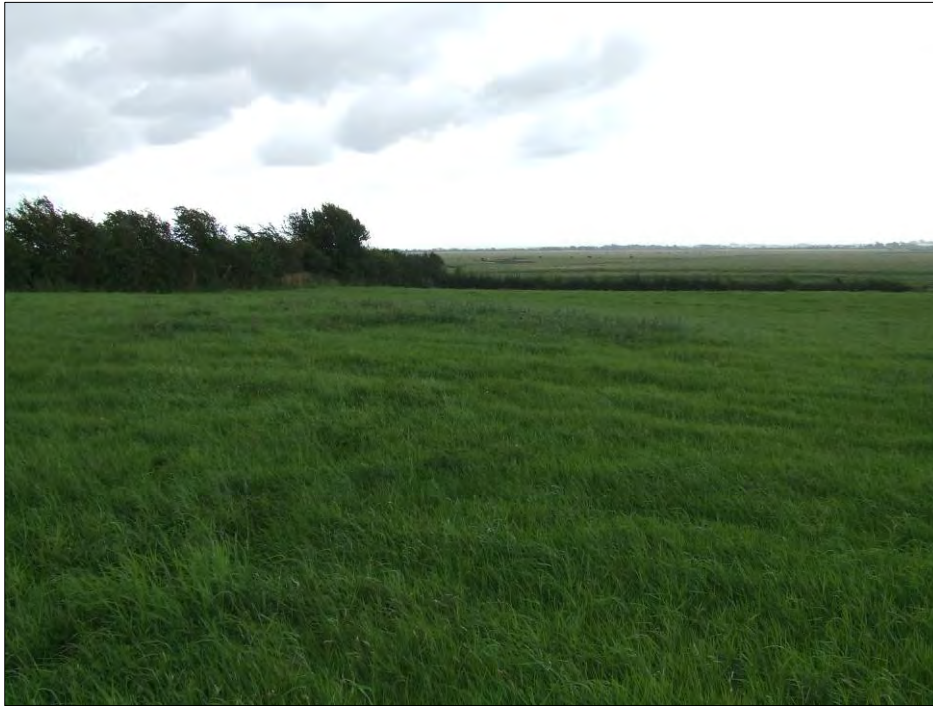
The Phase 2 survey recorded the remains of the milefortlet and camp (96) as consisting of a series of undulations in the field where they have been mapped from aerial photography (Figure 5.160). The remains were ephemeral and non-diagnostic. Local knowledge states that the site is visited regularly by metal detectorists, which may lead to the loss of significant archaeological deposits and contextual information.

Figure 5.160 Ephemeral earthworks of Roman Milefortlet 9, looking southeast.

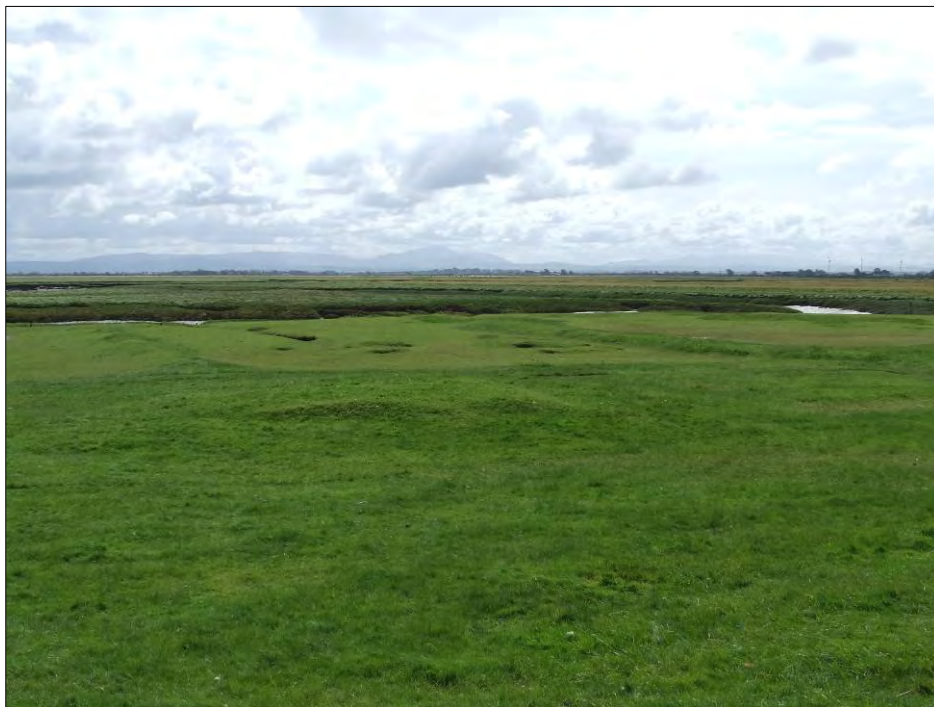
The linear banks were the most prominent feature of the monument and these were also recorded in the Hadrian's Wall NMP. A series of banks were recorded demarcating four enclosed areas aligned northwest to southeast abutting the shoreline (Figure 5.161, 5.162). The enclosures cover an area of  $\approx 105\text{m} \times \approx 30\text{m}$  and show evidence of previous erosion and subsequent accretion at the shoreline. The purpose of the enclosed area is uncertain, they most likely relate to the port as they are aligned along the shoreline, however they may also be the remains of a croft associated with the village.

Figure 5.161 Remains of a series of enclosed areas at Skinburness port/village, looking southeast.

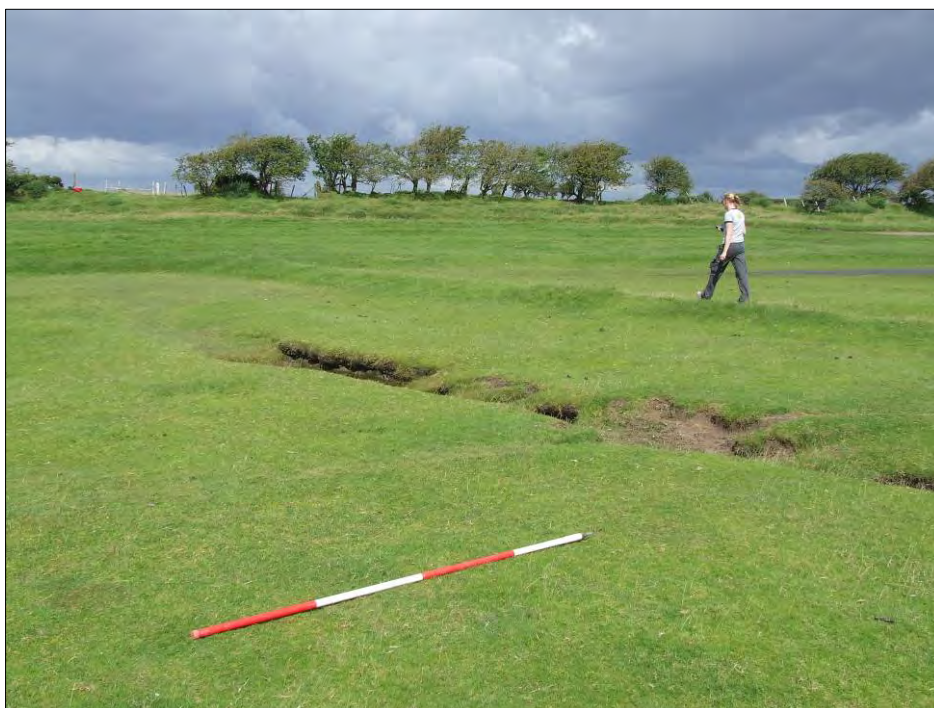
Figure 5.162 Recording the remains of well-preserved enclosed areas at Skinburness port/village, looking north (scale = 2m)

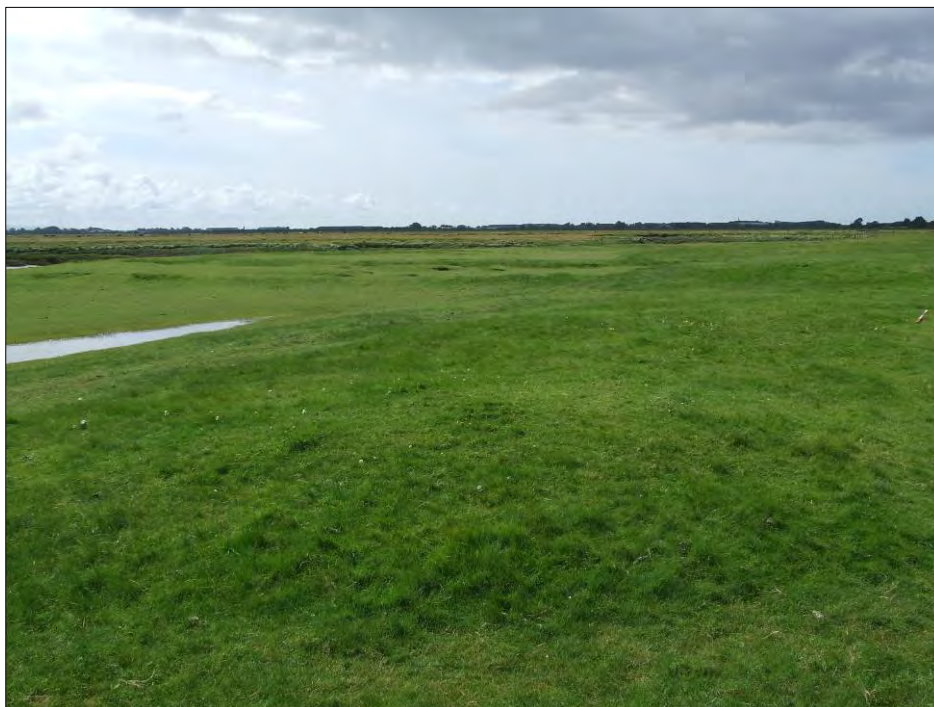
Immediately to the northwest of the enclosure the survey recorded the remains of two possible building platforms measuring  $\approx 70\text{m}^2$  and  $\approx 90\text{m}^2$  respectively (Figure 5.163). The

Figure 5.163 Remains of well-preserved building platforms at Skinburness port/village, looking south (scale = 2m)

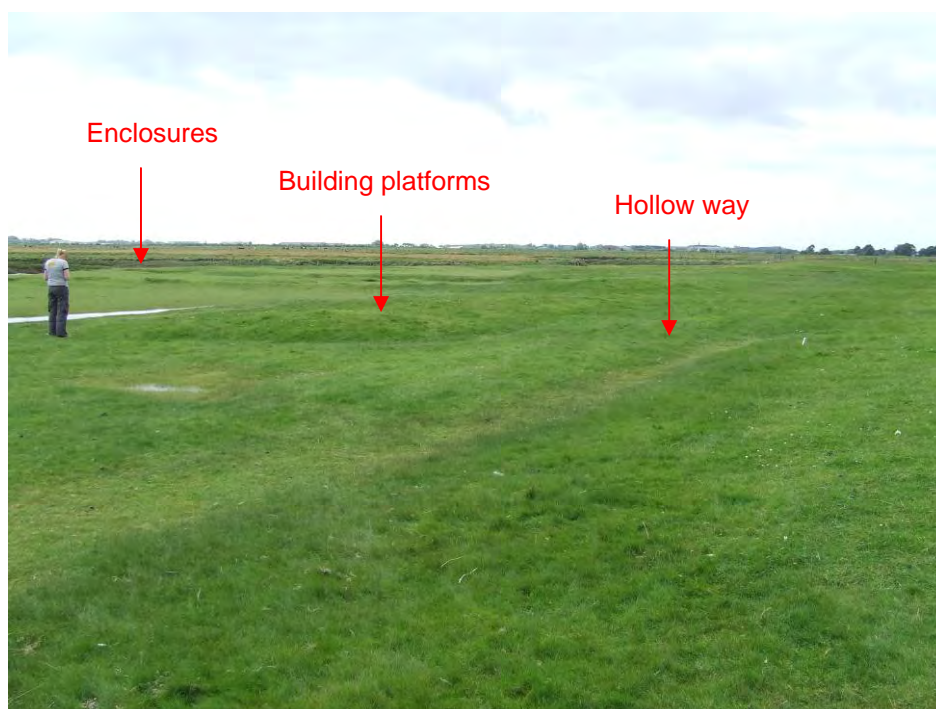
To the west of the building platforms a possible hollow way was recorded running from the site towards to the mainland in the southwest (Figure 5.164). It follows the line of the current footpath and was recorded for a length of  $\approx 120\text{m}$ , but extended beyond this recorded length.

Figure 5.164 Remains of well-preserved hollow way at Skinburness port/village, looking south.

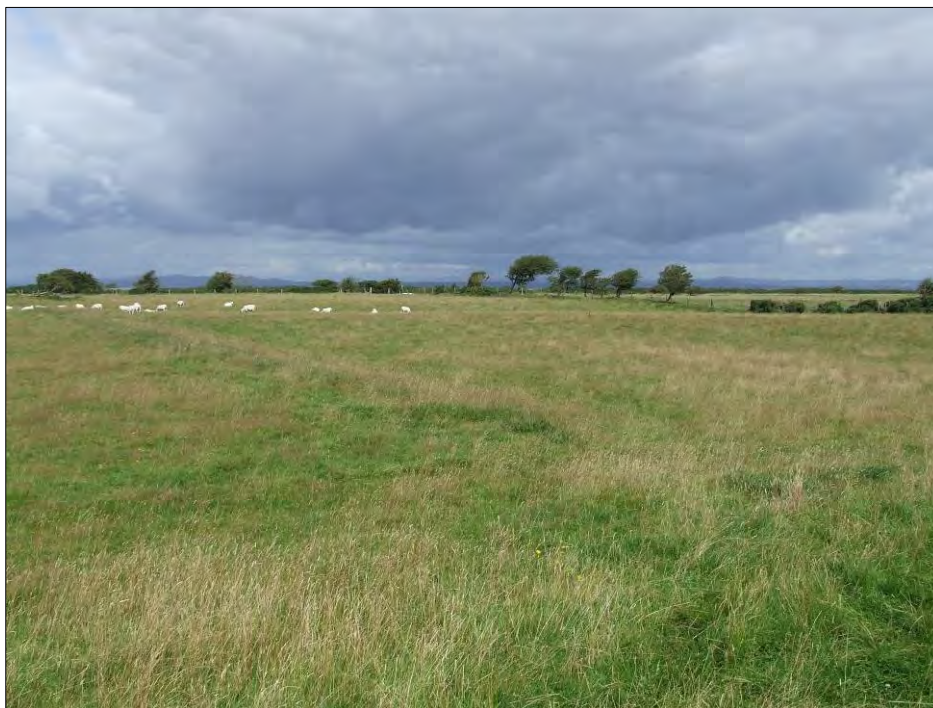
To the west of the enclosures, platforms and hollow the fields also contain earthwork remains that may be associated with the medieval village, or may be post-medieval field boundaries (Figure 5.165). No remains of St John's Chapel were recorded as part of the survey.

Figure 5.165 Remains of further earthwork remains in fields to the west of Skinburness port/village, looking northwest.

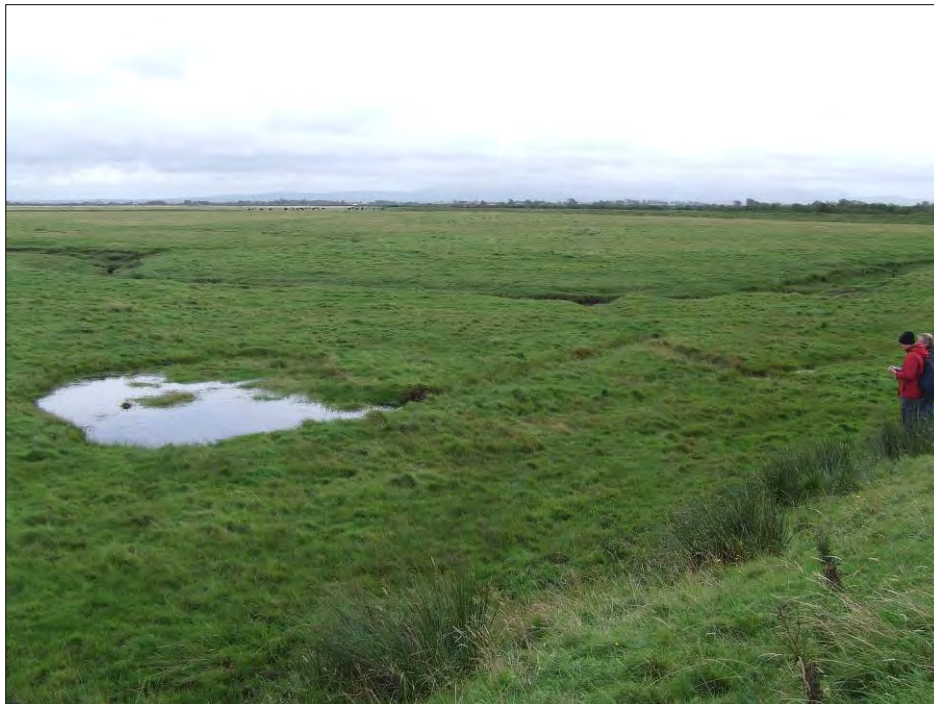
The Skinburness saltworking sites (129, 184) were recorded with the assistance of Peter Murphy of English Heritage. They consisted of extensive remains of small water-filled pools with an almost gridded system of cut water channels. Site (129) was recorded for a length of  $\approx 225\text{m}$  but extended beyond the mapped area. Four pools were recorded in this system with a general diameter of  $\approx 8.5\text{m}$  (Figure 5.166). Site (184) had a more defined area and was recorded running for a length of  $\approx 90\text{m}$  and had pools up to  $10\text{m}$  in diameter, one of which was rectilinear rather than circular (Figure 5.167).

Figure 5.166 Recording remains of a possible medieval saltworking site (129) on Skinburness Marsh, looking east.

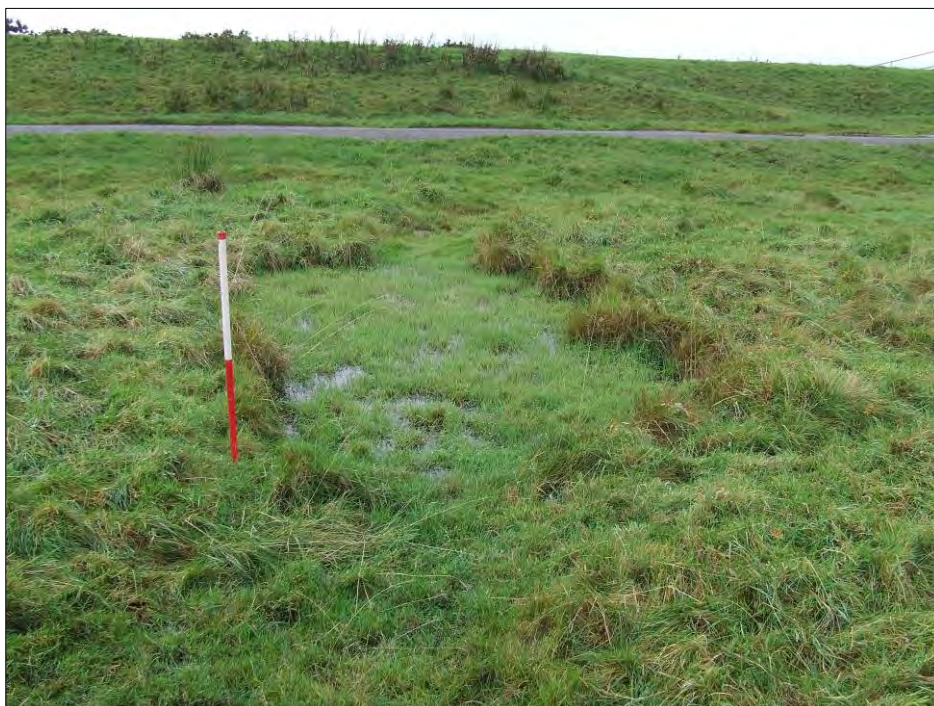
Figure 5.167 Possible remains of medieval saltworking site (184) on Skinburness Marsh, showing rectilinear pool with associated water channel, looking south (scale = 1m).

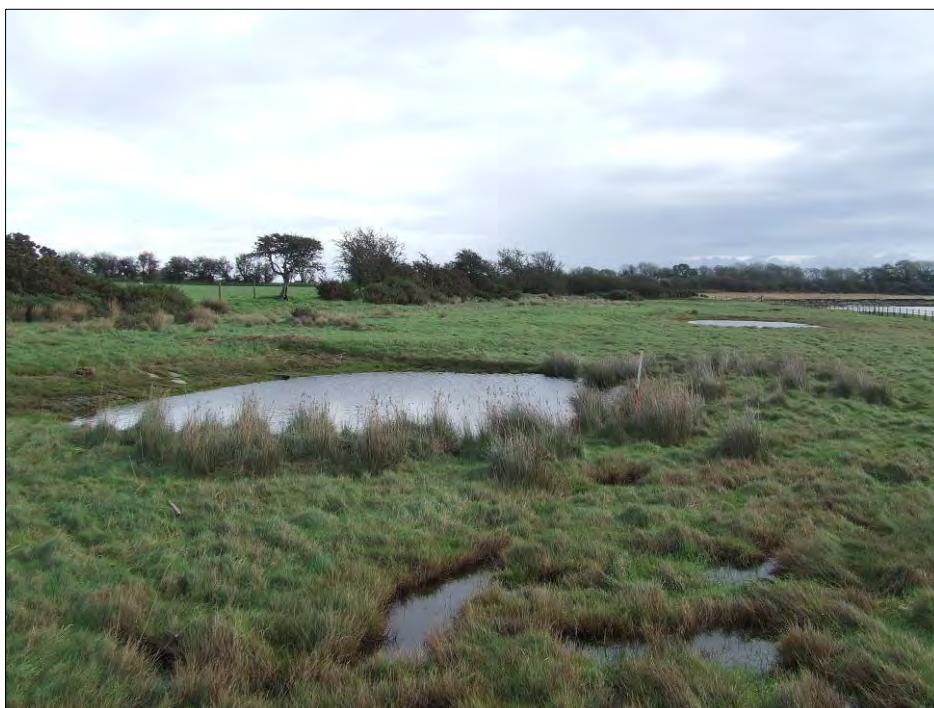
The Anthorn saltworking sites (174, 175) were less extensive and consisted of single pools, or twinned pools with an associated water channel. These sites are recorded as unknown extents of a medieval salt works in the Cumbria HER (HER: 41696) and the Phase 2 survey has therefore provided an accurate location for these remains. Site (174) consisted of four pools in total; two small pools with a diameter of  $\approx 4.5\text{m}$ , joined by a water channel; and two large pools with a diameter of  $\approx 12\text{m}$ , each with its own water channel (Figure 5.168). Site (175) consisted of a single pool with a diameter of  $\approx 10.7\text{m}$ , and an associated water channel (Figure 5.169).

Figure 5.168 Possible remains of a medieval saltworking site (174) on Anthorn Marsh, looking east (scale = 1m).

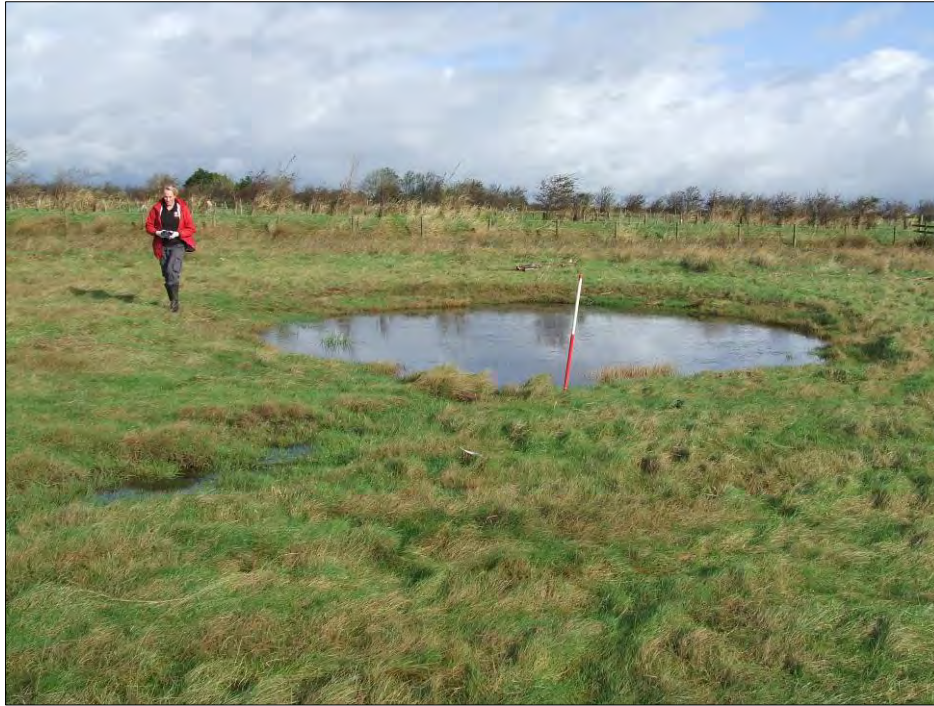
Figure 5.169 Recording possible remains of a medieval saltworking site (175) on Anthorn Marsh, looking north (scale = 1m).

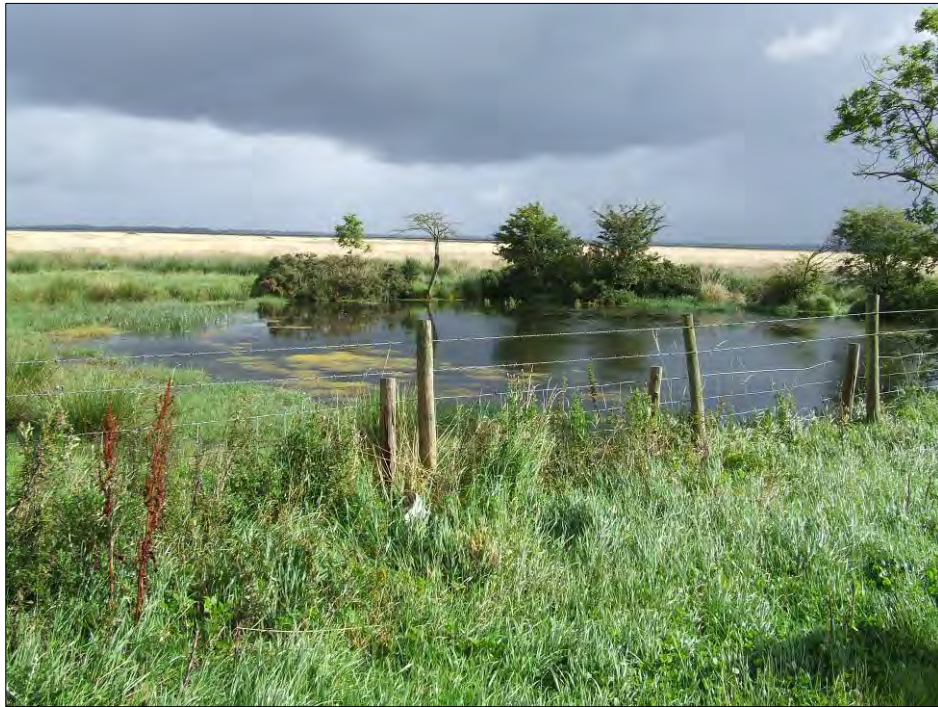
Site (130), on Skinburness Marsh was located at Sea Dyke End Farm. The survey of this feature was assisted by Peter Murphy of English Heritage. The site has previously been surveyed during an investigation into the sea dyke by Fletcher and Millar in 1997, who identified it as a salt pan (Fletcher and Millar 1997, 210). It is recorded in the Cumbria HER (HER: 41703). The site consisted of a large circular, banked pool with a diameter of  $\approx 30\text{m}$  and an associated water channel (Figure 5.171). Fletcher and Millar recorded the depth of the pool as  $0.75\text{m}$  (Fletcher and Millar 1997, 210). The earthen bank may cover

a stone wall and had a breach linking it to the water channel. This breach must have been a water inlet, possibly controlled with a sluice gate.

5.170 Water-filled pool, possibly being the remains of a medieval/post-medieval salt pan, looking northeast.

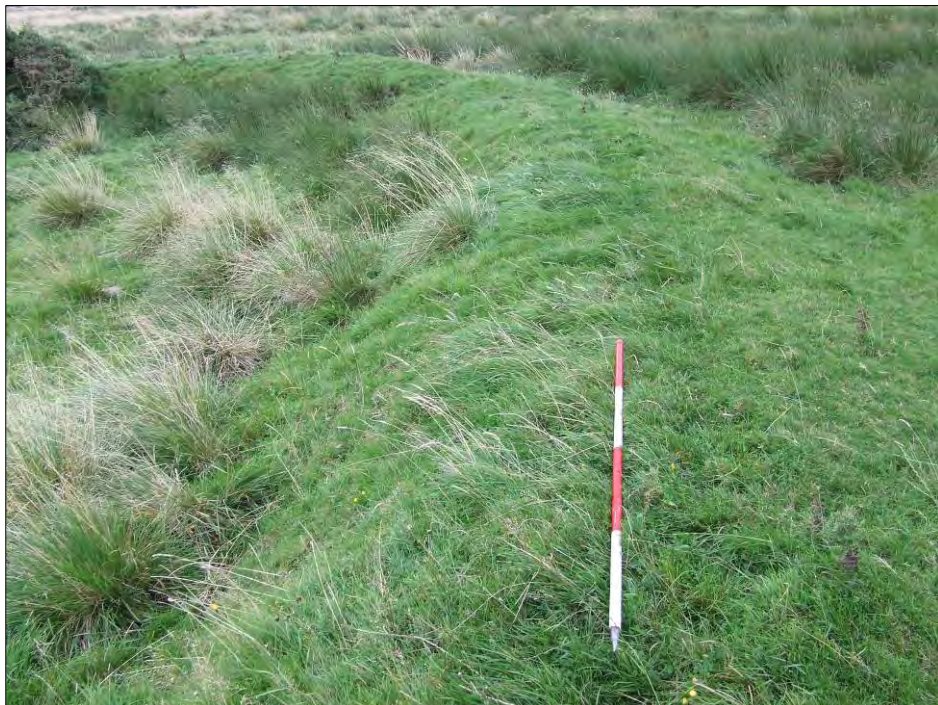
5.171 Bank of large post-medieval salt pan at Sea Dyke End Farm (130), looking northwest (scale = 2m).

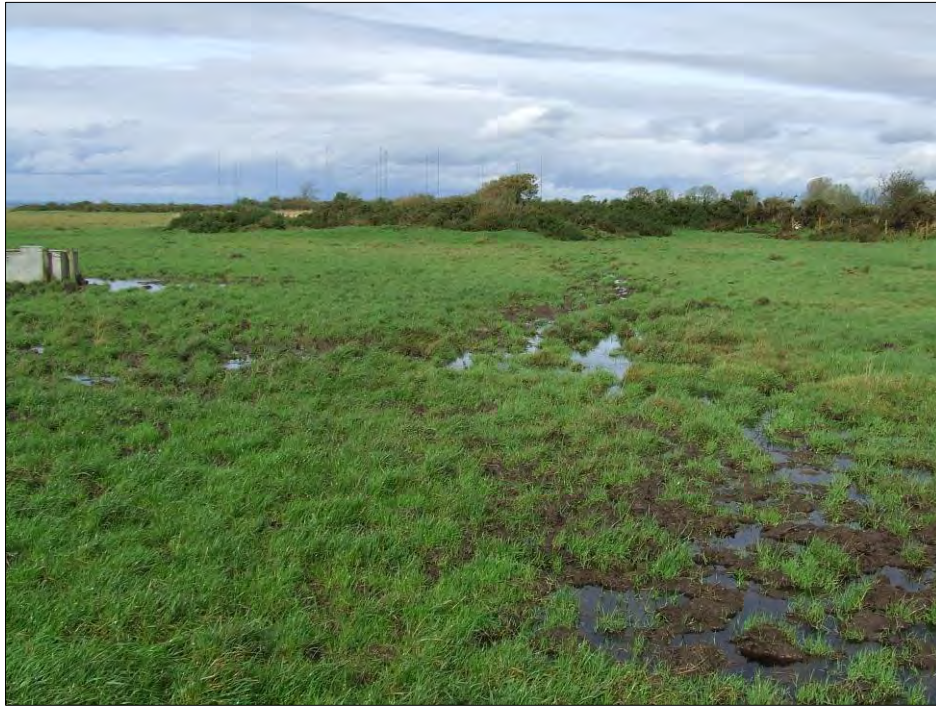
Site (167) at Salt Coates consisted of a large circular banked pool with a diameter of  $\approx 30\text{m}$ , together with an associated water channel (Figure 5.172). The channel was mapped for a length of  $\approx 62\text{m}$ , but extended beyond the mapped area.

5.172 Large banked, circular salt pan and associated water channel at Salt Coates (167), looking north.

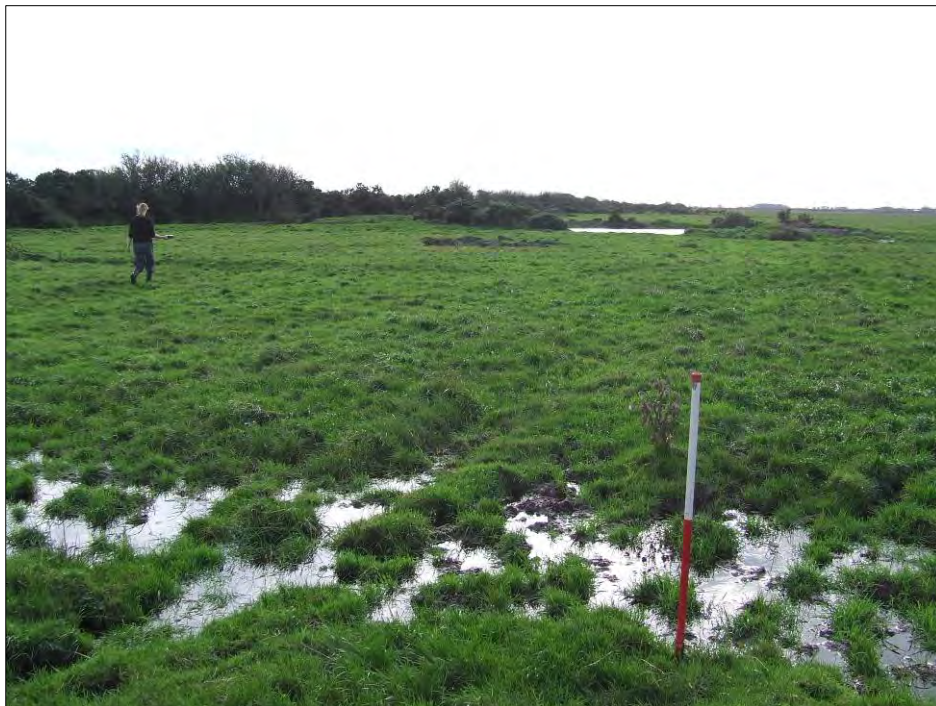
Site (173), southwest of the Parish Church of St John at Newtown Arlosh, consisted of a large circular banked pool with a diameter of at least 30m, together with an associated system of water channels (Figure 5.173). The channels were mapped for a length of c.190m, but extended beyond the mapped area.

5.173 Recording the large circular salt pan and associated water channels southwest of Newtown Arlosh (173), looking southwest.

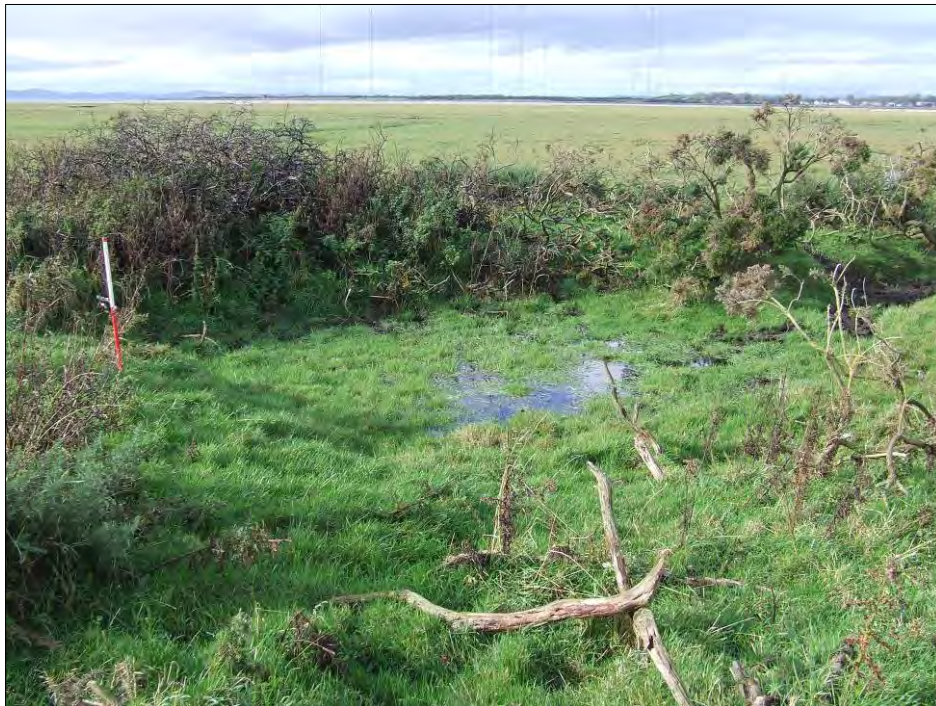
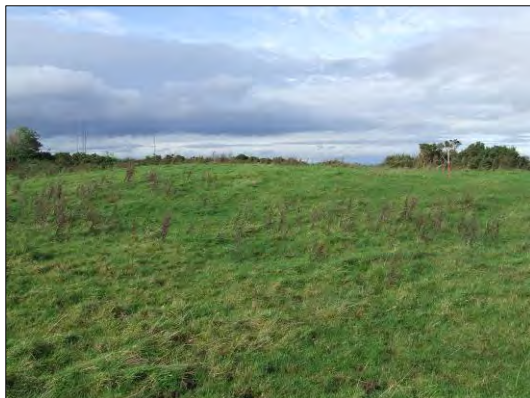
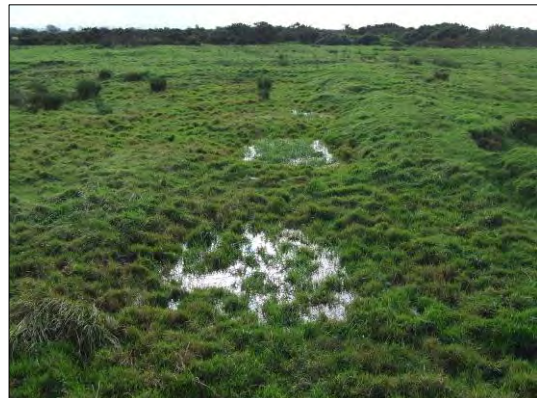
Sites (168-172), northeast of the Parish Church of St John at Newtown Arlosh, consisted of earthwork remains of an extensive system of salt pans, water channels, a spoil heap, and possible extraction areas. This site is recorded as a medieval salt works in the Cumbria HER (HER: 41699). There were at least seven salt pans consisting of circular and sub rectangular depressions, some of which were water-filled, but other smaller pans were dry (Figure 5.174a). The largest pan had a diameter of  $\approx 30\text{m}$ , with the smallest having a diameter of  $\approx 10\text{m}$ . There was a large spoil heap measuring  $\approx 50\text{m}$  in length consisting of a flat topped mound (Figure 5.174b) and extraction areas consisting of hollowed out areas were also noted. The extraction areas may not be related directly to the salt working industry. This site ran for a length of  $\approx 500\text{m}$  (Figure 5.174c) and was clearly an important, industrial-scale operation.

5.174 (a) Water-filled salt pan (171); (b) flat-topped spoil heap (170); and (c) water-filled depressions and channels (171) (scale = 1m).

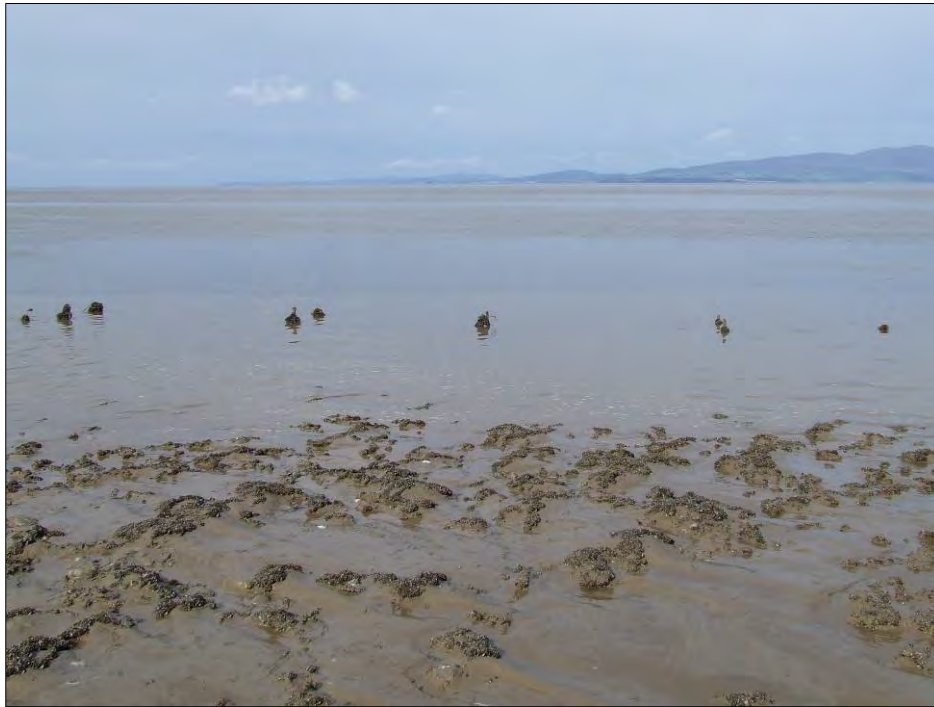
The shipwreck site (106) was located on the western shoreline of Skinburness, south of the Grune Peninsula. It consisted of a series of nine upright timbers only visible at extreme low tide. The vessel was  $\approx 13\text{m}$  in length and most likely represents the remains of a small fishing vessel (Figure 5.175).

5.175 Remains of possible post-medieval fishing vessel at Skinburness (106), looking west.

The sites that lie within SMP2 policy unit 11e6.2 that recommends ‘Hold the Line’ for the following 100 years, are inter-tidal sites that will not be protected by shoreline defences. These sites (92, 106) are therefore considered to be at immediate and long term risk of coastal erosion.

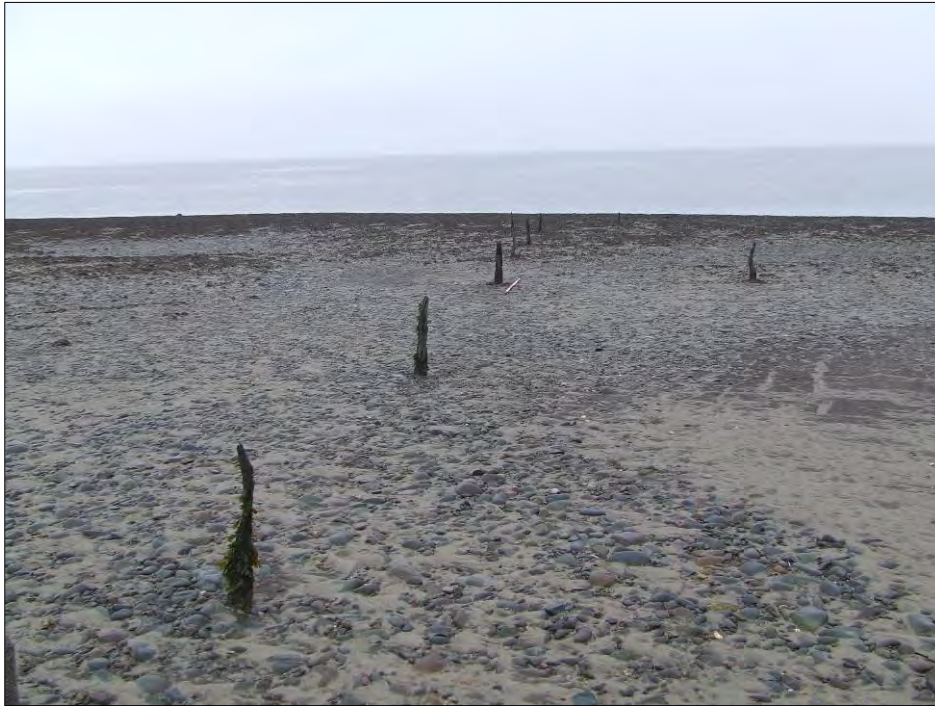
Around 950m northeast of the shipwreck site, the survey recorded the remains of a possible fish weir, jetty or groyne of post-medieval date (92). This consisted of eleven upright timber posts, in a linear alignment running seaward for a length of  $\approx 38\text{m}$ , with timbers located either side of the linear alignment at the seaward end, suggesting that the function of the site was to trap fish in nets at this end. The posts were highly degraded and stood to a height of  $\approx 0.7\text{m}$  (Figure 5.176).

5.176 Remains of possible post-medieval fishing weir or jetty at Skinburness (92), looking west (scale = 2m).

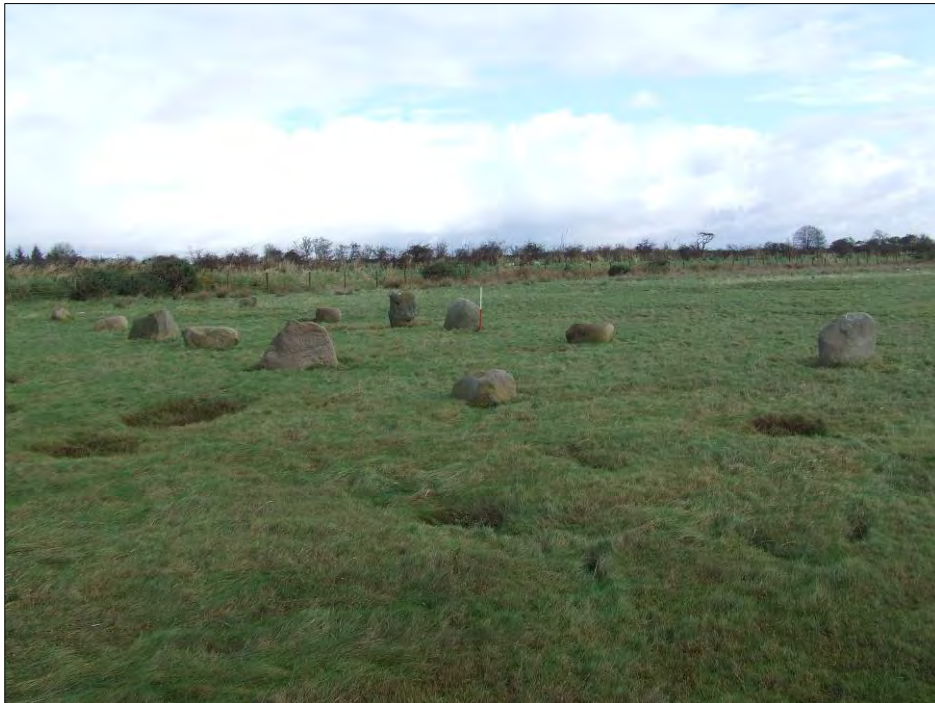
5.177 Remains of parallel stone alignment at Anthorn Marsh (176), looking northeast (scale = 1m).

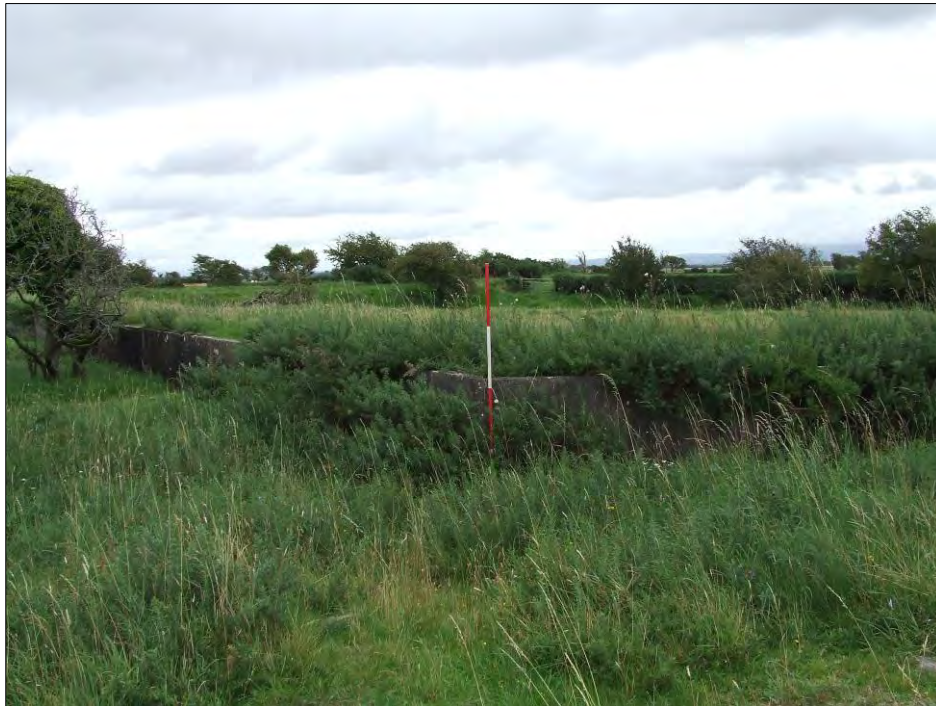
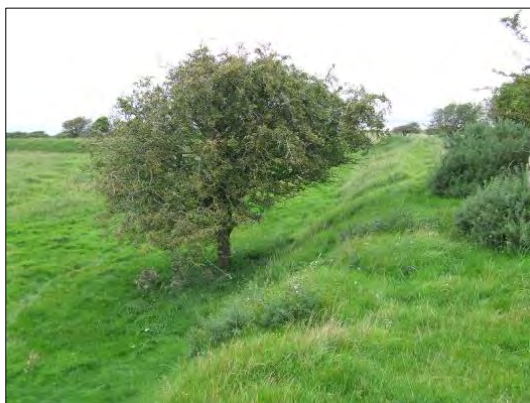
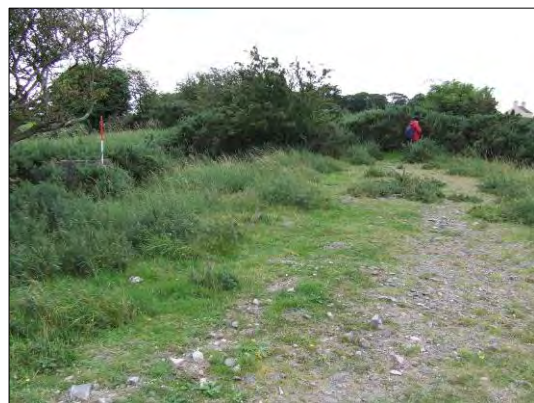
The air gunners' range (109) was of similar construction to that recorded on the north end of Walney Island (see Section 5.6.6). However, the Grune example was better preserved consisting of an embanked concrete wall demarcating the target area within. This stood to a height of  $\approx 1\text{m}$  and was recorded as a three-sided structure running for a length of  $\approx 108\text{m}$  (Figure 5.178). The wall most likely continued beyond this measured extent, but was inaccessible due to vegetative cover. A rail track would have been located outside the concrete wall, fitted with mounted machine guns that would be fired into the target area. The earthwork remains of this rail track were also recorded as part of the survey encircling the wall for a length of  $\approx 117\text{m}$  with an offshoot of  $\approx 38\text{m}$  to the east.

5.178 Remains of air gunners' range on the Grune Peninsula (scale = 2m).

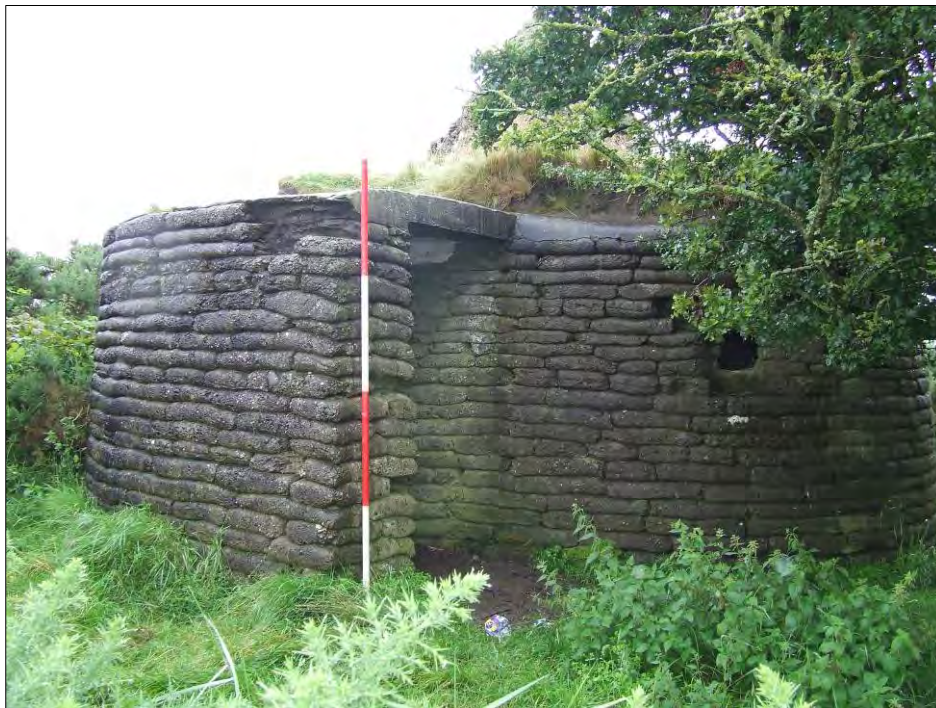
Around 1km northeast of the air gunners range the Phase 2 survey recorded the remains of a Second World War pillbox (93). This consisted of a Cumberland Machine-Gun and Anti-Tank Rifle Emplacement ([www.users.globalnet.co.uk/~rwbarnes](http://www.users.globalnet.co.uk/~rwbarnes)). It was a circular structure with a short blast wall over the entrance and a flat concrete roof supported on a central pier (Figure 5.179). It had a diameter of  $\approx 13\text{m}$  and was constructed using concrete sand bags, the hessian of which survives in places internally. A pointed cairn was erected on the roof of the structure as a memorial to four firemen who lost their lives off Grune Point attempting to rescue a wildfowler (later found to be a false alarm).

5.179 Cumberland Machine-Gun and Anti-Tank Rifle Emplacement at Grune Point (scale = 2m).
