## **5.12 Barrowmouth and Saltom Bay (Map Figure 5.129)**

### *5.12.1 Location and geology*

#### *5.12.3 NWRCZA Phase 2 Archaeological Investigation*

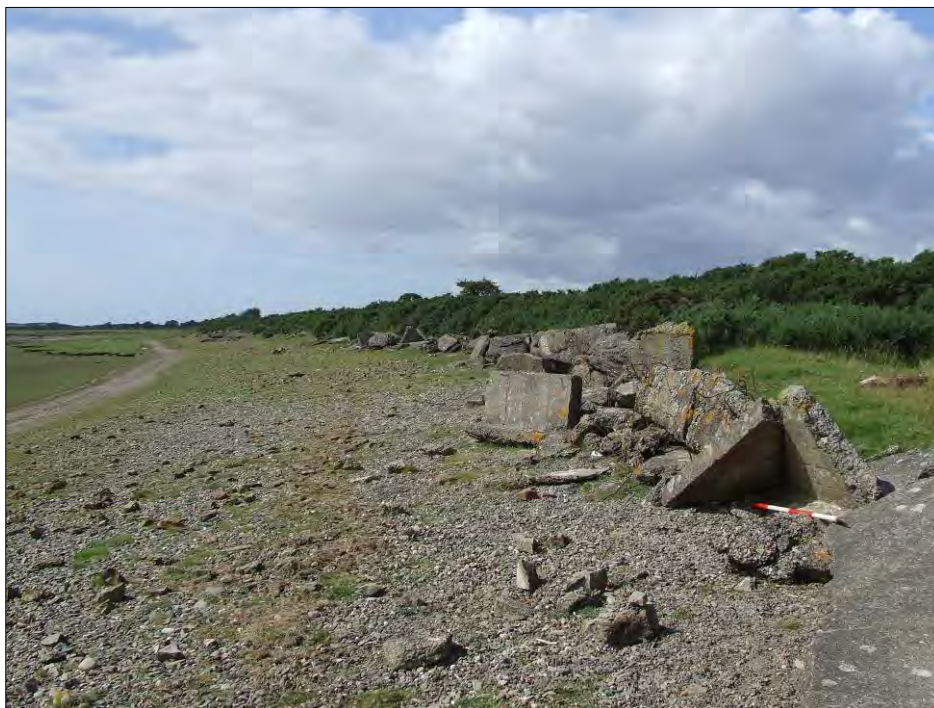
Around 210m southwest of the pillbox the Phase 2 survey recorded substantial concrete and brick demolition waste that was Second World War in character. This appeared to be arranged as a flood defence running for  $\approx 330\text{m}$  along the southeastern shore of the peninsula (Figure 5.180). The origin of these remains may have been the Second World War firing range that was mapped as part of the Hadrian's Wall NMP (NRHE: 1467482), but is now destroyed.

5.180 Second World War debris used as a flood defence on the Grune Peninsula, looking southwest (scale = 2m).

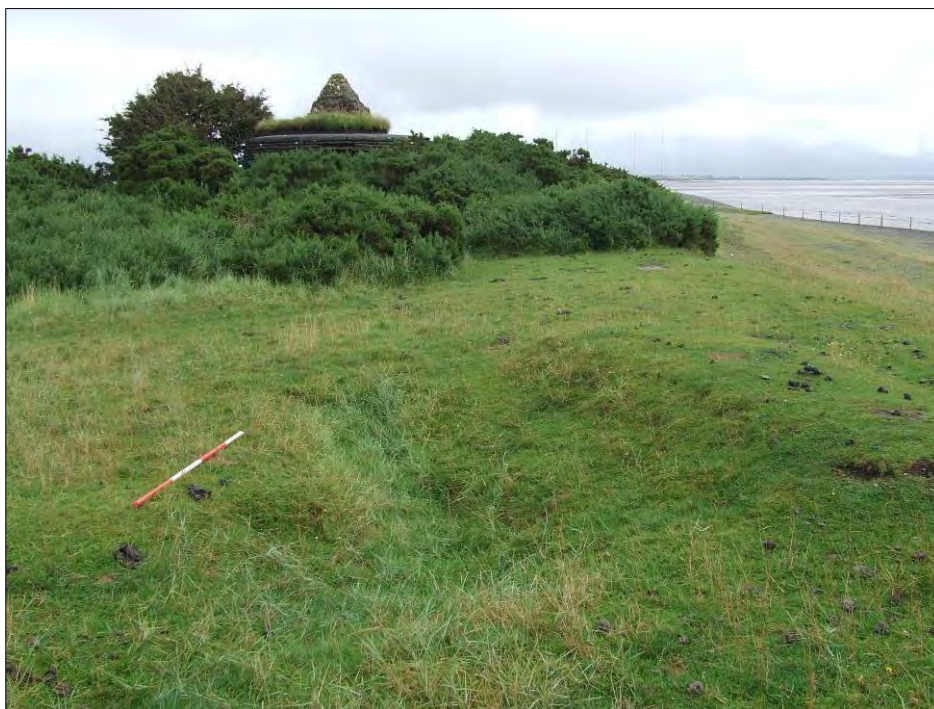
5.181 Slit trench (94) adjacent to the pillbox (93) on the Grune Peninsula, looking northeast (scale = 2m).

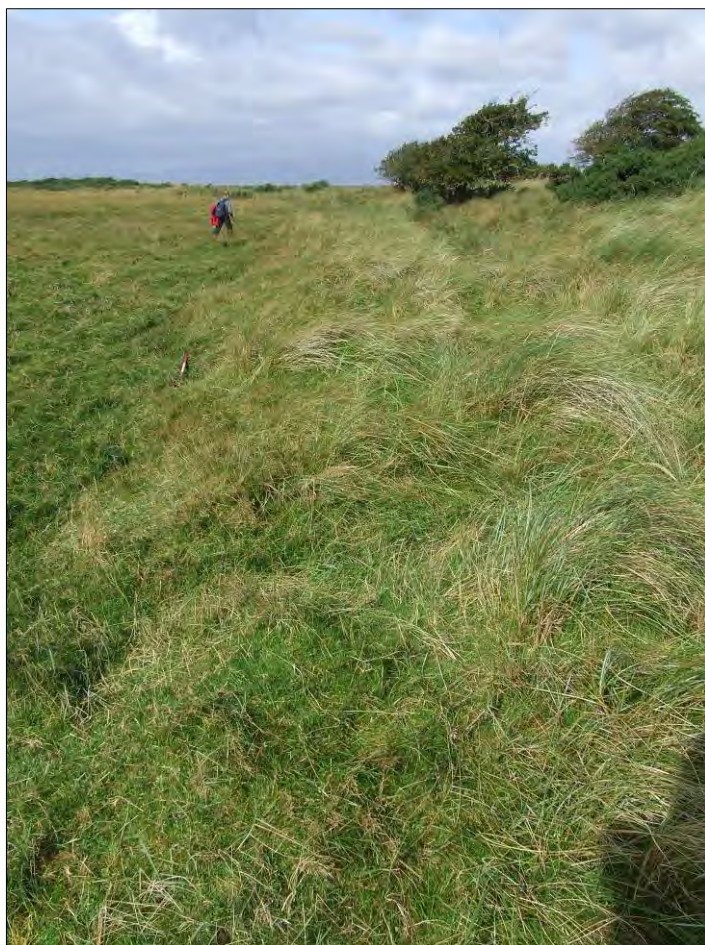
Three sets of Second World War trenches were also recorded (121, 122, 123), of which site (123) was the most substantial. This ran for a length of  $\approx 45\text{m}$  and appeared to be sited to defend the northeastern point of the peninsula (Figure 5.179). The remaining

5.182 Recording the Second World War trench network on the northeast end of the Grune Peninsula, looking northwest (scale = 2m).

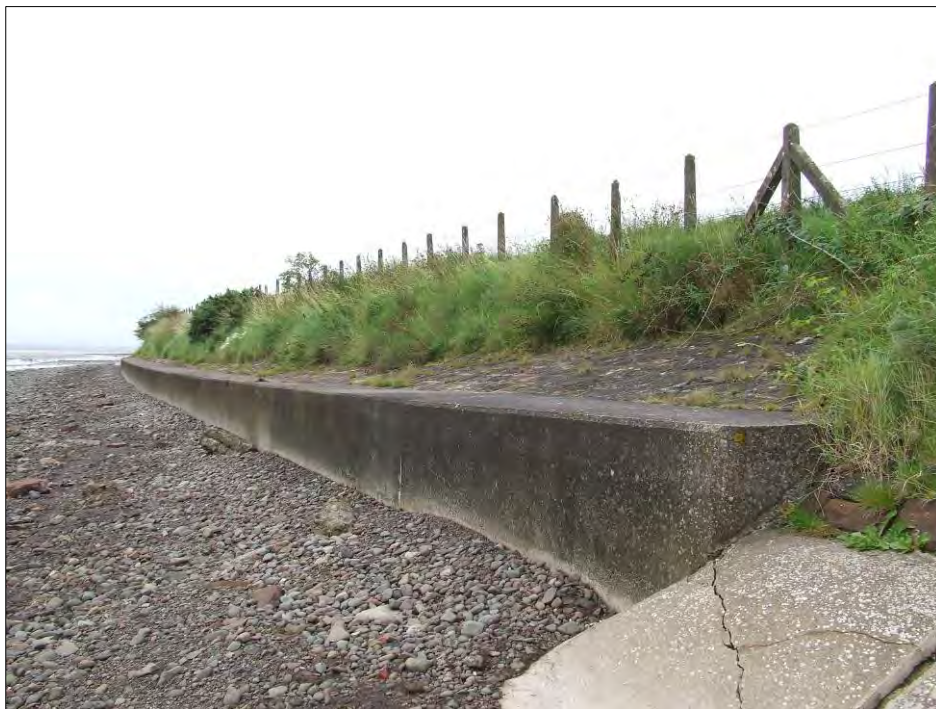
The area of Bowness is composed of solid geology of Triassic Mudstone, Siltstone and Sandstone with a superficial geology of Quaternary Raised Marine Deposits of sand and gravel with outcroppings of superficial Quaternary Diamicton Till (BGS 2008). The principal soil in the area is Seasonally Wet Deep Silty which is suited to cereal and permanent or short term grassland (Farewell 2007). The shoreline in Bowness and westwards towards Port Carlisle is protected by a sea wall which is higher around Bowness to protect housing and infrastructure in the village. To the west it protects the coast road which is liable to flooding during extreme conditions. The sea wall backs on to a narrow shingle and sand inter-tidal zone with limited areas of saltmarsh accumulation (Figure 5.186).

Figure 5.186 Shoreline west of Bowness-on-Solway showing a concrete and stone sea wall and upper shingle beach section.

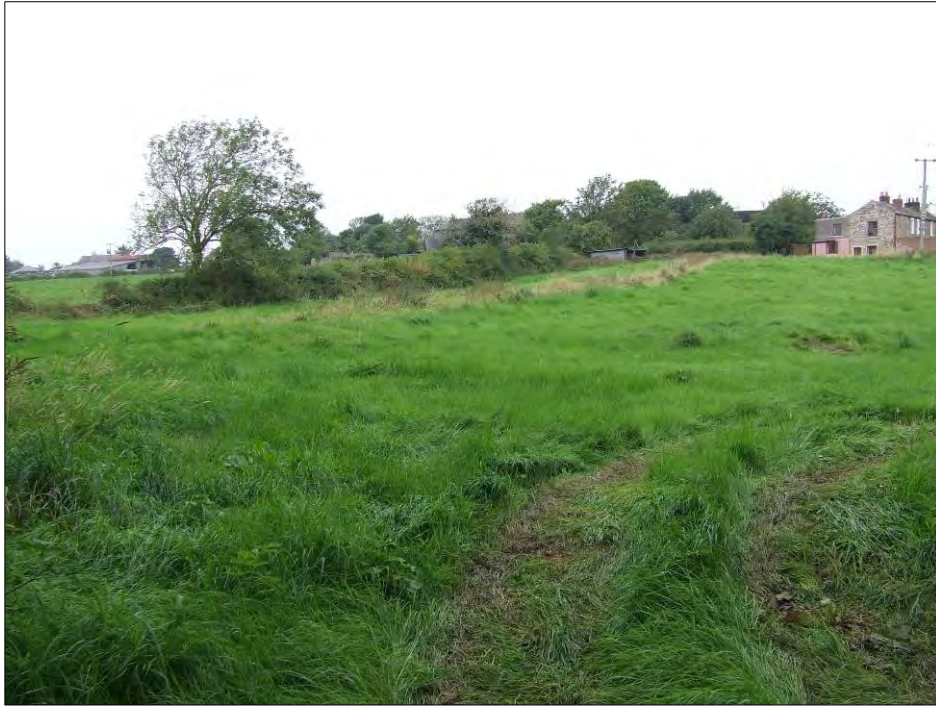
The remains of the Roman Road running south from the Fort (now under the village) at Bowness were clearly visible as well preserved surface features during the Phase 2 survey, as were the remains of building platforms forming the Roman *vicus*. The survey recorded the remains of the road (118) as consisting of a north-south aligned ridge running for a length of c.90m with narrow parallel ditches on either side (Figure 5.187). It had a width of c.12m. The road survives in a field that appears to have been taken out of agricultural use and does not survive as earthwork remains in fields further to the south, where it is likely to have been ploughed out.

Figure 5.187 The remains of the Roman Road (defined by change in vegetation) running south from the Roman Fort of *Maia* in Bowness-on-Solway, looking northwest.

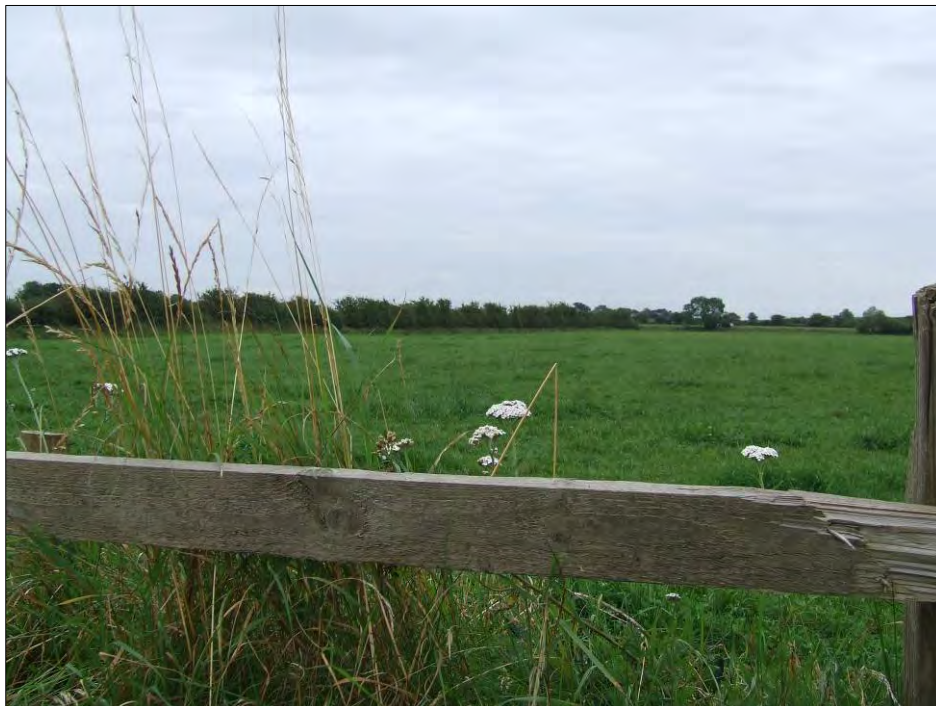
The temporary marching camp at Knockcross (111), c.700m west of the Roman Fort, was recorded during the Phase 2 survey as consisting of very ephemeral earthworks within a pasture field (Figure 5.188), with the site being partially occupied by a house. No definitive earthwork remains that could be related to structural elements were observed. The site lies within 60m of the shoreline behind the coast road that is protected by a concrete and stone-built sea wall.

Figure 5.188 Slight undulations in the field where the Roman Temporary Camp at Knockcross was mapped during the Hadrian's Wall NMP, looking south.

The Roman Temporary Camp at Knockcross (111) and the associated possible Roman Road (141) are considered to be at risk of damage caused by the set-back of the coast road along this frontage and this should be taken into consideration when plans are drawn up for the new road.

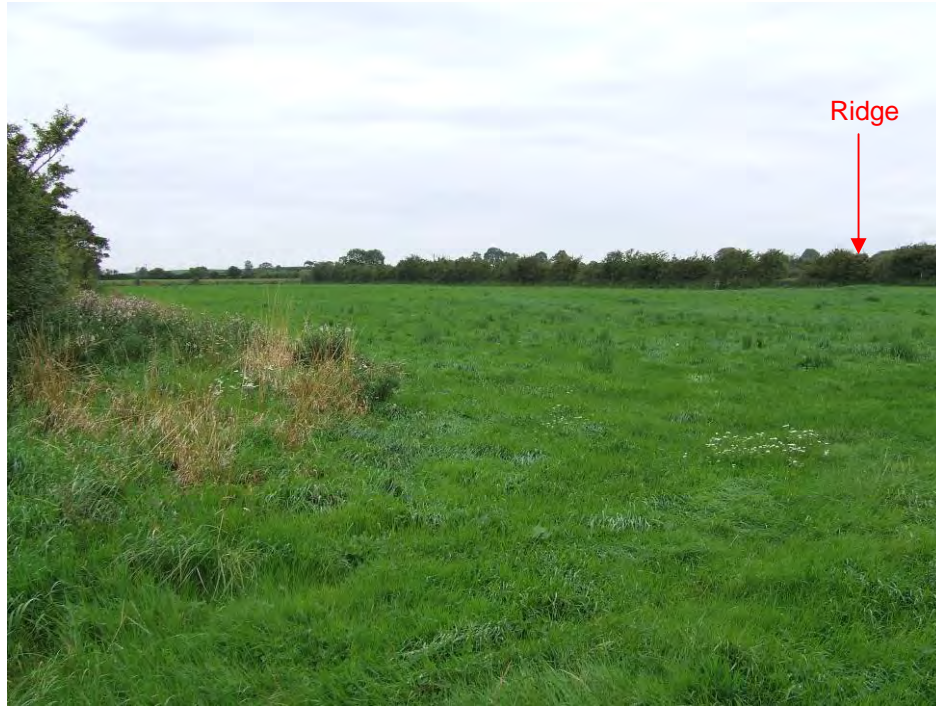
Despite the ephemeral remains of the temporary camp a more prominent ridge was noted extending southeastwards from the mapped eastern entrance to the camp. This was recorded as a possible Roman Road (141) and extended across a number of privately-owned fields in both pasture and arable (Figure 5.189). It was recorded to a

length of 175m in two fields, but extended beyond this recorded distance. On inspection the ridge was broad, with a width of between 18m and 20m, suggesting that it is perhaps not a road, or that it has been damaged by ploughing and is now spread over a much wider area than its original width. The feature may be a natural raised beach (Brian Irving *pers. comm.*). The site lies within the buffer zone of the UNESCO World Heritage Site 'Frontiers of the Roman Empire (Hadrian's Wall)'.

Figure 5.189 Ridge or possible Roman Road visible in fields to the southeast of the temporary camp at Knockcross, looking west.

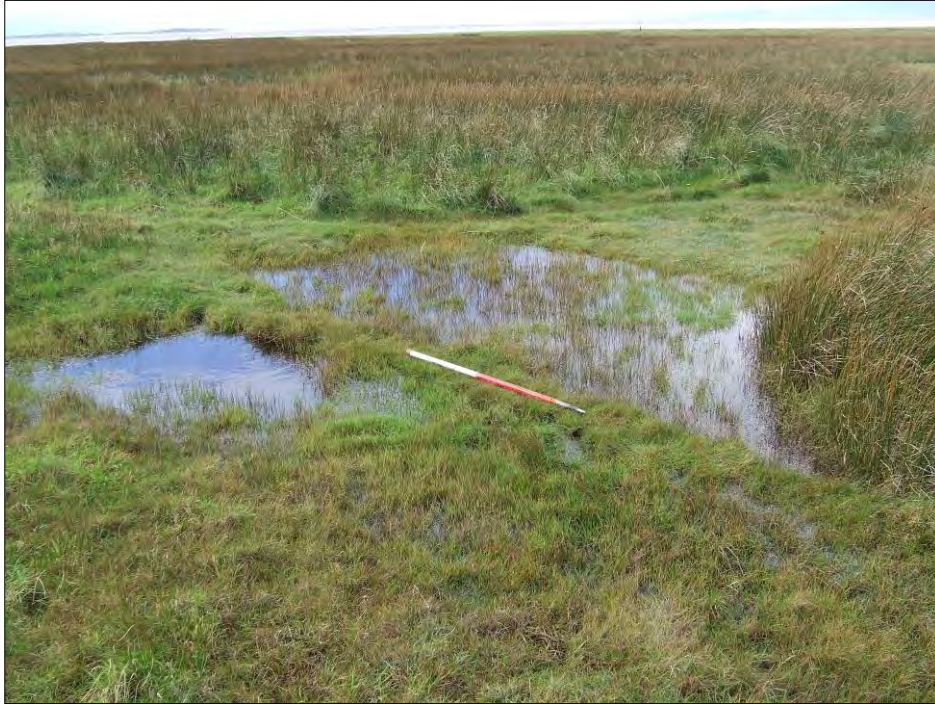
In Cardonuck, 6km southwest of Bowness-on-Solway, the survey recorded the remains of possible post-medieval, domestic-scale peat cutting (177). The remains consisted of several rectilinear, water-filled cut features in the saltmarsh measuring between  $\approx 10\text{m}^2$  and  $\approx 16\text{m}^2$  (Figure 5.190). The location of these extractive pits was recorded as a point as the remains were too extensive to map as part of this project.

Figure 5.190 Evidence of possible domestic-scale peat extraction at Cardonuck Marsh (scale = 1m).

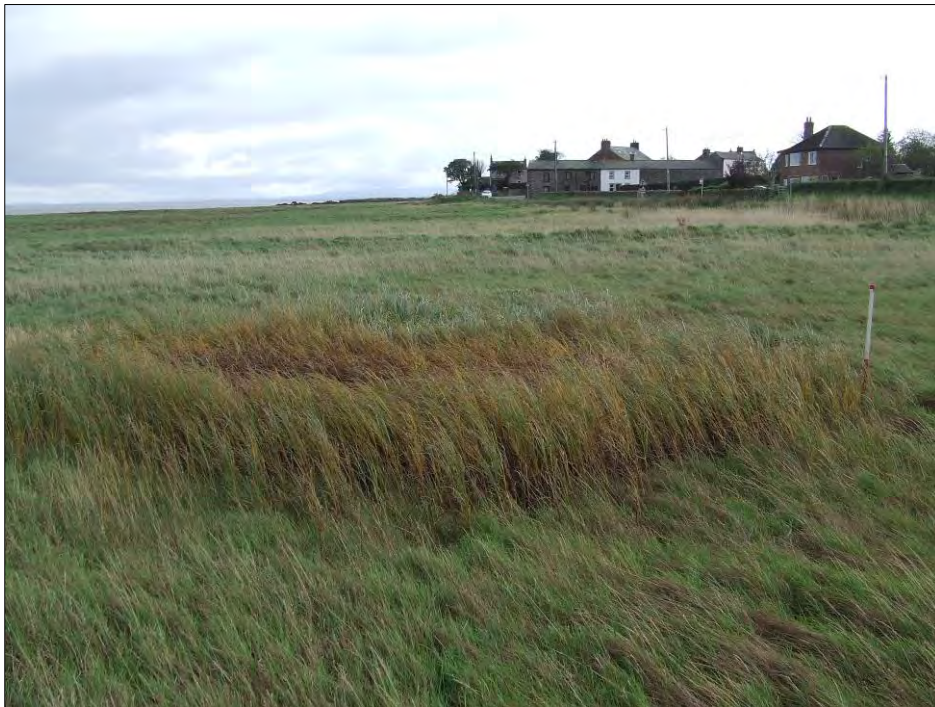
Further evidence of domestic-scale industry was recorded  $\approx 770\text{m}$  west of Knockcross temporary camp, in an area of saltmarsh accumulation along the coastal frontage. This consisted of the remains of a possible saltworking site (178) similar to those described at Skinburness and Moricambe Bay (see Sections 5.16.5 and 5.16.6). The remains of a water-filled circular pool mark the position of a possible salt pan with a diameter of  $\approx 7.8\text{m}$  (Figure 5.191)

Figure 5.191 Evidence of possible domestic-scale salt working east of Bowness-on-Solway (scale = 1m).

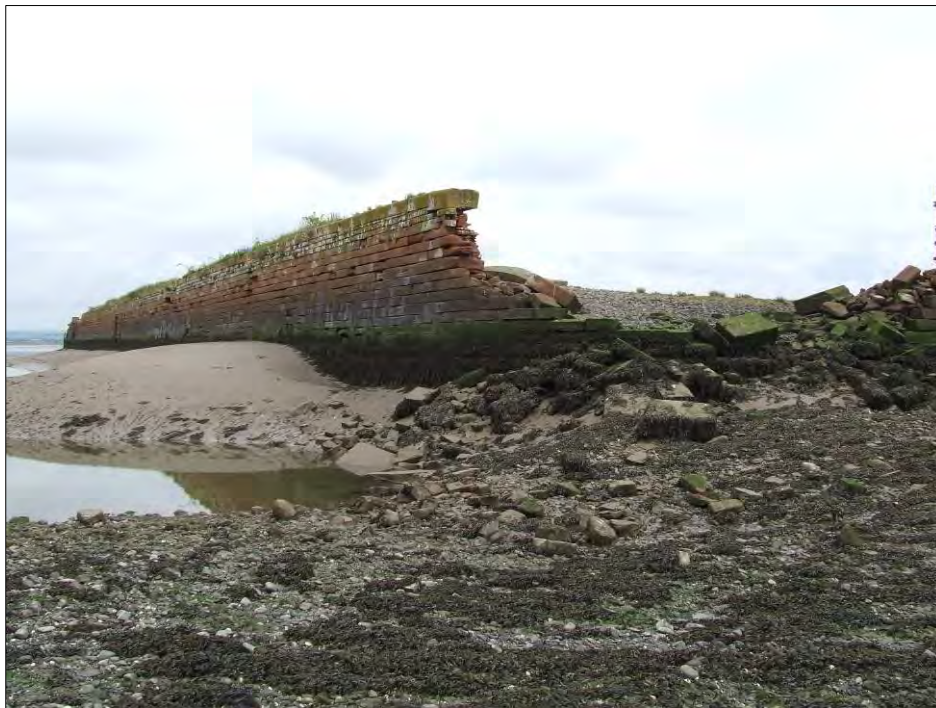
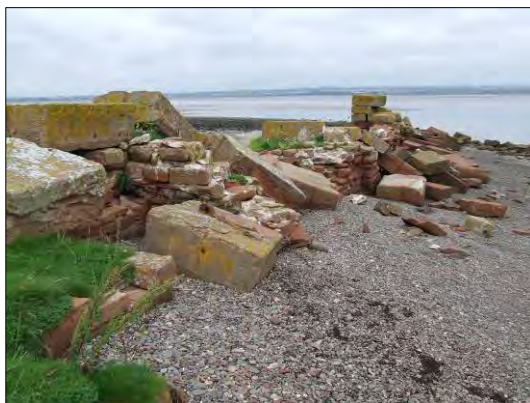
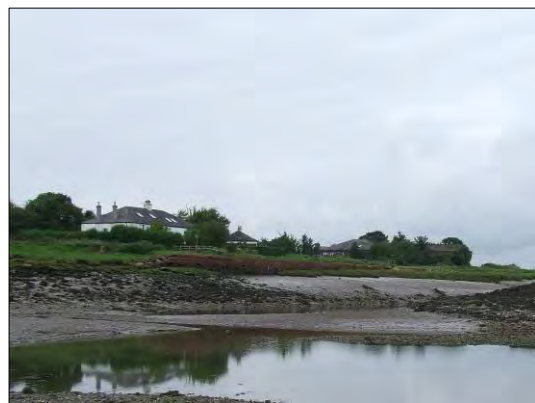
Figure 5.192 Eroding remains of Port Carlisle Quay.

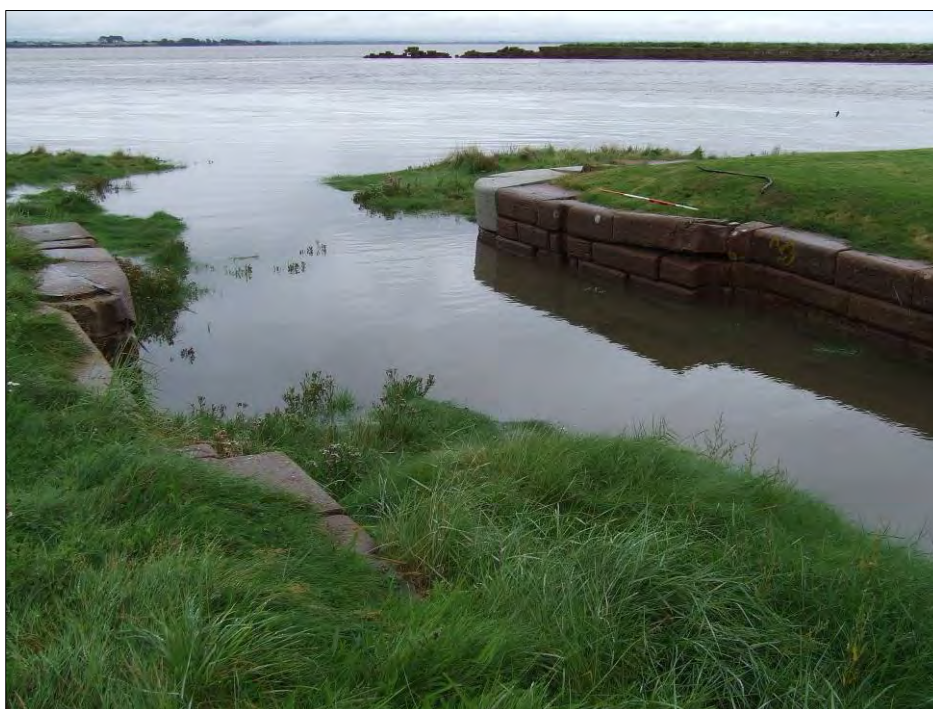
The remains of the canal (110) were recorded during the Phase 2 survey as consisting of the well-preserved remains of the canal mouth and lock. It was constructed of well-coursed Red Sandstone ashlar of similar style to the quayside (Figure 1.193). The canal has largely silted up and could only be traced for a short distance before being blocked by elements of the construction of the railway line.

Figure 5.193 Remains of the Carlisle Navigation Canal at Port Carlisle (with the quayside in the background), looking east (scale = 2m).

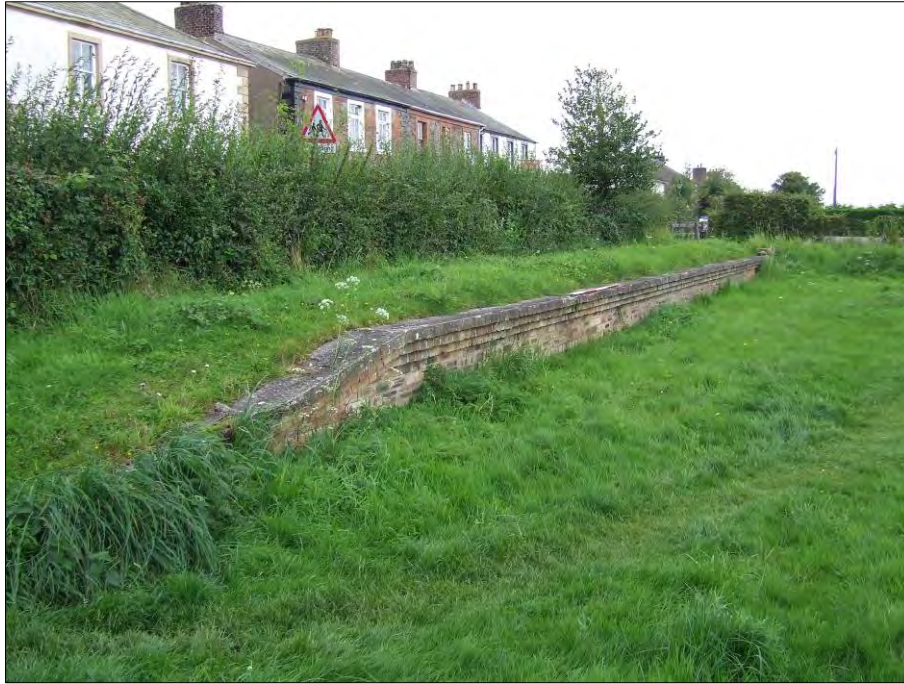
The Phase 2 survey recorded the remains of the railway as a relatively well-preserved railway platform (126) in Port Carlisle, together with associated railway buildings that are now residential buildings within the village (Figure 5.194). The platform survives exposed in private ground for its easternmost extent, standing to a height of c.1.5m. Whilst the westernmost extent is traceable as a line of Red Sandstone blocks covered by concrete within the car park of the bowling club. The platform was c.75m in length.

Figure 5.194 Remains of the railway platform and associated buildings looking northwest (scale = 2m).

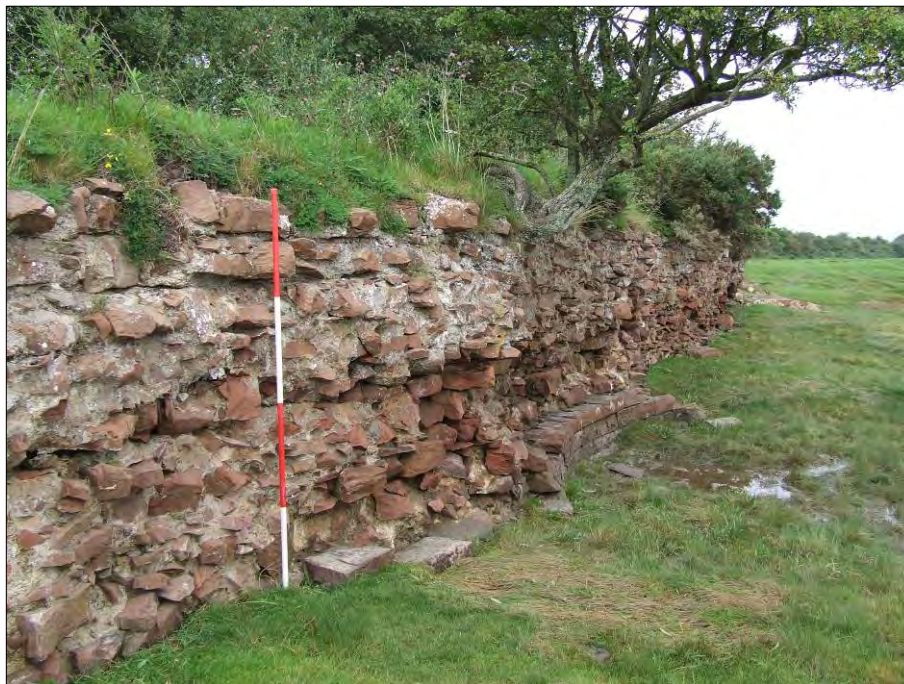
Figure 5.195 Remains of possible industrial activity showing ruined Red Sandstone walling and circular niche (scale = 2m).

Along the line of the railway, c.525m to the southeast of the platform, the Phase 2 survey also recorded the remains of what appears to be industrial activity that may have taken advantage of the railway or canal for export. This consisted of a stretch of ruined Red Sandstone walling with the remains of circular niches in its seaward side (Figure 1.195). This has been interpreted as a possible salt working site (113), but may have had another purpose that could be determined by historical research. The walling extended for a length of c.53m, with the circular niches having a diameter of c.7m.

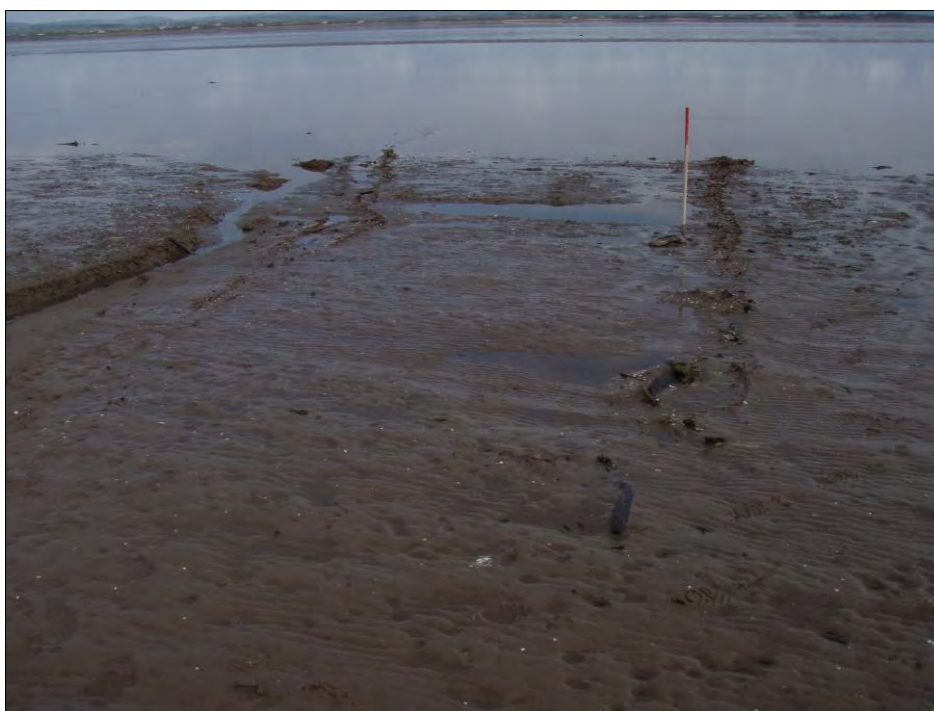
Figure 5.196 Remains of possible timber trackway at Glasson (scale = 1m).

Adjacent to this deposit, however, two parallel rows of ephemeral degraded timbers and stone, and an accumulation of heavier deposits, were recorded forming what appeared to be a trackway (240). The trackway had a width of  $\approx 2.5\text{m}$  and led out from the saltmarsh to the inter-tidal silts and muds of the River Eden (Figure 1.196). The dating of this feature is uncertain as there were no diagnostic features or associated landscape elements that could place this trackway within a historical context. Further work would be necessary to better understand this feature that is undergoing active erosion.

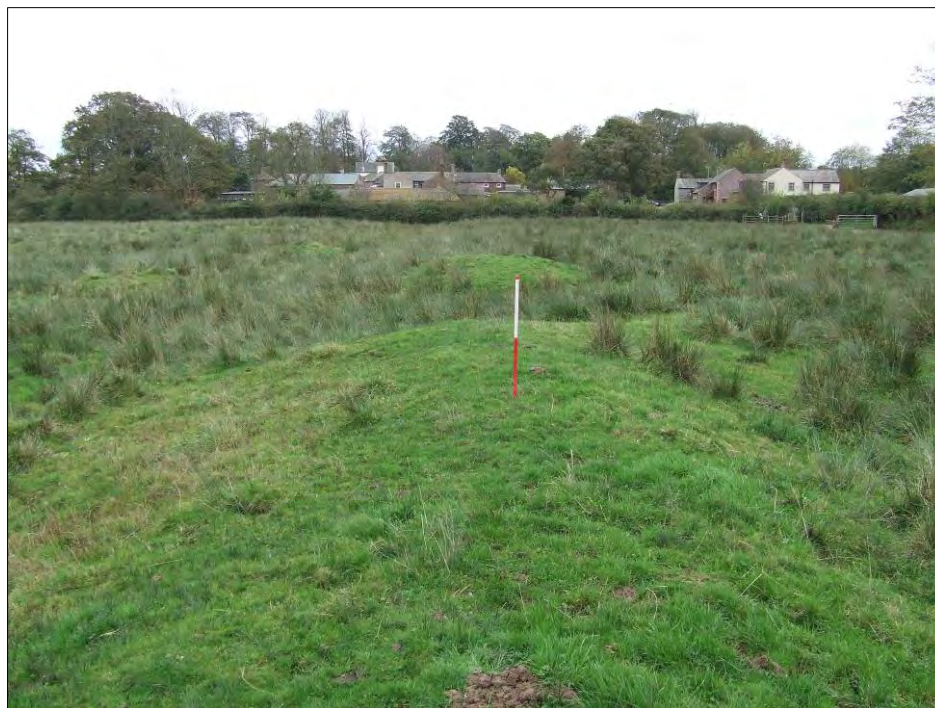
Figure 5.199 Possible unrecorded section of Hadrian's Wall Vallum (217), looking east (scale = 1m).

The Phase 2 survey attempted to ground-truth this identification and recorded the remains of the possible vallum (217) as consisting of a prominent raised bank, to the west of Burgh-by-Sands (Figure 5.199). The full length of the bank could not be investigated owing to the high water levels in the marsh at the time of survey and it is recommended that any fieldwork in relations to this monument are scheduled for the summer months. The bank had a width of  $\approx 5.5\text{m}$  and was intersected by water and drainage channels within the marsh. This recorded section of possible vallum lies within the buffer zone of the UNESCO World Heritage Site 'Frontiers of the Roman Empire'.

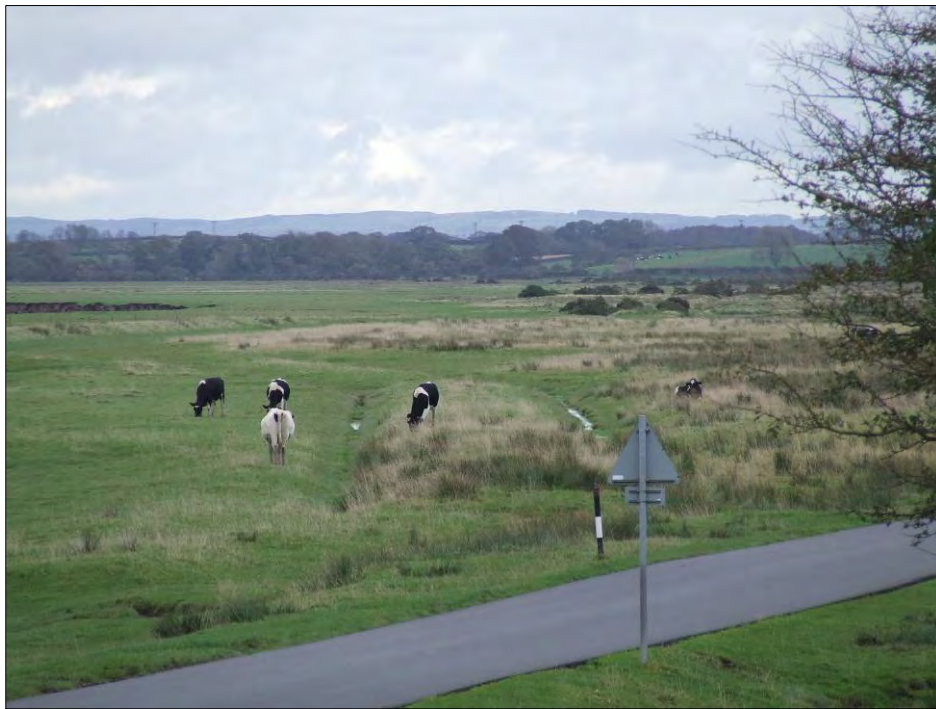
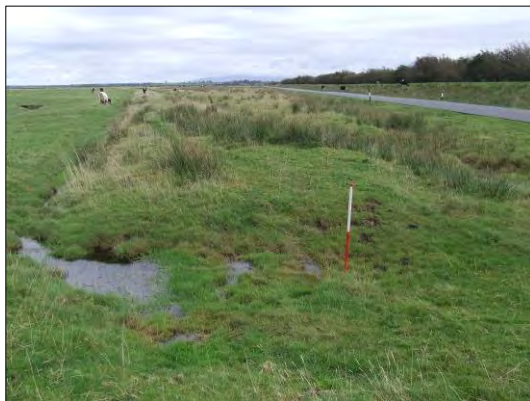
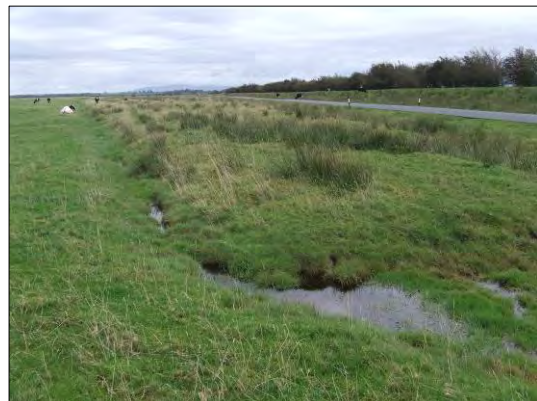
Figure 5.200 Remains of possible medieval boundary bank in Burgh Marsh (scale = 1m).

The possible boundary bank is marked on Ordnance Survey mapping as a drain, however, Peter Horn of English Heritage suggested that the site was probably archaeological and would warrant further investigation (Peter Horn *pers. comm.*). The Phase 2 survey showed the site to be a substantial feature consisting of a low, wide bank with ditches on either side (Figure 5.200). It extended out into the marsh from the modern coast road, before arching round and turning back towards the road. It ran for a length of  $\approx 2.7$ km and was  $\approx 6.5$ m wide, although some elements appeared to have been re-cut. The Phase 2 survey recorded the western terminal point only.

It is possible the bank functioned as an intake or parish boundary, although further research would be needed to confirm this interpretation. It may also have been a flood defence, although the presence of ditches on either side of the bank would be an unusual feature in this case.

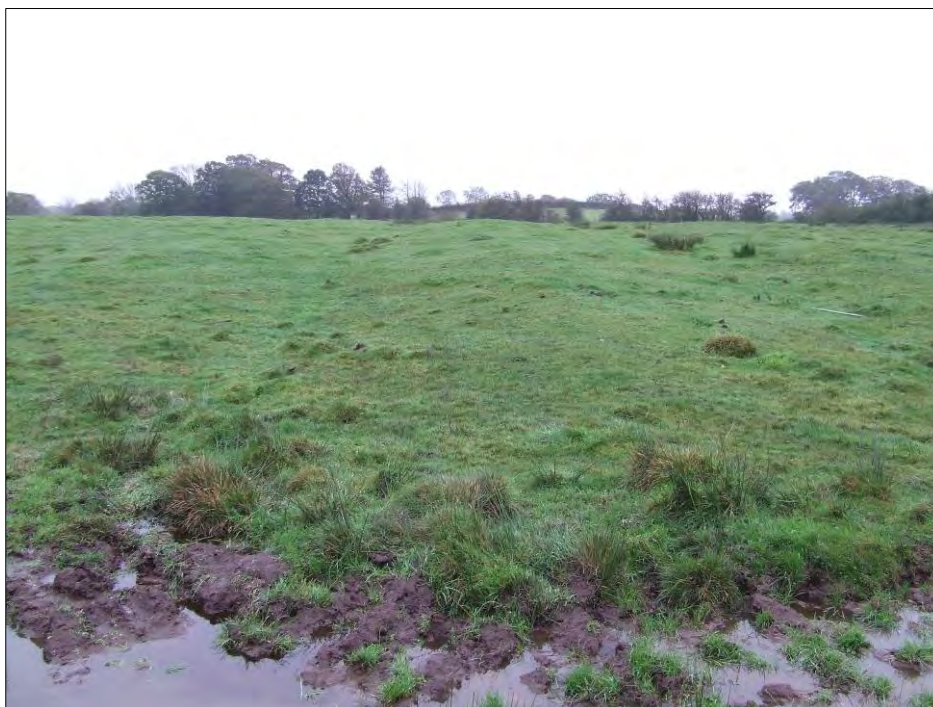
Figure 5.201 Broad medieval ridge and furrow on Burgh Marsh, looking southeast.

Medieval ridge and furrow (182) was mapped within the marsh as part of the Hadrian's Wall NMP (NRHE: 1372802). This was ground-truthed during the course of the Phase 2 survey and the boundary of this area of cultivation, marked by a prominent plough headland, may represent the extent of surviving medieval marsh (Figure 5.201). Brian Irving suggests that the marsh has eroded and re-accreted in the post-medieval period and therefore believes that the marshland nearest the coast road is the surviving medieval portion (Brian Irving *pers. comm.*). This assessment is corroborated by the recorded evidence.

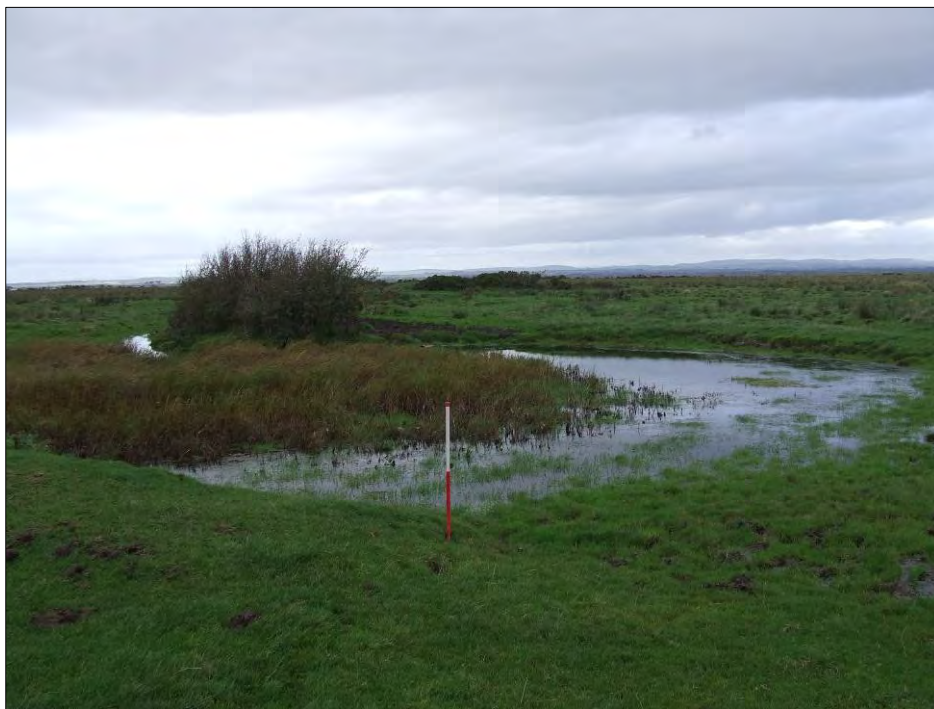
Figure 5.202 Remains of possible salt working site on Burgh Marsh, looking west (scale = 1m).

The Phase 2 survey recorded the remains of a medieval/post-medieval saltworks (185) c.450m to the west of Burgh-by-Sands. This consisted of a large circular water-filled pool with a diameter of c.12m (Figure 5.202). This is similar to sites described by Brian Irving and those recorded in Moricambe Bay (see Sections 5.16.5 and 5.16.6). The other three sites selected for field inspection had similar characteristics to this site when viewed on Google Earth™ and may therefore be interpreted as potential salt working sites.

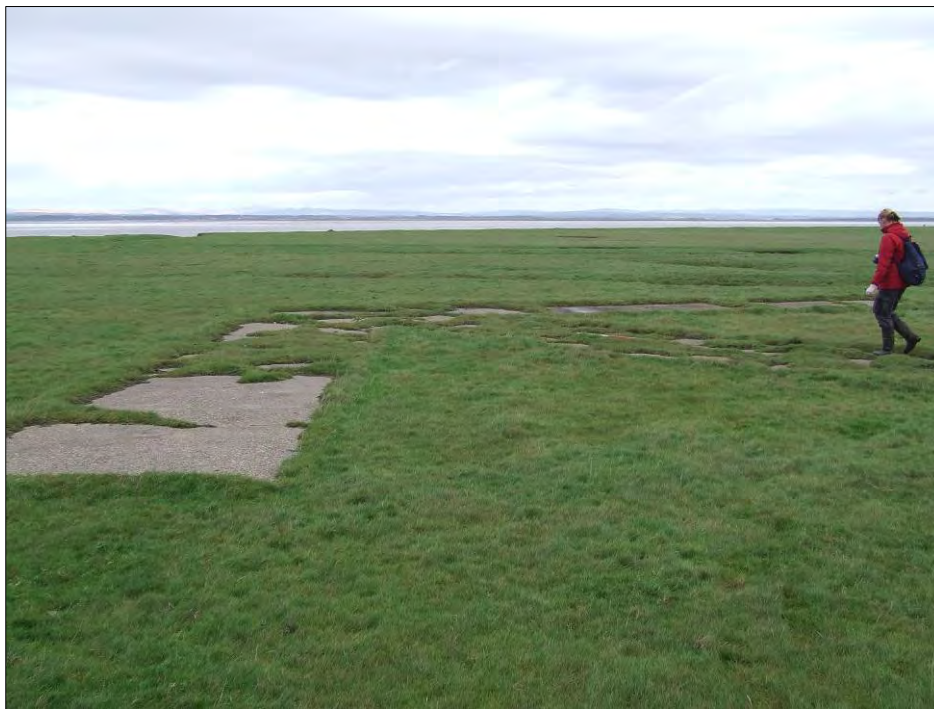
Figure 5.204 Recording the remains of a bombing range marker on Burgh Marsh, looking north.

The bombing range marker arrow testifies to the use of the marsh for military training purposes. The marker was constructed of concrete slabs, laid out to form an arrow when viewed from above (Figure 5.204). Each arrow usually had three concrete circles laid out on their nodal points, however these did not survive, or were not used, at Burgh Marsh. The recorded arrow (180) measured 23.5m in length with a span of 18m. The remains were these features were relatively well-preserved although significant intrusion of vegetation was noted, causing the concrete slabs to crack.

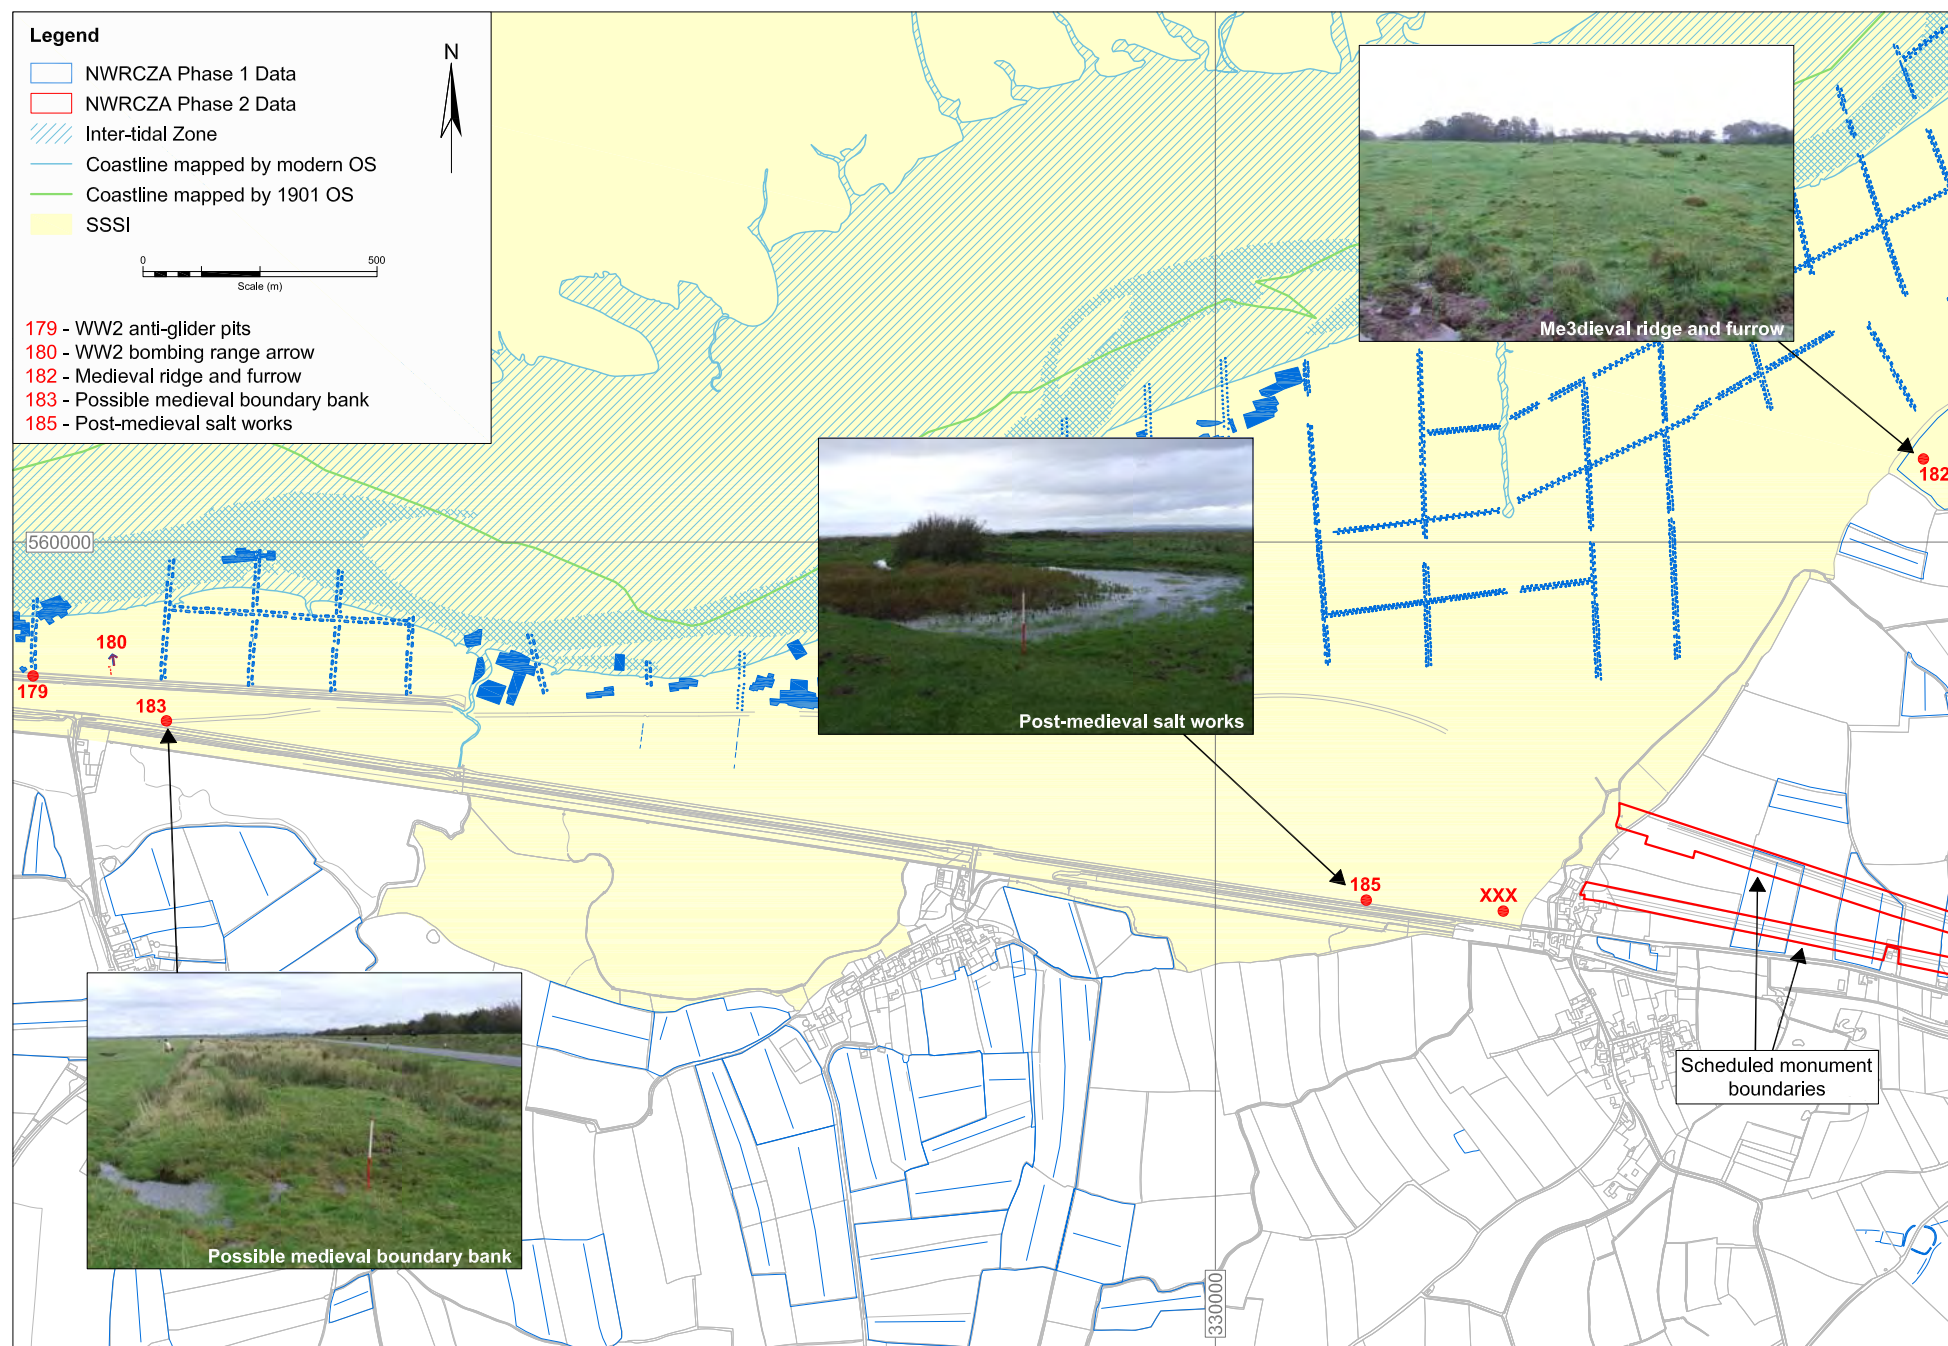
Figure 5.205 Location of sites recorded on Burgh Marsh

The remains recorded at Burgh Marsh (179-183, 185, 217) lie within policy units 11e8.4 and 11e8.5, both of which recommend 'Managed Realignment' for the following 100 years. This will promote a more naturally functioning coastline, but also includes a plan to re-route the presently at risk undefended coast road (Halcrow 2011).
