**Waterlogged Archaeological Deposits
Nantwich, Cheshire**

**Desktop study of archaeological and borehole investigations
Cheshire County Council and English Heritage 2663/522**

July 2007

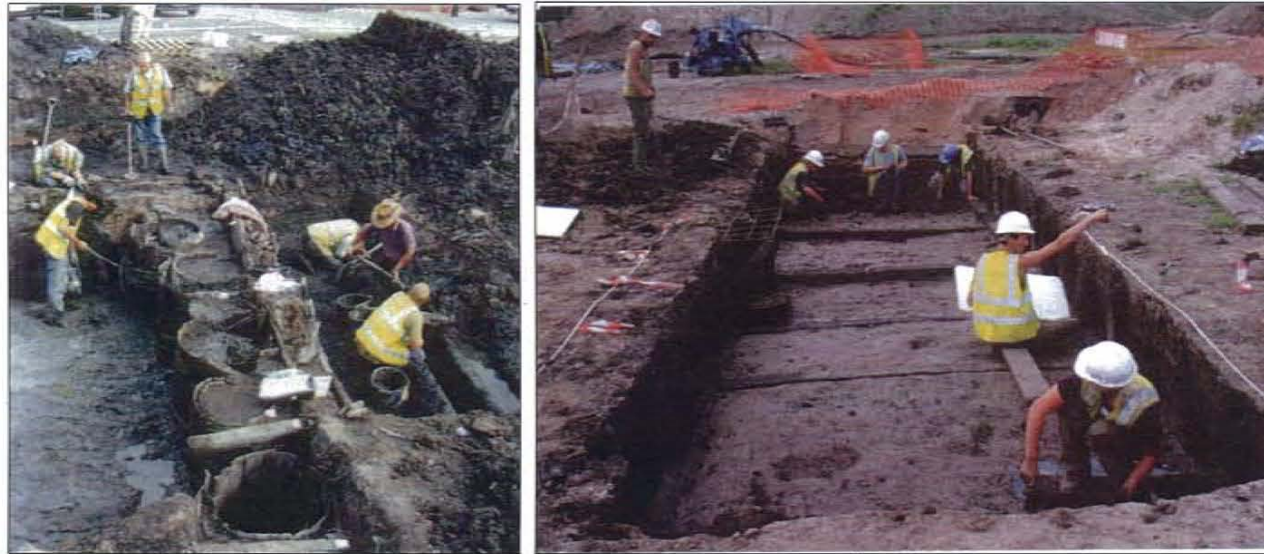
Plates 1 & 2: Waterlogged deposits found during excavations at 2nd Wood St and Kingsley Fields

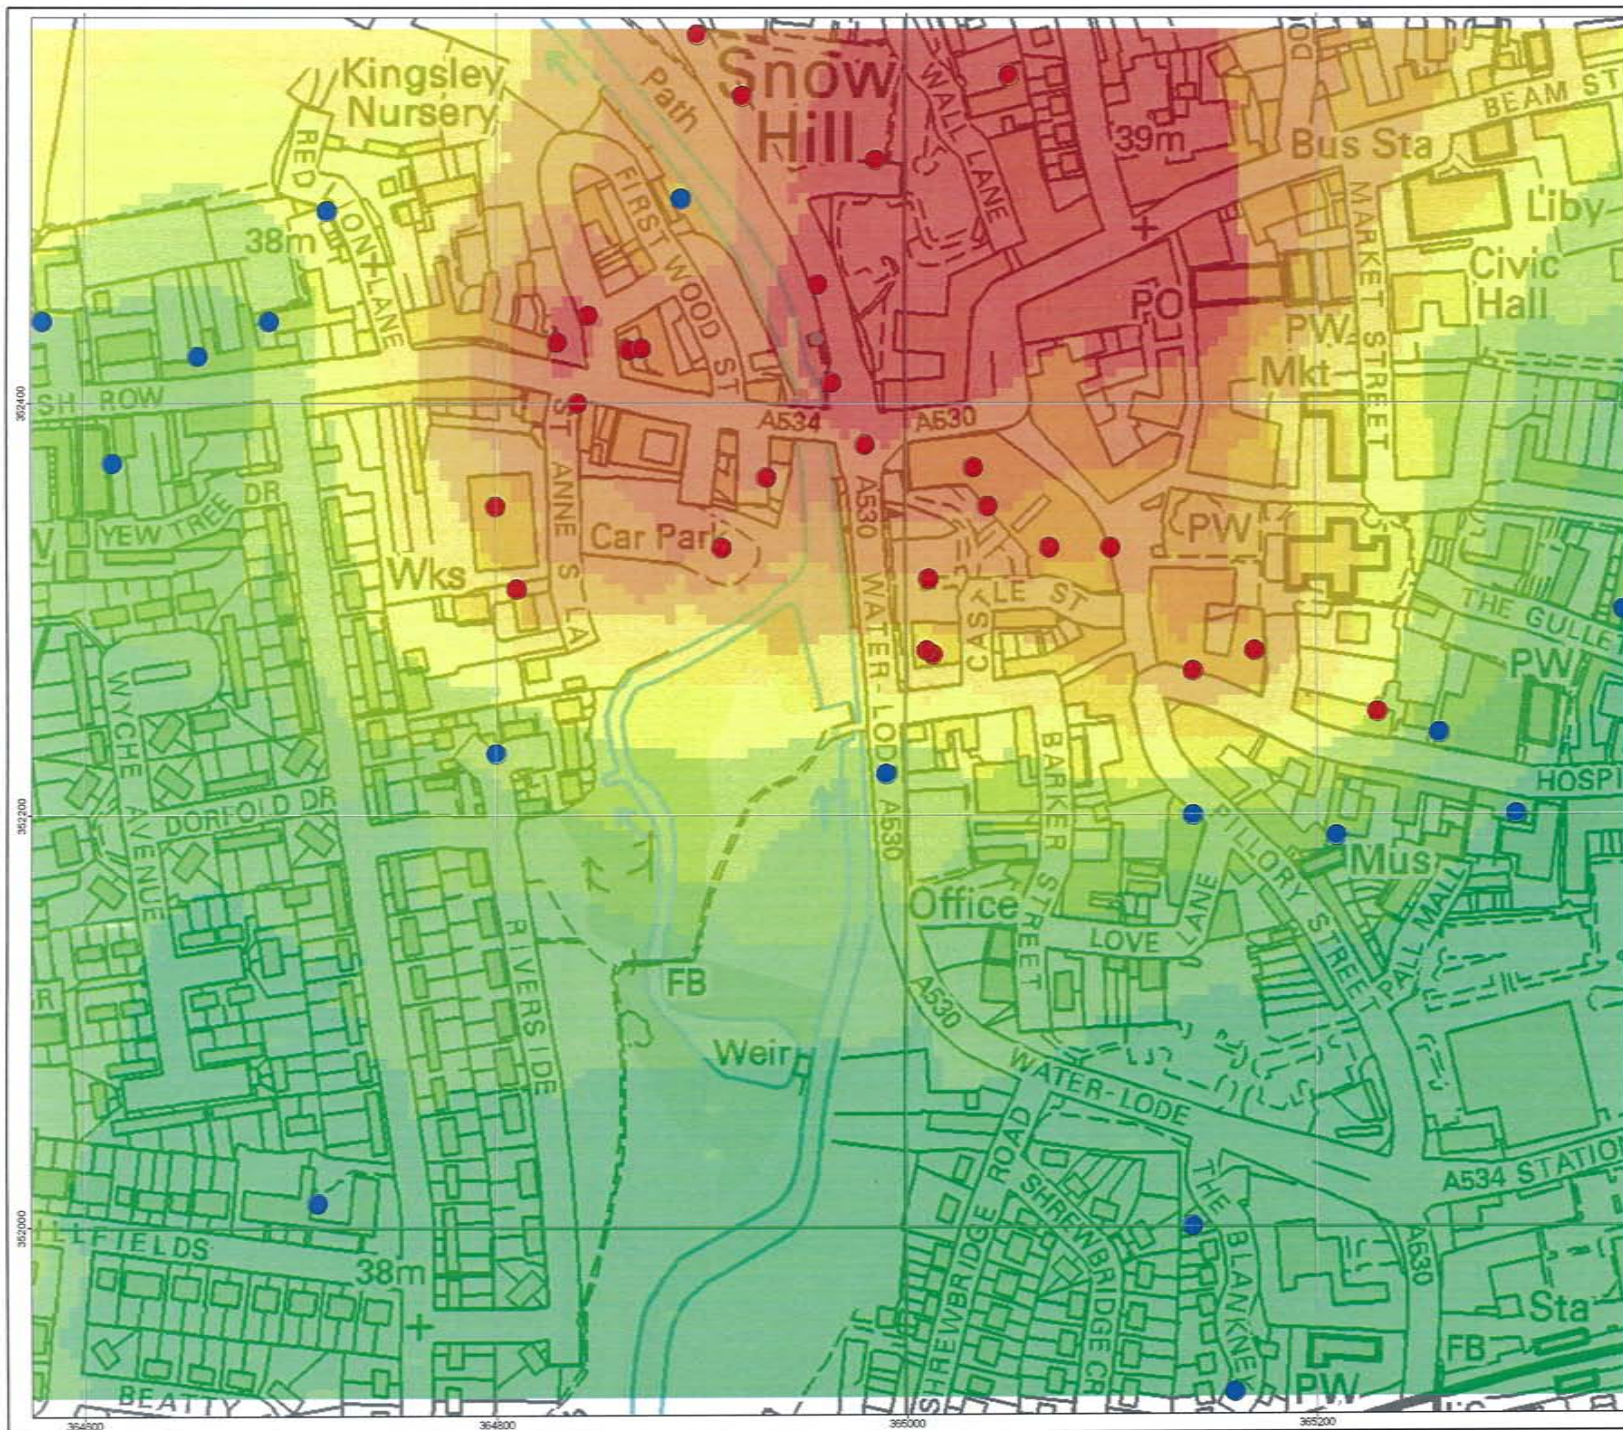
FIGURE 6

- Waterlogged
- Not Waterlogged
- Thickness of organic deposits (m)
- 0 - 0.3
- 0.31 - 0.58
- 0.59 - 0.85
- 0.86 - 1.11
- 1.12 - 1.38
- 1.4 - 1.69
- 1.7 - 1.99
- 2 - 2.29
- 2.3 - 2.61
- 2.62 - 4.5
