Old Manor House (Remains of)
Manor Road
Portslade-By-Sea
Brighton
East Sussex

Dendrochronological Investigation of an *ex situ* Oak Lintel
Martin Bridge

Research Report Series no. 268/2020

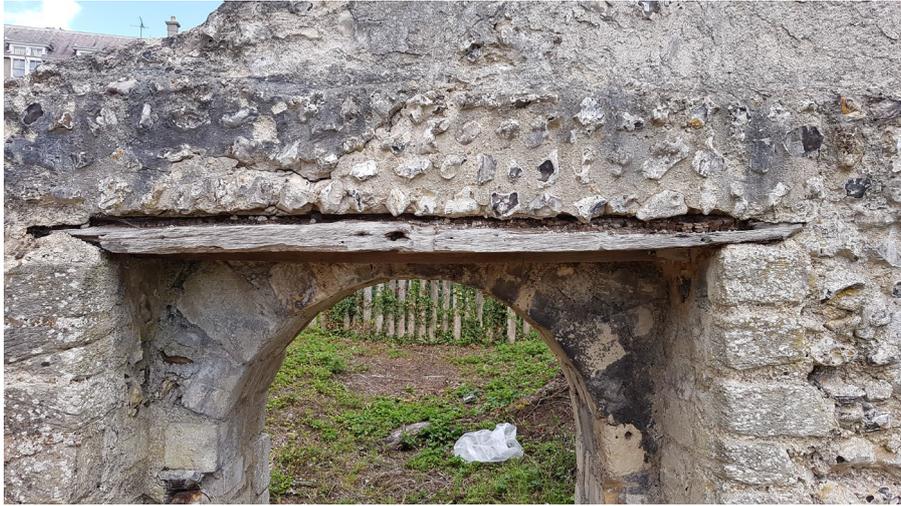
Figure 2: Photograph of the lintel in position over a doorway (photograph Maria Buczak)

The remains of a single timber lintel above a doorway in the ruins (Fig 2) had been removed during a programme of repair, and decisions on whether the timber was to be reinstated or replaced were under consideration at the time of sampling, which required dating input.

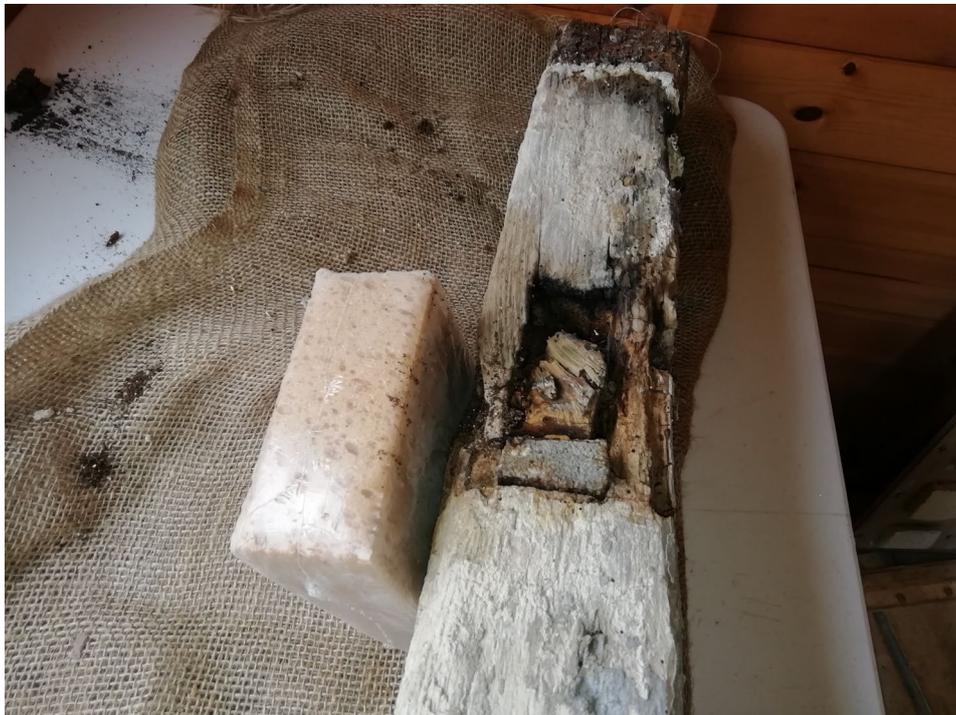
Figure 3: Ex situ lintel showing mortice from a former role (photograph Martin Bridge)

An assessment of the *ex situ* timber for dendrochronological study (Fig 3) sought more than 50 rings and where possible traces of sapwood, although slightly shorter sequences are sometimes sampled if little other material is available. If the timber had been deemed suitable discussion would take place about acceptable sampling methods. In this case, however, the decayed state of the timber meant that it could not be reinstated. There was discussion about the possibility of future display instead, for which a date would be edifying, and so it was agreed that to remove a slice from the widest section of the *ex situ* timber for further analysis was acceptable.

The *ex situ* timber was oak (*Quercus* spp), but had very few rings with no sapwood and was very decayed. It was also evident from various mortices within the timber (see Fig 3) that it had probably been reused from a different position. The slice removed was sanded, and revealed approximately 30 rings (Fig 4), making it unsuitable for conventional ring-width dendrochronology or for oxygen isotope analysis, which also requires a higher ring-count for meaningful correlations. The remains of the timber were returned to Portslade, pending further decisions.

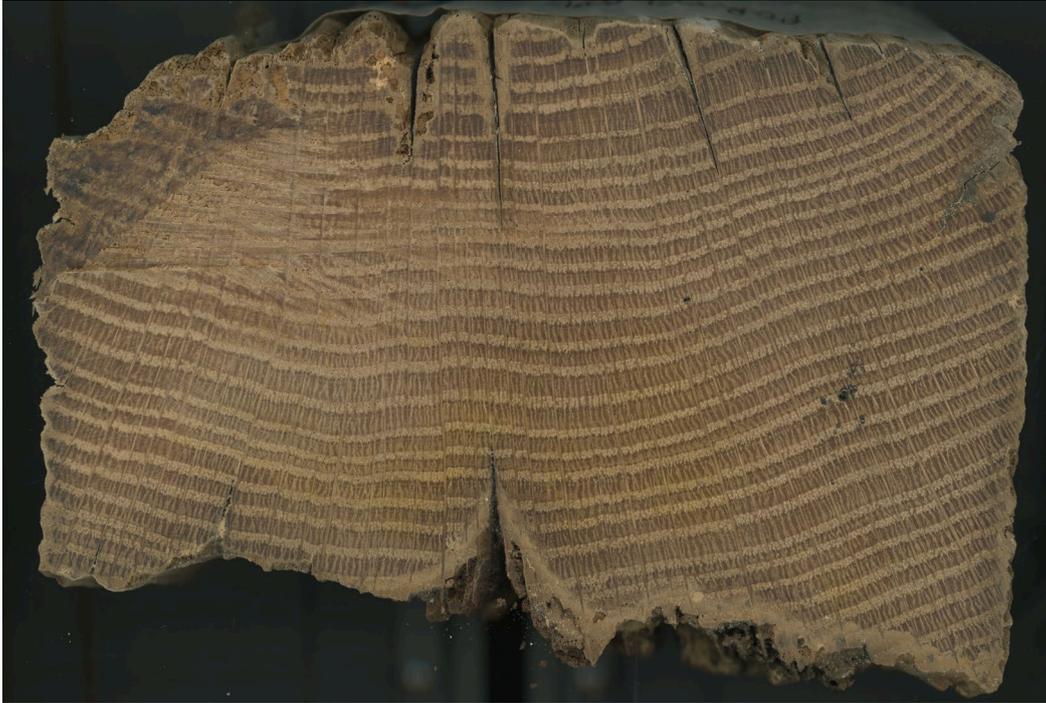
*Figure 4: Slice removed from the ex situ lintel for possible future analysis
(photograph Martin Bridge)*

The slice was polished on a belt sander using 80 to 400 grit abrasive paper to allow the ring boundaries to be clearly distinguished. The ring widths were measured from the photograph (Fig 4) using CooRecorder 9.6 (www.cybis.se) and are given in the Appendix.
