Historic England

A Study of the Roof Environment in Four Domestic Buildings

Brian Ridout, Iain McCaig and Soki Rhee-Duverne

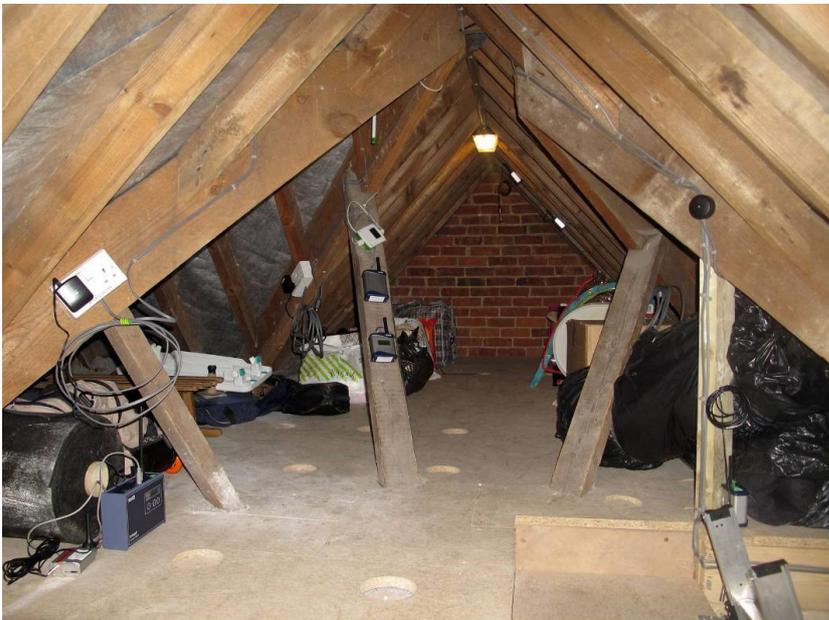
Fig 1: Building 1 ‘Addison’ attic interior

The roof at Building 1 was constructed using plain tiles on softwood battens, with Tyvek Enercor underlay directly beneath. (This is described by the manufacturer as a vapour-permeable membrane with a metallised surface to control heat gain and loss.) The roof construction below the membrane is of softwood, and unventilated. Blown cellulose insulation and an AVCL – Tyvek AirGuard – are incorporated in the attic floor construction. The general construction is shown in Figure 1; the attic floor construction is shown in Figure 2.

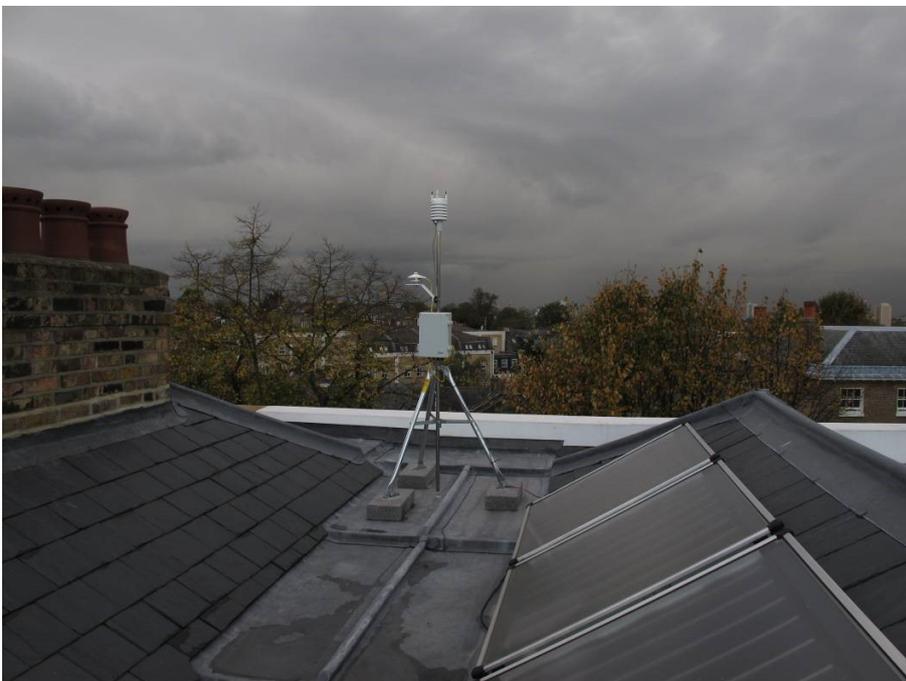
Fig 46: Slate covered roofs and weather station at Building 2 ‘Rectory’

Building 2 ‘Rectory’ differs from Building 1 ‘Addison’ in having two parallel shallow pitched roofs (Fig 46). Further construction details, together with sensor types and locations, are provided in Figures 49 and 50.

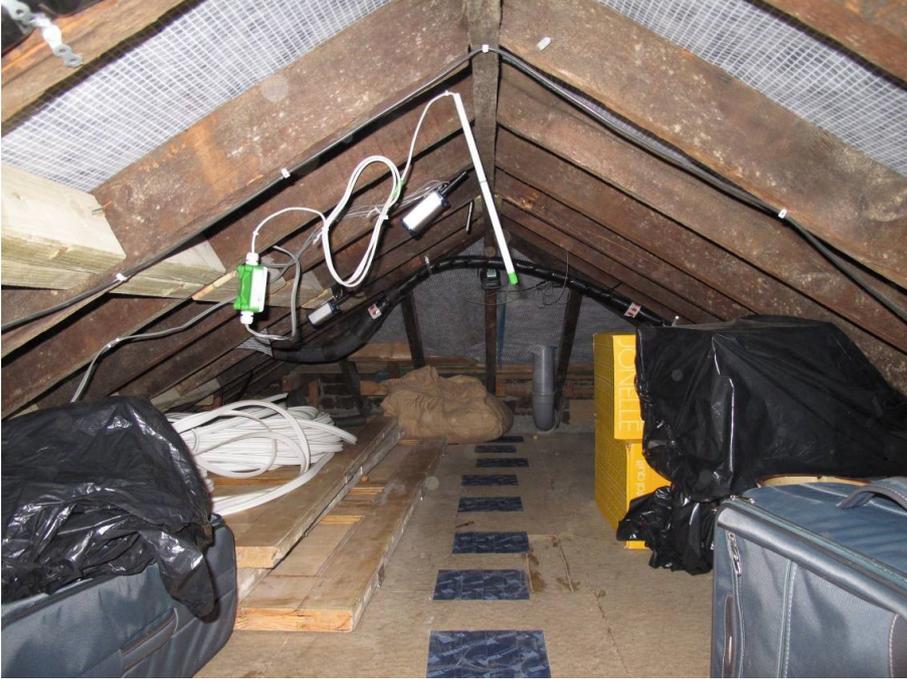
Fig 47: Building 2 'Rectory' attic

The unventilated softwood roof is slated and has a vapour-permeable underlay – Pro Clima Solitex – beneath the battens. The attic floor is insulated and covered with particle board (Fig 47). A vapour-permeable AVCL –Pro Clima Intello Plus – is incorporated in the attic floor construction.

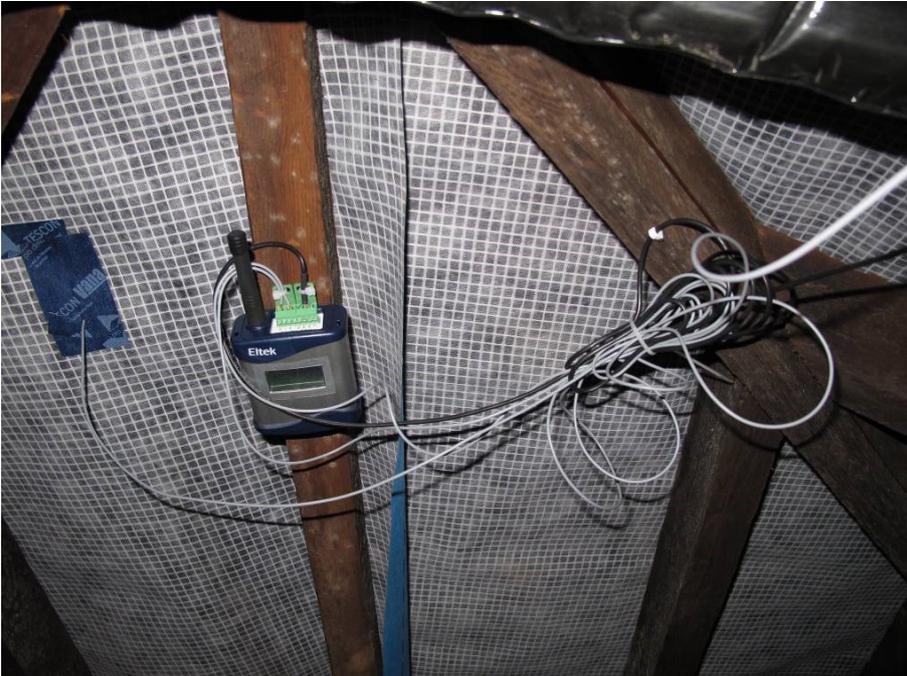
Fig 48: The underlay was slit to allow sensors to be installed behind, then sealed with Tescon Vana tape

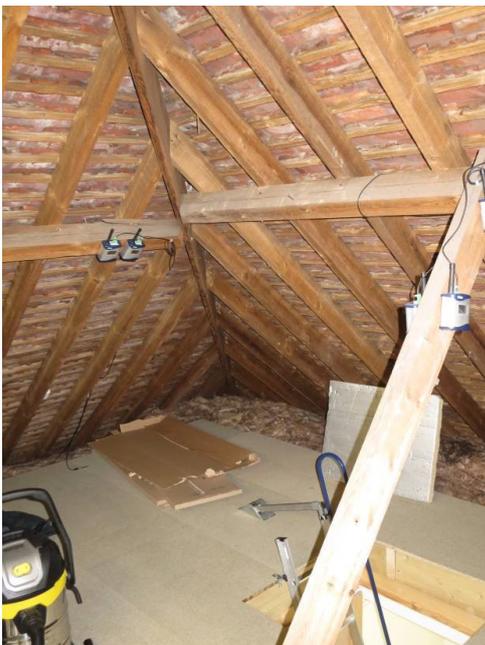
Fig 74: Building 3 ‘Woodbury’ attic

The roof of Building 3 ‘Woodbury’ is constructed from softwood, covered with plain clay tiles without an underlay. This construction is shown in Figure 75.

The attic floor had a 100mm layer of fibre glass insulation between the joists when monitoring commenced, and this was increased to 300mm in March 2016. The floor is covered with particle board.

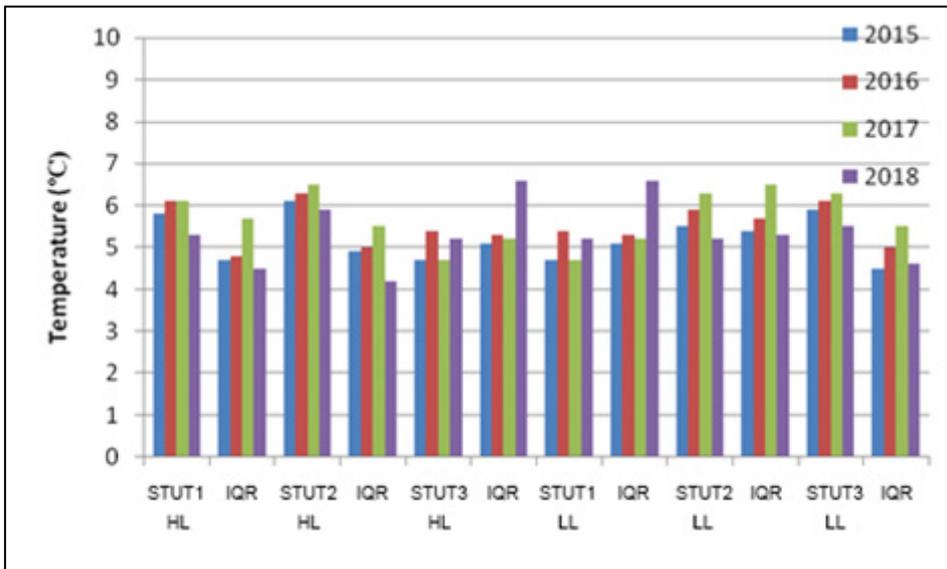
Fig 79: Median and interquartile ranges (IQR) for surface temperatures (°C) at high (HL) and low levels (LL) for January/February 2015 to 2018

Medians and interquartile ranges are similar and do not vary between years by much more than 1°C. Data for 2016 are presented as a box plot in Figure 80.

Surface temperatures on the underside of the tiles are presented in Table 16 and Figure 79. High level sensors were located at A and low level at B, as shown in Figure 75.

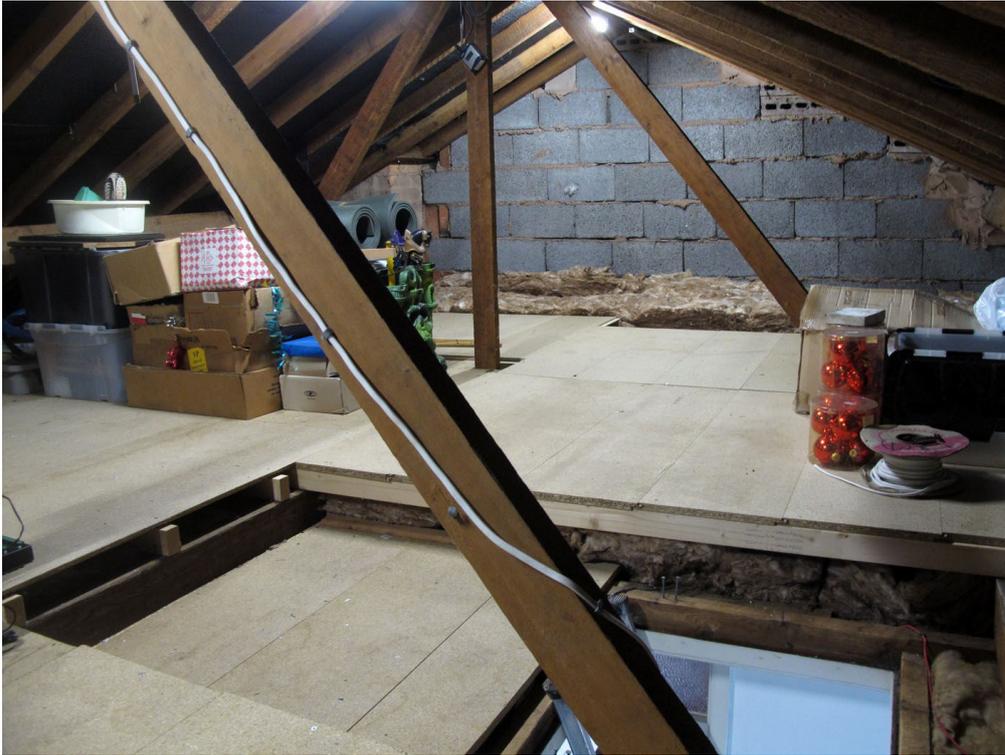
Building 4 ‘Long Compton’ is a terraced house built in the 1970s. The roof incorporates an impermeable BS747 Type 1F bituminous felt underlay below single lap concrete tiles. There is an eaves board that restricts ventilation. The construction is shown in Figures 110 and 111.

Fig 110: Loft construction with an impermeable BS747 Type 1F underlay and a boarded floor

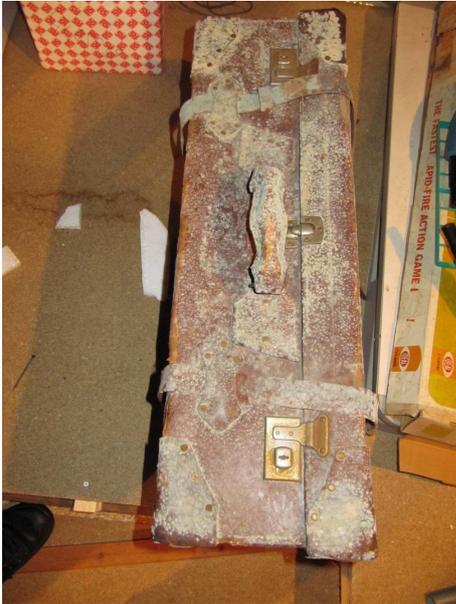
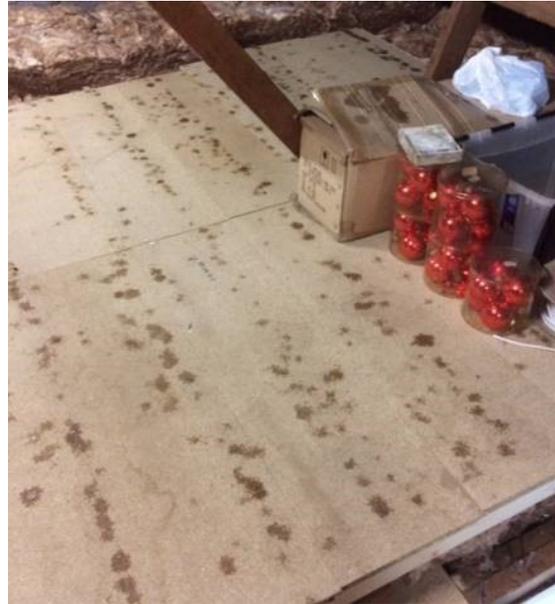
A visit to the attic in November 2015 revealed that the addition of the extra insulation had apparently caused extensive condensation. A leather suitcase was coated in mould, there were drip lines on the floor boarding and water was dripping from the impermeable roof underlay (Fig 113). The additional insulation would seem to have destabilised the roof environment after 30 years of use as dry storage.

Fig 113: A mouldy suitcase, drip marks on the floor boarding and condensation on the impermeable BS747 Type 1F underlay

The roof space was visited to store some items on 13 November 2017, when a severe condensation event was found to be occurring. This is illustrated in Figure 113 and the temperature drop is shown by an arrow in Figure 124. This condensate accumulated over a two-day period.

Fig 124: A severe condensation event (below red line) commenced on the night of 12 November 2017 and was observed on 13 November 2017. This is the event photographed in Figure 113

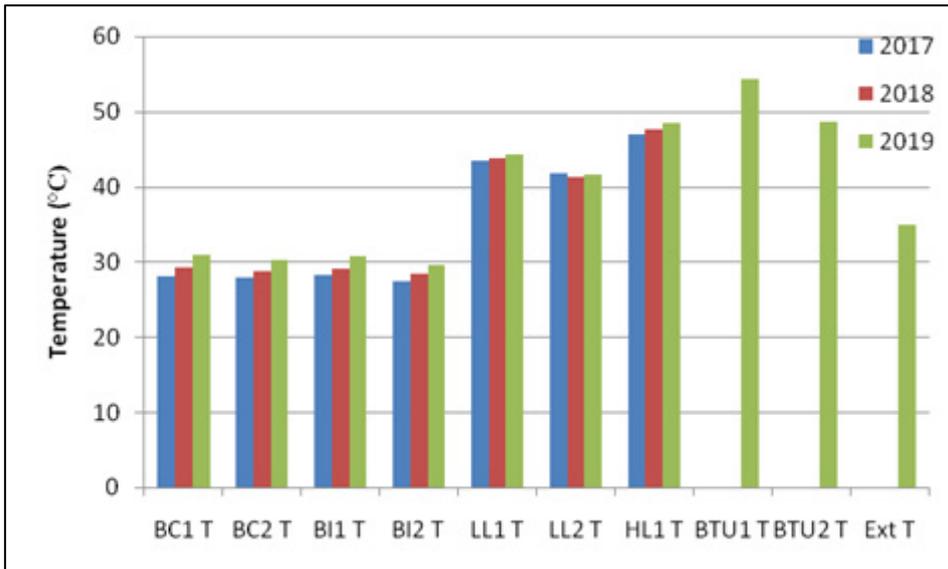
Fig 133: July/August maximum temperatures (°C) recorded in the rooms (BC), beneath insulation (BI), low level (LL), high level (HL), between tiles and underlay (BTU) and exterior (Ext) during 2017 to 2019. LL1 and BTU1 are on the south side; LL2 and BTU2 are on the north side; HL1 is below the ridge
