The Undercrofts of Westgate Street, Gloucester

Historic Buildings Assessment

This report examines the evidence for medieval undercrofts surviving on Westgate Street, Gloucester. For the purposes of this study undercrofts are defined as the stone-vaulted spaces beneath a building or principal room.

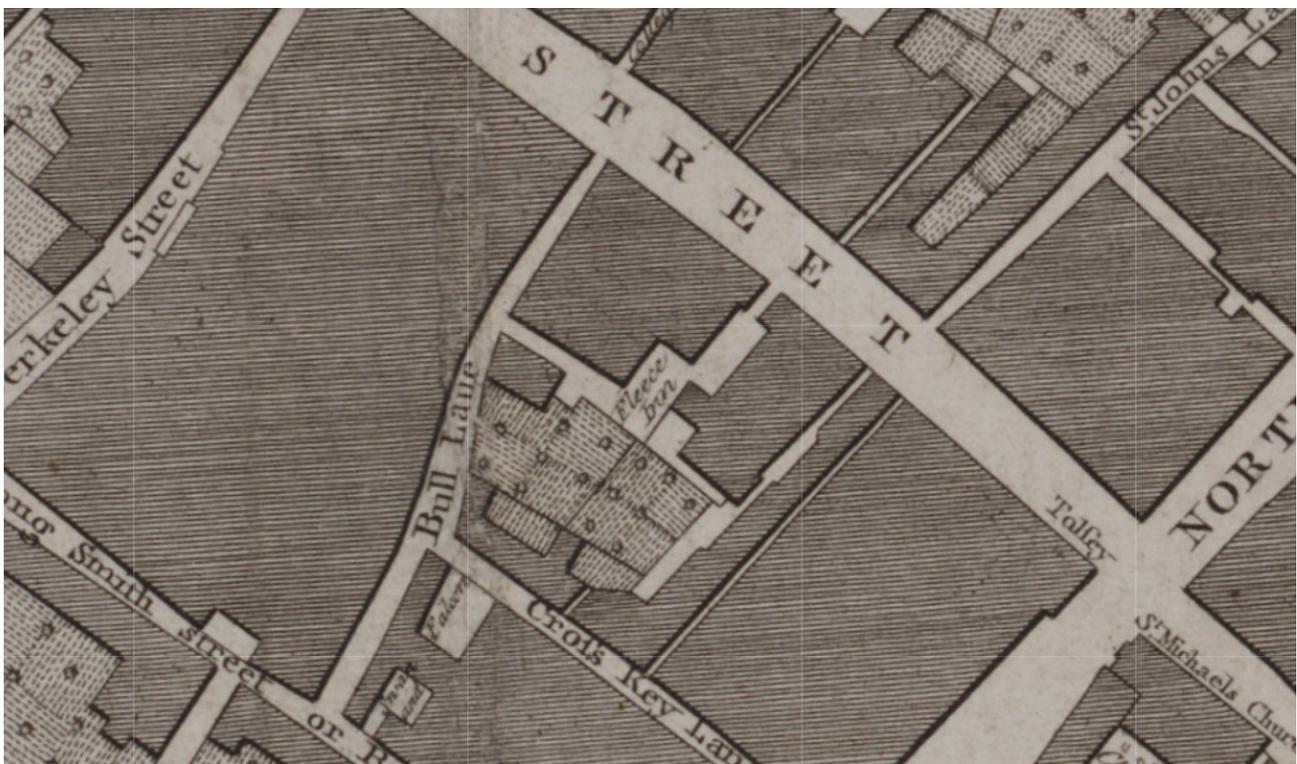
Figure 5: Detail of the site of the Fleece Inn as shown on the 1780 Hall and Pinnell map of Gloucester. [Image reproduced from Know Your Place. Reproduced with the permission of Gloucestershire Archives]

Hall and Pinnell's Map of Gloucester of 1780 is the first map to show the city centre in a modern conventional form, although many of the built-up areas are shown as large solid blocks.¹²⁹ Despite this, the Fleece can clearly be identified (Figure 5). The rear yard is labelled with the name. The passageway from Westgate Street is evident, as is the route out to Bull Lane. Looking at the structure above the undercroft, the mapping shows a projection at its south-west corner. Neither of the currently existing, western, projecting bay windows are depicted. It seems as if there is a southern extension against the south gable end of the building above the undercroft. There appears to be an alleyway running along the eastern side of the building above the undercroft, between it and the plot which is now no. 15. The southern extension of the building above the undercroft projects slightly into the alleyway.

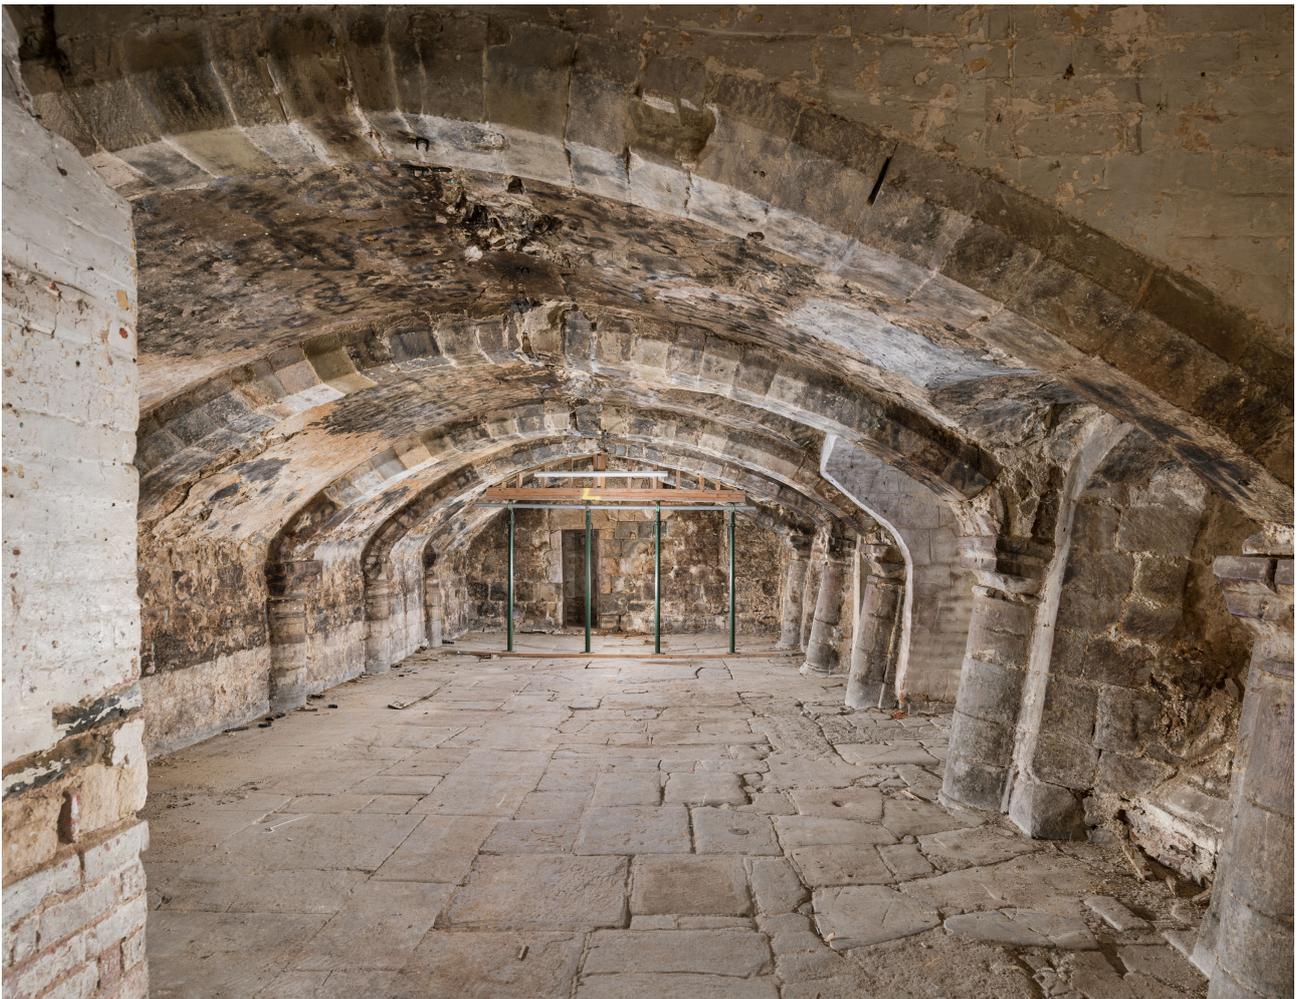
Figure 8: The undercroft at the Fleece Inn in 2023. [DP325617]

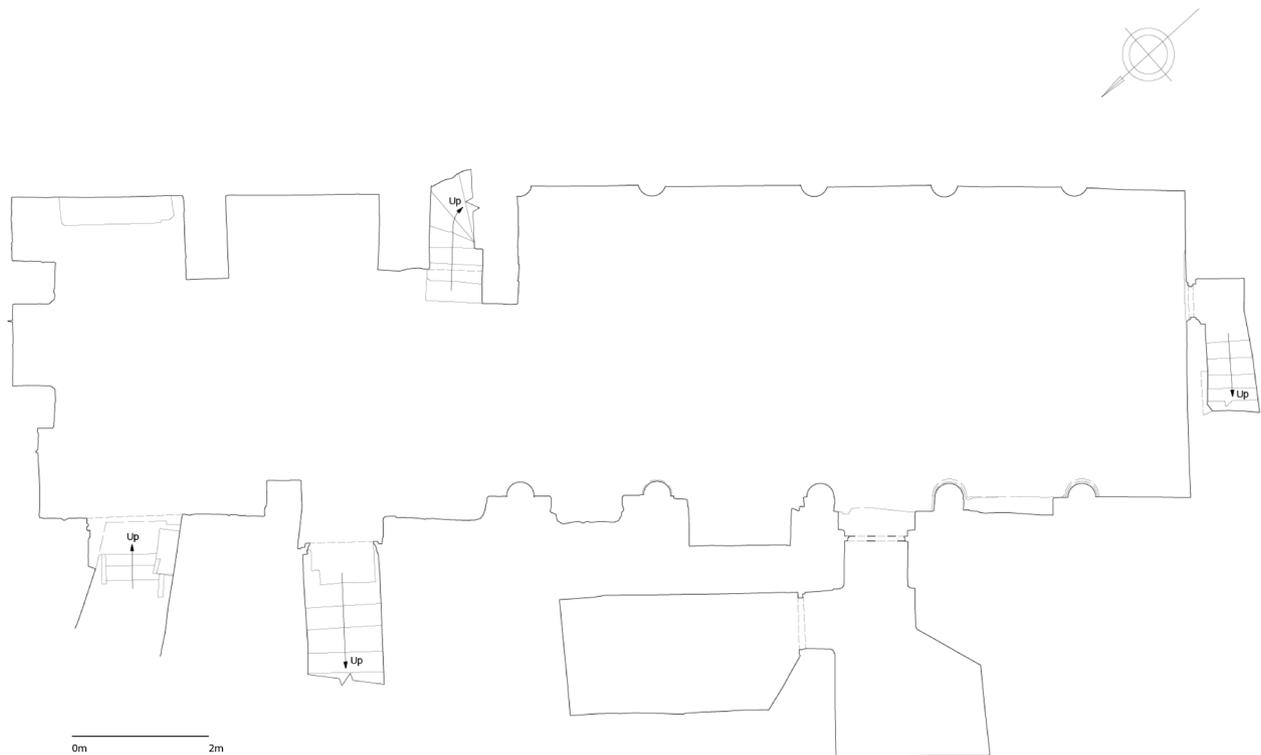
Figure 9: A measured survey plan of the undercroft at the Fleece Inn created in April and May 2022. [Historic England Geospatial Survey Team © Historic England]

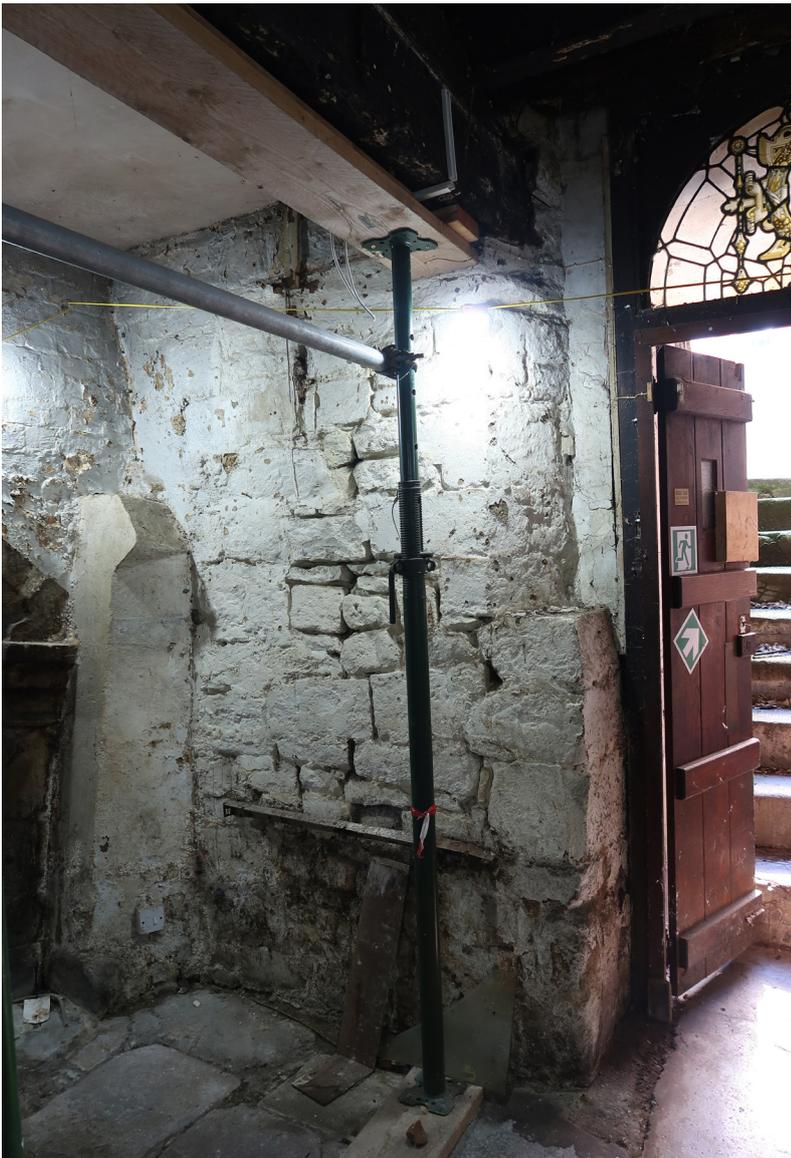
Figure 10: Bay 6 of the undercroft at the Fleece, numbering from the south, truncated with only the beginning of the splayed opening surviving. [Abigail Lloyd © Historic England]

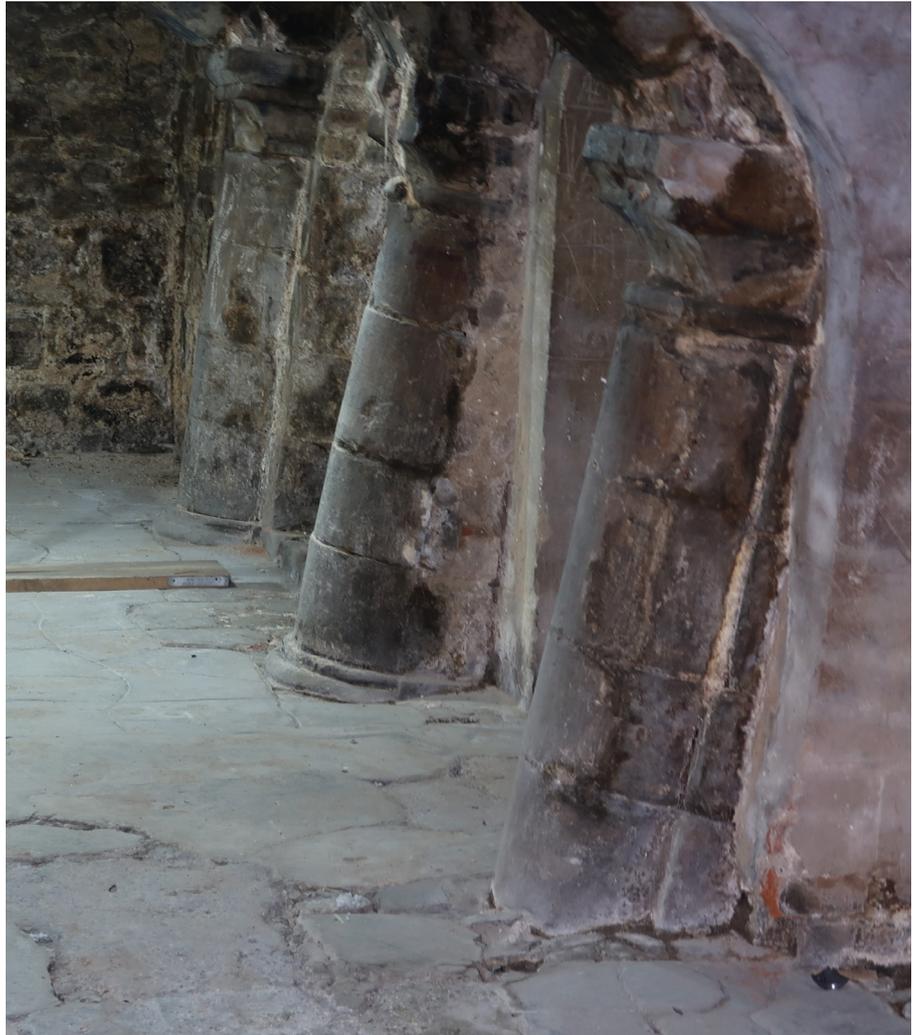
Internally, the bases of some of the columns along the north and south walls are missing or not visible. It seems that the floor of the undercroft has been replaced. However, some of the bases remain visible, so floor levels cannot have been altered greatly (Figure 11). The floor has been laid with flagstones, of very mixed sizes. It probably was laid with flagstones (predecessors to these) when constructed. The height of the space beneath the vaulting is roughly 2.25m from floor to apex of the vault.

Figure 11: A pillar base visible at the Fleece on the western side of the undercroft. [Abigail Lloyd © Historic England]

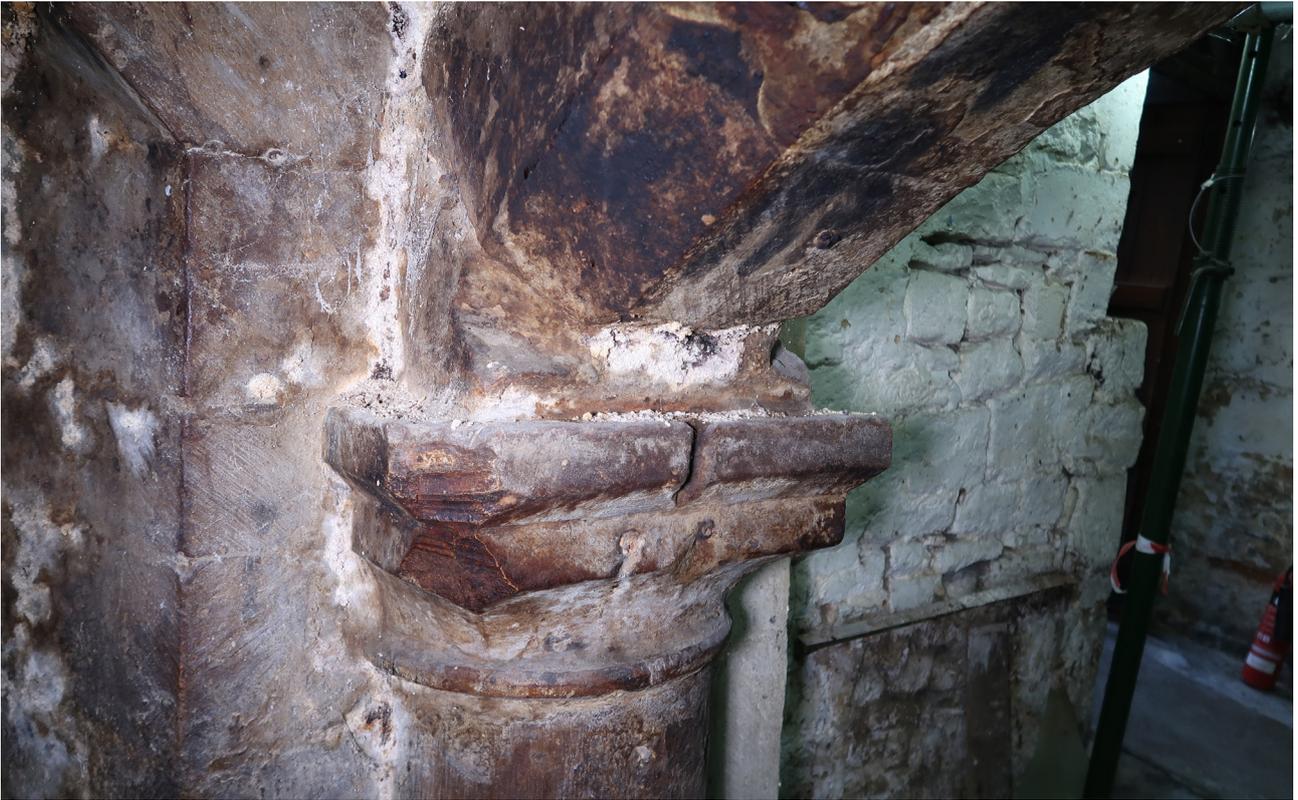
Figure 12: A close-up of the northernmost surviving capital, impost and springer, on the west side of the undercroft at the Fleece. [Abigail Lloyd © Historic England]

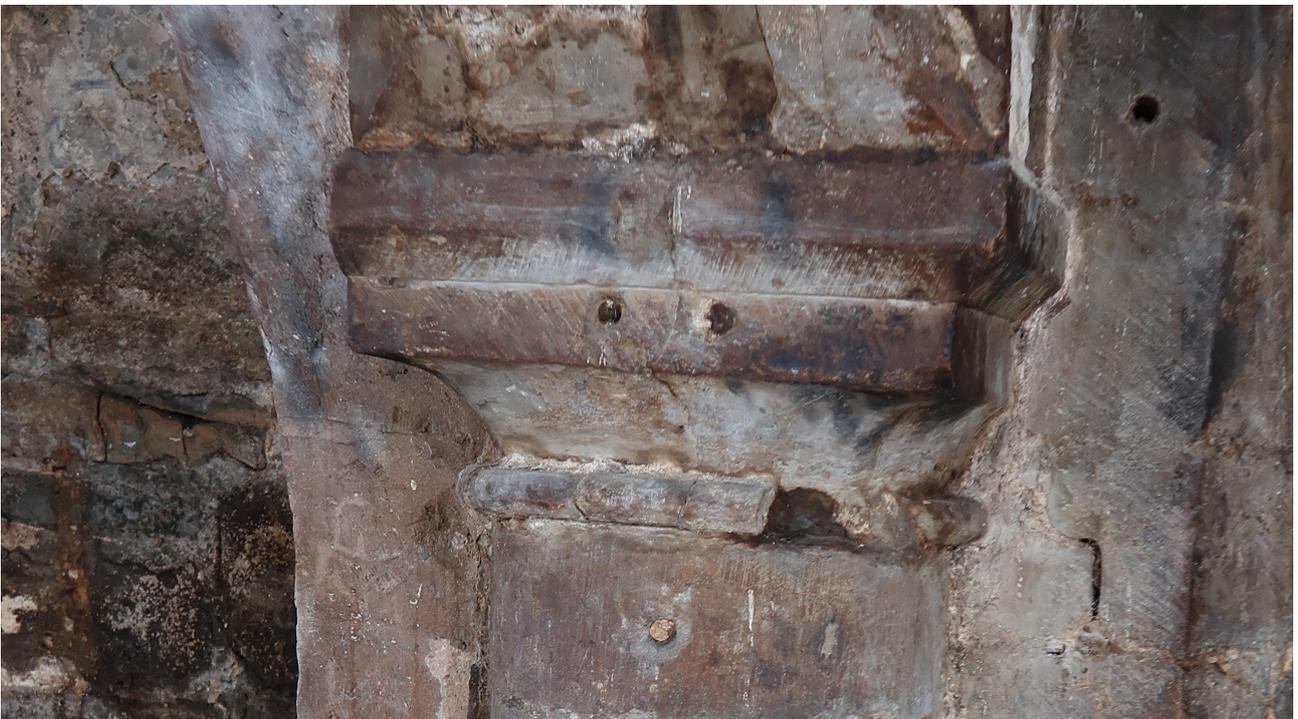
Figure 13: A close-up of the third capital from the south, impost and springer, on the west side of the undercroft at the Fleece. [Abigail Lloyd © Historic England]

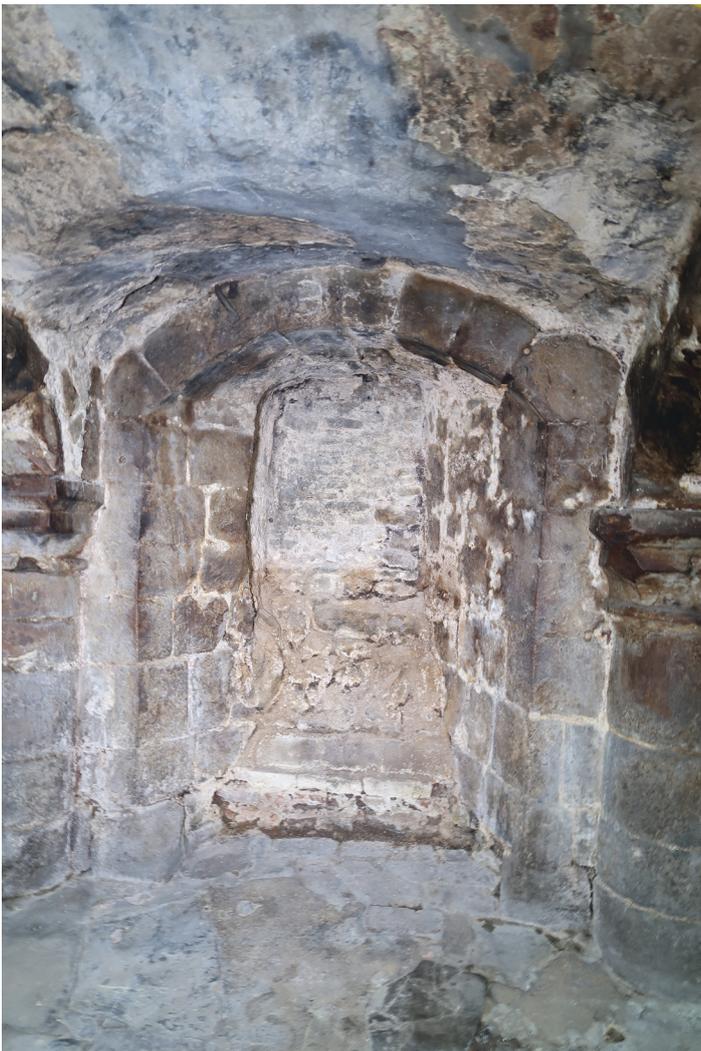
Figure 14: The blocked window opening in bay 5 of the undercroft at the Fleece, numbering from the south. [Abigail Lloyd © Historic England]

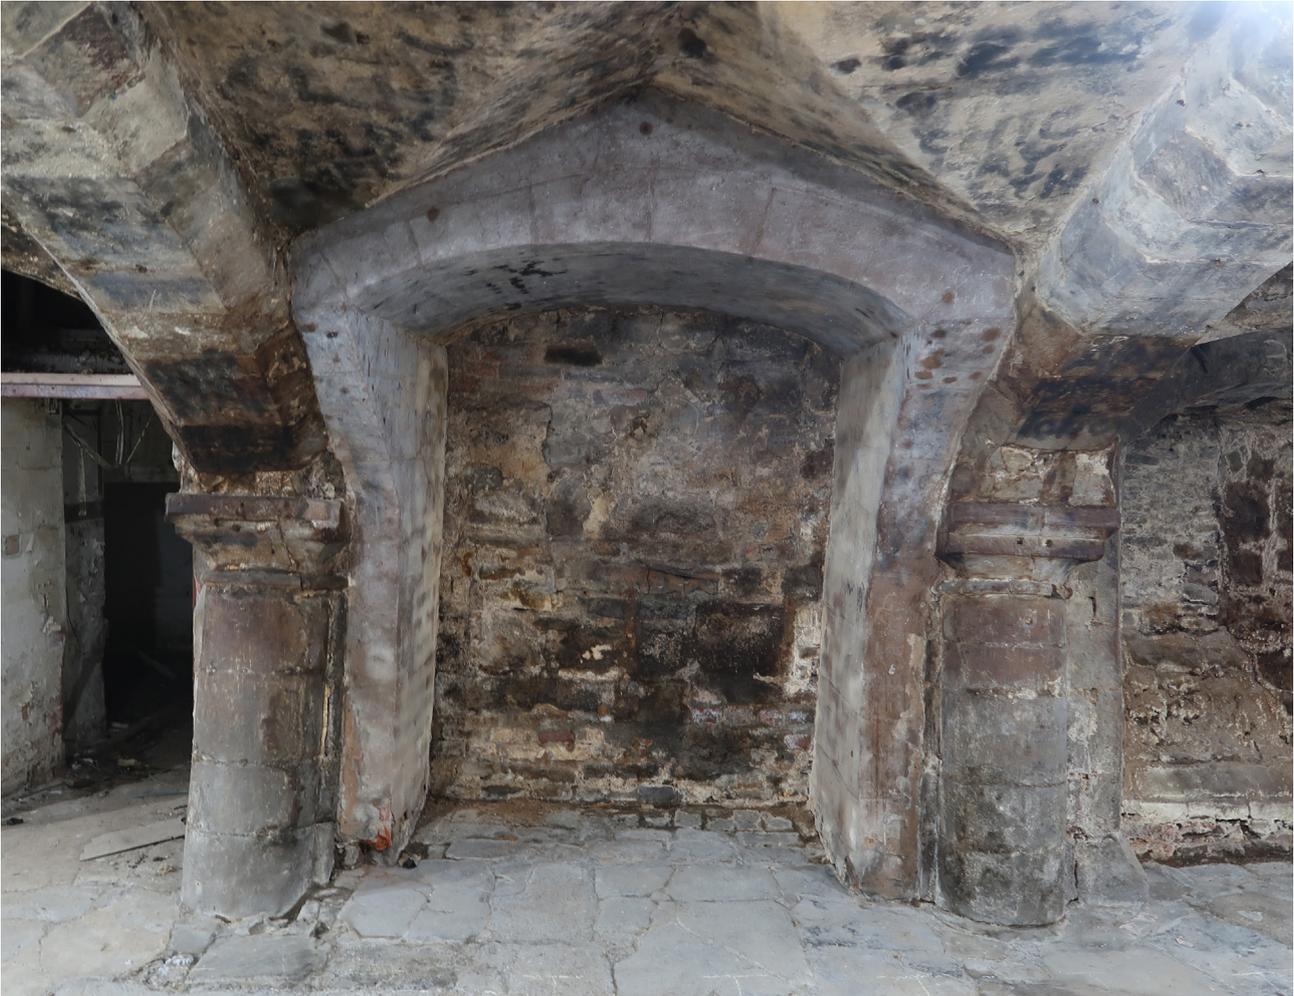
Figure 15: The wider bay 4 on the west side of the undercroft at the Fleece which was the primary entrance, now blocked and reinforced with later rendered brick framing. [Abigail Lloyd © Historic England]

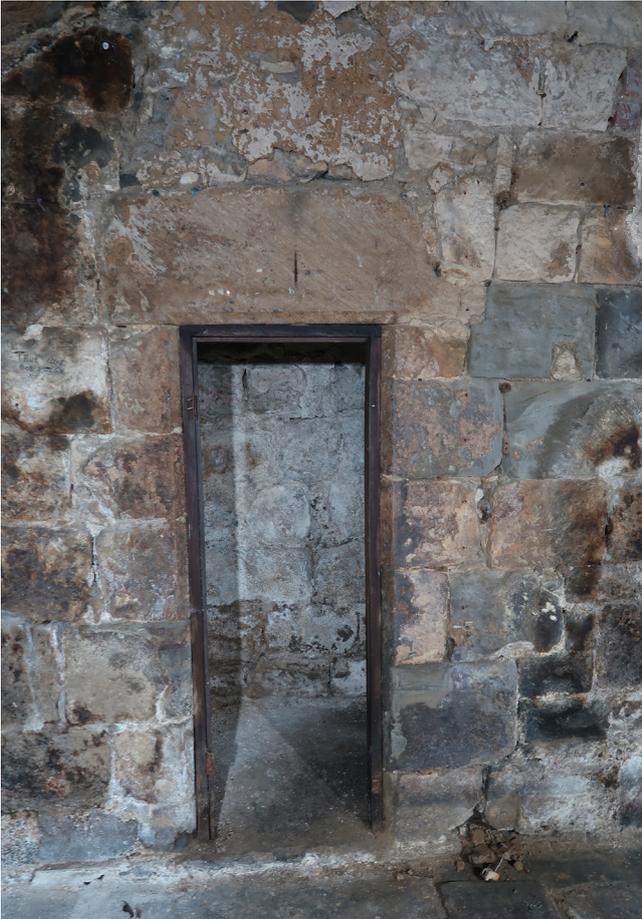
Figure 16: The southern door giving access to an intramural staircase in the undercroft at the Fleece. [Abigail Lloyd © Historic England]

The southern end wall is the original wall of the undercroft, also built of dressed stone laid in courses. Within the wall, just off-centre to the east, is a small doorway giving access to an intramural stair (Figure 16 and see Figure 8). The jambs of the doorway are constructed of coursed stone blocks with a finely cut chamfer on the northern undercroft side. On the soffit-face angle of its large stone lintel, the chamfer continues. The detailing demonstrates that the doorway was integrated into the primary construction of the southern wall and was not a later insertion. The stairs, of which four steps are visible, are at right-angles to the doorway within the wall itself and made of stone. They

ascend to the west along the wall line. The rear wall of the stairwell is also made of the same squared stone as the front wall. There is an arch comprised of stone voussoirs in the roof of the stairwell just east of the first step; the keystone of the arch has dropped. There is a rebate on the southern side of the doorway and space (although it is tight) for a door to have swung open, within the wall space, resting flat against the eastern wall of the stairwell when fully open.

There is also evidence of a hinge point at the top eastern corner of the doorway, within the wall space, but no surviving evidence of a pintle. Given the small dimensions of this doorway and stairwell – the intramural space is only about 0.6m wide – in addition to the very sharp right angle that has to be made on entering or exiting the stairwell, it would have been impossible to bring bulky goods into the undercroft using this means. Hence, it is highly unlikely to have been the principal entrance into the undercroft. Instead, it gave access into the undercroft from the structure above the undercroft, leaving the western entrance in the fourth bay as access for larger items externally from the courtyard. The top of the intramural stairs was later blocked and the place at which they

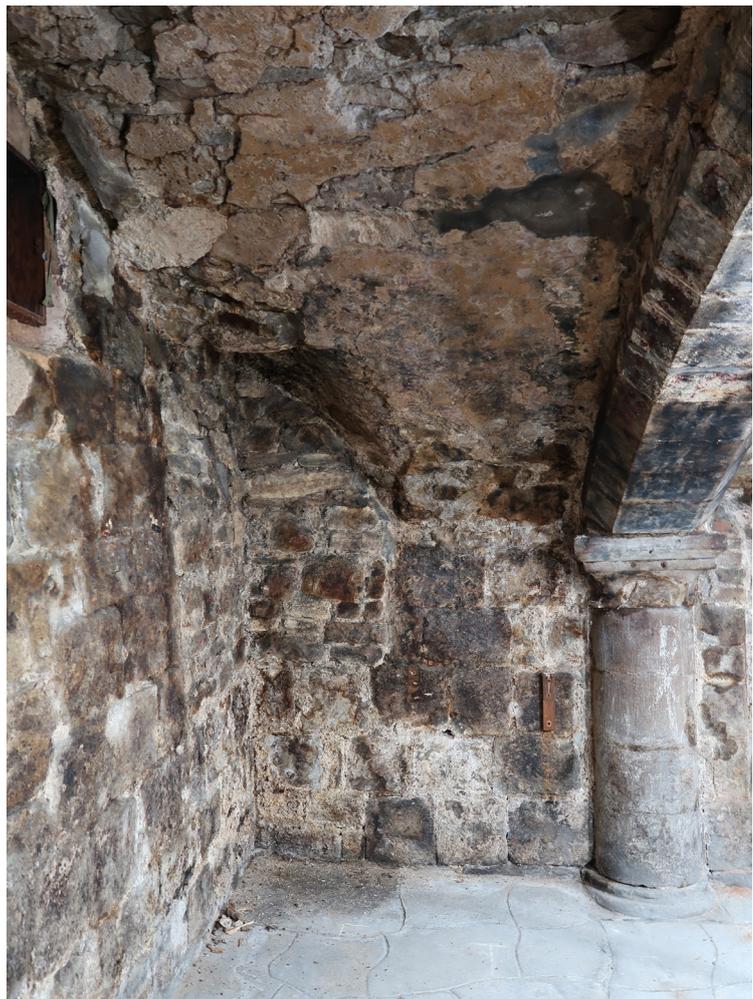
Figure 17: In the south-western corner of the undercroft, a recessed part of the stone vault together with disturbance in the stonework of the south and west walls. [Abigail Lloyd © Historic England]

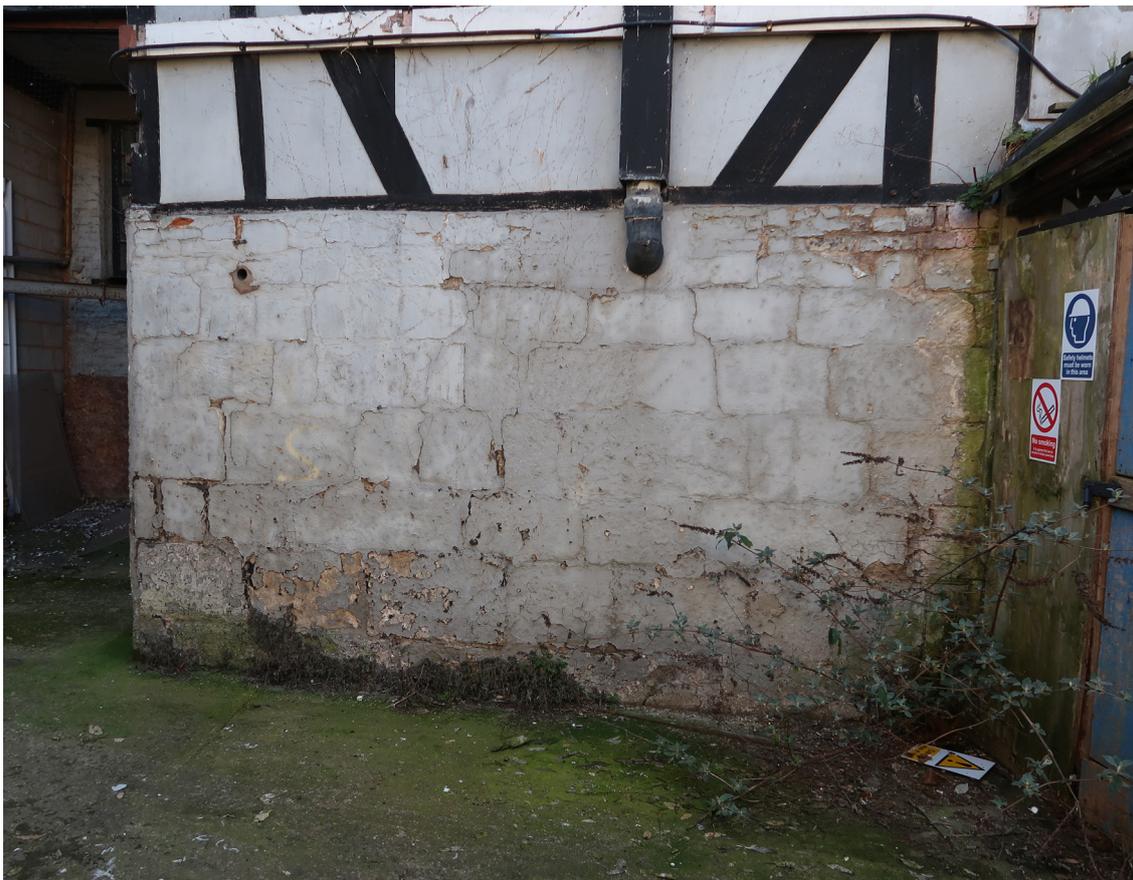
Figure 18: The stone plinth beneath the western elevation of the structure to the south-west of the undercroft at the Fleece. [Abigail Lloyd © Historic England]

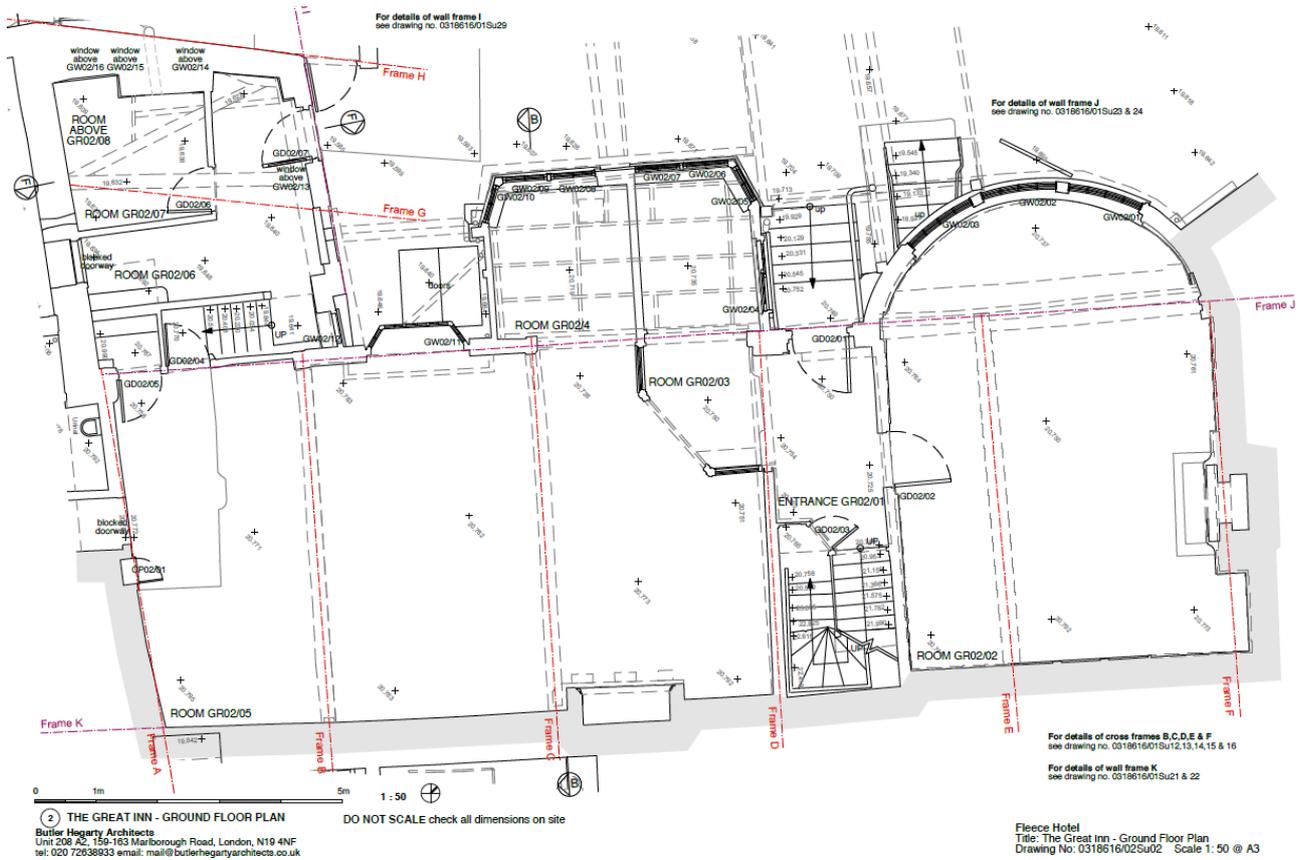
Figure 19: A survey of the ground floor of the Fleece, great inn range, showing the irregular alignment of the southern wall, on the far left-hand side (north is to the right). [© Butler Hegarty Architects, reproduced with permission.]

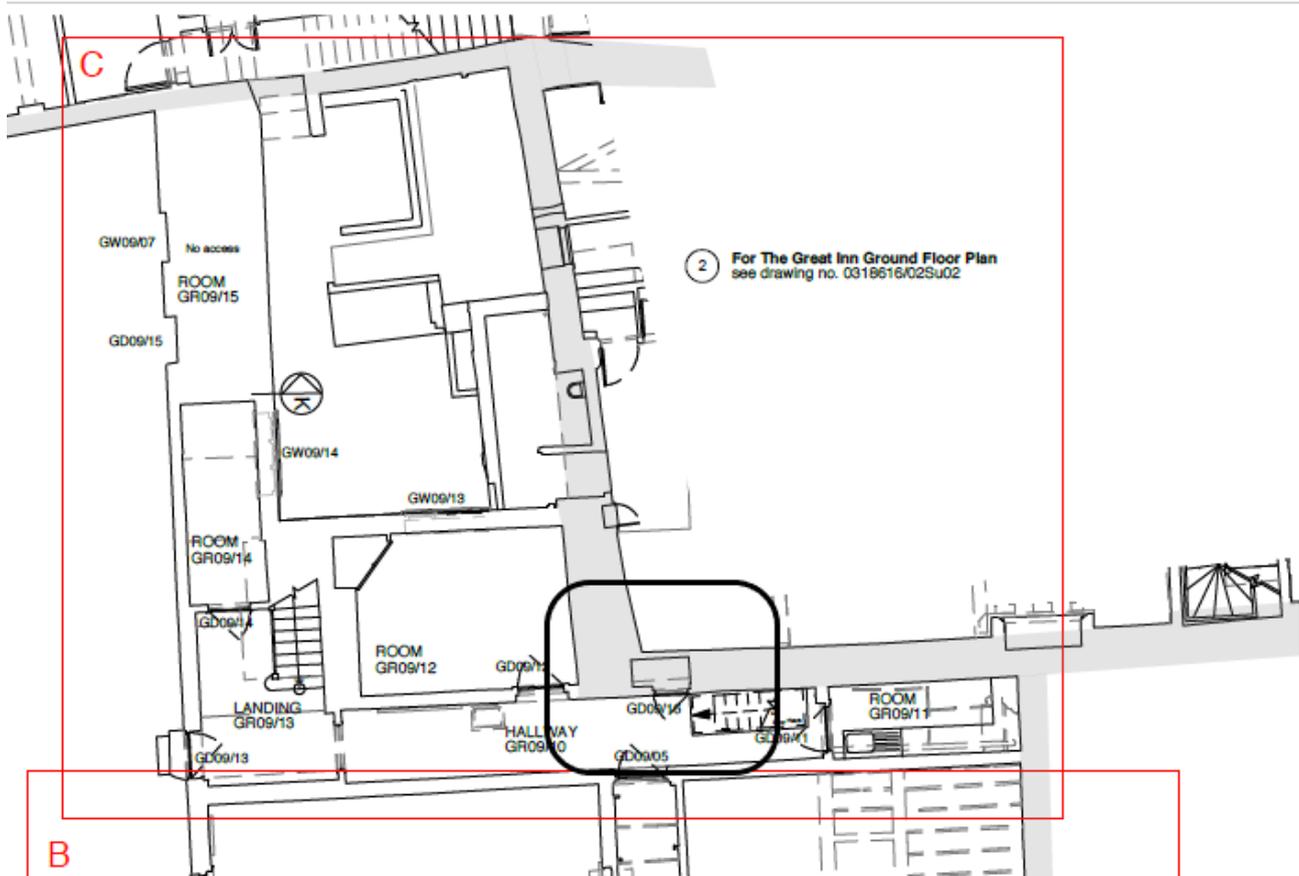
Figure 20: A survey of the buildings at the south-west corner of the great inn range, showing the position of the opening in the wall of the Fleece, now a cupboard, and the thickening of the wall at the south-west corner (bounded within the black box). [© Butler Hegarty Architects, reproduced with permission.]

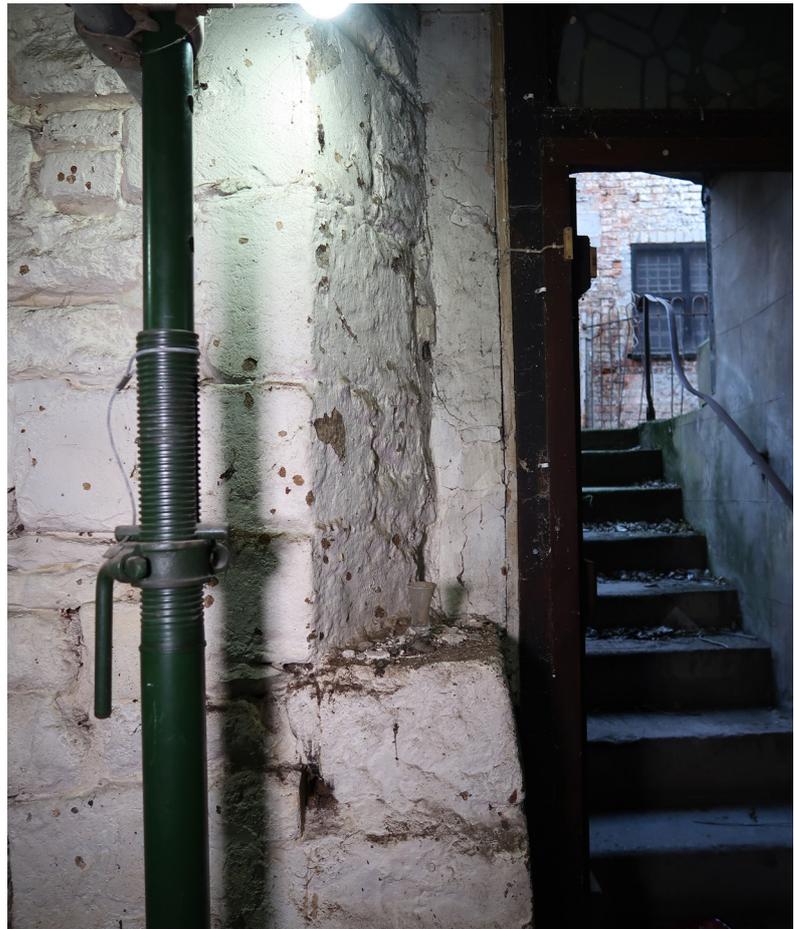
Figure 21: A close-up of the southern splayed jamb of the later window inserted into the north part of the undercroft at the Fleece in the western wall. [Abigail Lloyd © Historic England]

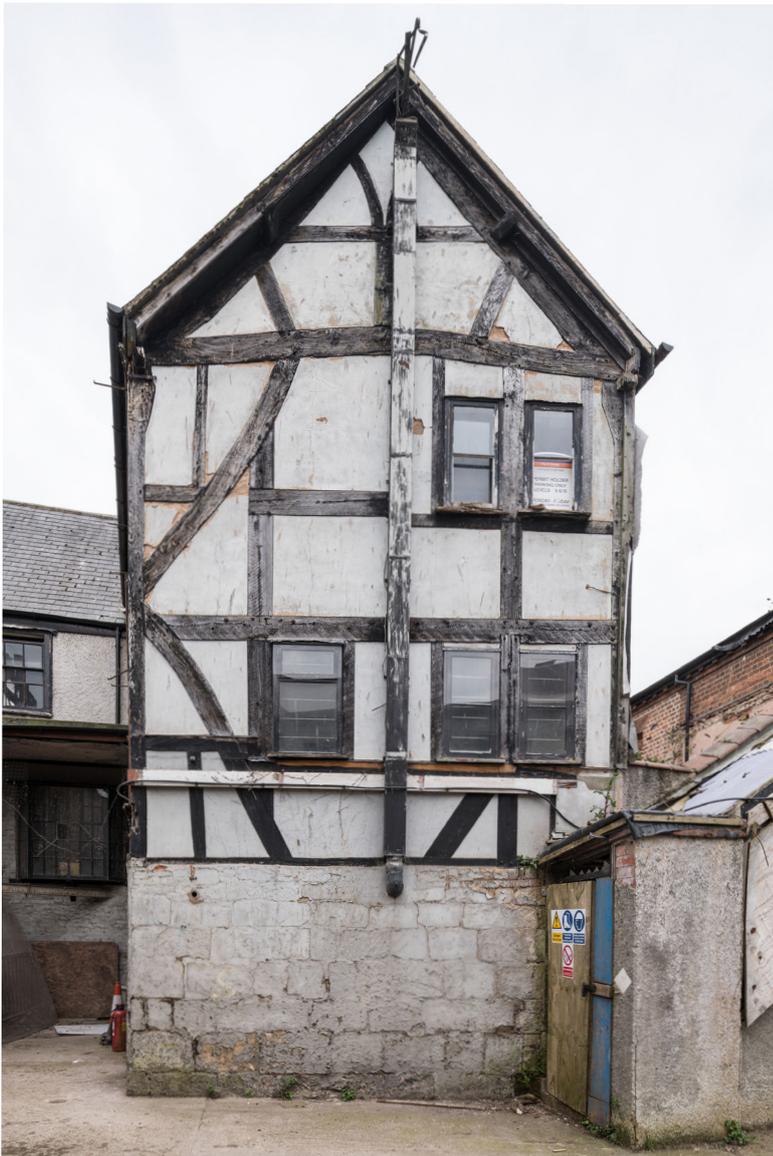
Figure 22: The western elevation of the south-western wing of the great inn range at the Fleece. [DP325653]

At the south-west corner of the great inn range there is an extant three-storey timber-framed extension which sits on the stone plinth described above (Figure 22). The timber-framed element of the structure has been dated on stylistic grounds to the 17th century.¹⁵⁶ The floor levels of the wing do not correspond to those of the great inn range, nor of the undercroft. The height of the ground level of the south-west wing is between that of the floor level in the undercroft and ground-floor level of the great inn range, and the floors above are similarly staggered. Small flights of steps enable access between the great inn range and the south-west wing. This building is very irregular in form and poses many questions about the extent to which its form was dictated by earlier structures on the site. The fabric in this location appears to suggest that there has been

some form of structure sitting alongside the undercroft since before the great inn range was erected, which has been modified and incorporated into the later buildings standing at this south-west corner. There is insufficient evidence to answer whether it was in origin contemporary with the undercroft or subsequent to it. Nor is it possible to clarify exactly what the structure was and what function it performed.

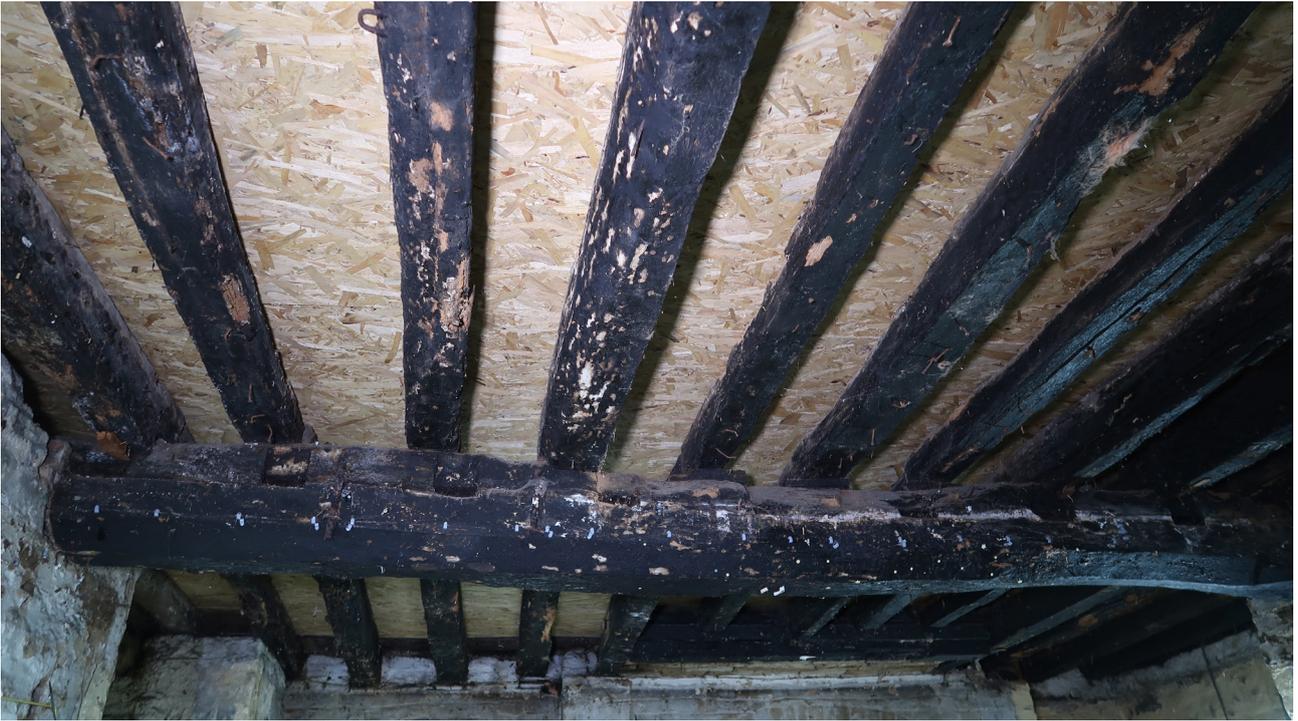
At some point, the 17th-century joists between the transverse beams at the northern end of the undercroft were replaced with joists which were not tenoned-in but laid over the beams (Figure 23). A chimney stack was inserted at the far northern end, north of frame II, and a brick wall was inserted into the undercroft to support the stack. This wall now forms the northern limit of the undercroft and is utilitarian with no effort at decoration that would have been in keeping with the rest of the undercroft. There is a blocked doorway in the north-west corner of the wall beneath the stack, the wooden lintel of which is still visible (Figure 24). Originally, this must have ensured continued access between the undercroft and a more northern cellar space under the northernmost bay (now lost) of the great inn range. A passageway was also constructed between the northern end of the undercroft and the cellar underneath no. 19A, which presumably allowed this cellar to be used for further storage in relation to the inn.

Figure 23: The transverse beam in the northern part of the undercroft at the Fleece, showing later joists laid on top of the beam and the mortices for earlier joists. [Abigail Lloyd © Historic England]

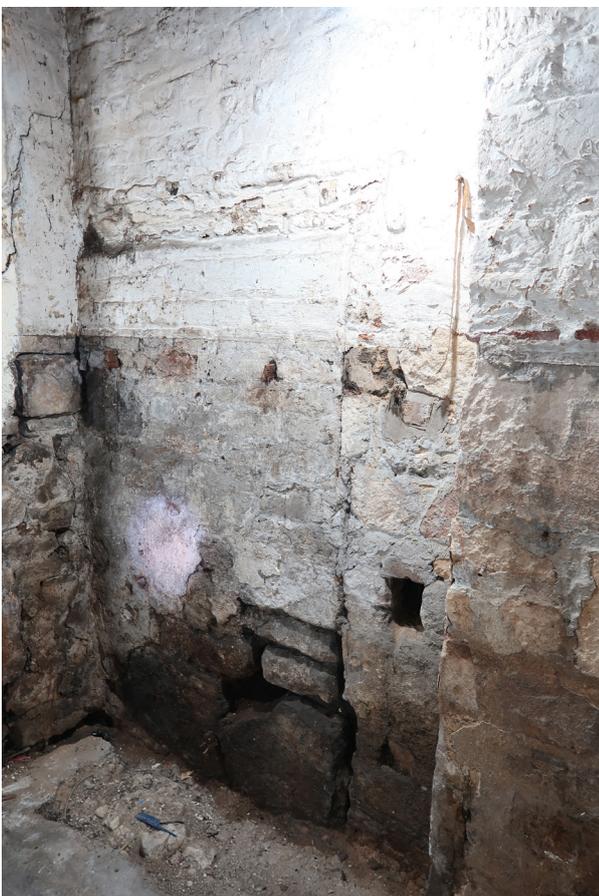
Figure 24: Blocked doorway with wooden lintel in the north-western corner of the undercroft at the Fleece. [Abigail Lloyd © Historic England]

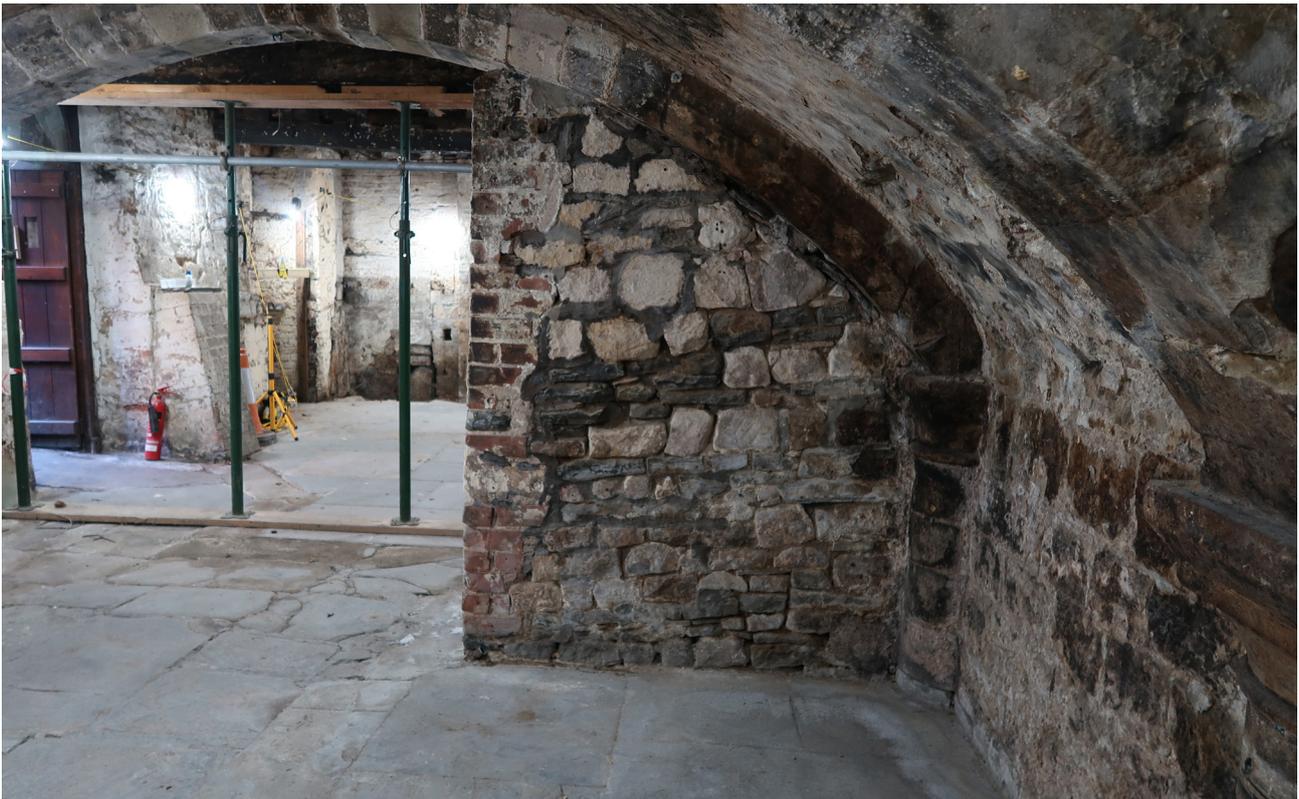
Figure 25: The block of stairs inserted on the north-east side of the undercroft at the Fleece, beside the fifth vaulting rib from the south. [Abigail Lloyd © Historic England]

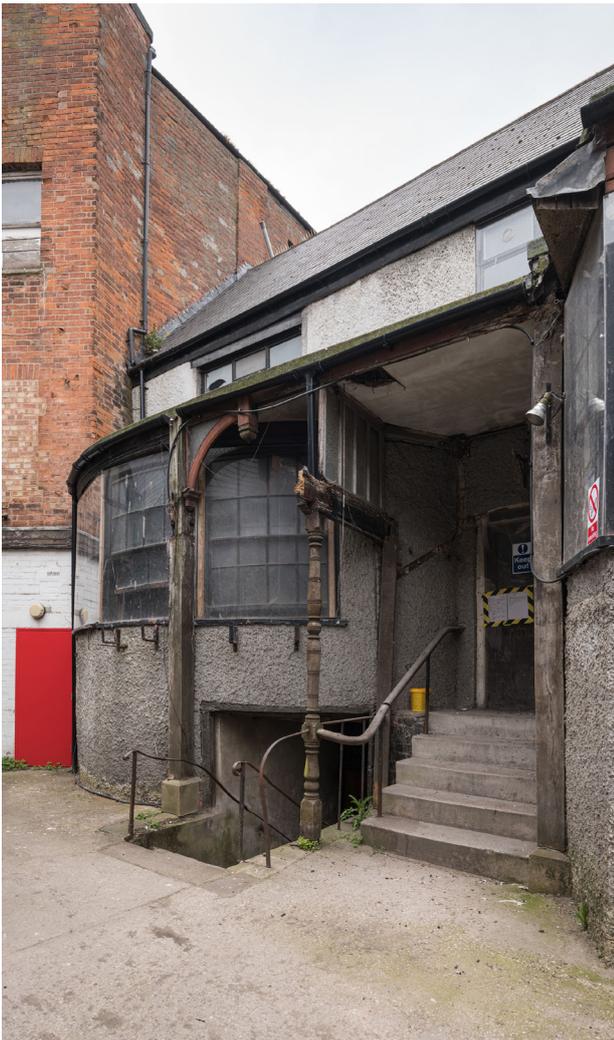
Figure 26: Bay window added to the west side of the great inn range with entrances to the undercroft and the great inn above at the Fleece. [DP325655]

Above ground, the bay window on the western side of the great inn range at its north end probably was inserted at the same time as the renewed floor joists and chimney stack (Figure 26).¹⁵⁷ Also, above ground, a partition was inserted into the fourth bay from the south of the great inn range, to create a cross passage and entry way, in which at the eastern end there is a staircase rising to the first floor. A brick and stone dog-leg staircase was inserted underneath this, descending to the undercroft. In terms of its position within the undercroft, it does not respect the bay divisions of the undercroft but sits on the line of the northern-most vaulting rib, extending into the truncated sixth bay, abutting the eastern wall (Figure 25 and see Figure 9). It provided access from the undercroft to the great inn range above. It is considerably wider than the earlier intramural stairs. Perhaps, once this staircase had been created, the intramural stairs were blocked up.

absence on this mapping is not conclusive. Historic maps might have omitted features, and an earlier date for the creation of this entrance cannot be ruled out. The current external undercroft stairs are shown on plans for a building control application in 1919.¹⁵⁹ Although the 20th century gallery has gone, part of the remaining wooden archway over the cellar stairs externally appears as if it might belong to this phase (see Figures 26 and 27).

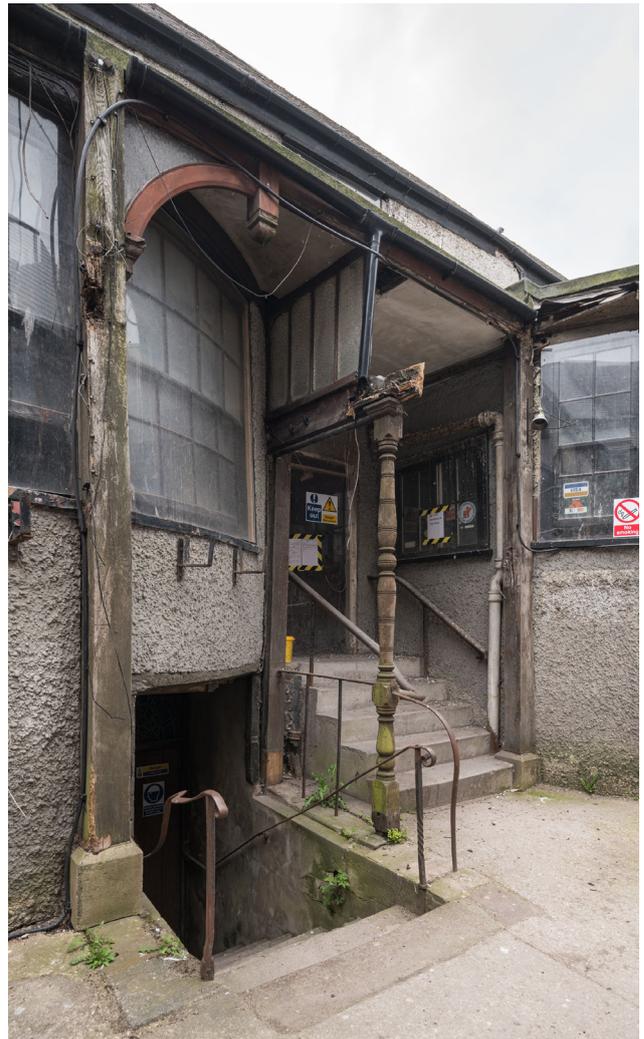
Figure 27: Close-up of the later inserted stairs into the undercroft beside stairs up into the great inn range at the Fleece. [DP325656]
