The Undercrofts of Westgate Street, Gloucester

Historic Buildings Assessment

This report examines the evidence for medieval undercrofts surviving on Westgate Street, Gloucester. For the purposes of this study undercrofts are defined as the stone-vaulted spaces beneath a building or principal room.

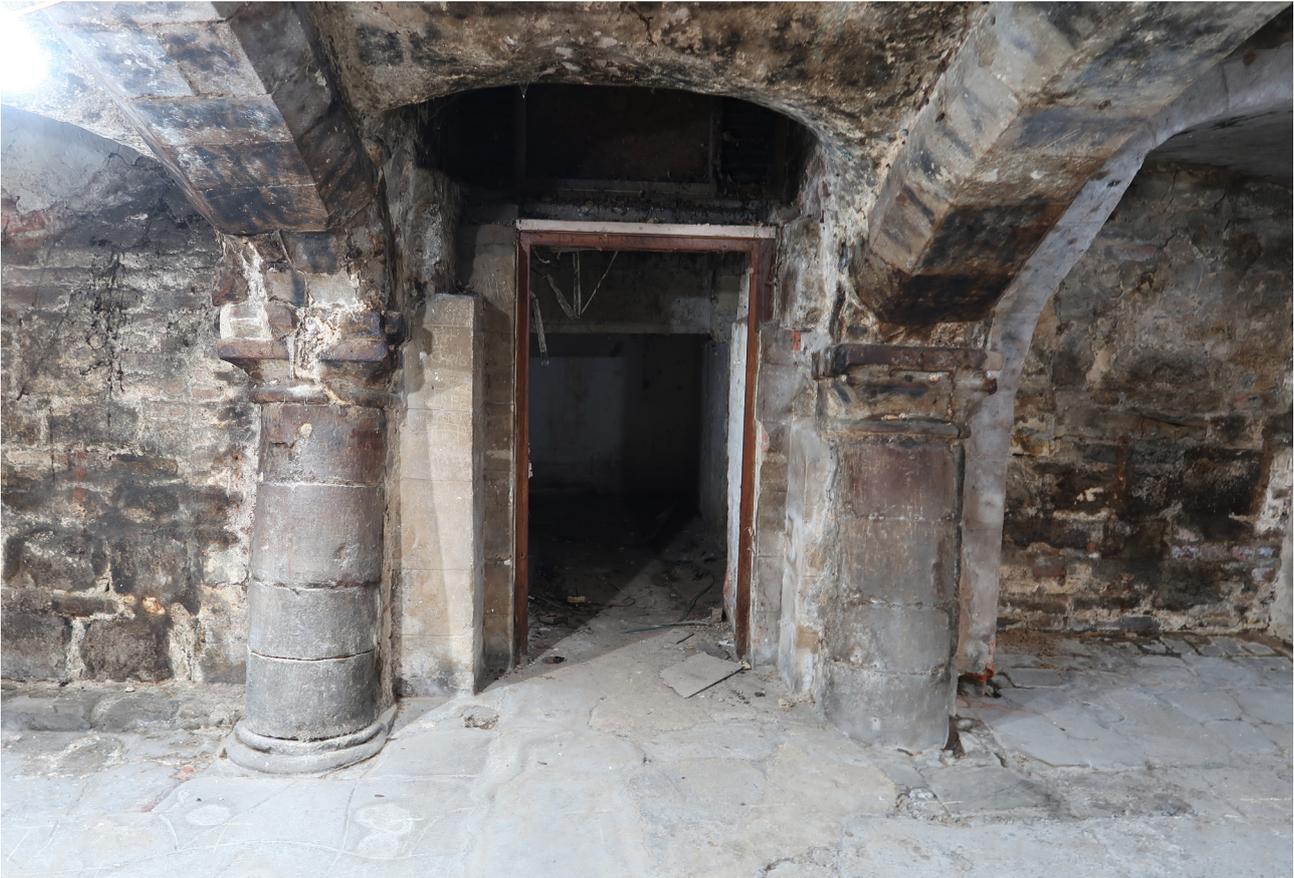
Figure 28: A doorway inserted into an earlier opening in the third bay from the south of the undercroft at the Fleece, leading to an ancillary semi-subterranean room. [Abigail Lloyd © Historic England]

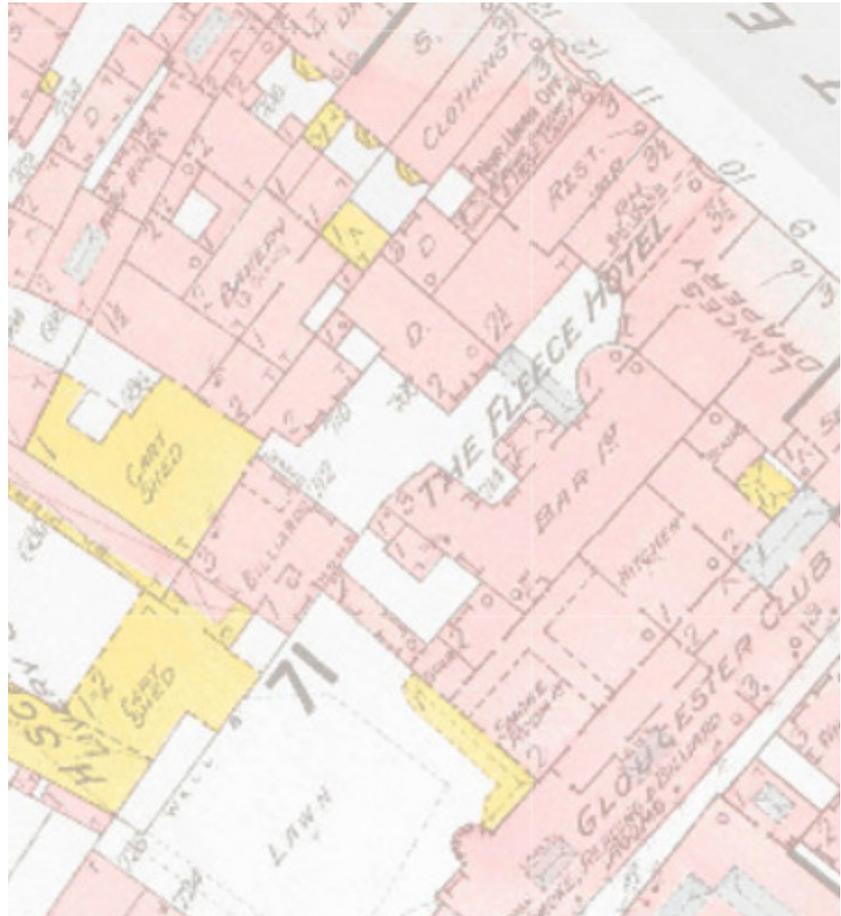
Figure 29: The Goad Fire Insurance map of 1891 showing the stairs entering the great inn range at the Fleece beneath what appears to be a canopy structure spanning the courtyard. [© Landmark Information Group Ltd. Licence No. GD0003]

It seems that money was spent in the 20th century on aesthetic changes which historicised the Fleece in appearance.¹⁵⁸ Around 1914 to 1919, an open gallery was erected against the west wall of the great inn range to emulate medieval galleried inns. Potentially this could have been the time in which the undercroft was brought back into service as a public area, trading on its historic appearance. The creation of the ‘Monks’ Retreat’ bar in the undercroft deliberately emphasised the age and character of the surviving 12th-century fabric. A new external entrance was created in the sixth bay from the south of the undercroft. It cut through the high-level window that had been there, leaving only the southern splayed jamb remaining (see Figures 21 and 27). The new entrance accessed the undercroft from the courtyard to the west via several steps down, much as the original courtyard entrance must have done. In effect, a similar means of entering from the courtyard was moved further north from its original position. It is worth noting that, although stairs up into the great inn range are visible on the Board of Health map of 1852, no steps are visible descending into the undercroft, either in their probable original position further south, or in their current position further north (see Figure 7). The same is true on the Goad mapping of the early 20th century (Figure 29). However, their

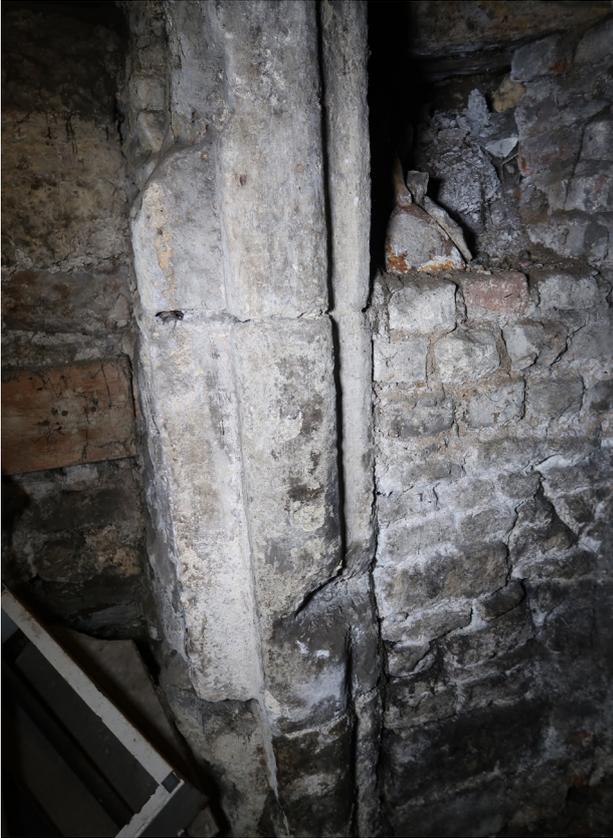
In the northern wall of the undercroft, there are the remains of an in-situ, dressed-stone, moulded, western jamb for a doorway (Figure 31). There is a rebate on the internal southern face and hollow moulding on the external northern face. The stones comprising the remains of the equivalent eastern jamb are preserved ex-situ loose in the undercroft (Figure 32). (They were apparently removed from their original location during works in the 20th century.)¹⁶⁹ Unfortunately, nothing of the door head is extant; it might have been stylistically helpful for dating, had it survived. It is difficult to gauge the width of this primary entrance, given the removal of the eastern jamb. However, it seems likely to have been more suited to pedestrian entry and not bulky goods. North of the doorway, on the western side, coursed rubble stone continues northwards from the moulded jamb as if forming an entrance, flanking the steps that would be needed in this position to descend from street level (Figure 33). Similar spur walls are visible at nos 47–49 Westgate Street, discussed below. It is these kinds of structures which are often deemed to have been encroachments in documentary records.

Figure 31: The western jamb of the doorway from the undercroft of no. 33 Westgate Street on to the street itself. [Abigail Lloyd © Historic England]

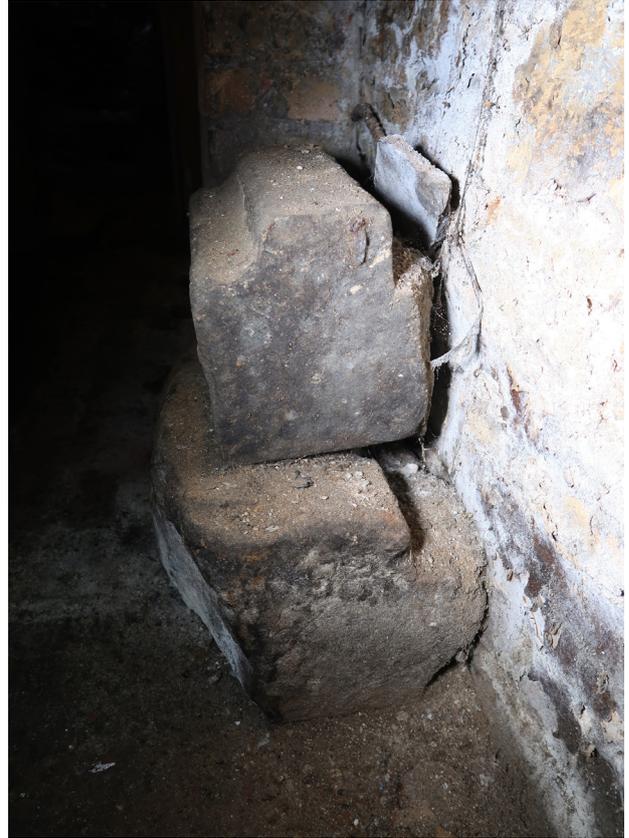
Figure 32: Two stones from the eastern jamb of the doorway from the undercroft of no. 33 Westgate Street, now lying on the floor out of their original position. [Abigail Lloyd © Historic England]

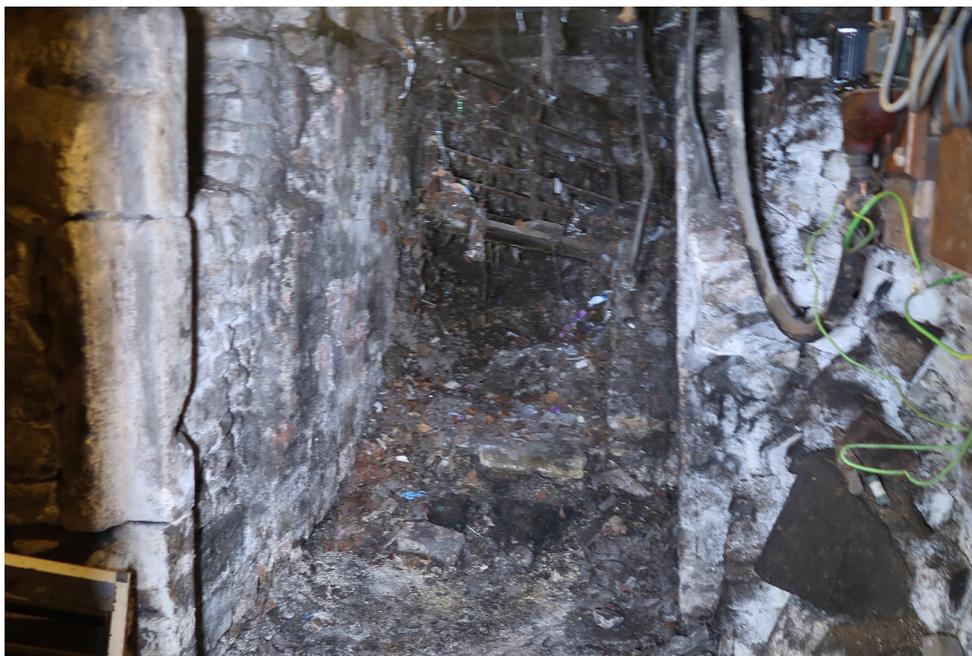
Figure 33: The western spur wall (on the left) flanking the original entrance into the undercroft at no. 33 Westgate Street (later brickwork on the right). [Abigail Lloyd © Historic England]

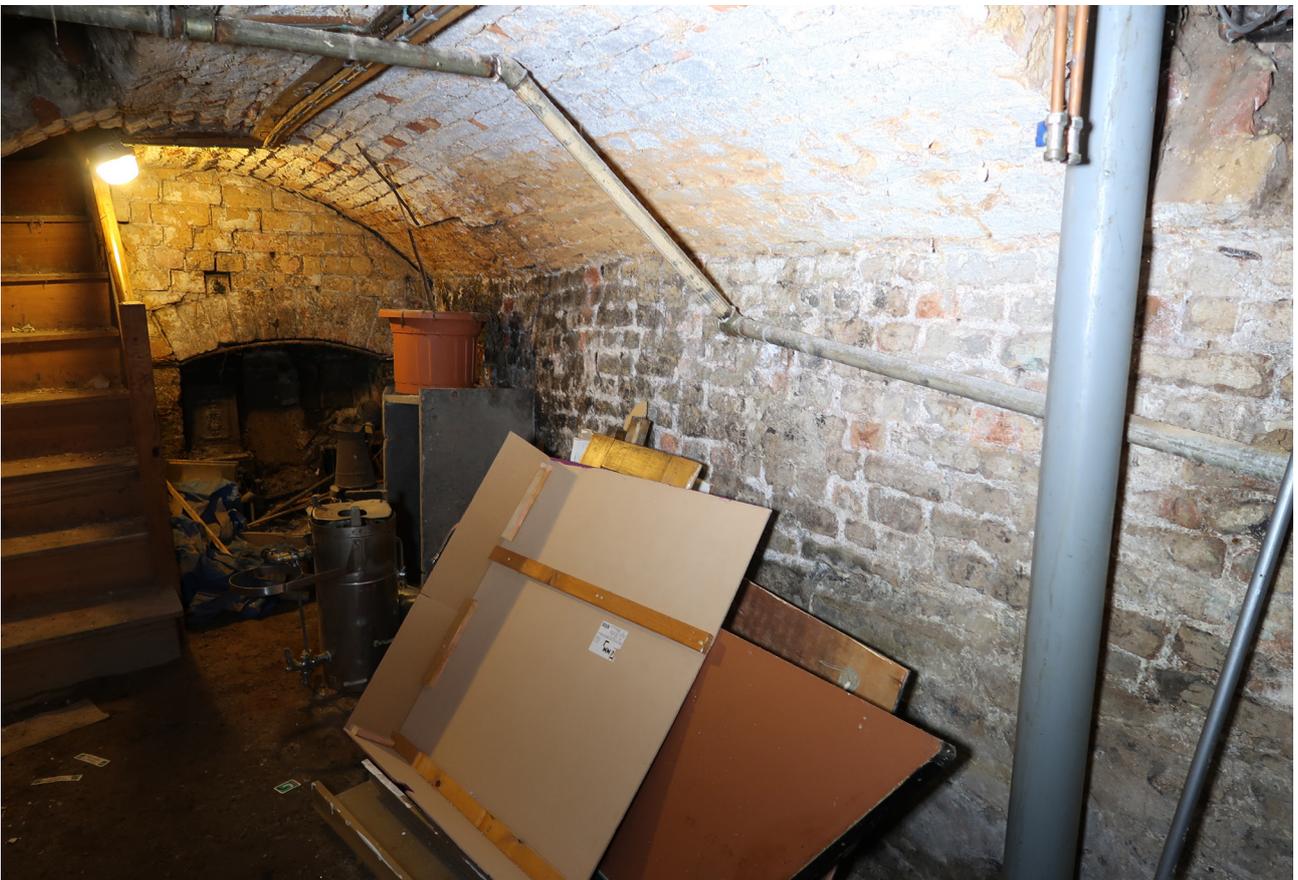
Figure 34: Looking south in no. 33 Westgate Street at the inserted staircase, brick vault and fireplace. [Abigail Lloyd © Historic England]

At the southern end of the undercroft, a brick barrel vault was created which replaced any stone vault that existed (see Figure 34). The line of the brick arch seems to be angled more acutely than what would have been the line of any stone segmental arch springing from the same level. Above the brick vault, the level of the ground floor in the building remains above street level. Hence it requires a step up from street level to accommodate it. However, the brick vault was not continued throughout the undercroft into its northern end. As a result, a split-level configuration was created in the ground floor of no. 33, whereby the front northern part is at street level and the rear southern part (within the shop) is a step up. The step now cuts across the shop internally.

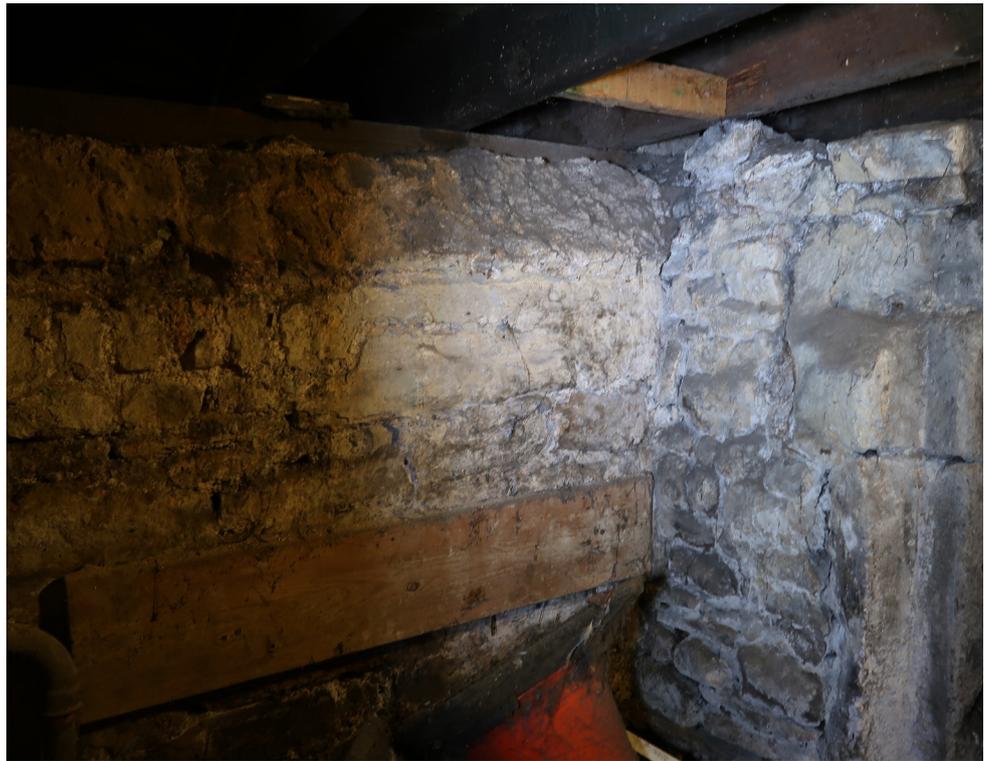
Figure 35: The top of the western wall in the undercroft at no. 33 Westgate Street, showing angled stones. [Abigail Lloyd © Historic England]

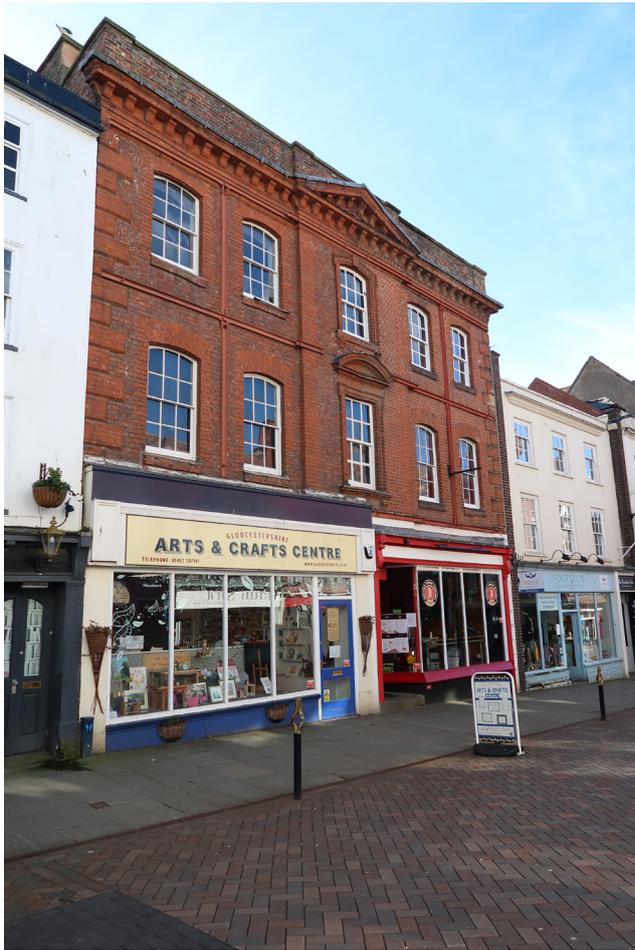
Figure 36: The Westgate Street frontage of nos 47–49 showing how they are united architecturally in this elevation in March 2023. [Abigail Lloyd © Historic England]

Nos 47–49 Westgate Street present a unified front architecturally to the street, as will be discussed further below (Figure 36). However, this is a later unification of what were historically separate plots. The undercroft at nos 47–49 lies largely under no. 47 Westgate Street, but does not follow the later plot boundaries. The undercroft space is currently accessed via no. 49. As with the other plots on Westgate Street, the plots which became nos 47 and 49 Westgate Street have been the subject of much change and alteration, amalgamation and subdivision at various points, and it should not be assumed that the modern boundaries and access points are the same as those for the medieval plots.

In the early 18th century, a symmetrical brick building of three storeys and five bays was built on top of the undercroft, spanning the two plots which form nos 47 and 49 (see Figure 36). The central bay is pedimented. This building has not been investigated so it is not possible to say the extent to which it entirely replaced its predecessors on the site, or was a refacing exercise, leaving a historic core intact. The southern rear wall of the building is further north than the southern wall of the rear undercroft. The southernmost two and half bays of the rear undercroft, including the diagonal line on the south-western corner, are outside the line of the building above. This corresponds with the map evidence discussed above.

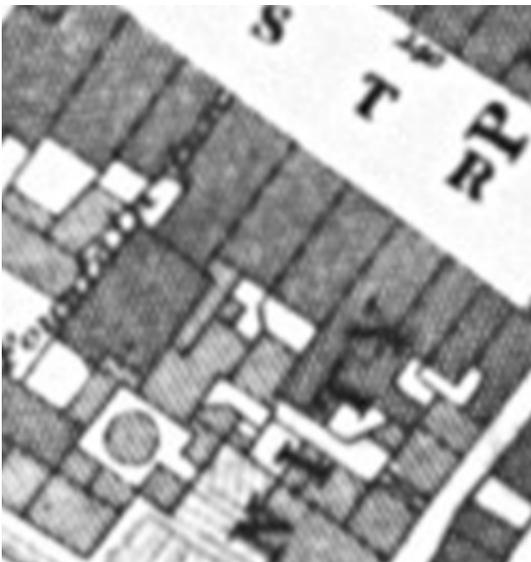
Figure 39: The angled boundary line at the rear of nos 47 and 49 in open ground as shown on the 1843 Causton Map of Gloucester. [Image reproduced with the permission of Gloucestershire Archaeology, Gloucester Civic Trust and Gloucestershire Archives]

On the 1843 Causton map, an angled boundary line between nos 47 and 49, at the rear, is clearly present but it appears to exist in open ground between two rear yards (Figure 39). The common boundary runs back south perpendicular to Westgate Street for about 13m and then it deviates to the east on a diagonal line for several metres, before running perpendicular to Westgate Street again, on a line slightly further east. In the 1852 Board of Health map, it appears as if a small structure (shaded grey) is built against this diagonal boundary on the side of no. 47 (Figure 40). By 1900, the maps appear as if the buildings have been extended at the rear for both nos 47 and 49. Nevertheless, the angled boundary line is preserved within the buildings and is visible in the undercroft in no. 47 Westgate Street, as well as on aerial imagery looking at the plots from above.

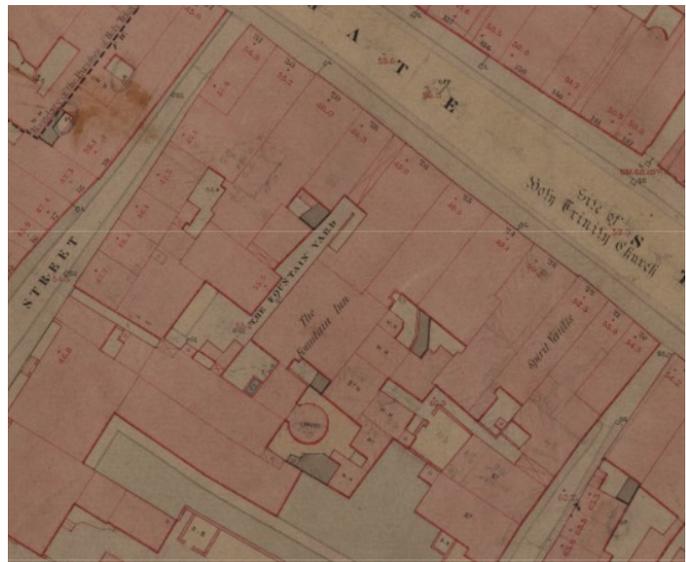
Figure 40: The angled boundary line at the rear of nos 47 and 49 with a structure against it on the side of no. 47, as shown on the 1852 Board of Health Map of Gloucester. [Image reproduced from Know Your Place. Reproduced with the permission of Gloucestershire Archives: GBR/L10/1/2]

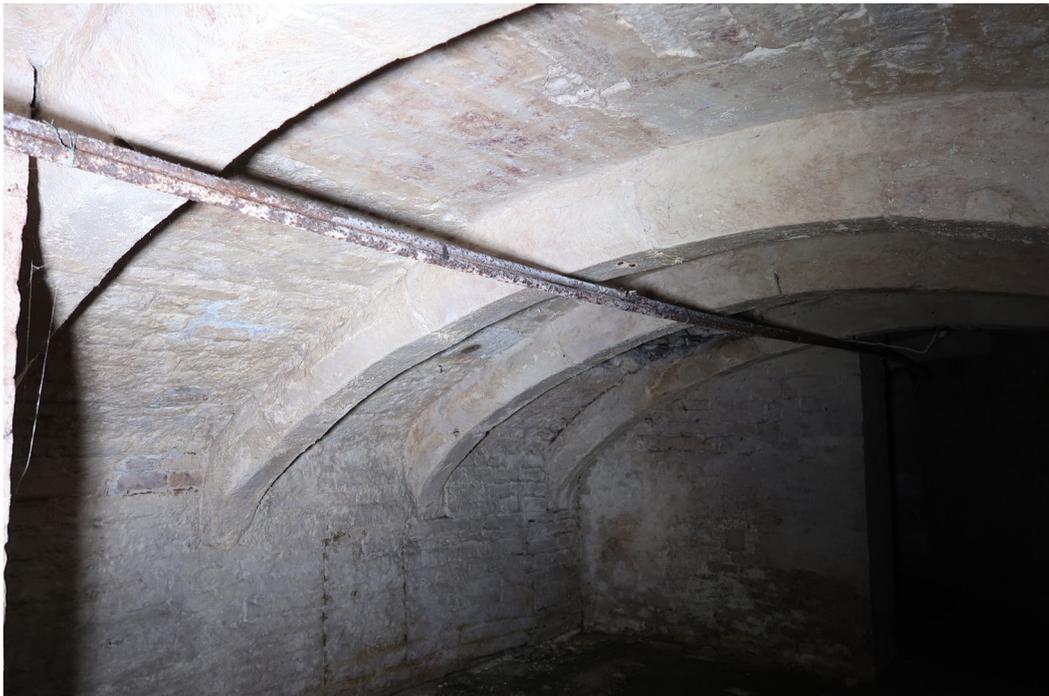
Figure 41: The eastern wall of the undercroft at no. 47 Westgate Street showing finely dressed and chamfered ribs dying away into the stone wall. [Abigail Lloyd © Historic England]

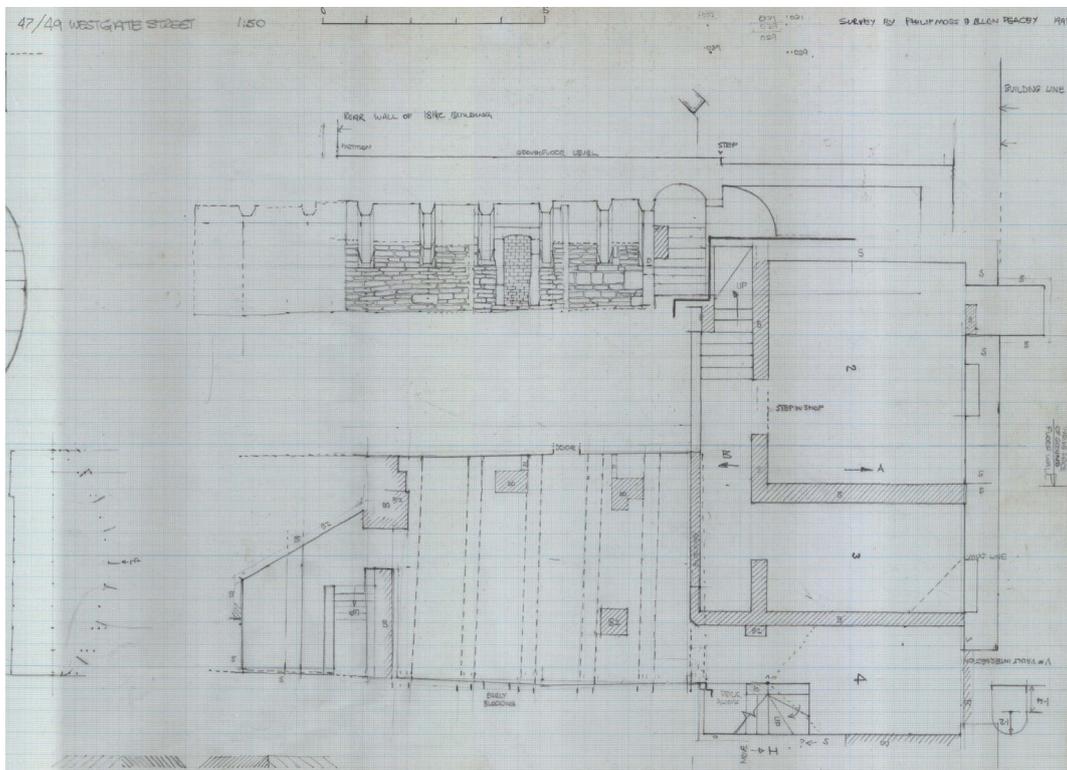
Figure 42: A scale drawing from a survey at nos 47 and 49 by Philip Moss and Allan Peacey in 1991. Includes an elevation drawing of the west wall of the rear undercroft. [Reproduced with permission.]

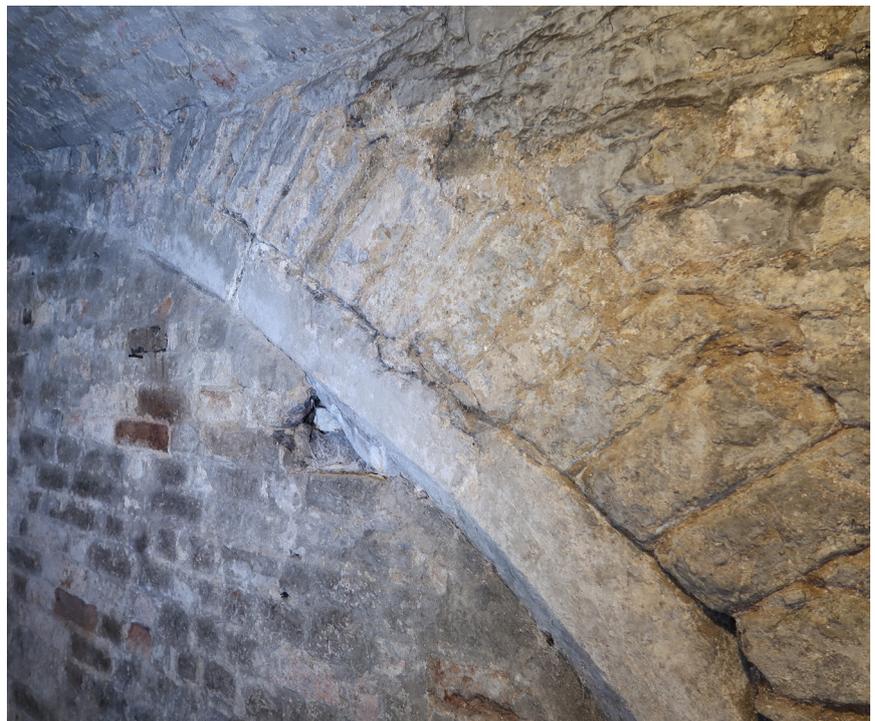
Figure 43: The northernmost rib and the end of the vaulting showing the chamfer on the north face and the absence of any continuation of the vault or of any truncation. [Abigail Lloyd © Historic England]

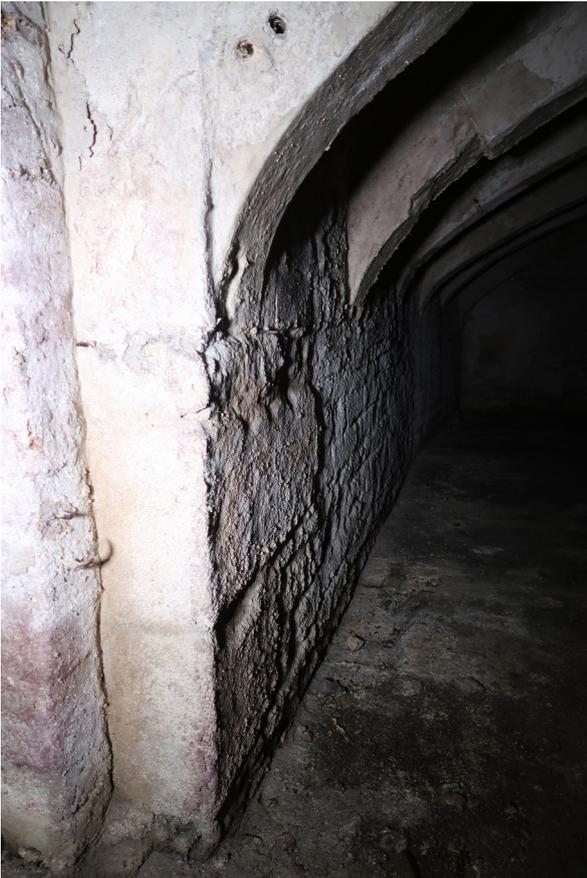
Figure 44: The north-east corner of the rear undercroft showing finely dressed quoin stones at the junction where the rear undercroft widens out into the street-front range. [Abigail Lloyd © Historic England]

The northernmost extent of the vaulted part of the undercroft is set back from the street by about 6m. However, where the northernmost bay ends, the stones above the vaulting rib are all neatly finished with smooth stone voussoirs and coursed rubble stone, with no evidence of original through-stones, or stones which have been cut back (Figure 43). It appears as if the vaulting was intended to finish at this point. At the point where the eastern wall of the vault ends, there is a line of stones embedded in the floor that appear to be continuing the line of the eastern wall of the undercroft further north. However, the northern face of the eastern wall is very smoothly finished with quoin stones, and not hacked or cut back in any way (Figure 44).

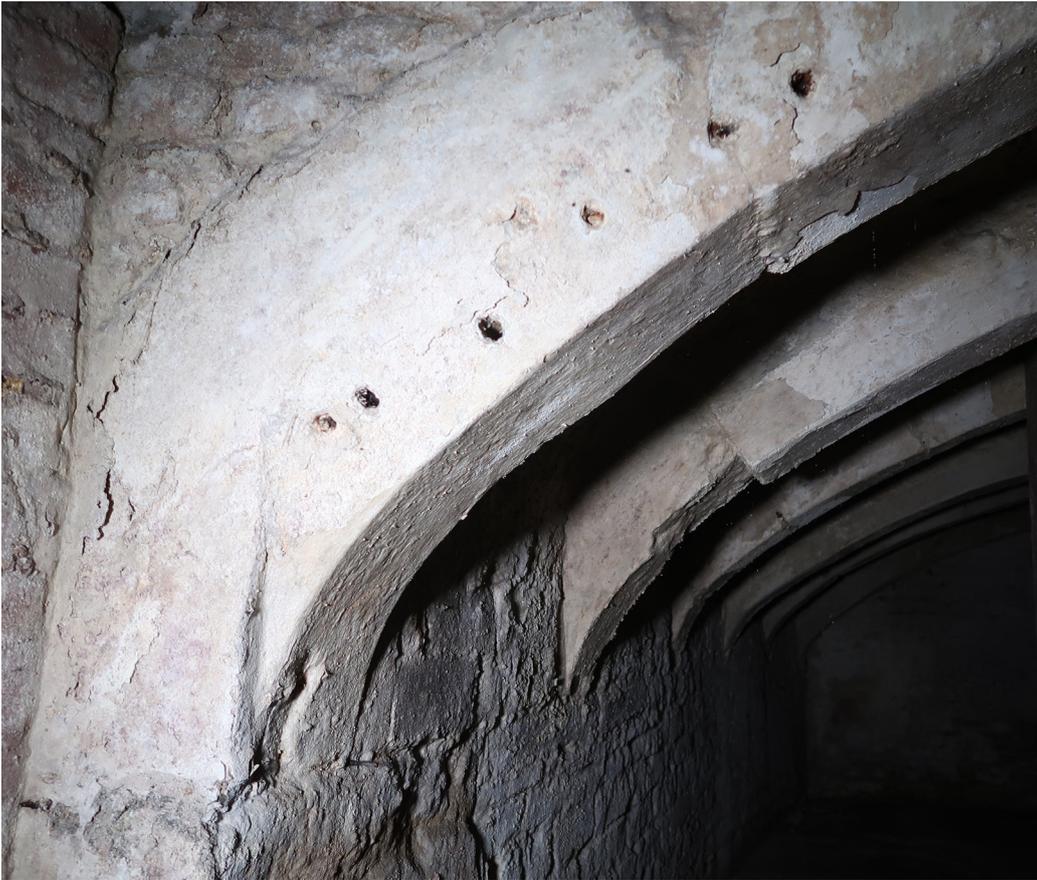
Figure 45: The northern face of the northernmost rib of the rear undercroft at no. 47 Westgate Street, showing holes in the chamfer. [Abigail Lloyd © Historic England]

It is possible that the holes were used in the construction of a vault further north in the street-front range. Rods were used from the 12th century onwards as part of wattle centering for the building of a vault. There are examples in the 12th-century barrel vaults at Helmsley Castle and in the Bishop's Palace in Norwich. Later examples have been cited from Gloucestershire at Avening, and nearby parallels are also found at Tewkesbury and Pershore.¹⁹⁰ On the other hand, if this is the explanation, this technique must only have been used to create a vault in the street-front range; it was not employed for the construction of the rear undercroft. (Such visible holes would visually mar the finely dressed quality of the voussoirs and, with it, much of the point of expending resource on a space for display.) Moreover, the fact that the holes are in the chamfer and not in the face of the rib is a problem for the plausibility of this idea. The angle of the chamfer points downwards to a certain extent and so is not ideal for a continuation of some form of vaulting. If anything, something that was angled upwards would be more to be expected in the case of a vault.

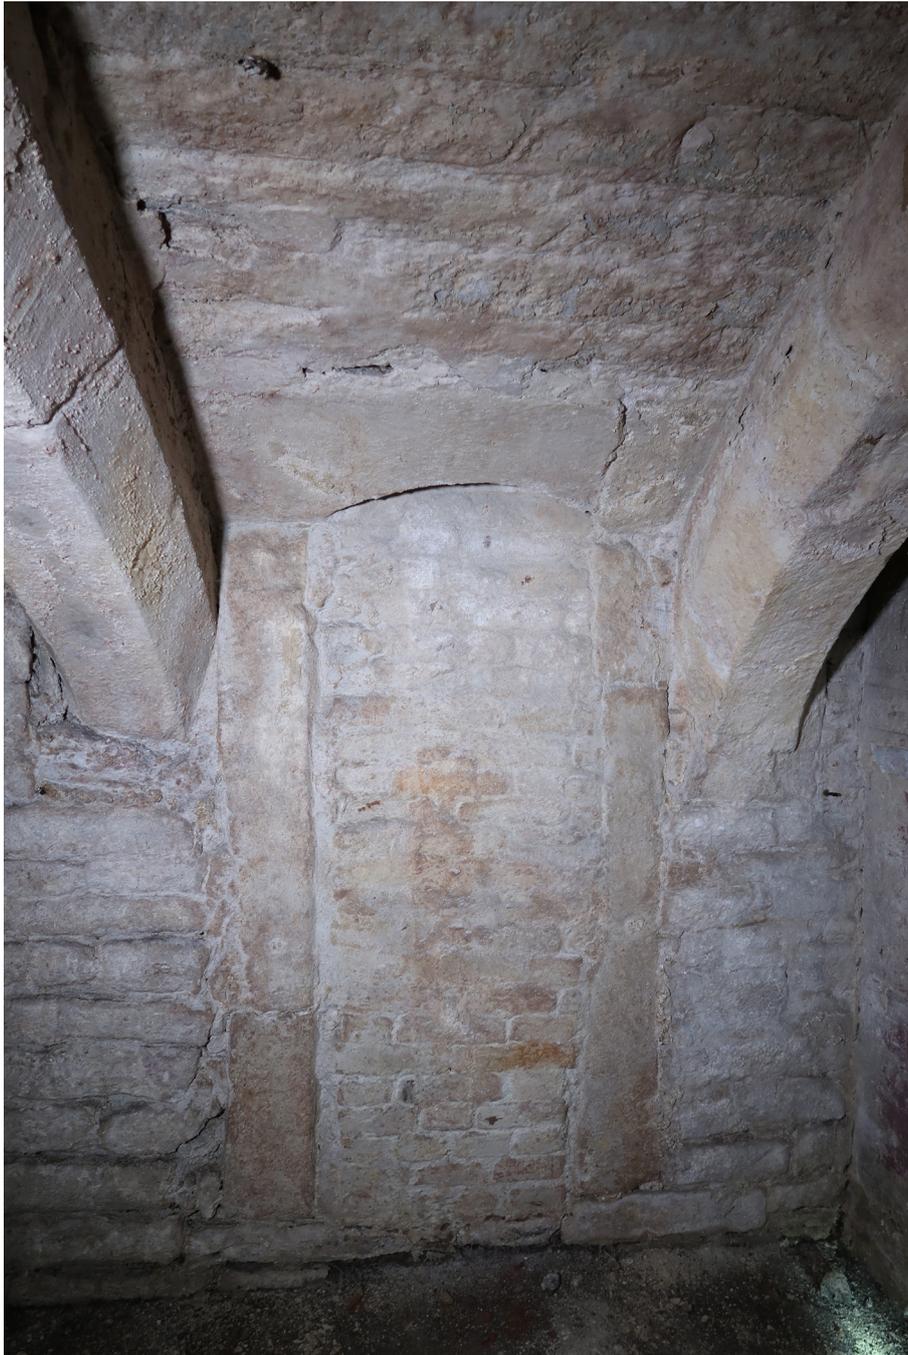
Figure 46: The small western door in the sixth bay from the south, now blocked but with dressed stone jambs and arched lintel. [Abigail Lloyd © Historic England]

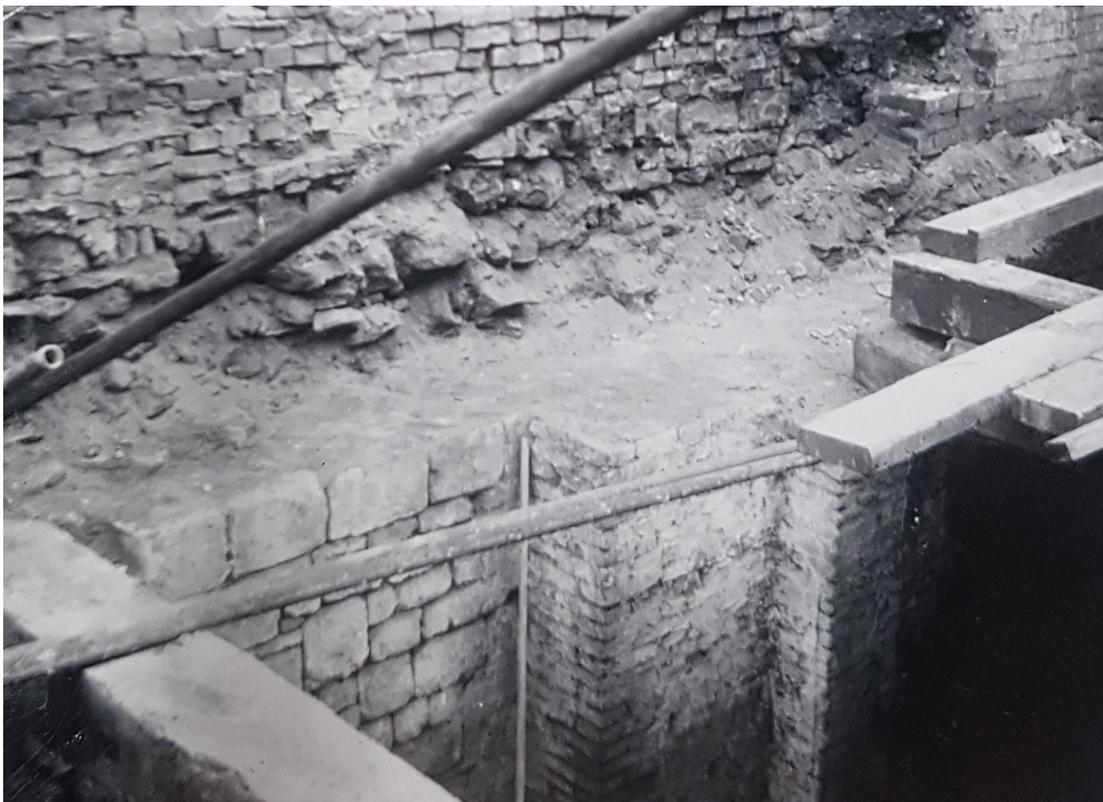
Figure 47: A subterranean wall on the boundary line between nos 49 and 51 showing a finely dressed and coursed stone wall, seen during the 20th-century demolition and rebuilding of no. 51. [D4982 3/1: Image reproduced with the permission of Gloucestershire Archives]

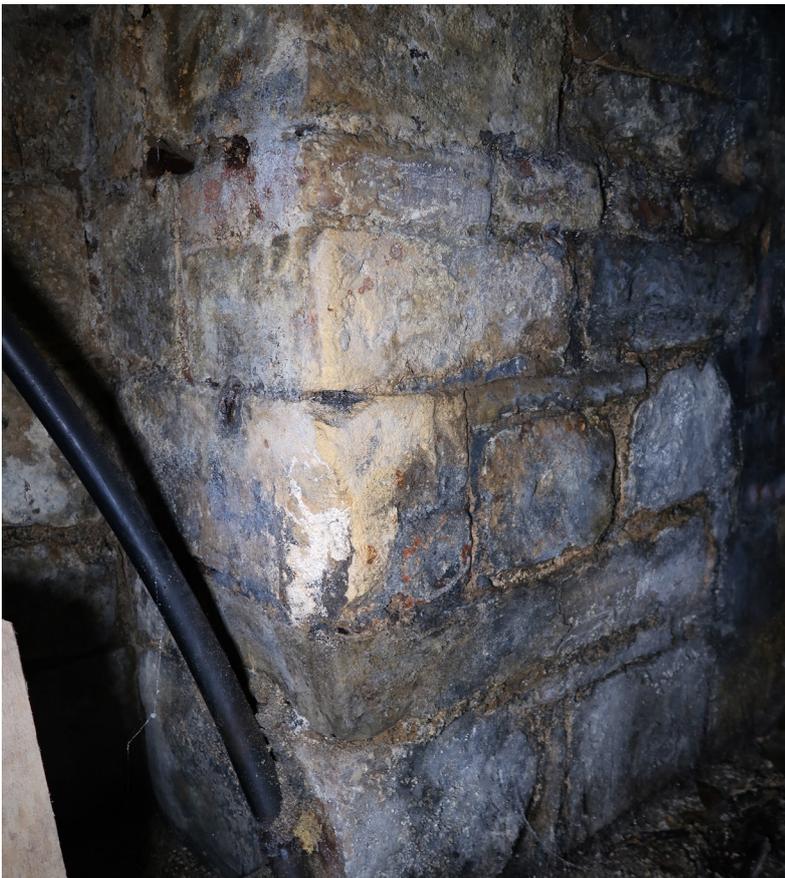
Figure 48: The western spur wall projecting from the north-west corner of the street-front range at nos 47-49 Westgate Street, looking from within the range north-westwards, the entrance from the street on the right-hand side of the image.[Abigail Lloyd © Historic England]

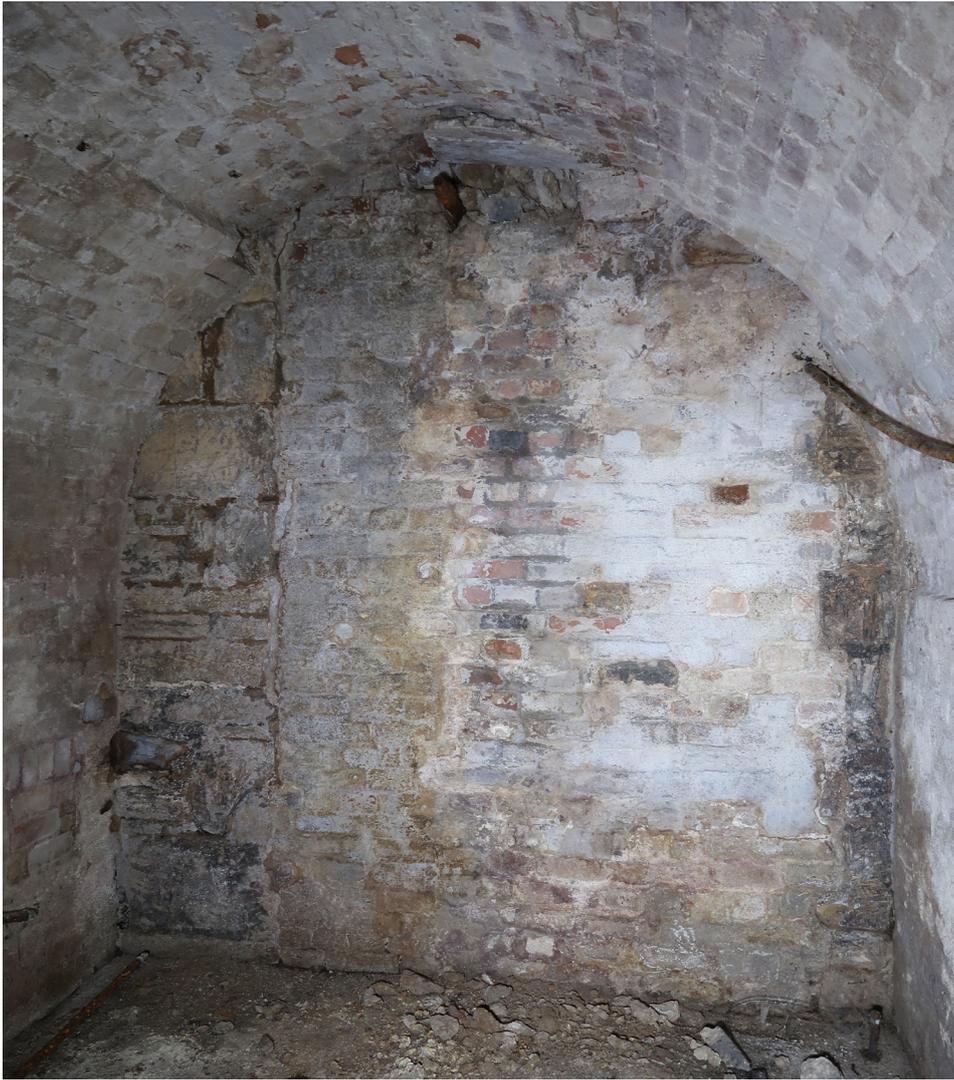
Figure 49: A blocked opening in the north-eastern corner of the street-front range at nos 47–49 Westgate Street, showing dressed quoin stones either side of brick infill. [Abigail Lloyd © Historic England]

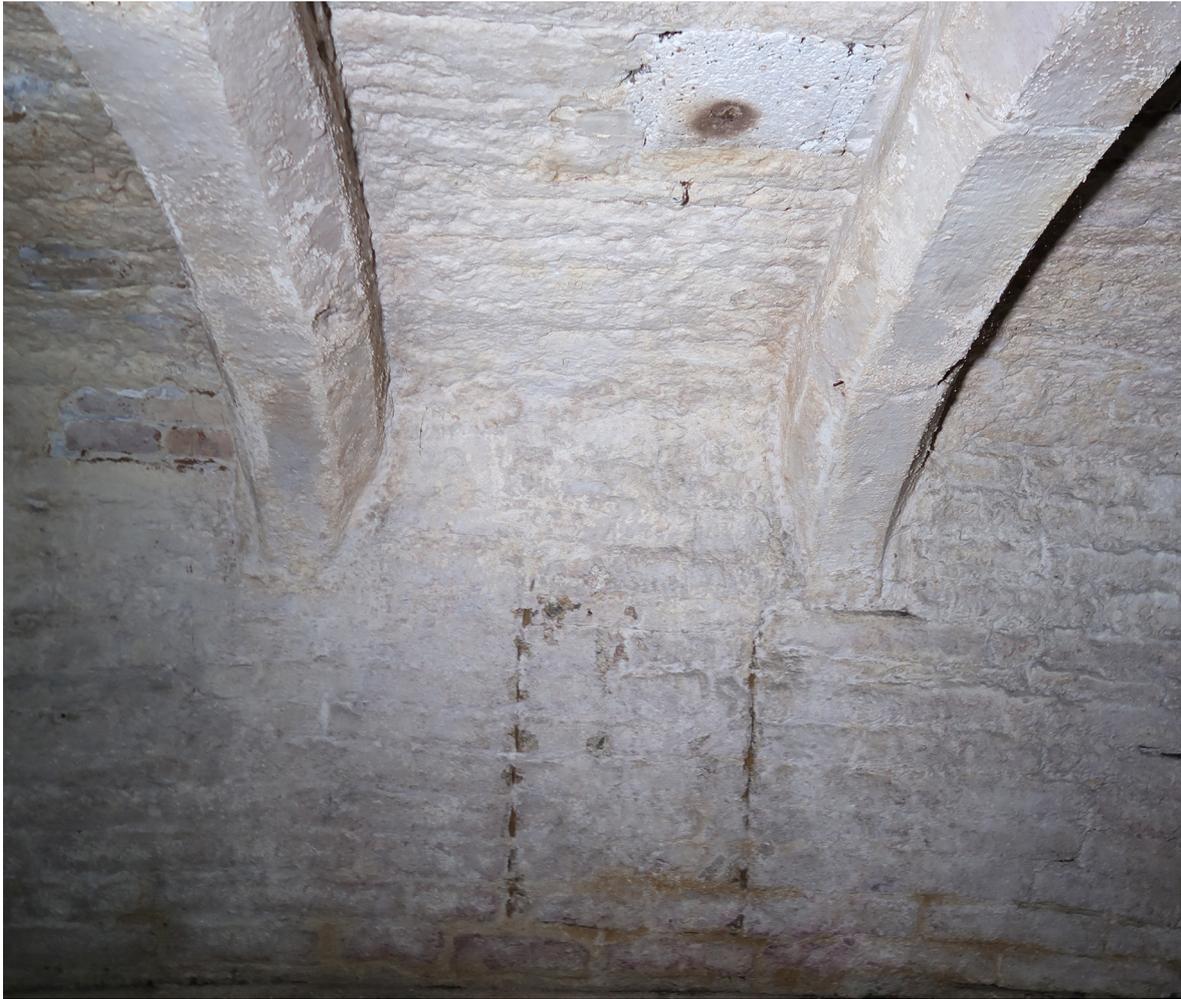
Figure 50: A possible blocked recess in the eastern wall of the undercroft at no. 47 Westgate Street. [Abigail Lloyd © Historic England]

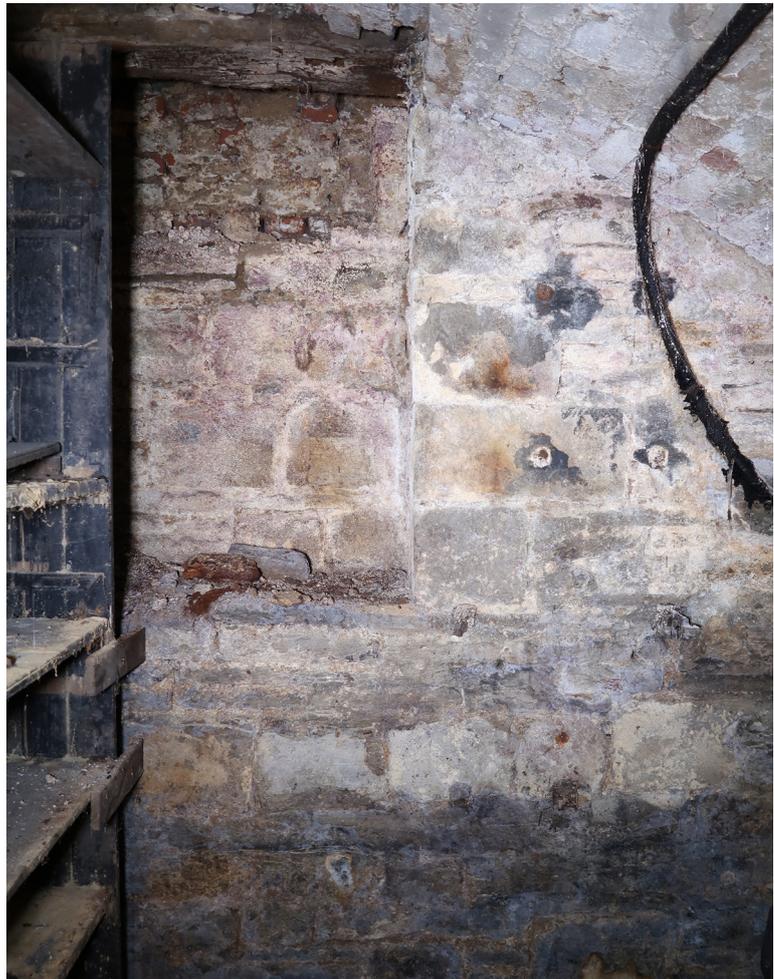
Figure 51: One of two possible windows in the north wall of the street-front range of nos 47–49 Westgate Street, both now blocked. [Abigail Lloyd © Historic England]

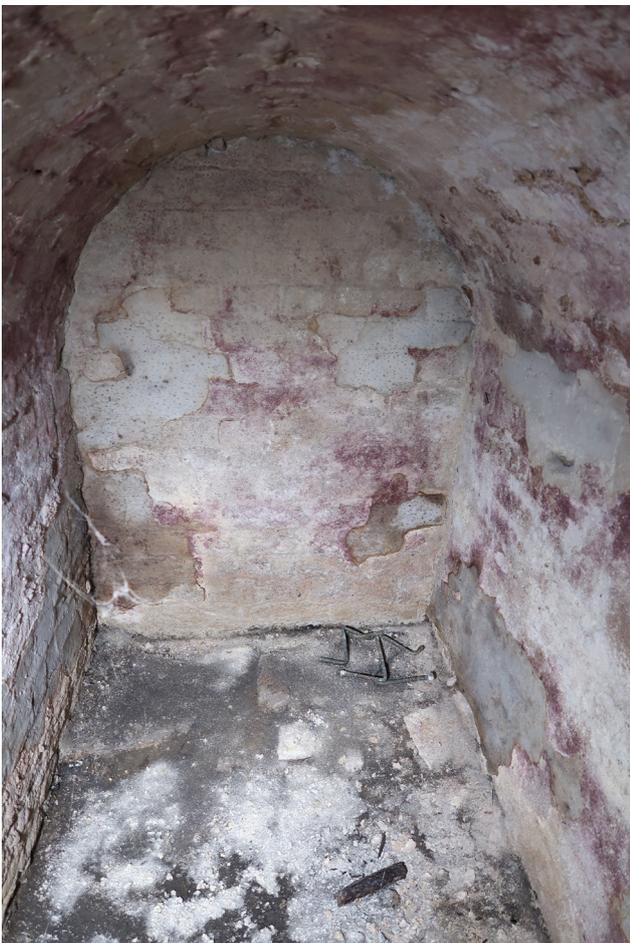
Figure 52: The small brick-vaulted room measuring roughly 2.5m wide inserted into the street-front range at nos 47-49 Westgate Street. [Abigail Lloyd © Historic England]

In the street-front range, brick walls were inserted which divided that range into a corridor (about 1.25m wide), running just in front of the now blocked rear undercroft, and three smaller rooms closer to the street front, the western two of which are accessible from off the corridor. The first room on the west is approximately 5m wide; the second is approximately 2.5m wide (Figure 52). Both are just under 5m deep.

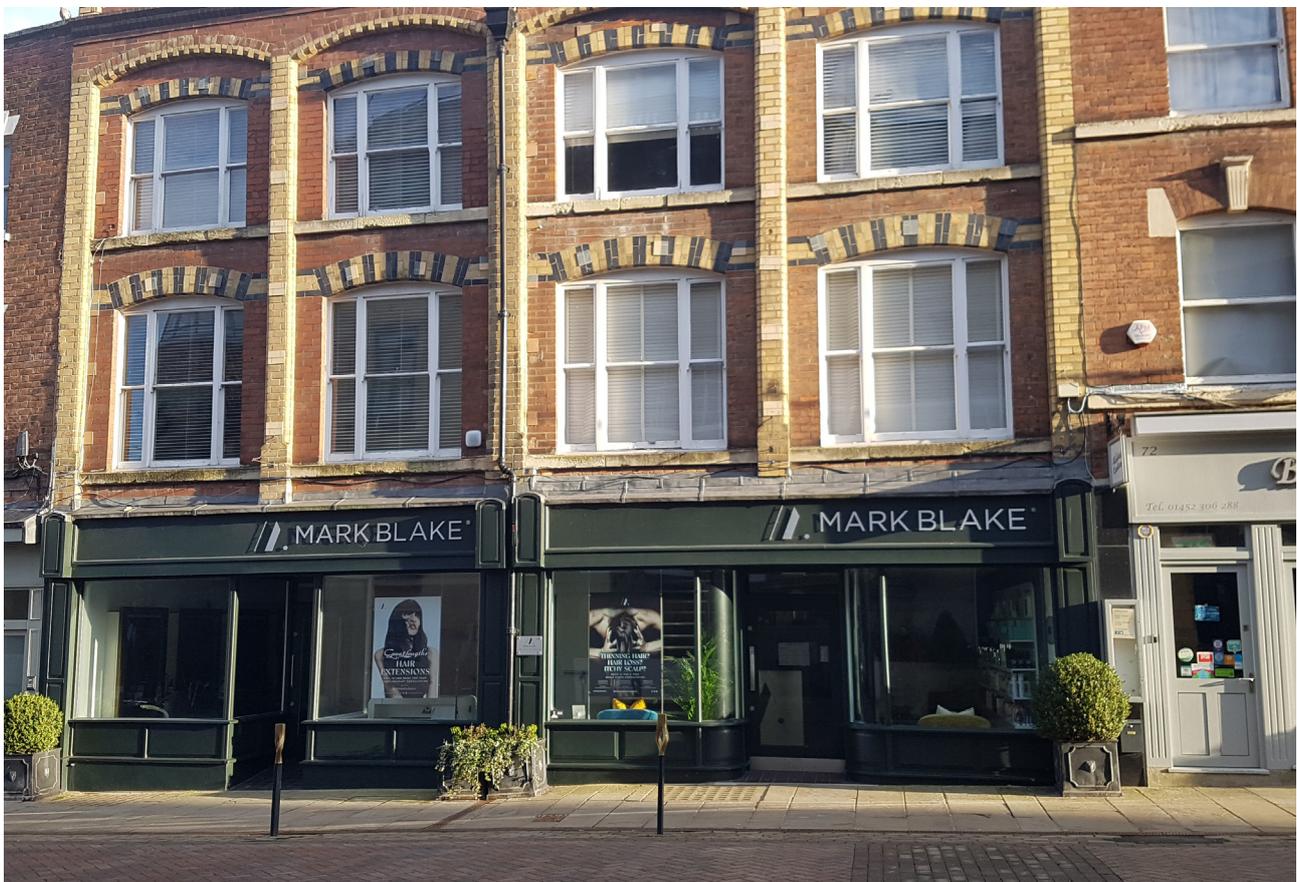
Figure 53: The street frontage of nos. 74 and 76 Westgate Street presenting a unified architectural elevation in March 2023. [Abigail Lloyd © Historic England]

Although nos 74–76 present a unified front to Westgate Street today, historically, as with nos 47–49, they were often in separate ownership or occupation (Figure 53). As before, the documentary history compiled by Rhodes is used but there are gaps within it.

By 1900, the southern elevation of nos 74 and 76 Westgate Street had been rebuilt above ground fronting on to Westgate Street (see Figure 53).²⁴⁴ They were unified with a three-storey brick elevation of four wide bays in multicoloured brick. However, it does not seem likely that many of the brick alterations within the undercroft and the cellar under no. 74 date from this time. If they did, one might expect a more unified insertion of brick (see the equivalent process at nos 47–49 Westgate Street) whereas the respective spaces under nos 74 and 76 have very different brick phases.
