The Undercrofts of Westgate Street, Gloucester

Historic Buildings Assessment

This report examines the evidence for medieval undercrofts surviving on Westgate Street, Gloucester. For the purposes of this study undercrofts are defined as the stone-vaulted spaces beneath a building or principal room.

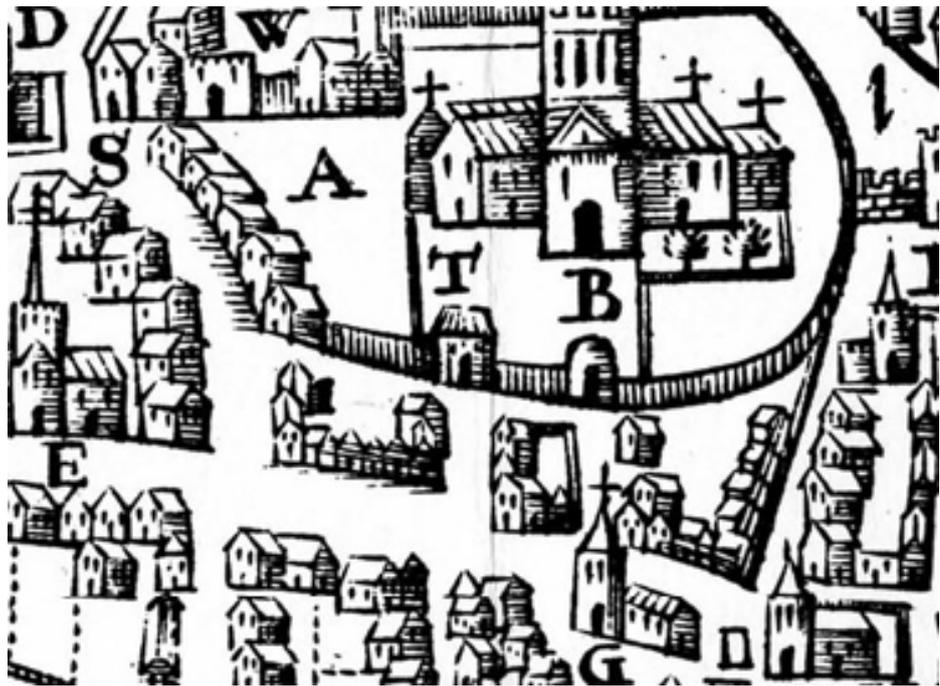
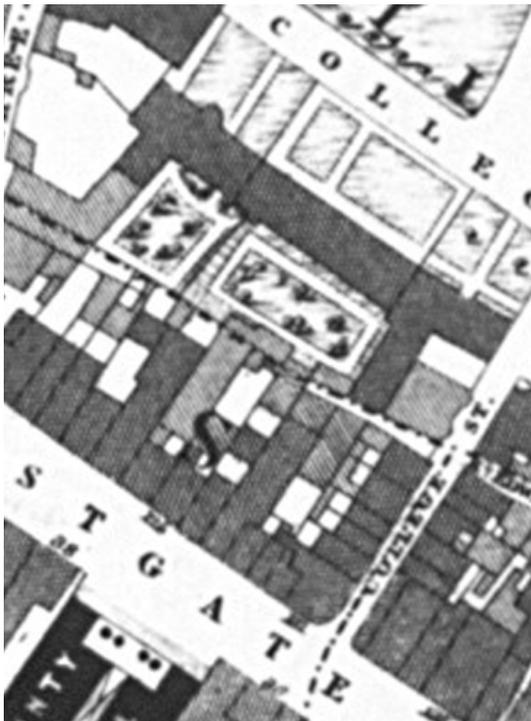
Figure 55: A detail of the back plots behind the site of nos 74-76 Westgate Street, as shown in the 1843 Causton Map of Gloucester. [Image reproduced with the permission of Gloucestershire Archaeology, Gloucester Civic Trust and Gloucestershire Archives]

By 1780 and 1805, mapping shows a dense block of development with no indication of access from east or west, but this is a consequence of the scale used. The 1843 Causton map gives a clearer, more detailed picture (Figure 55). It is evident that there are still open courtyards behind various plots but no clear and unimpeded lane running from either Three Cocks Lane or College Street. Both nos 74 and 76 appear to have been extended northwards; the latter preserves a small open yard immediately in front of the precinct boundary wall where the former does not. On the other hand, in the 1852 Board of Health mapping, it appears that no. 76 extends back to the precinct wall, but a courtyard remains behind no. 74 and other plots to the east (Figure 56). This is the layout preserved in subsequent 19th- and 20th-century mapping until development in the 1990s placed an office block immediately behind nos 74 and 76, with access opened up again along a lane to the east, in front of the precinct wall, leading to College Street.

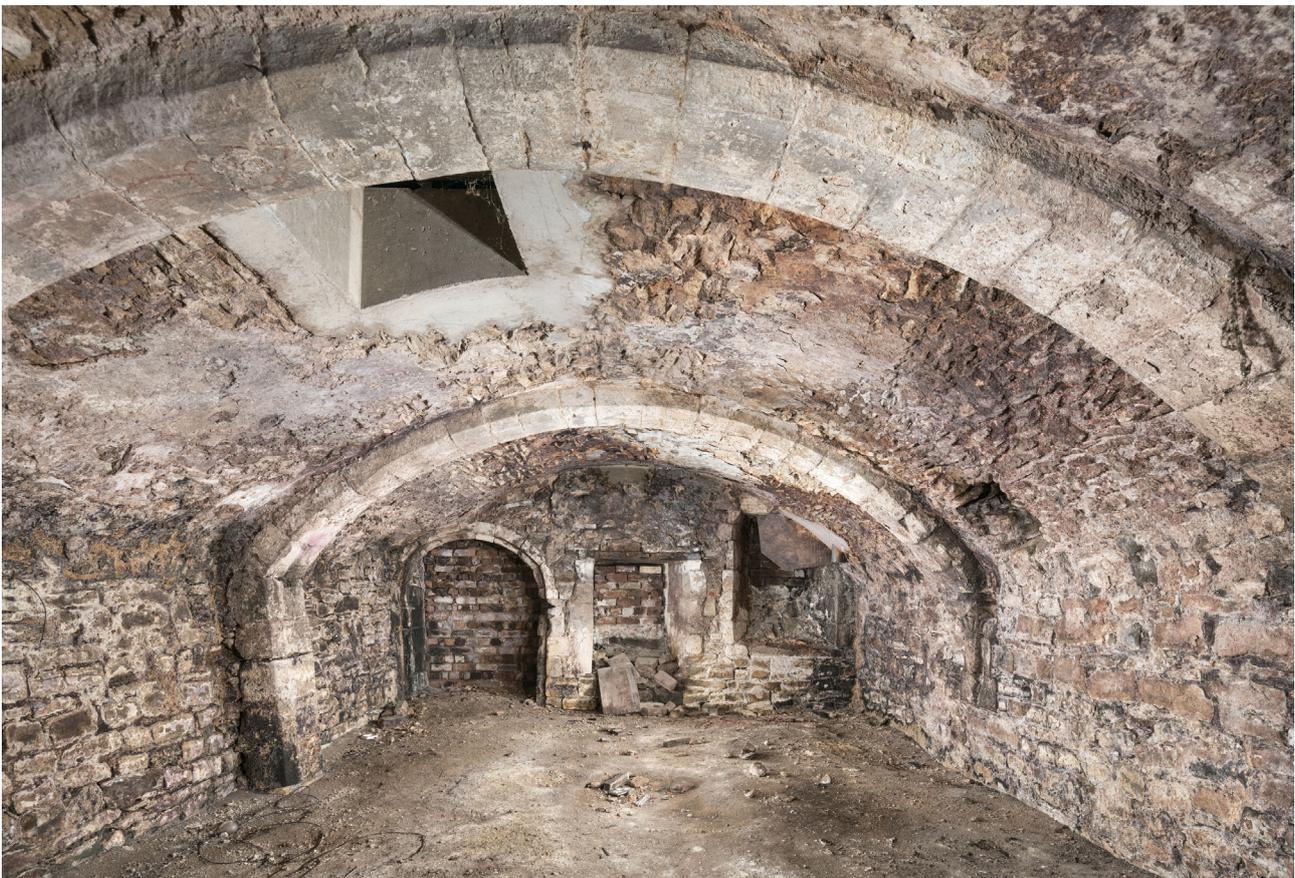
Figure 57: The undercroft at no. 76 Westgate Street looking north. [DP325714]

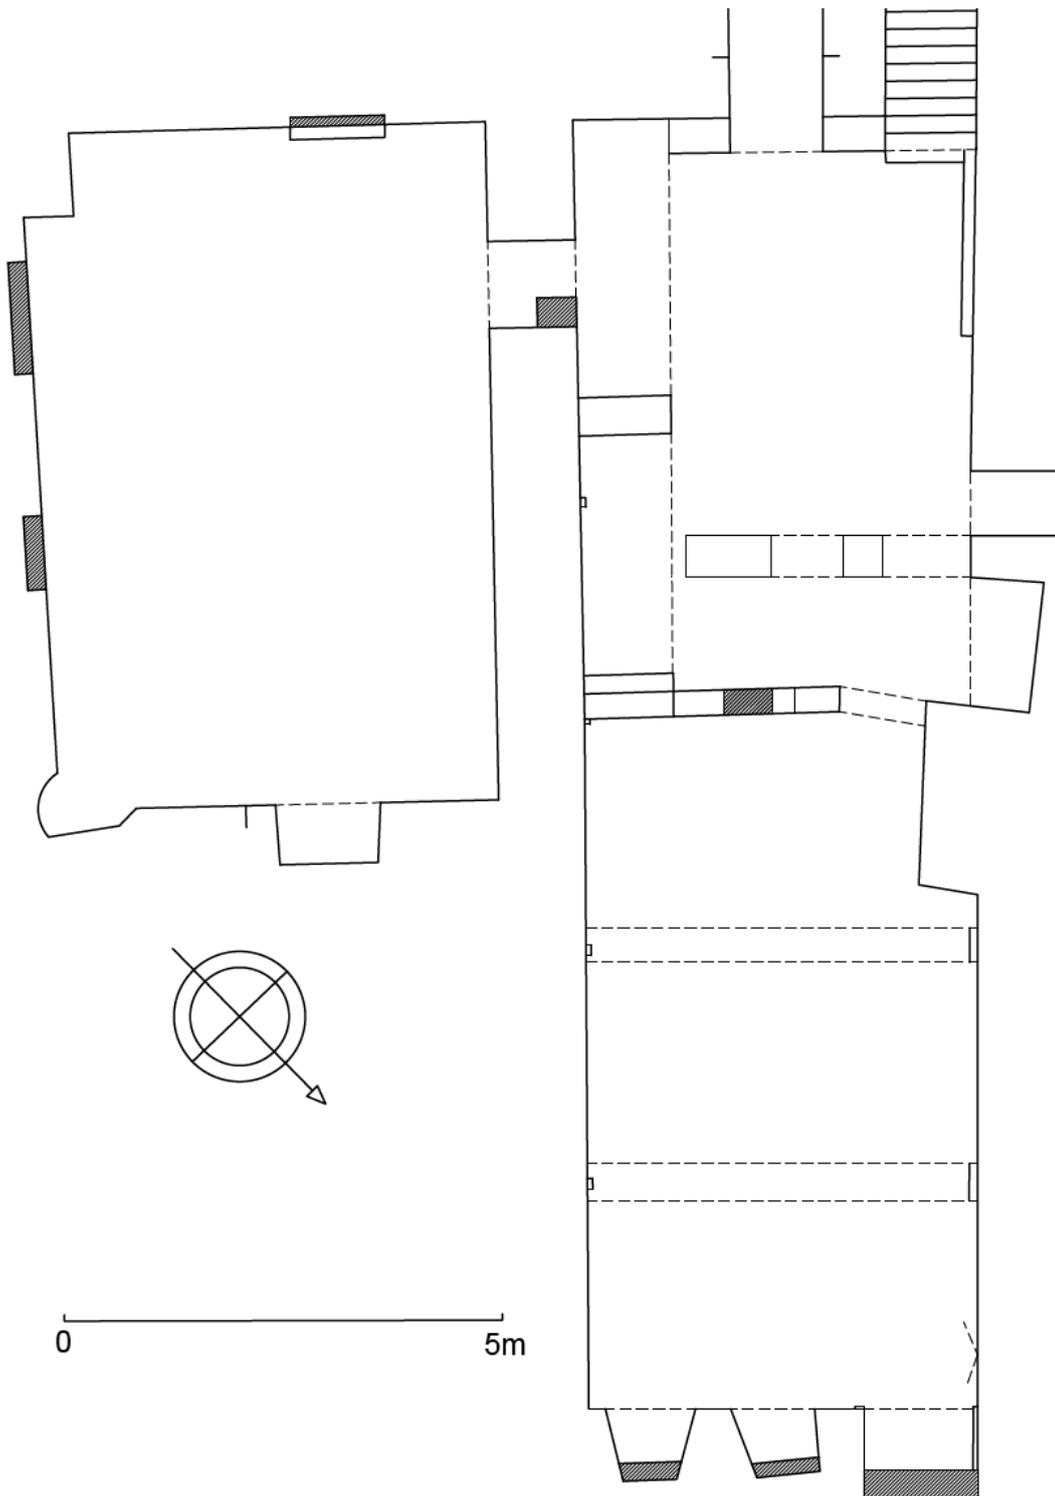
Figure 58: Plan of a measured hand survey of nos 74-76 Westgate Street, carried out in March 2023. [Abigail Lloyd © Historic England]

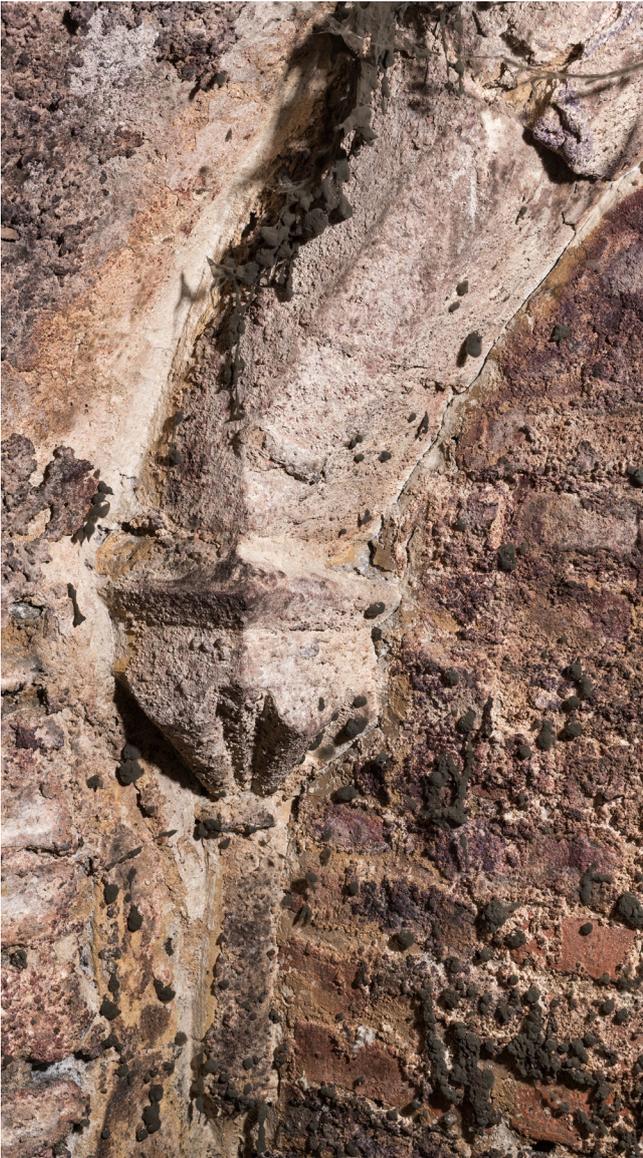
Figure 59: The third corbel from the north in the undercroft at no. 76 Westgate Street, on the eastern side of the undercroft. [DP325722]

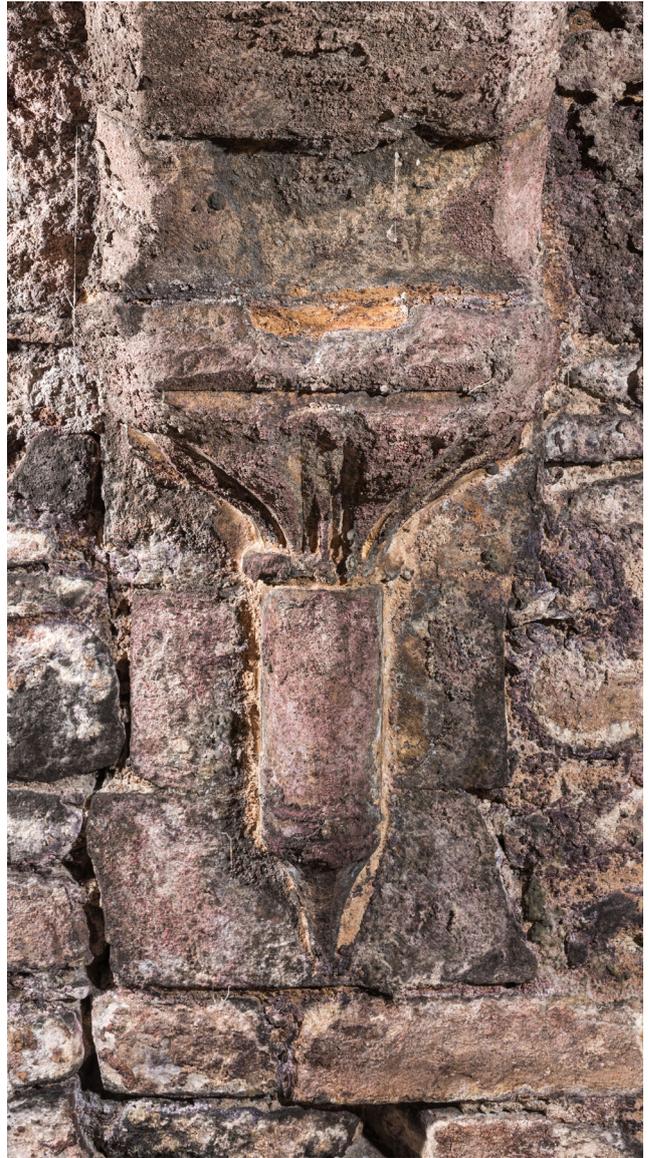
Figure 60: The second corbel from the north in the undercroft at no. 76 Westgate Street, on the eastern side of the undercroft. [DP325720]

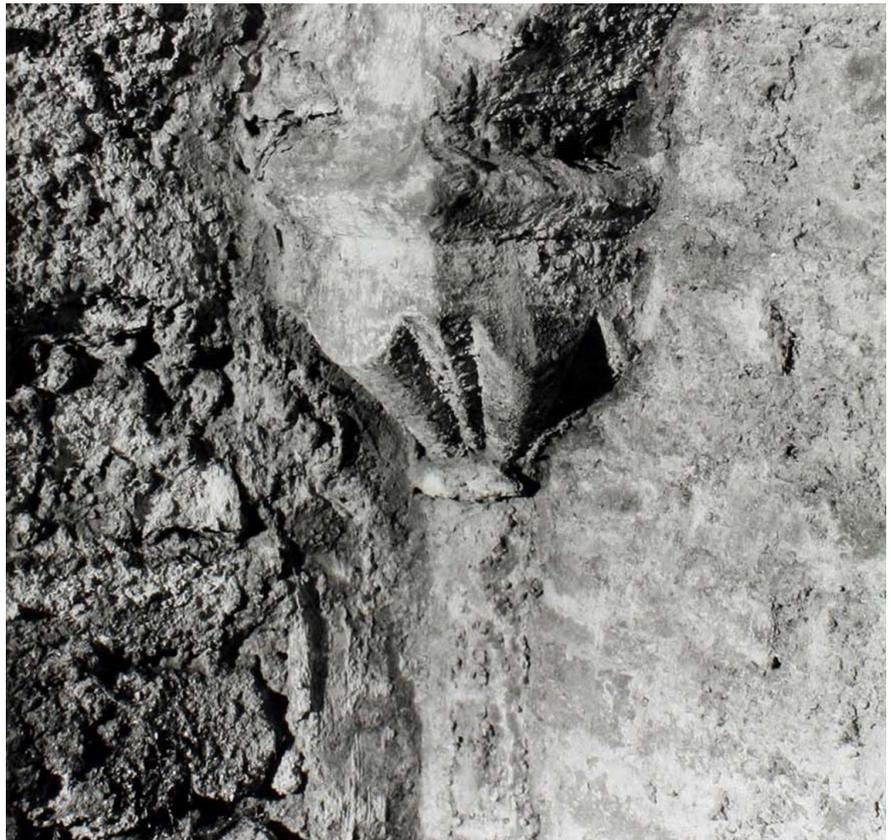
Figure 61: The third corbel from the north in the undercroft at no. 76 Westgate Street, on the eastern side of the undercroft, taken by the Royal Commission in 1972. [BB72/5675]

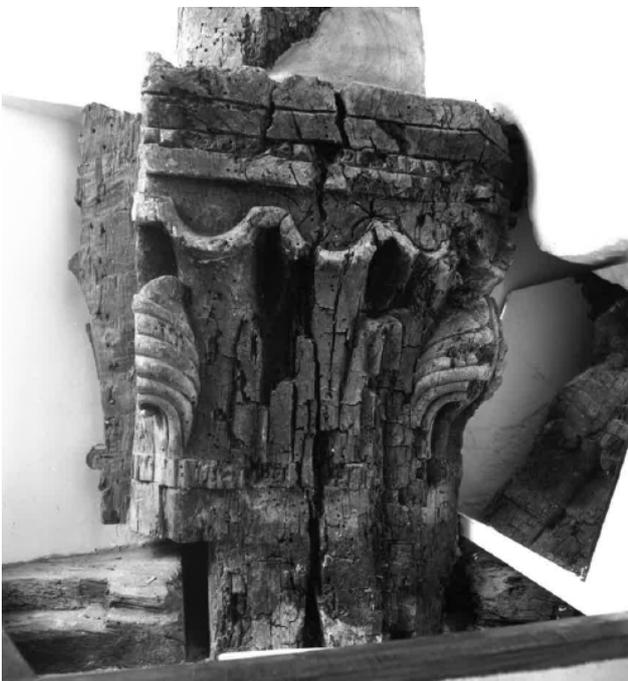
Figure 62: A wooden capital from the aisled hall at Burmington Manor as photographed by the Royal Commission. [AA98/14199]

In another secular context, the carved wooden capitals at the aisled hall in Burmington Manor, Warwickshire, have been dated by dendrochronology to 1194 or 1195.²³² There are capitals in both wood and stone. The wooden capital appears to be ornamented with a trumpet scallop and an early form of stiff leaf decoration (Figure 62). Stylistically, it is later than the capitals in the undercroft at no. 76 Westgate Street. The scalloped wooden capital at the Bishop's Palace in Hereford is closer stylistically and occurs in a domestic setting, even if linked to the ecclesiastical world. This capital is dated by dendrochronology to approximately 1179 (Figure 63).²³³ The capitals at no. 76 Westgate are perhaps closer in date to this. Based on the stone carving detail, the undercroft appears to have been constructed in the late 12th century.

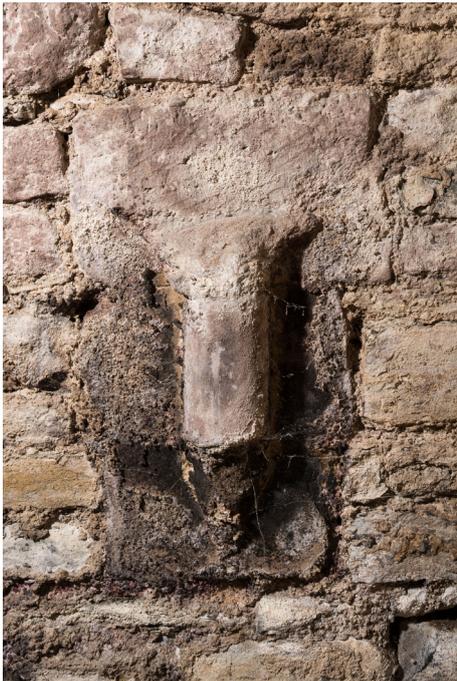
Figure 64: The eroded and partially removed fourth corbel from the north in the undercroft at no. 76 Westgate Street. [DP325711]

The third transverse rib from the north remains in situ in part. The scalloping of the capital is particularly well preserved. A surviving corbel is the only part remaining in situ from the fourth transverse rib from the north. This corbel is heavily eroded and/or hacked back (Figure 64). It survives up to the roll moulding at the top of the colonnette, but no higher.

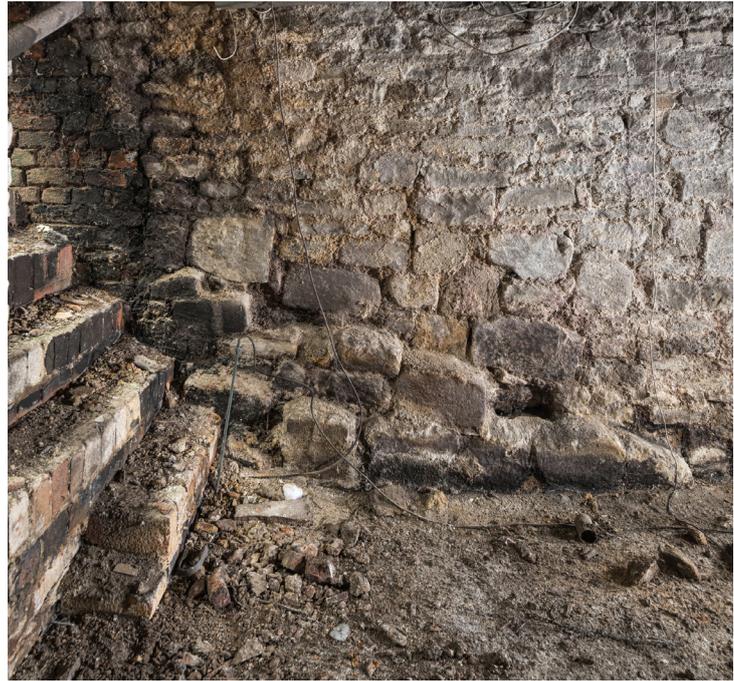
Figure 65: A projecting and sloping stone plinth in the south-western corner of the undercroft at no. 76 Westgate Street. [DP325712]

In the south-western corner of the undercroft, next to an altered brick-stepped opening on to the street, there are the remains of a sloping stone plinth against the western wall of the undercroft (see Figure 65). It is not clear whether the plinth supported steps or a ramp. Nevertheless, there is a clear slope in the stonework and the plinth protrudes from the line of the west stone wall. It has already been noted that the undercroft appears to have been held or occupied separately from the rest of the tenement; a direct entrance on to Westgate Street itself would have facilitated such separate usage. On account of later alteration, there is now no indication of how wide the original entrance might have been. The current, later, opening is approximately 1.05m wide.

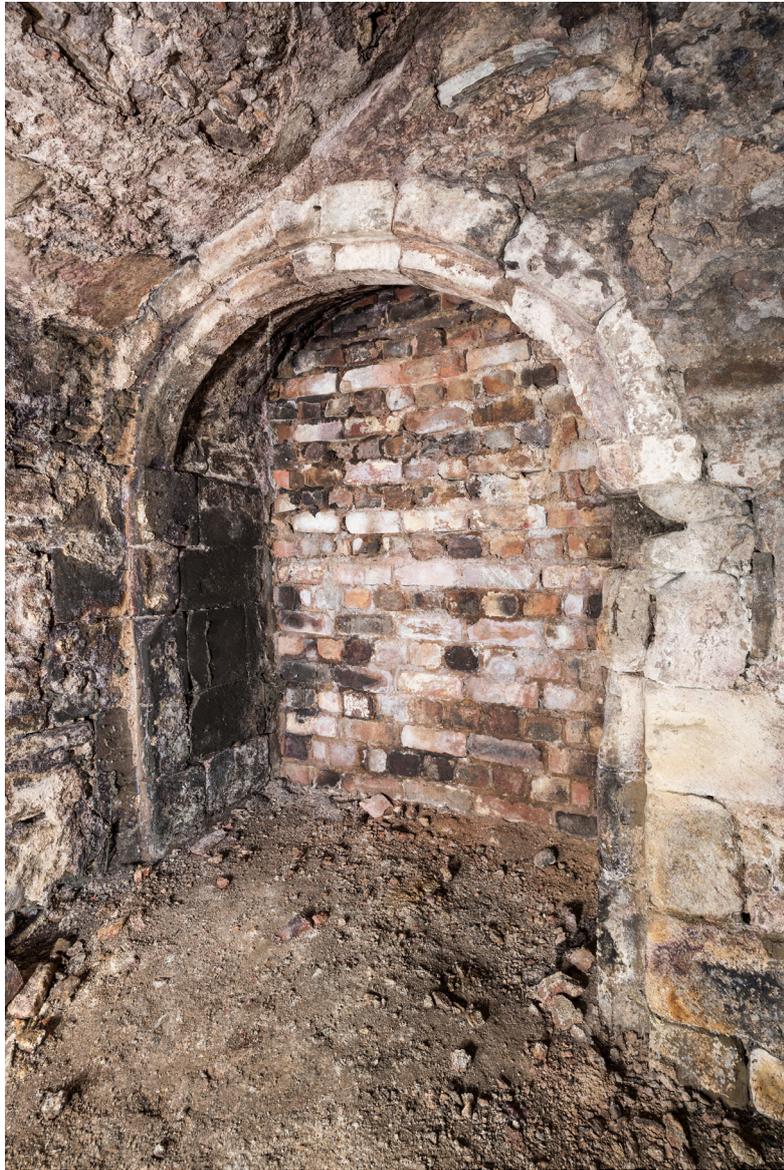
Figure 66: The round-arched doorway in the north-western corner of the undercroft at no. 76 Westgate Street seen from the south. [DP325717]

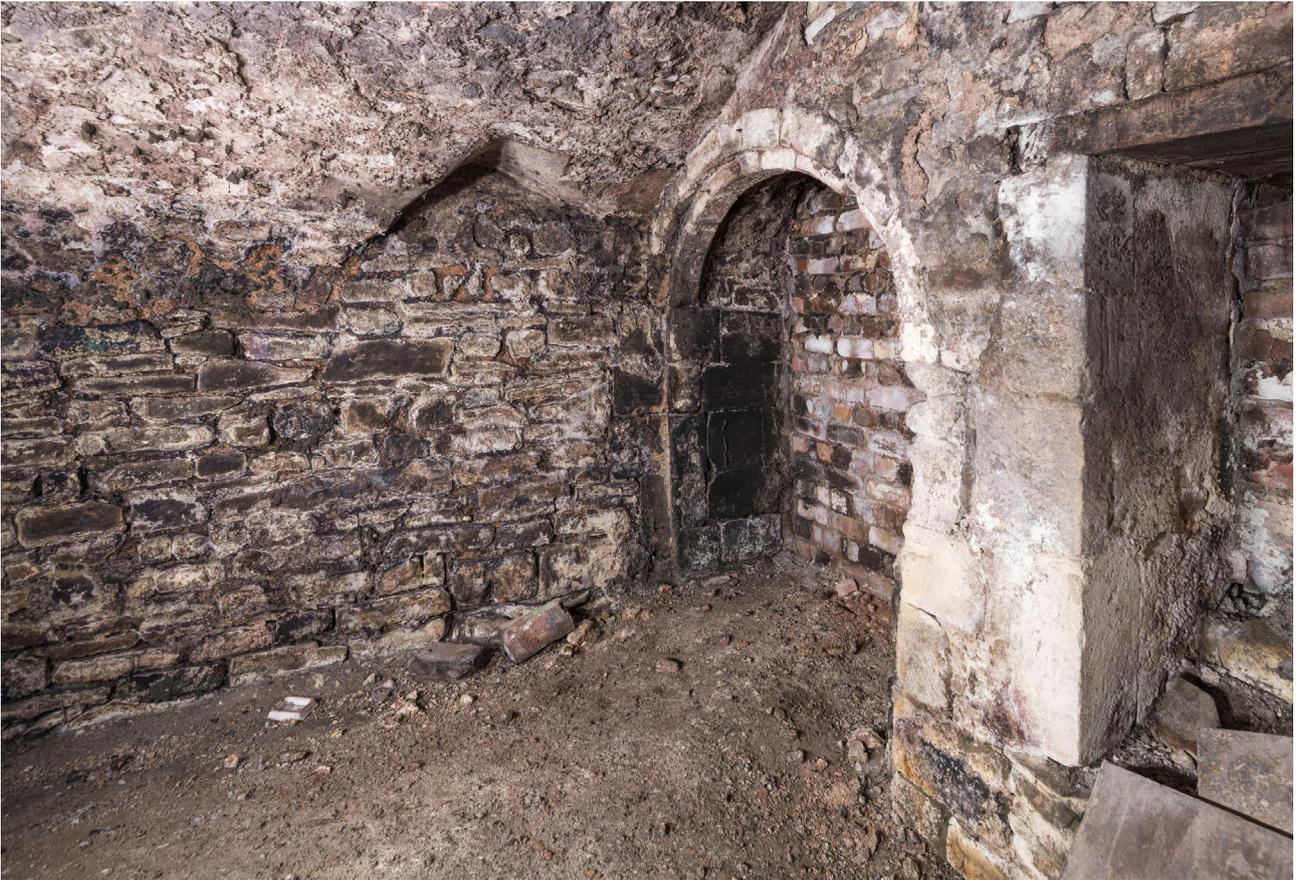
Figure 67: The recess in the vaulting of the undercroft designed to accommodate a door opening inwards from the north-western doorway, hinging from the western jamb. [DP325716]

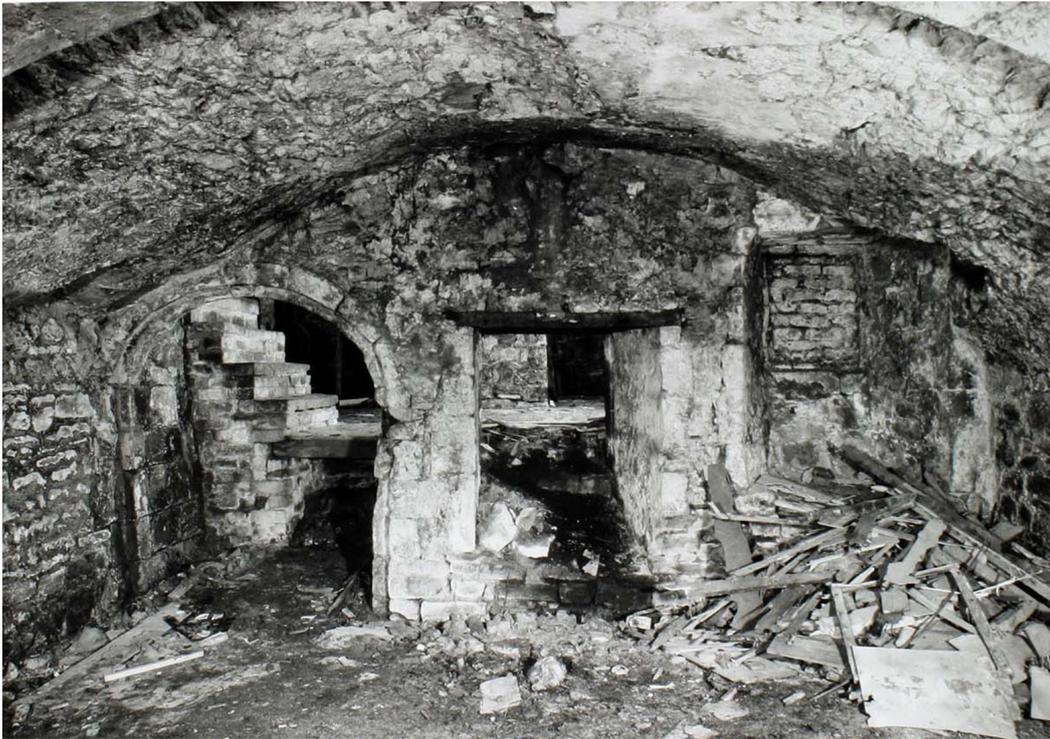
Figure 68: The north wall of the undercroft at no. 76 Westgate Street photographed by the Royal Commission in 1972 when the doorway and central opening were not blocked. [BB72/5668]

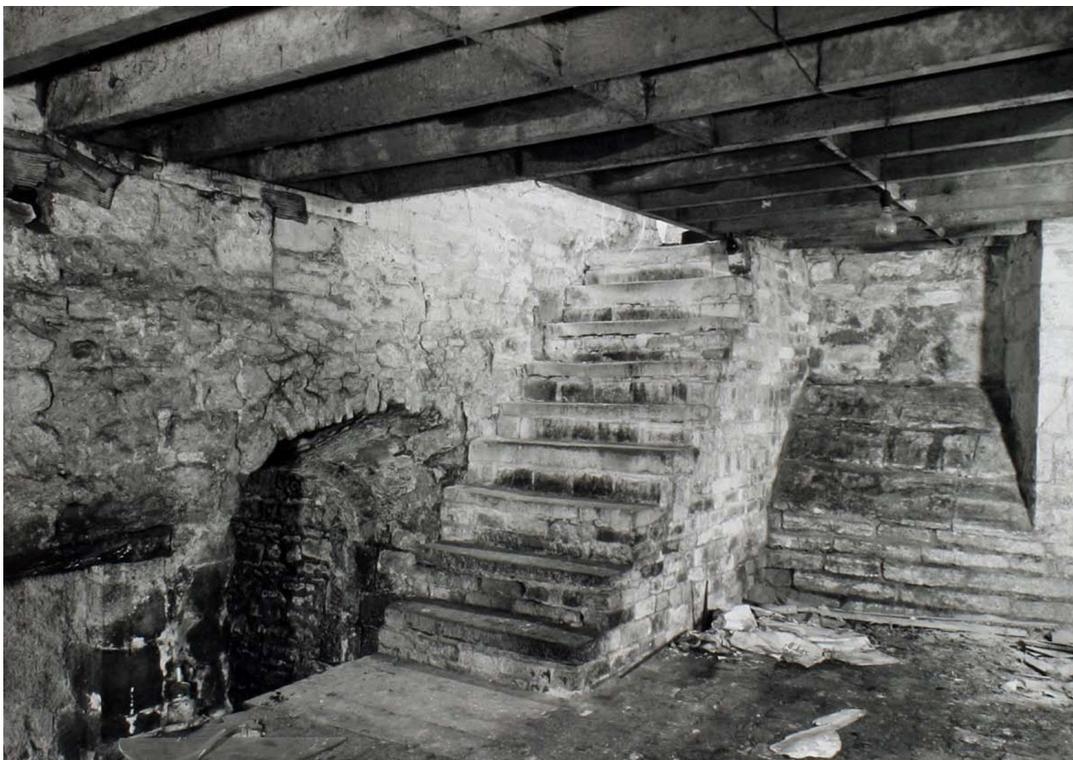
Figure 69: Within the space to the north of the undercroft at no. 76 Westgate Street, showing the stairs that blocked the undercroft north-eastern doorway, as well as a stone wall on the western side of this space, and a splayed recess, photographed in 1972. [BB72/5666]

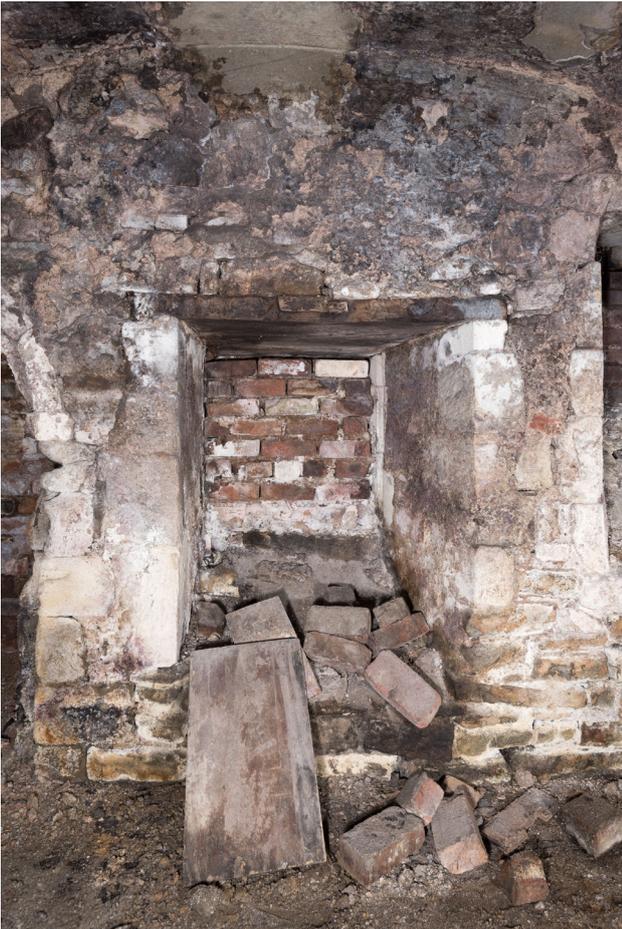
Figure 70: The central opening in the north wall of the undercroft, now blocked with brick. Note the splay visible on the eastern side.[DP325718]

To the east of the round-arched doorway in the north wall, is another opening with a low sill (Figure 70 and see Figures 57 and 68). It is rectangular in shape and splayed on one side. Its width is approximately 0.96m at the front (south) and 0.75m at the back (north). The eastern jamb is internally splayed but the western jamb is barely splayed, possibly because the opening is placed so close to the doorway. An internal splay in the western jamb, had it existed, would have helped to bring greater light in from the east. The central opening has dressed stone reveals and part of a moulded, chamfered stone jamb visible on the eastern side. The lintel is wooden and appears to cut across the stone jamb, albeit there is no sign, in the stone of the northern wall within the undercroft, of the opening having once been taller. In 1972, this central opening was open, along with the doorway to the west. The central opening is similar in form to a feature in the undercroft at no. 39 Strand Street, Sandwich which has been interpreted as a chute.²³⁸ Such chutes could be used for hauling goods in to and out of undercrofts. However, the presence of such a chute so close to a primary (and relatively wide) door at a lower level and a primary window at a higher level is not easily explicable in terms of how this configuration worked and corresponded to ground levels and/or structures outside the undercroft.

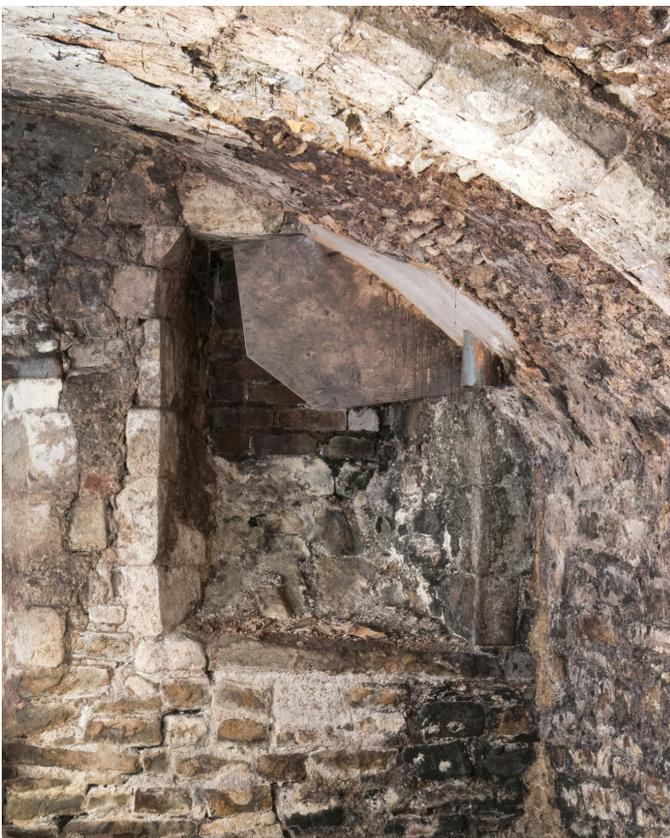
Figure 71: The north-eastern window in the undercroft at no. 76 Westgate Street, set at a higher level than the central opening. [DP325714 crop]

East of this in the north wall of the undercroft there is a further opening, the sill of which is set at a higher level than that of the central opening (Figure 71 and see Figures 57 and 68). It is splayed internally to the undercroft in both the east and west jambs. Its width is approximately 1.03m at the front (south) and 0.70m at the back (north). Again, the reveals are comprised of dressed stone. There is a flat stone lintel. (Flat lintels and simple chamfered jambs could be used across the medieval period.) The lintel sits above the curved line of the main vault, which is possible because it is located in an end wall. In the soffit of the lintel, centrally placed, is a mortice for a bar which would have run vertically in the centre of the opening. Any corresponding mortice in the windowsill was not observable. The sill is made of stone and slopes downwards at a pronounced angle. The height of the sill, and the pronounced slope of the same, suggest that there was no light available at a lower height outside the north-eastern corner of the undercroft. This is inconsistent with the lowered and non-sloping sill of the central opening, unless that is a later modification. If there has not been any alteration to the central opening, the two openings read awkwardly together, sitting at very different heights for no obvious reason.

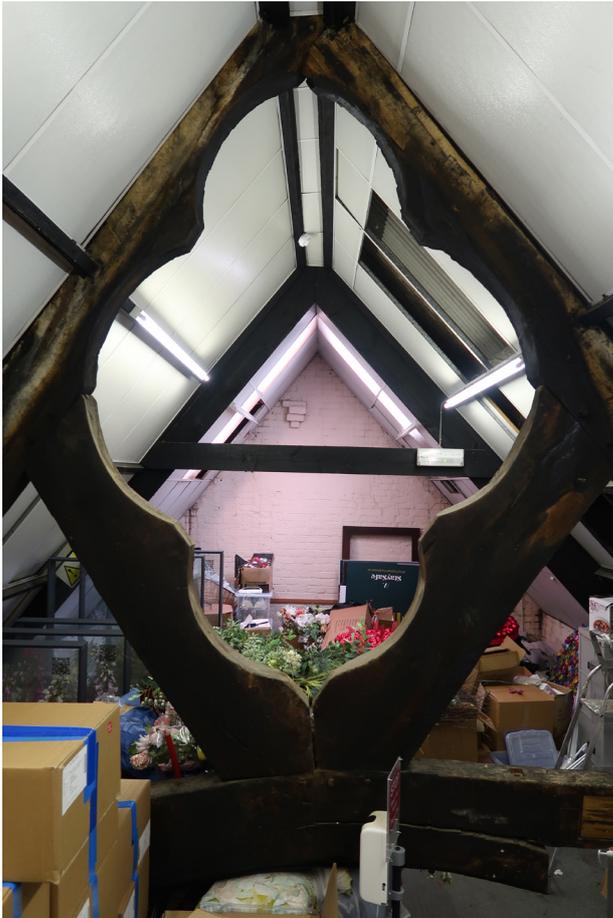
Figure 72: The central, cusped, quatrefoil truss of the timber-framed building above the undercroft at no. 76 Westgate Street, looking north, in 2023. [Abigail Lloyd © Historic England]

A later timber-framed building was erected on the northern part of the undercroft possibly in the 14th century. The dating of this structure relies upon the stylistic form of the ogee quatrefoil of the very large central truss between tie beam and apex (Figures 72 and 73). Although no obvious signs of smoke encrustation or blackening were observed on a brief site visit, it is clear that this truss was designed to be seen as part of an open hall. The timber-framed structure appears to sit over the undercroft at no. 76. However, it does not now extend as far south as Westgate Street, whereas the undercroft might have done so originally. What is left of the building appears to be a 3-bay structure and its northern wall is constructed out of brick. On plans submitted for a 1986 planning application, there is reference to removing the end truss and making good the ends of the purlins.²³⁹ There would be benefit in examining this building in detail to understand its history and precise relationship with the undercroft (at least in part) below it.

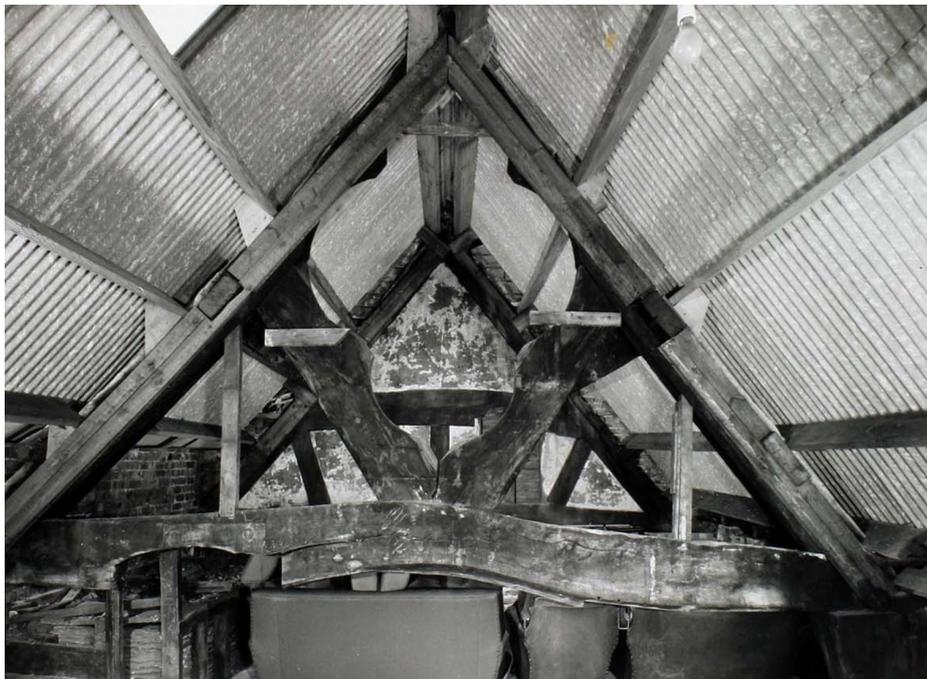
Figure 73: The central, cusped, quatrefoil truss of the timber-framed building above the undercroft at no. 76 Westgate Street, photographed in 1972, looking south. [BB72/5680]

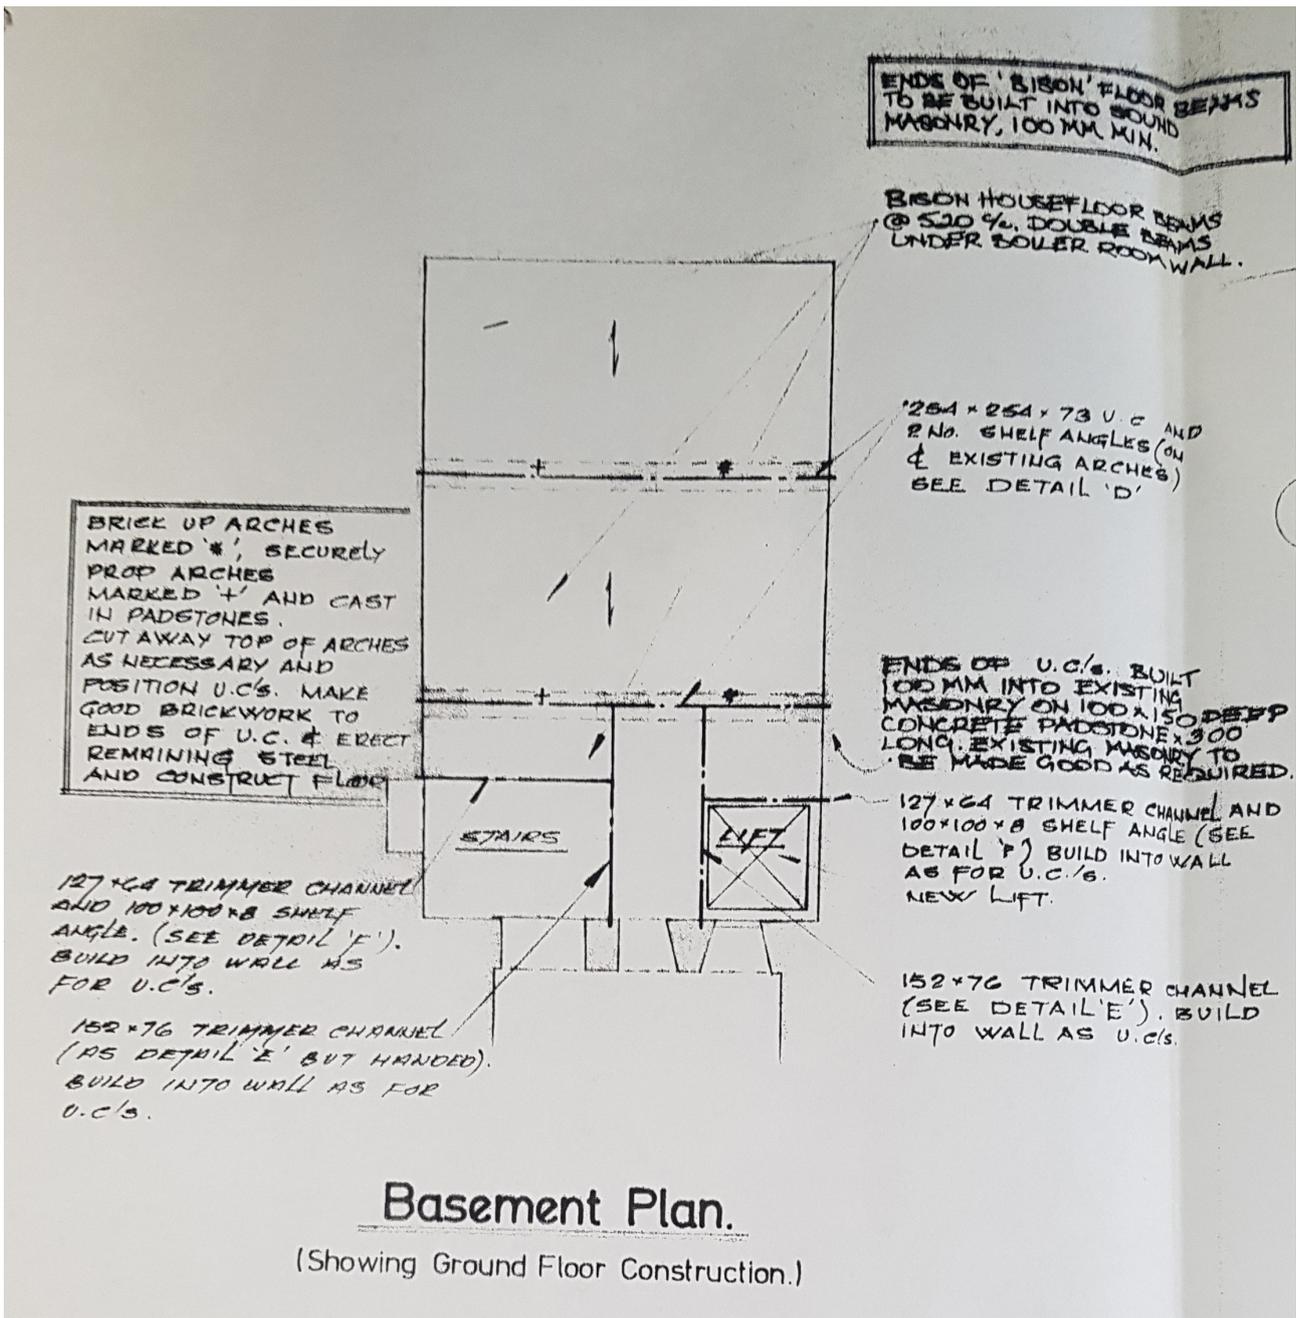
Figure 74: Proposed alterations to the space to the north of the undercroft in 1987. [© Simpson Associates Consulting Engineers, reproduced with permission.]

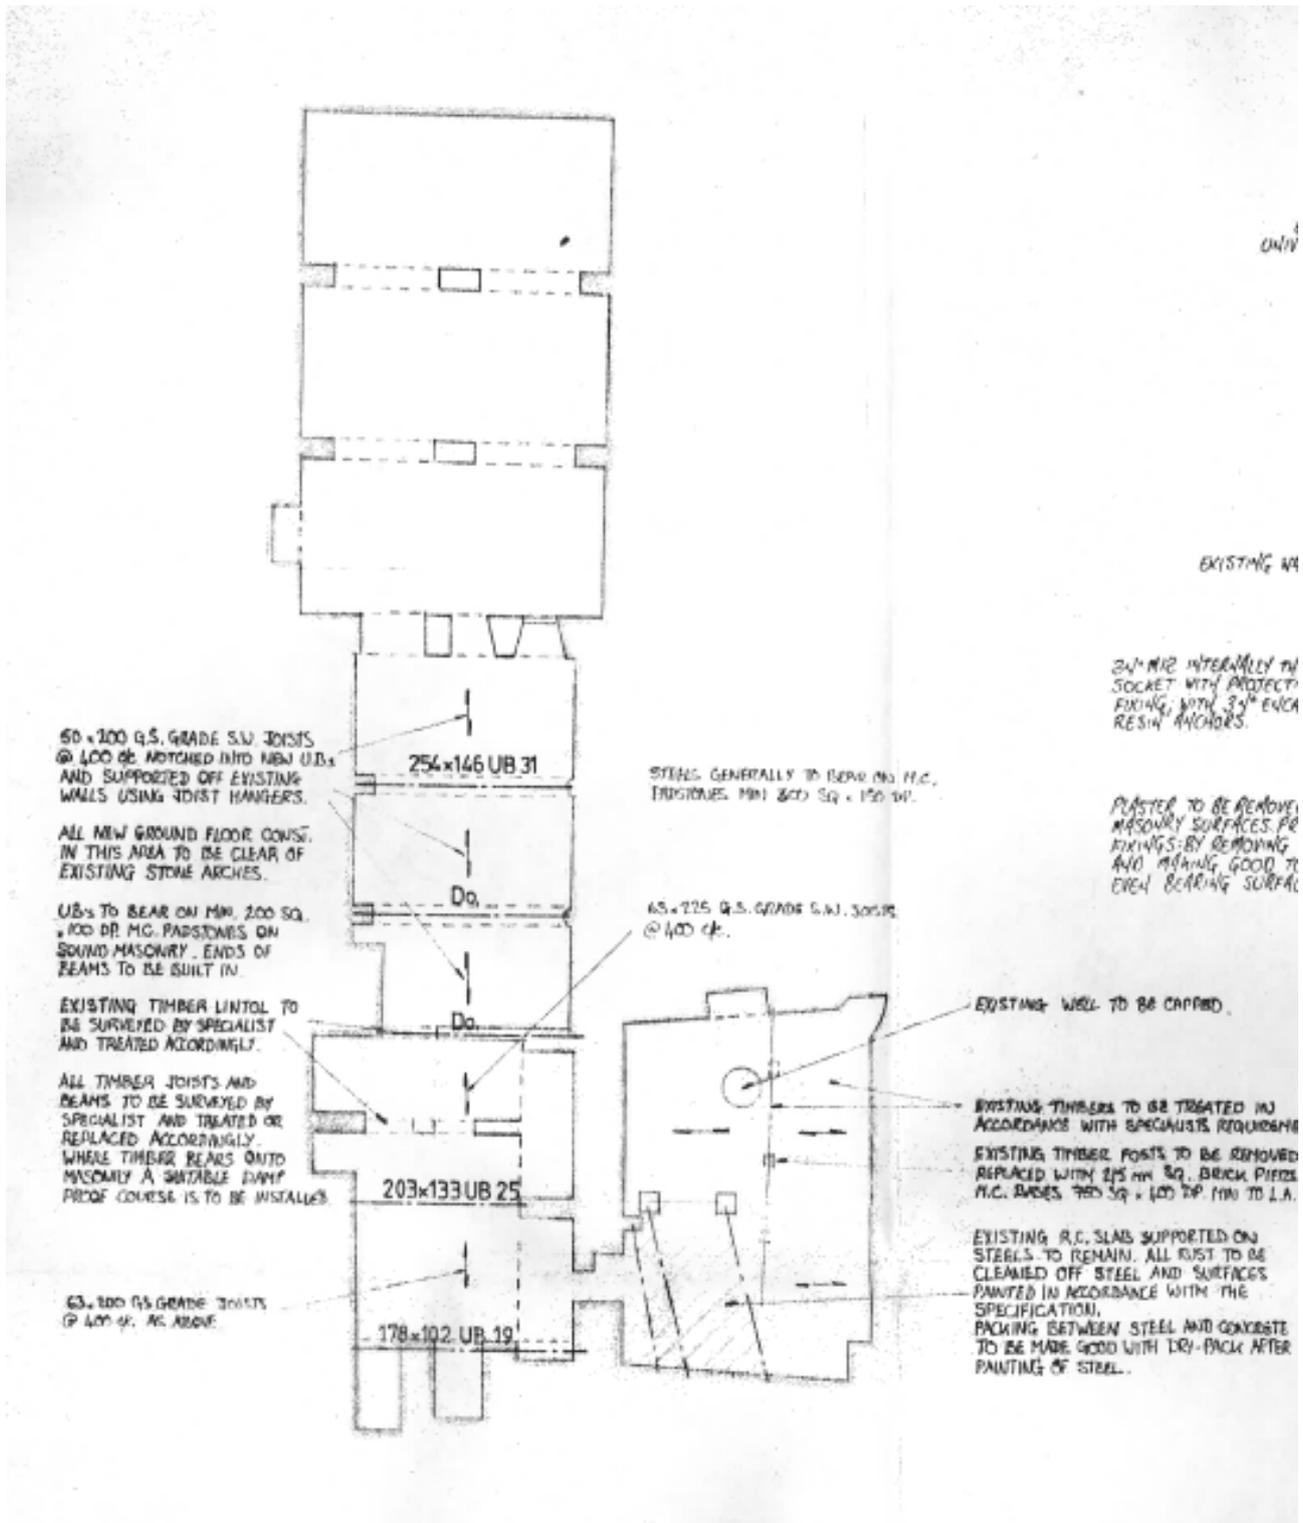
Figure 75: Proposed alterations to the undercroft and cellar under nos 74-76 Westgate Street in 1987. [© Simpson Associates Consulting Engineers, reproduced with permission.]

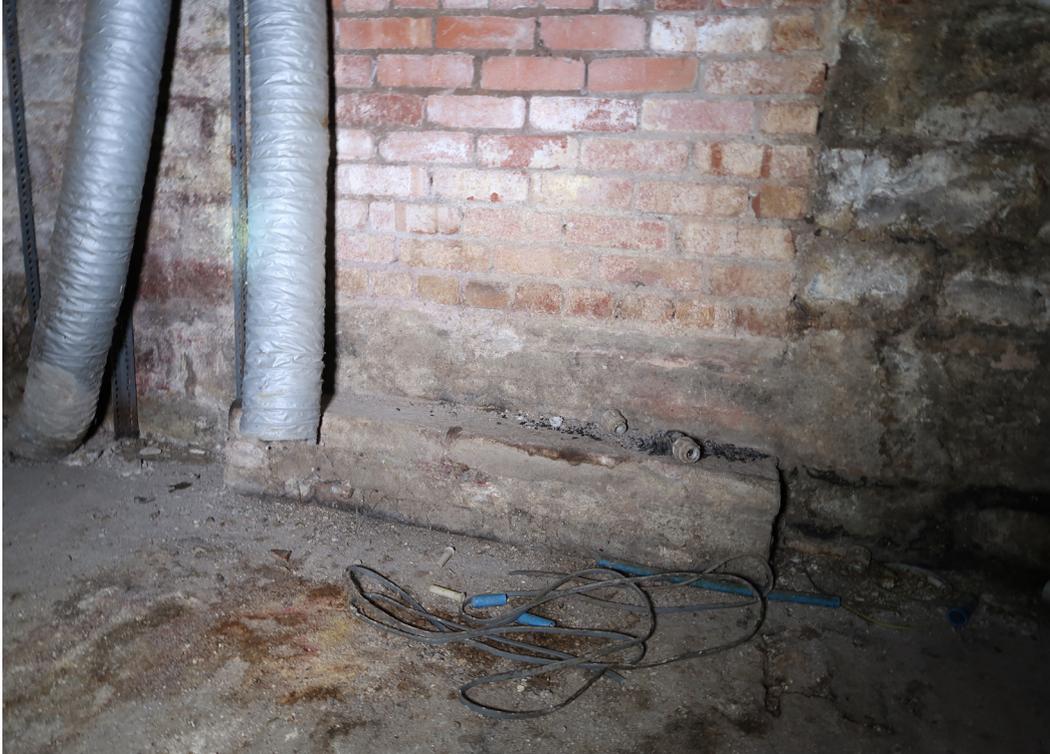
Figure 76: The step correlating with the brick infill of an earlier opening, the stone jambs of which are visible. [Abigail Lloyd © Historic England]

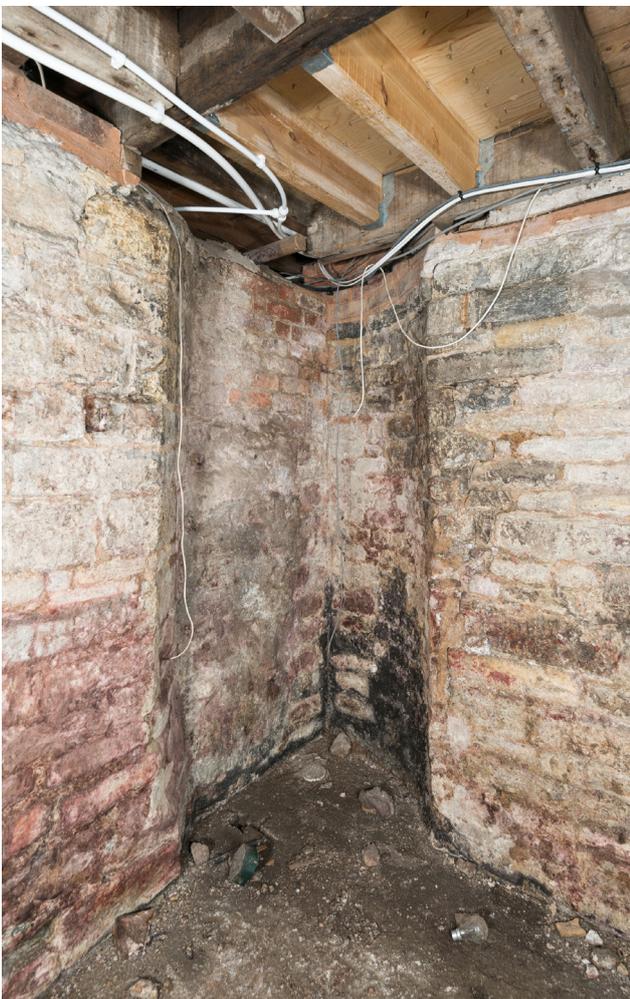
Figure 77: In the north-eastern corner of the cellar under no. 74 Westgate Street, there is a curved recess which might have housed a stair. [DP325706]

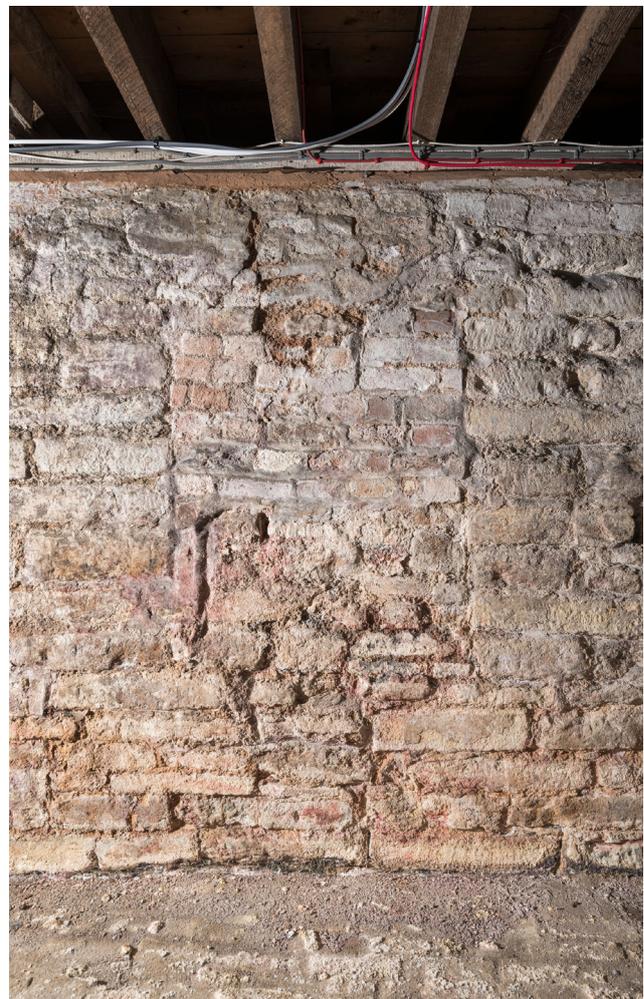
Figure 78: One of the blocked recesses on the eastern wall of the cellar under no. 74 Westgate Street. [DP325704]

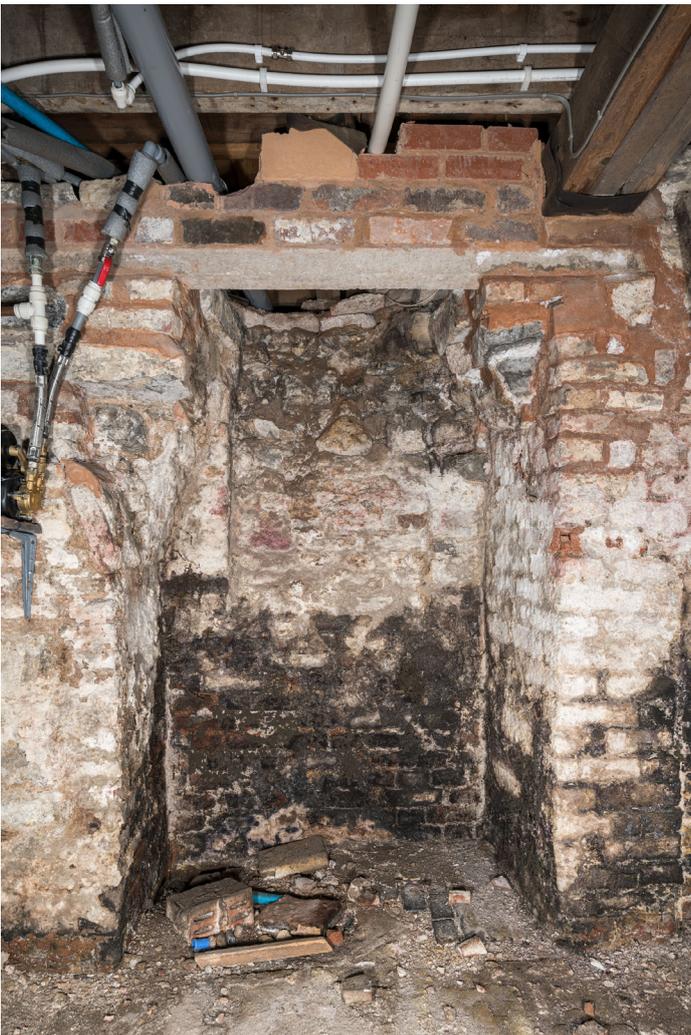
Figure 79: An opening on the north wall of the cellar under no. 74 Westgate Street, which appears to have the form of a chimney flue. [DP325707]
