The Undercrofts of Westgate Street, Gloucester

Historic Buildings Assessment

This report examines the evidence for medieval undercrofts surviving on Westgate Street, Gloucester. For the purposes of this study undercrofts are defined as the stone-vaulted spaces beneath a building or principal room.

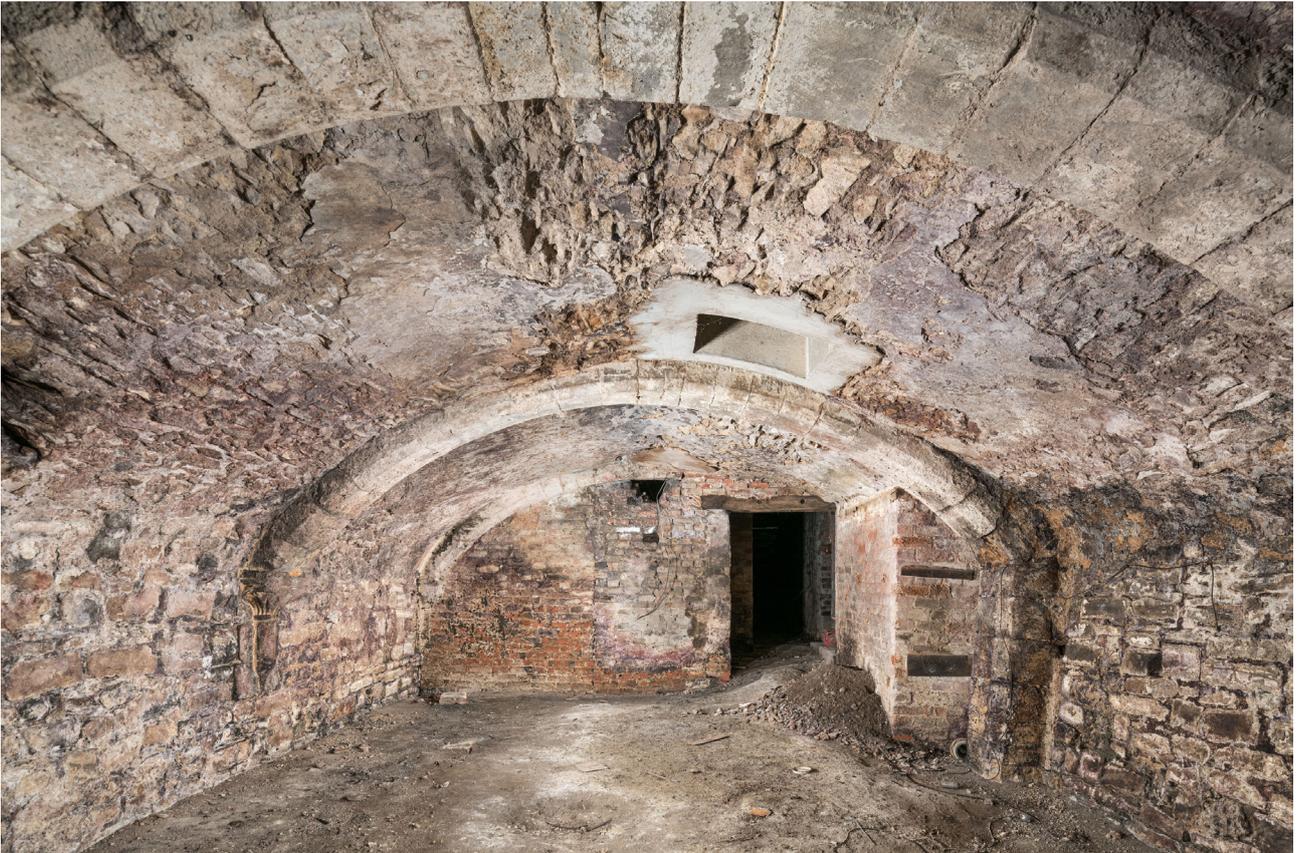
Figure 80: Looking south in the undercroft underneath no. 76 Westgate Street at a later brick transverse partition. [DP325713]

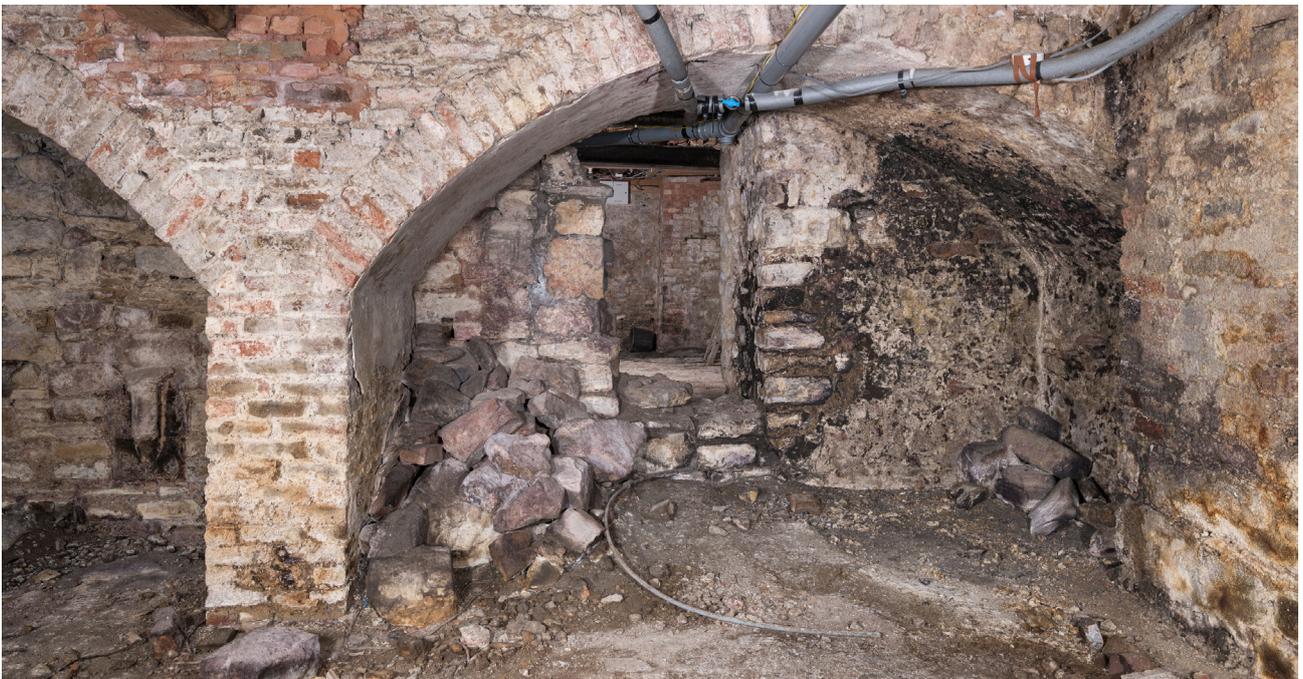
Figure 81: The brick arcade inserted against the south-eastern wall of the undercroft beneath no. 76 Westgate Street. [DP325709]

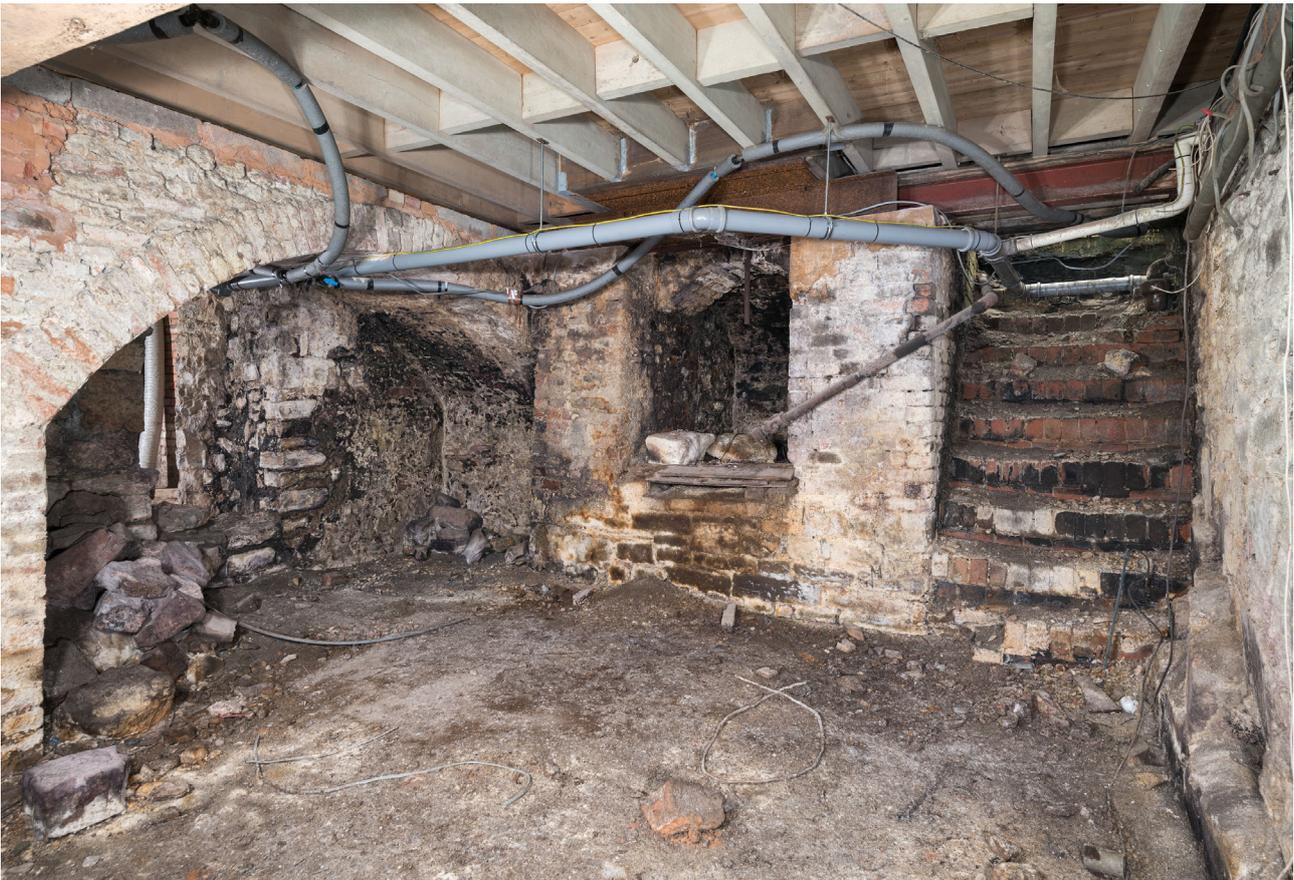
Figure 82: Looking at the south-eastern corner of the undercroft beneath no. 76 Westgate Street, showing brick stairs ascending in the south-western corner to street level. [DP325710]

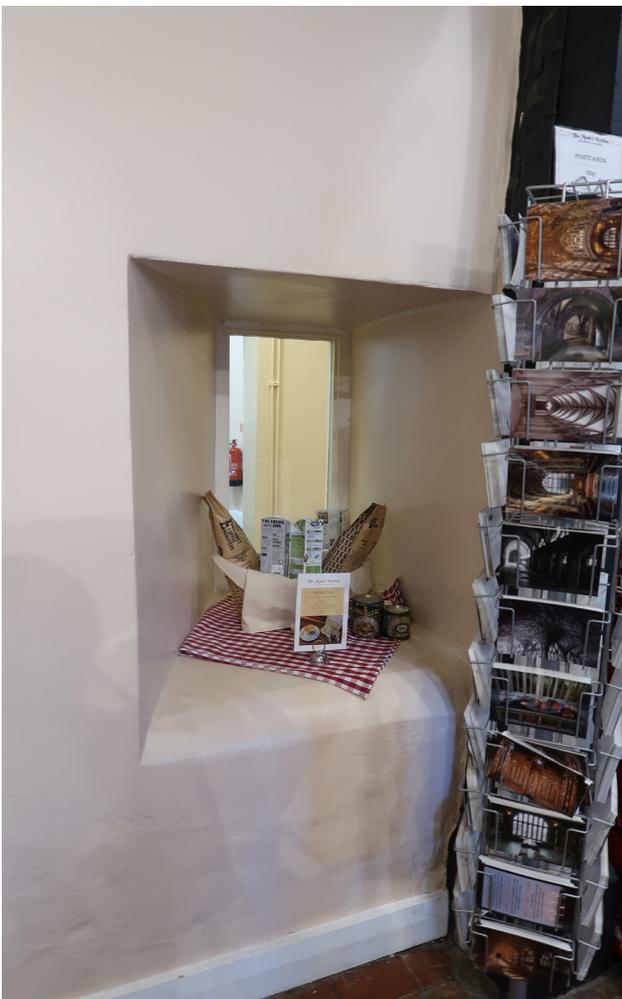
Figure 83: The splayed window in the possible undercroft at the north end of Church House in the Gloucester Cathedral precinct. [Abigail Lloyd © Historic England]

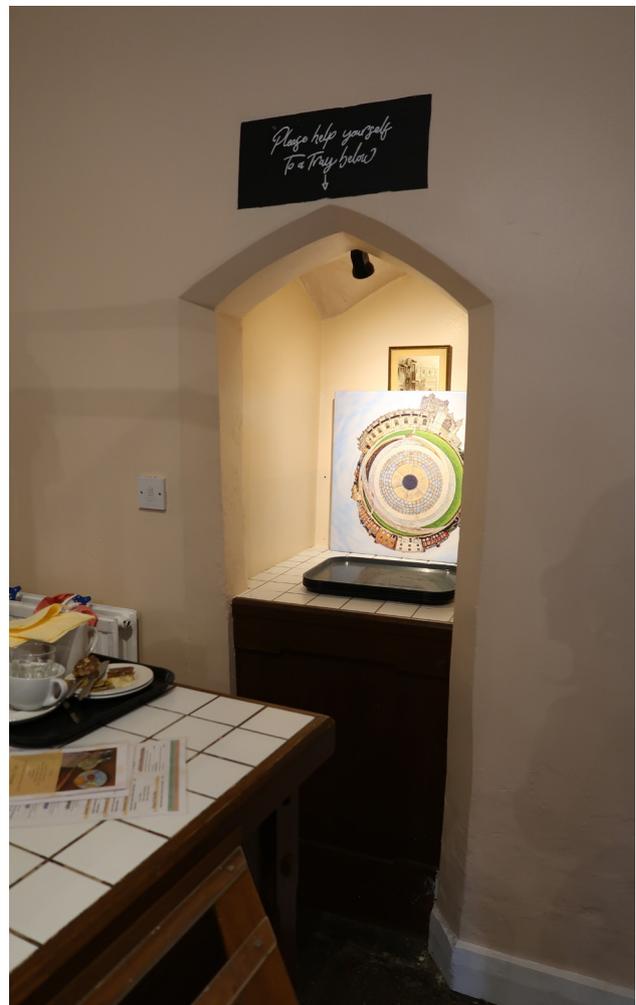
Figure 84: The pointed-arched blocked doorway in the possible undercroft at the north end of Church House in the Gloucester Cathedral precinct. [Abigail Lloyd © Historic England]

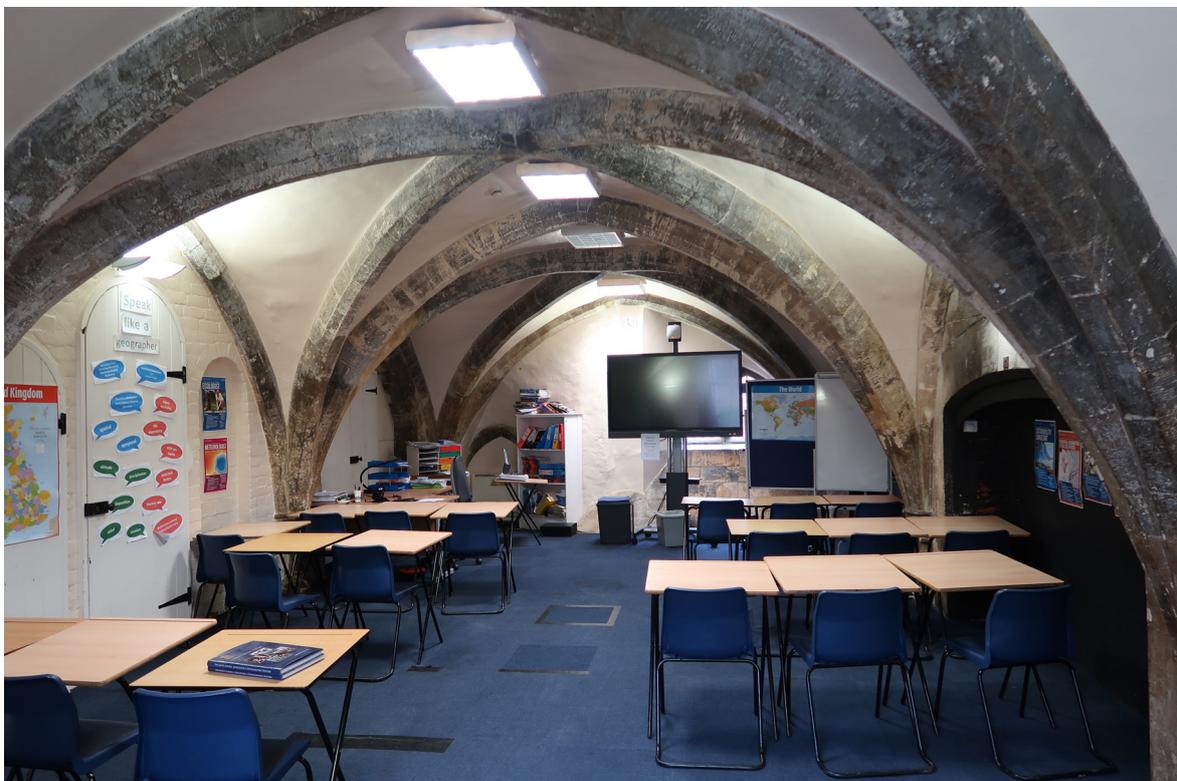
Figure 85: The 13th-century undercroft, looking north, beneath the monastic infirmary refectory. [Abigail Lloyd © Historic England]

Within the inner precinct, at the little or infirmary cloister, on its western side, there is a north-south range, the ground floor of which comprises an undercroft thought to date to the 13th century (NHLE 1271579) (Figure 85). The undercroft's three bays are defined by transverse and quadripartite ribs rising from short wall shafts with foliate capitals (Figures 86 and 87). (The southernmost surviving pair have bell capitals with roll moulding.) The chamfer on the ribs does not appear to be as broad as those in the undercrofts on Westgate Street. Again, this undercroft in the inner precinct is not subterranean nor semi-subterranean. Above the undercroft was the infirmary refectory (or misericord).

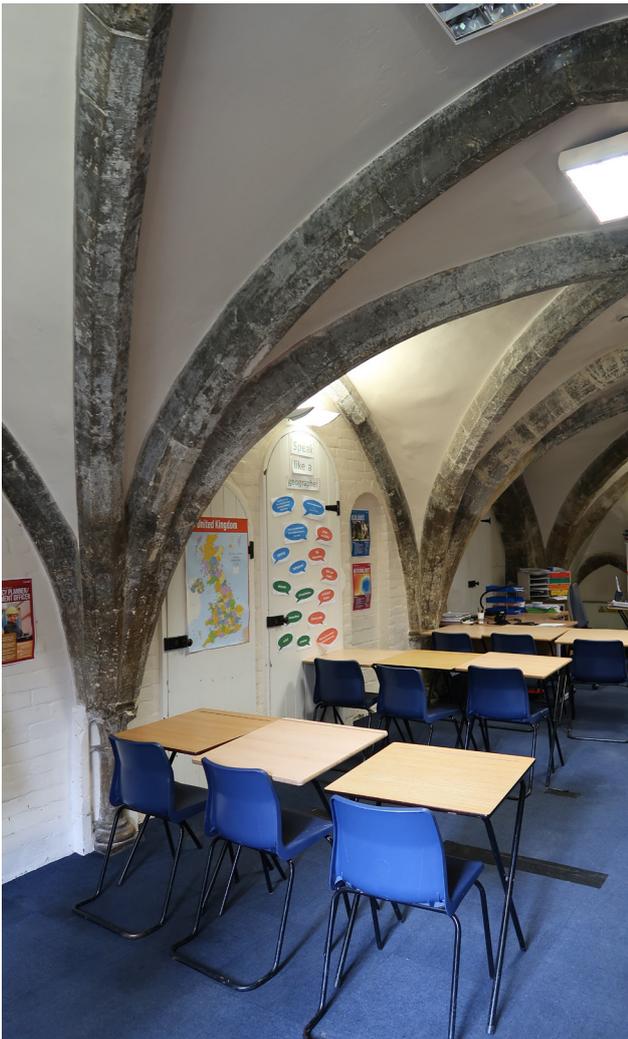
Figure 86: The wall shafts within the 13th-century little cloister undercroft from which the quadripartite vaulting springs. [Abigail Lloyd © Historic England]

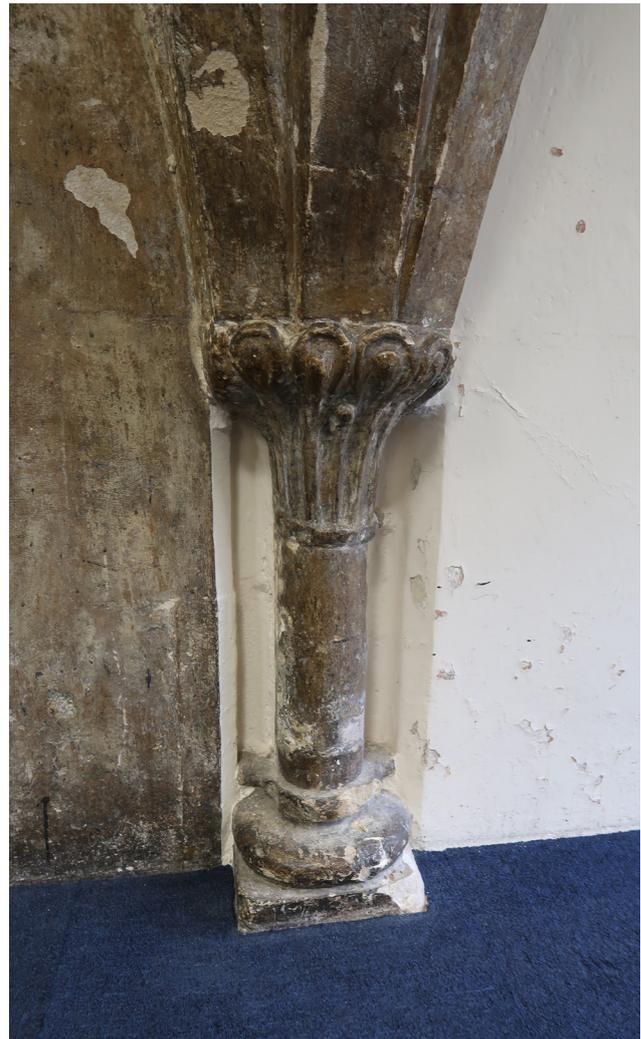
Figure 87: One of the shafts with foliate capital supporting the vaulting in the 13th-century little cloister undercroft. [Abigail Lloyd © Historic England]

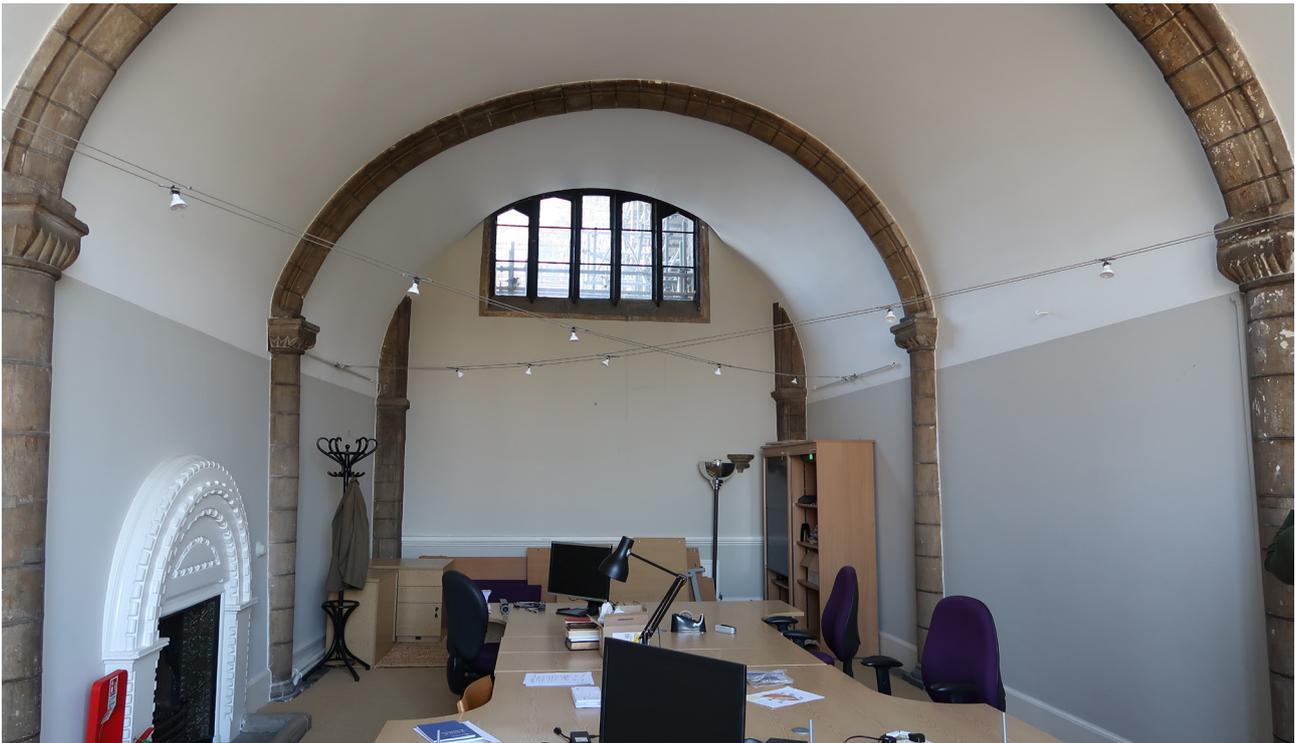
Figure 88: The chapel above the western slype in the former abbot's lodgings, looking east, showing the barrel vault and supporting pillars with scalloped capitals. [Abigail Lloyd © Historic England]

An earlier example, dating to the early 12th century, are the two barrel-vaulted spaces in the former abbot's lodgings (NHLE 1245900); namely, what is now known as the western slype and the chapel above it (Figures 88 and 89).²⁵⁸ Both the chapel and the slype have been truncated at the western end. In both, the bays are defined by transverse ribs, but the ribs are semi-circular in profile with hollow moulding, and not the square-chamfered type of rib found in all three of the 12th-century undercrofts on Westgate Street. The ribs spring from engaged pillars with scalloped capitals. The variety of the scalloped forms in these two spaces, in addition to the many other examples elsewhere in the Cathedral – such as in the crypt or in the arcading of the barrel-vaulted passage between the north transept and chapter house²⁵⁹ – demonstrate how varied such scalloped capitals could be and how creative masons were with the carved form. (The ribs in the 11th-century crypt are mainly rectangular in profile, without a chamfer.)

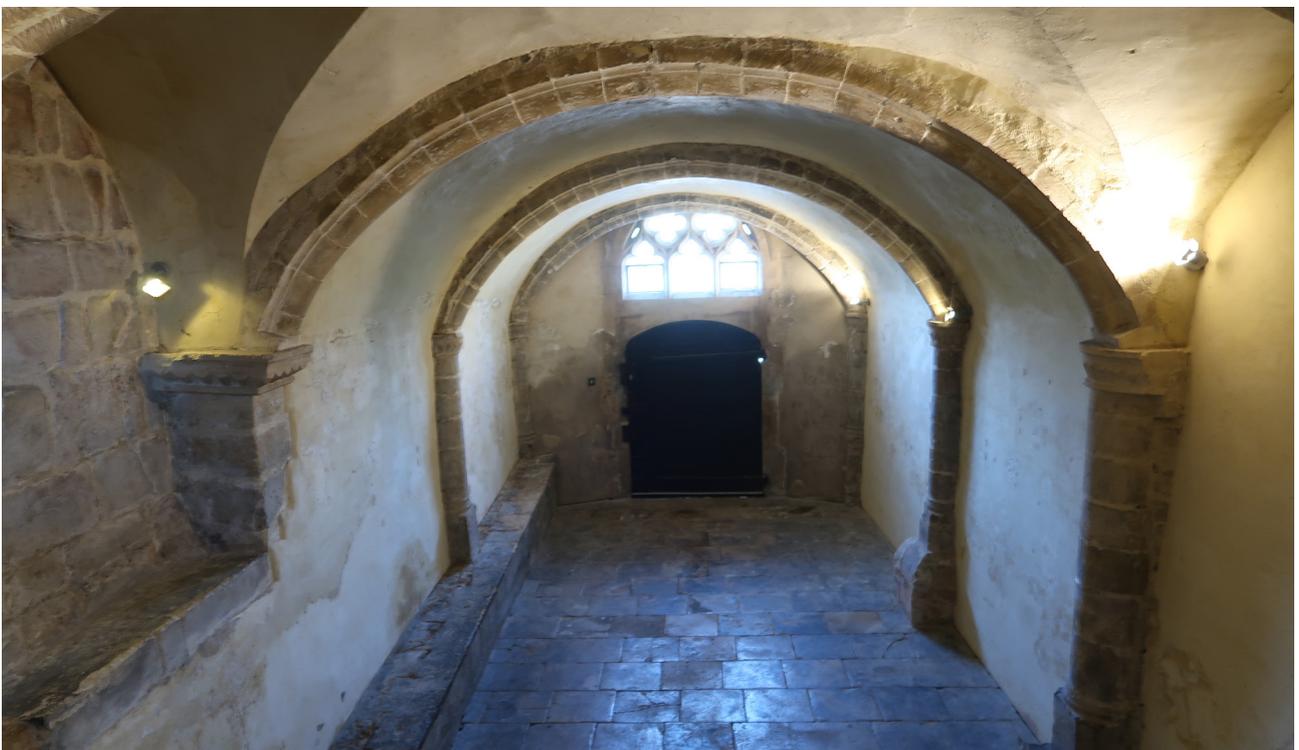
Figure 89: The western slype beneath the former chapel in the abbot's lodgings, looking west, again showing a barrel vault and supporting pillars with scalloped capitals. [Abigail Lloyd © Historic England]
