ENGLISH HERITAGE

HERITAGE AT  
RISK  
REGISTER  
2013

EAST OF ENGLAND

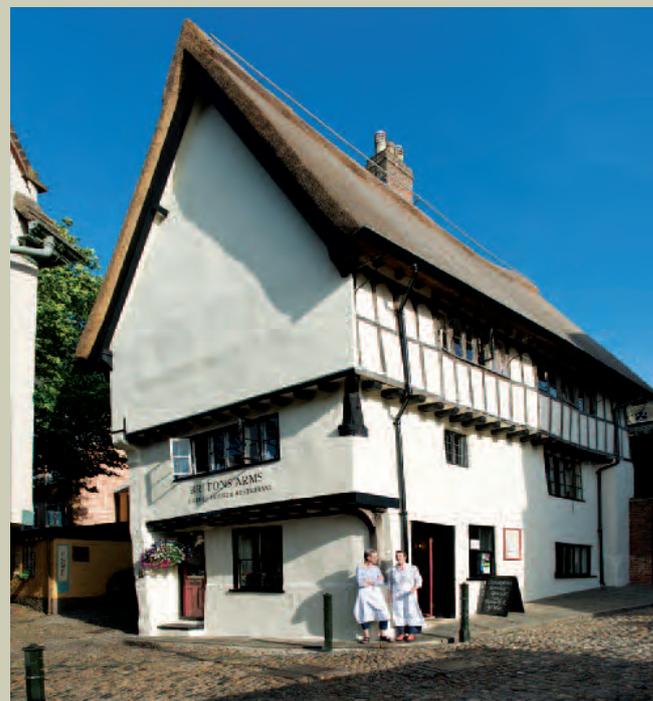
### BRITON'S ARMS, ELM HILL, NORWICH

Briton's Arms, reputed to be the only house in Elm Hill to have escaped destruction by fire in 1507. Located next to the church of St Peter, Hungate, it is a rare surviving example of a medieval city centre building with a reed thatched roof, once common in the city.

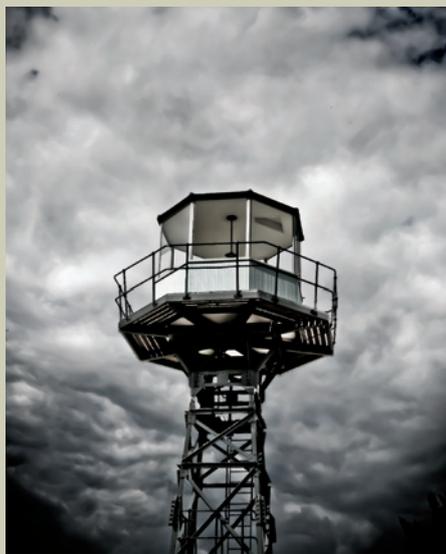
## ATOMIC BOMB STORE, BARNHAM, SUFFOLK

The Atomic Bomb Store at Barnham has been on the Heritage at Risk Register since 2012. Although much of the site has been in active use as a viable industrial estate since the RAF sold it in 1965, some elements, such as the perimeter fences, the 'igloos' and the watch-towers are not in use and until recently have been at risk of neglect and decay.

Exposed timber, steel reinforcement within concrete, and steel frames have decayed and corroded. The conservation of these elements is an on-going process, as new techniques are trialled and tested.

The parts of this nationally important site which are not in use have been targeted for selected pilot schemes to conserve the unstable and corrosive elements. English Heritage has offered grant assistance towards this work.

A conservation management plan was commissioned in 2008 and awarded a grant. This has led to three phases of investigation, repair and pilot studies in conservation, including dismantling and restoring one watch tower and work to fences and 'igloos'. These ensure the whole site is better understood. A fourth repair phase is envisaged.

Some elements within the site will not receive any conservation treatment, in order to better understand the nature of decay in these relatively modern fabrics.
