# Heritage at **Risk**

Historic England

**North West Register 2016**

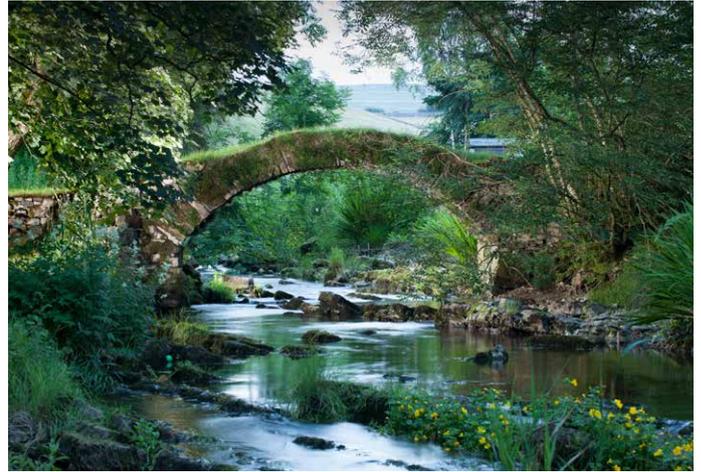
addition to working with Council Highways teams on numerous bridges, we supported a private land occupier in saving Gaisgill packhorse bridge (pictured), a stunning 18th-century scheduled monument in an idyllic rural setting near Orton in Cumbria. We put together a Section 17 Management Agreement for urgent repairs and an on-going management programme, ensuring this beautiful landscape feature is preserved for future generations to enjoy.

We also acted quickly to address flood damage to some of the region's most vulnerable heritage. In
