# Heritage at Risk

There are 683 assets on the London Register, just 1 more than in 2016

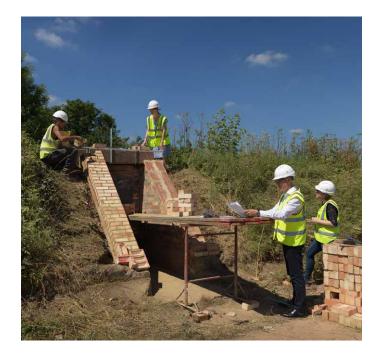
Kenley played a vital role throughout the Battle of Britain and the later London Blitz. Despite sustained aerial attacks, 11 of the original 12 fighter pens survive and are now protected as scheduled monuments. However, their condition has deteriorated, partly due to their wartime construction when materials were in short supply and often of poor quality. The surviving fighter pens were added to the Heritage at Risk Register in 2009.

Plans were soon underway to save the pens, led by the City of London, Kenley Airfield Friends Group and Historic England. On the 75th anniversary of the Battle of Britain, the Heritage Lottery Fund awarded a large grant to help conserve the site and ensure that Kenley's story is better revealed and shared. Historic England contributed a further £15.000.

Repairs are now well underway, due to complete in Autumn 2017, and an imaginative calendar of events will help to keep the story of RAF Kenley alive for future generations.
