Detailed testing: moisture

CIBSE – Studio PDP Retrofit revisit

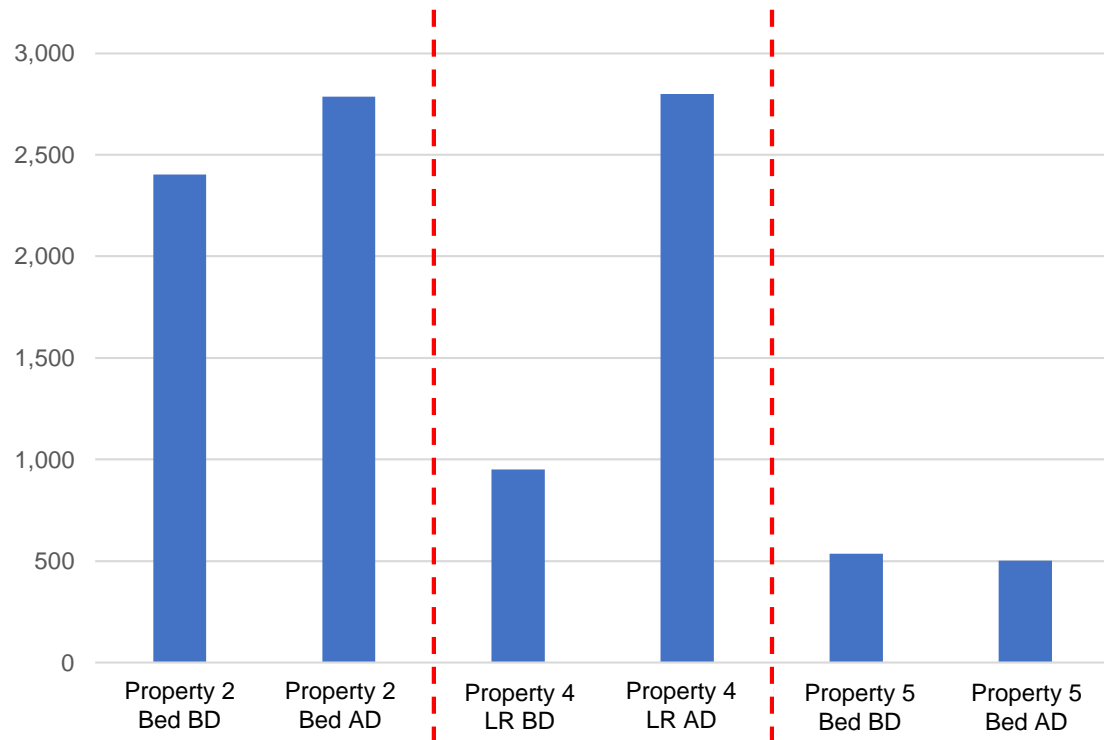
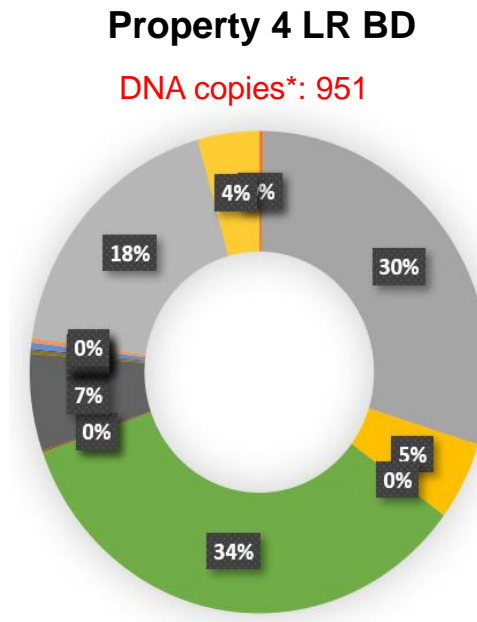
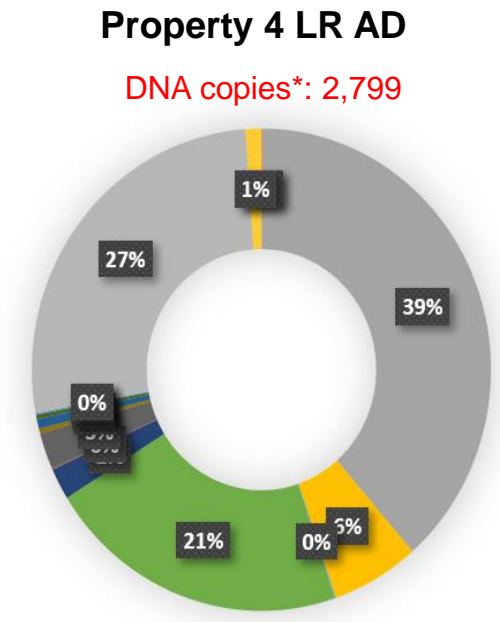
Air sampling before vs after depressurisation

DNA Copies of 16 targetted species

- Aspergillus niger
- Chaetomium globosum
- Cladosporium cladosporoides
- Cladosporium herbarum
- Stachybotrys chartarum
- Aspergillus versicolor
- Acremonium strictum
- Alternaria alternata
- Cladosporium sphaerospermum
- Penicillium chrysogenum
- Rhizopus stolonifer
- Aspergillus fumigatus
- Tricoderma viride
- Ulocladium chartarum
- Wallemia sebi
- Penicillium expansum

* Total DNA copies of 16 targetted species

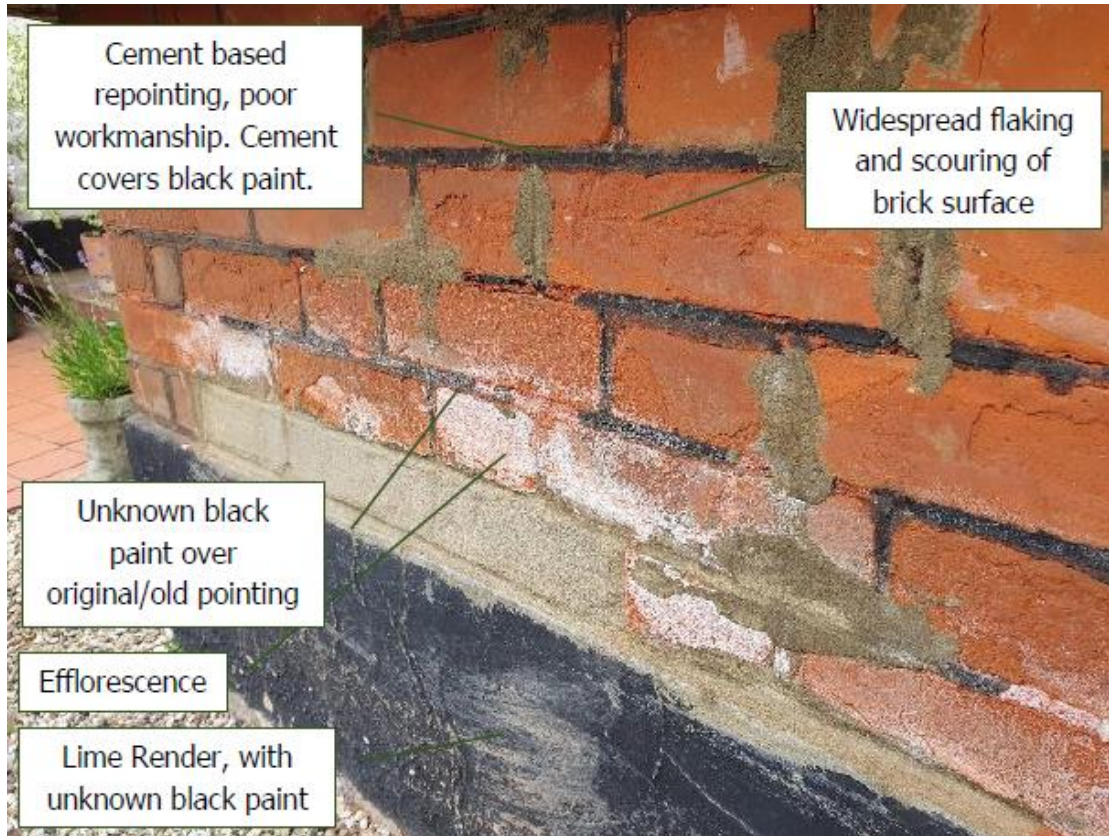
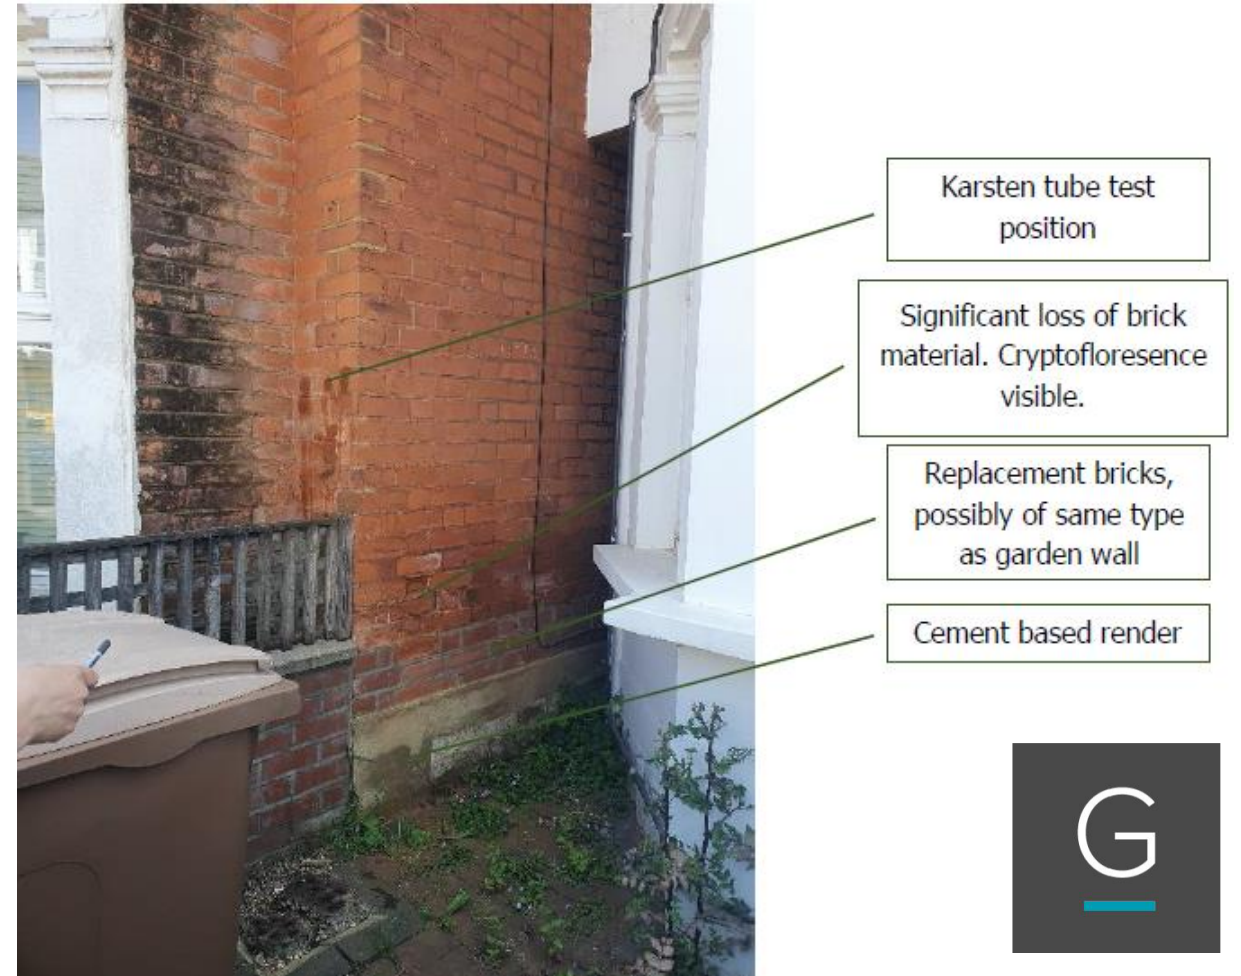
- Salt efflorescence at ground floor level, also in sleeper wall.
- Likely to be due to replacement of suspended floor to solid floor (concrete slab and EPS).

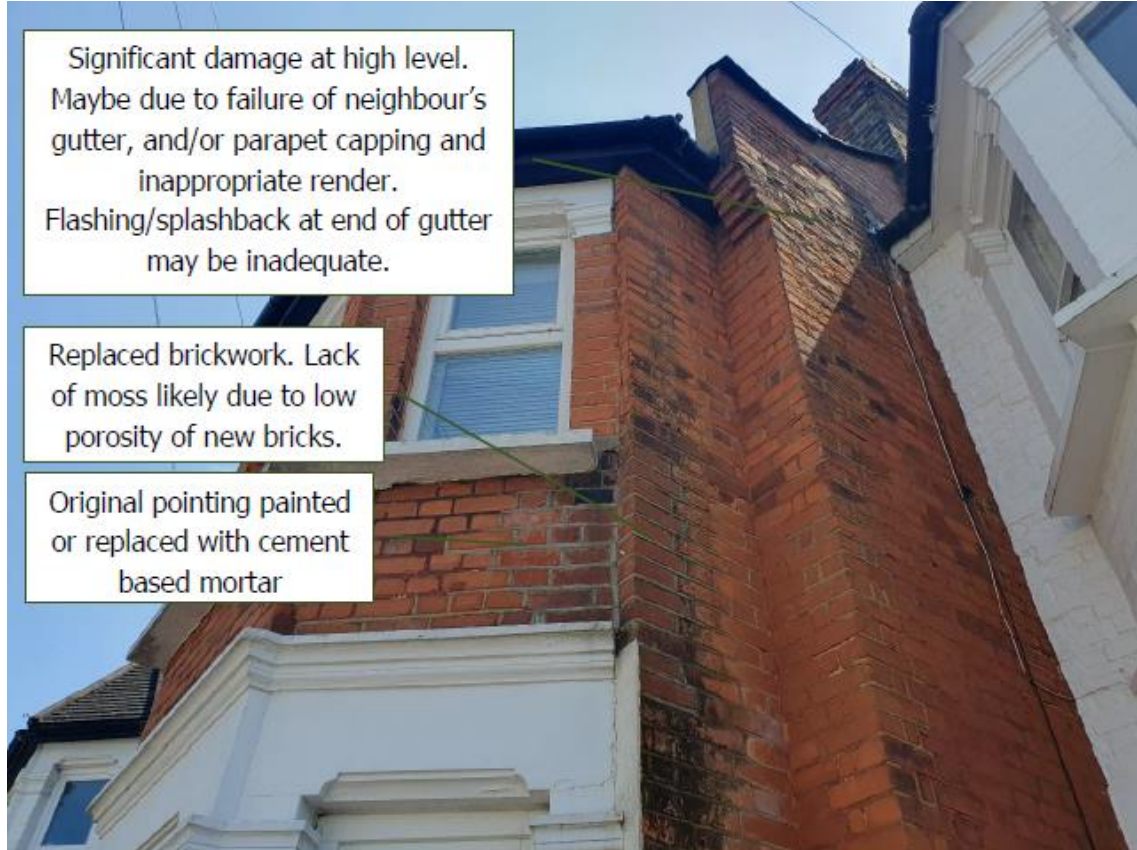
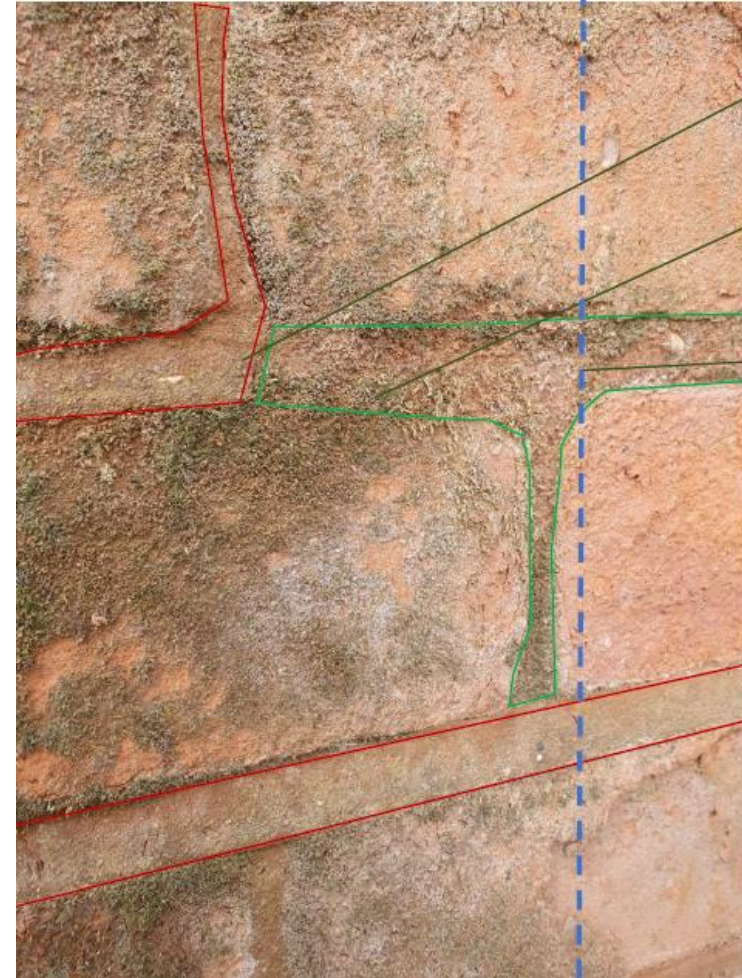
- Maintenance of gutters is an issue: leaking rain water goods
- Potentially leading to frost damage
