Historic England

IVY ON WALLS

Interim Seminar Report

2010

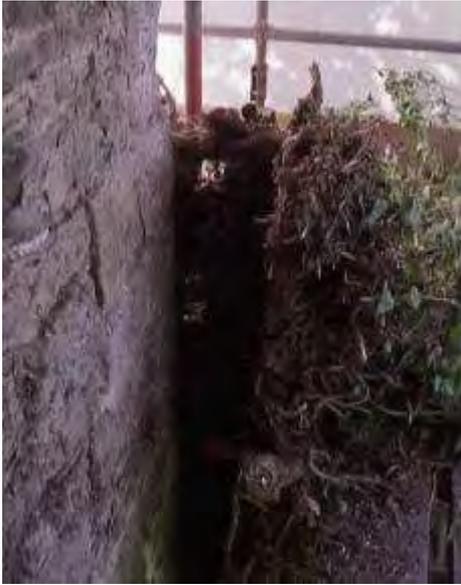
Figure 1.1 Wigmore Castle – decades old ivy being removed from unharmed walls.

The experience of English Heritage during the conservation of Wigmore Castle in Herefordshire crystallized these dichotomous viewpoints – some of the ivy covered walls were clearly being damaged by the plant which had rooted in at every opportunity whereas on others entire sheets of ivy were easily removed to reveal pristine stonework beneath (Figure 1.1). Following these observations it was decided that to produce better maintenance and conservation advice for the future, the impact of ivy on walls required a much more systematic examination by:

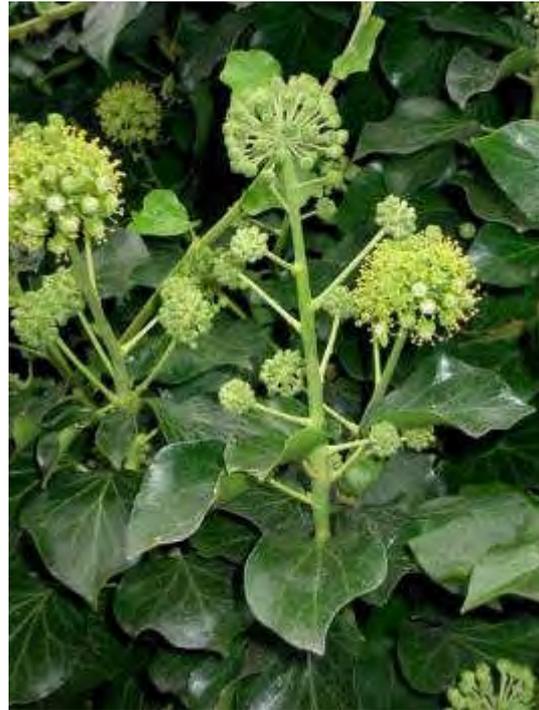
Figure 1.2 (right). Flowering or arboreal growth of *Hedera helix* showing altered leaf shape and flowering heads

Hedera helix is a native evergreen creeper/climber common in woodlands throughout the British Isles, Europe and into Asia Minor. It will creep along the woodland floor until it encounters something to climb up – usually a tree – although as we all know buildings will do equally well in providing a location for climbing. The driver for climbing is to reach high light levels to enable flowering. This usually starts when the ivy reaches the top of whatever it is climbing, but can then occur from the ground. It is unusual for flowering to occur before the top has been reached. The flowering growth, usually referred to as ‘arboreal growth’ is distinctly different from the climbing growth (Figure 1.2). It grows horizontally out from the vertical stems, is much more woody than the soft flexible ‘juvenile’ climbing stems and has leaves of a very different shape (Figure 1.3). In undisturbed situations this growth can reach several metres in length. Cuttings taken from this growth will grow as small shrubs and do not revert back to ‘juvenile’ growth.

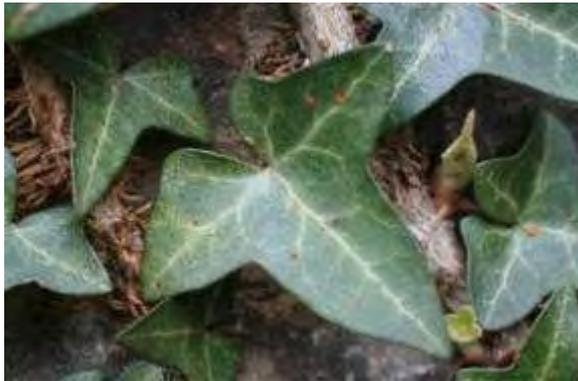
Figure 1.3 (below). Typical juvenile leaf of *Hedera helix*

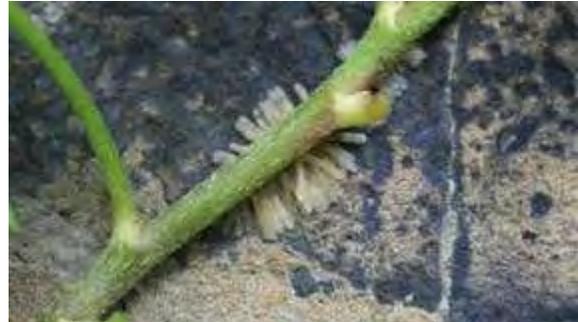
Typical aerial rootlets used to cling on to the climbing surface

2. The mechanism of attachment – how the aerial rootlets stick to walls and whether this causes permanent damage. Because ivy is a "self-clinging" climber it uses small, aerial rootlets to attach itself to the surface on which it climbs. Understanding how these rootlets adhere helps to determine the severity of an damage caused.

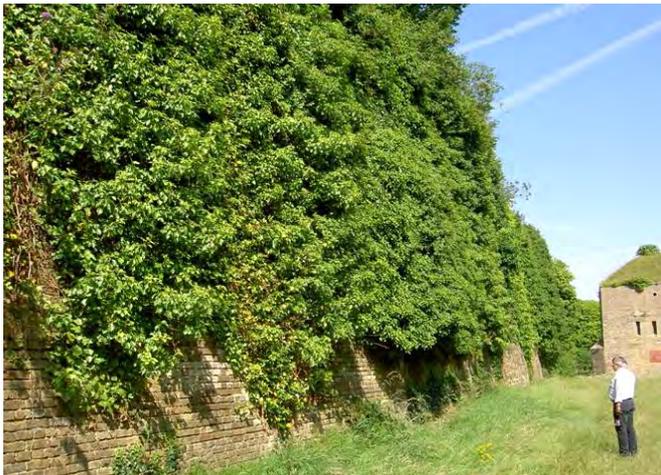
Condition surveys – are they possible with ivy cover?

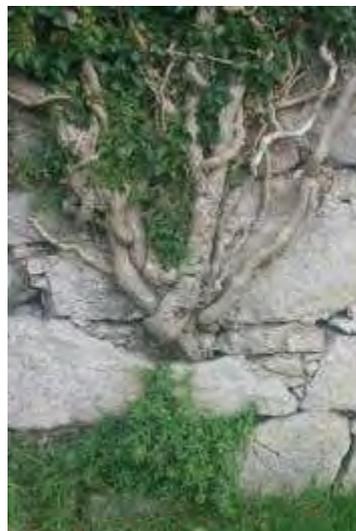
Figure 1.6 Ivy rooted in the wall, not the ground, is always damaging.

Clearly, despite our research goals, there are some circumstances where ivy is an undeniable nuisance and must be removed (Figure 1.6). There is no question that ivy or other plants properly rooted into walls will cause damage and should be removed in a similar way to any other tree or shrub – at the earliest possible stage.

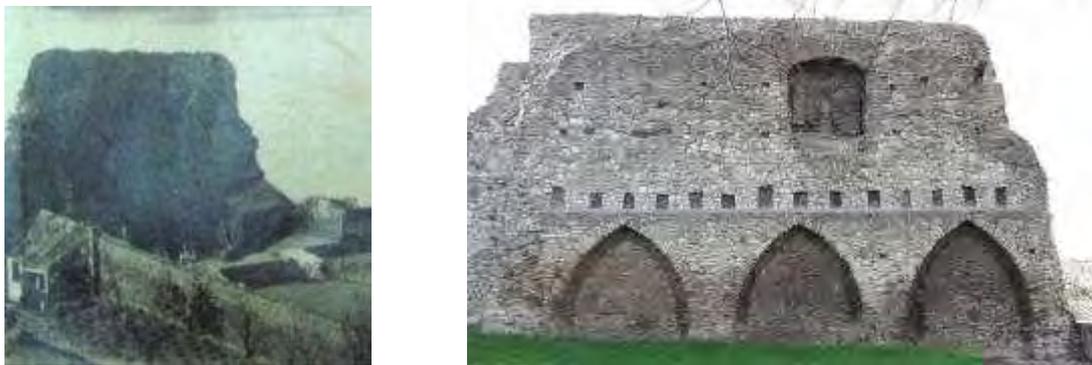
Figure 2.2 Rochester Castle wall covered in ivy (left) and without ivy (right).

The publications by Inspectors of Ancient Monuments, and also a number of antiquarians of the 18th and 19th centuries, make it clear that in their view, monuments were to be preserved for a well-defined social purpose: the instruction of those who visited them. As the Norfolk antiquary Henry Harrod wrote in 1872, historic buildings provided '*valuable studies for the architect, the antiquary and the historian*' or in other words, people with a high level of expertise, already minded and equipped to interrogate the monuments to ascertain their earlier form. At almost exactly the same time as Harrod was writing, a Royal Engineer took the black and white photograph of the castle gardens at Rochester in Kent, in which the section at the bottom left shows the drastic effect of ivy on site-presentation and the education of the visiting public. As the photo shows (Figure 2.2), the elevation of the curtain wall facing into the interior of the castle was entirely hidden by ivy until the early 20th century when the architect George Payne removed the covering in order to inspect and repair the stonework. This revealed several features of great interest in this stretch of the wall: the remains of two window embrasures of two lights (it has been suggested that there was formerly a third, in the place where the putlog holes mysteriously stop), the wall arches on the ground floor, the offset for the level of the first floor, and the line of joist sockets, which, incidentally, had to be restored by Payne: the medieval stonework in this area was fast deteriorating. But the obvious point to make is that only after the ivy came off was it possible to argue about the form of the building, or even to recognise that this was part of a building rather than just another stretch of the curtain wall. In fact it is generally accepted that this is one wall of the king's chamber in the castle, built in the 1220s on the orders of King Henry III, so there is evidence that the building is historically significant as well as architecturally reconstructable.

One further technical problem is implicit in the examples I have already used: as well as hiding the architectural and archaeological details from view, a thick growth of ivy will necessarily conceal the condition of the wall face, as was found to be the case in the decaying stonework of the curtain wall at Rochester: only when it comes off can a proper assessment be made.

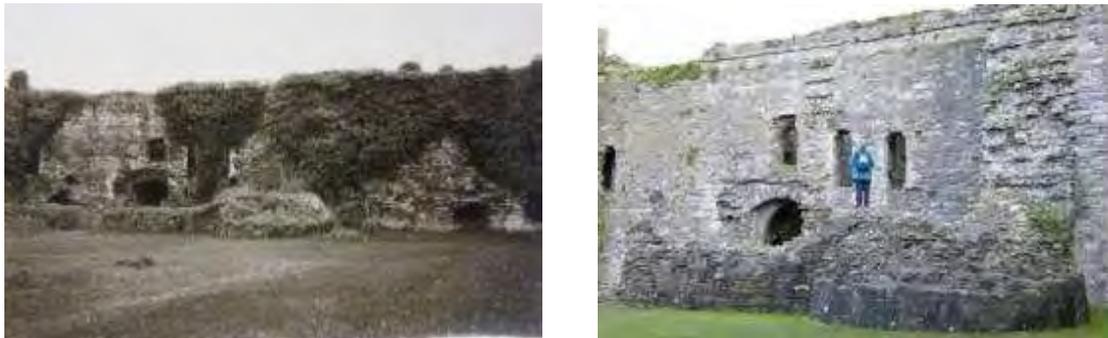
Figure 2.3 Beaumaris Castle with ivy (left) and without (right).

gatehouse at Beaumaris Castle on Anglesey is a complex but fragmentary structure that benefits from analysis according to the techniques of Buildings Archaeology (Figure 2.3). Only the de-vegetation of wall surfaces after the site came into guardianship in 1925 revealed the stubs of cross-walls, details of the wall-head and so on. (I should note in passing that the concealing ivy has adverse consequences for the modern work of interpretation and conservation in the 21st century: since there are very few good records from the early years of guardianship, historic photographs of this kind become crucially important in assessing how much of the fabric is original and how much dates from early consolidation works in the 1920s). When ivy or other vegetation compromises the legibility of a monument, this is obviously an impediment to the site's presentation, at least to an archaeologically informed audience: it's a good thing that the ivy has stayed off.

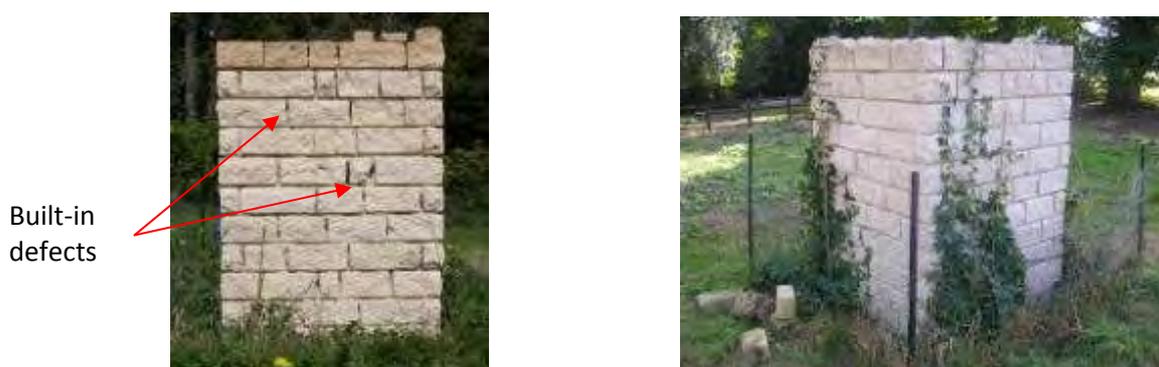
Figure 3.4 Wytham test wall before and after ivy growth.

In order to address this objective, we built a test wall at our field site at Wytham Woods, near Oxford, and allowed ivy to grow up it. Based on field observations, we hypothesized that ivy roots would penetrate into walls only when there are holes reaching right through the wall. The wall was built in August 2007 from Elm Park limestone with lime mortar. It consists of four faces (facing N, S, E and W) around a central core. Each face is 1.2m wide and 2m high. The wall was built with a range of defects which we hoped would encourage ivy to take root within the wall. The defects were different forms of hole within the mortar joints, from small tubes to large crevices. Ivy was planted at the base of the left hand side of each face and encouraged to grow up the walls, so that on each face we would end up with one ivy covered half and one bare half. A wire mesh fence was placed around the wall to prevent deer (common in Wytham Woods) and other animals from nibbling the ivy. The test wall is shown in Figure 3.4 before and after ivy growth.

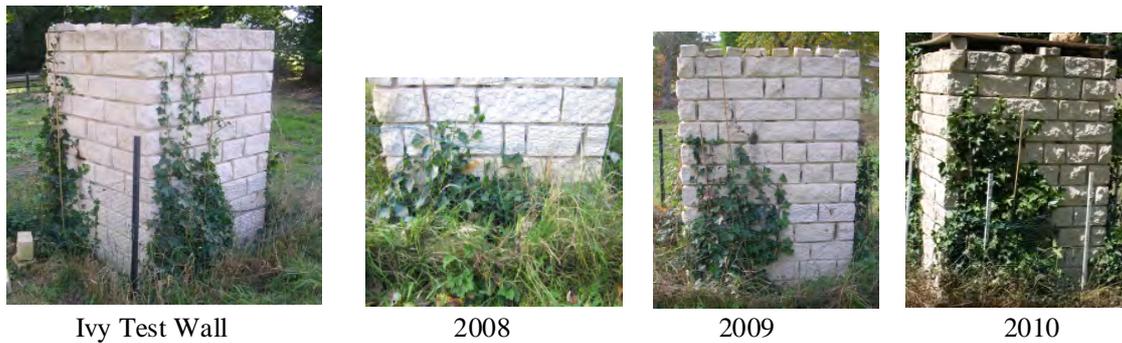
Figure 4.7 Ivy test wall, east face reflecting ivy colonization over time.

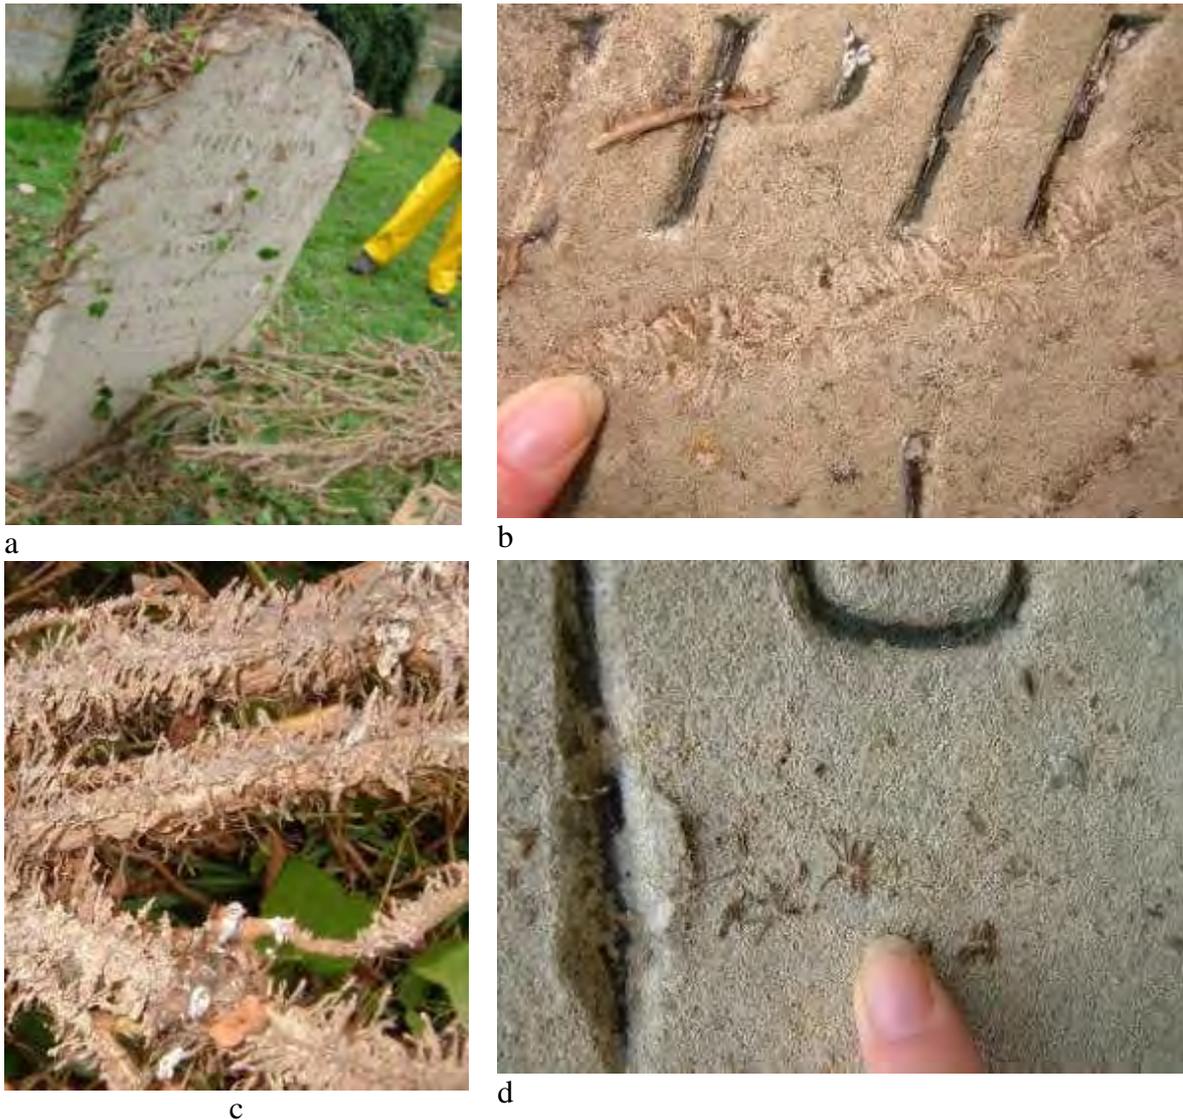
Figure 5.3 Minimal impact of aerial rootlets on limestone grave stones, Ramsey Churchyard, Cambridgeshire.

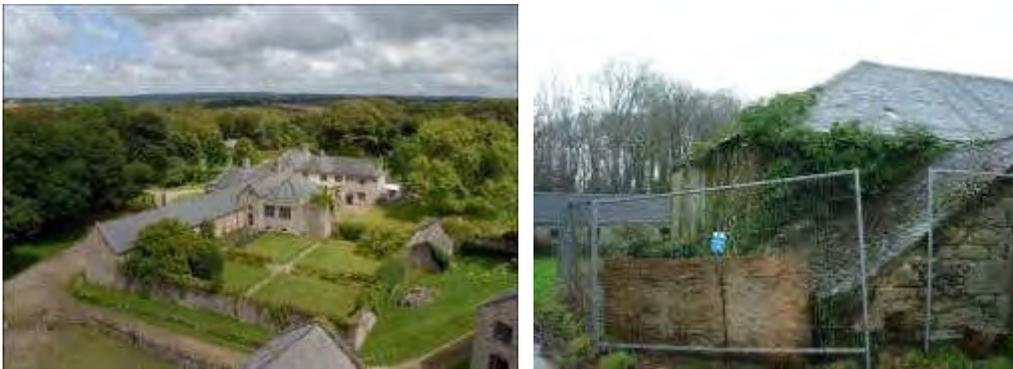
Figure 6.1 Godolphin Estate (left), section of wall undergoing ivy removal (right).

Ivy is a very resourceful plant with the ability to live under severe conditions. If cut it has the ability to multiply and grow as it finds new sources of nutrients and water. In this manner ivy can invade tiny cracks very aggressively in order to grow and survive. If left alone ivy matures and grows up building walls, using them as structural support. However, if buildings are in poor condition it will take advantage of small crevices that provide support. Ivy can grow year-round in southern areas of the UK because of the mild temperatures, with growth continuing throughout winter without needing food stored in the adventitious roots. In cooler areas the plant will stop growing in cold weather and survive using stored nutrients. The mild year-round temperatures at Godolphin in West Cornwall mean that there may not necessarily be a best time of year to remove the plant from walls. The research project timescale was less than one full year and further research over a longer period is needed to get the full range of results over all the seasons.

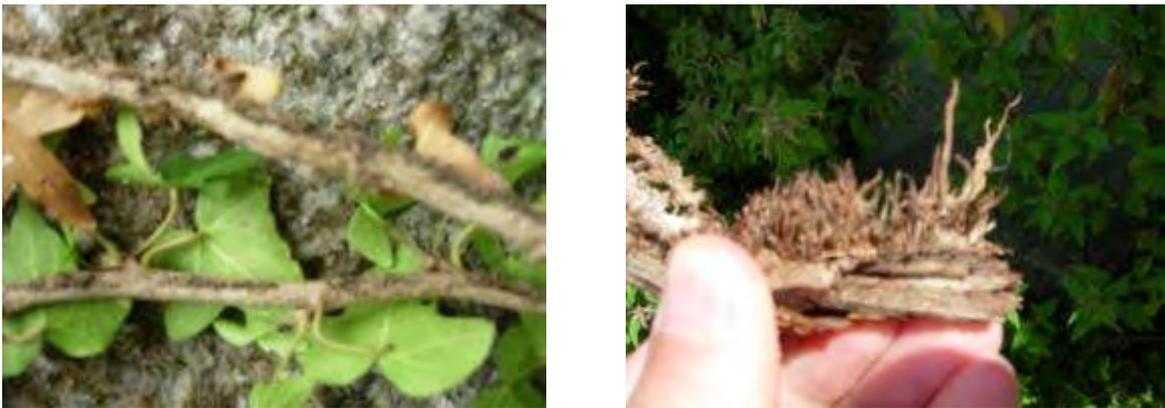
Figure 6.2 Adventitious roots on the cut ivy (left, upper stem) are much larger than on the live section (left, lower stem). This difference occurred over approximately 3 months. The photo on the right shows how large the adventitious roots can grow.

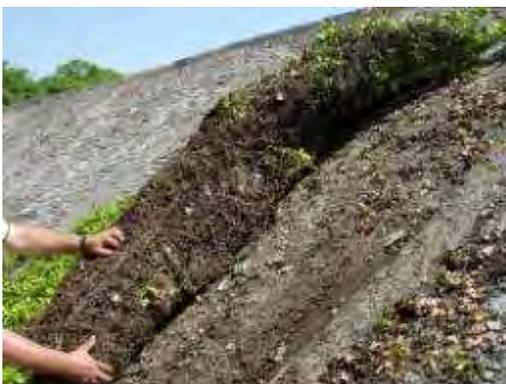
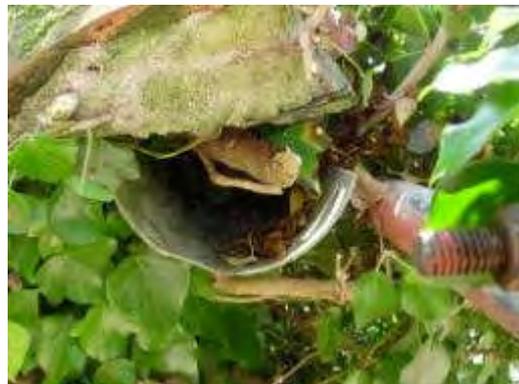
Figure 6.3 Ivy removal by hand (left). Care should be taken when removing ivy around eaves (left).

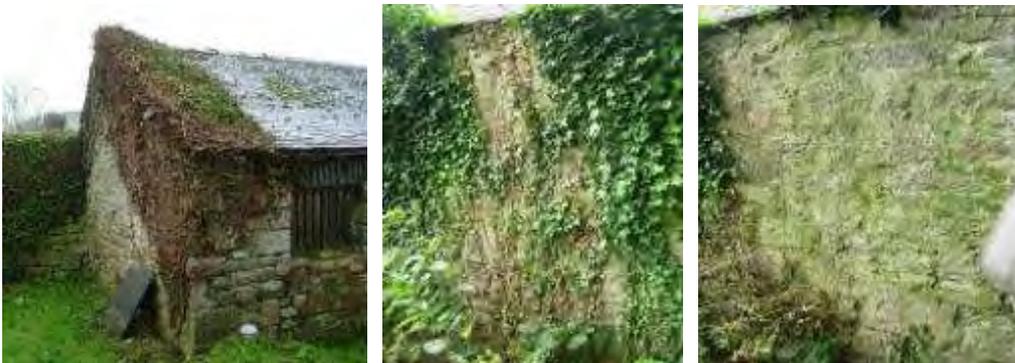
Figure 6.4 Methods of ivy removal. Cut stem (left), poison (centre) remove by hand (right).

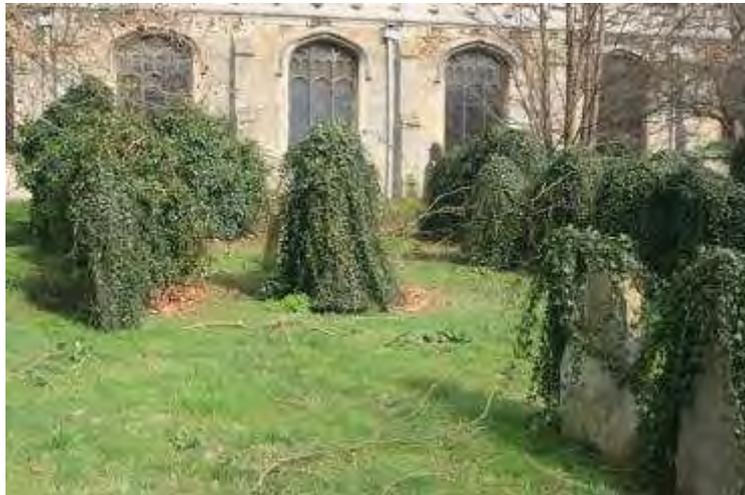
Figure 7.1 Ramsey Churchyard.

St Thomas a Becket Churchyard, Ramsey, Cambridgeshire was brought to the attention of English Heritage (EH) in January 2008 because of extensive and unusual ivy growth on the majority of gravestones in the churchyard (Figure 7.1). In March 2008 a team from EH and Oxford University were brought in to assess the impact of ivy on gravestones as part of the Ivy on Walls research project. The team removed all ivy from 3 gravestones and partially removed ivy from a 4th that served as a demonstration. The work followed initial discussions between EH, the District Council responsible for this scheduled area and local representatives of the Town and Ramsey Rotary Club who were keen to have all ivy removed. Ramsey Churchyard contained a remarkable, probably unique, number of gravestones completely encased in ivy growth. Individual stones, and in some cases whole rows of stones, were encased, often with neighbouring stones fully exposed.

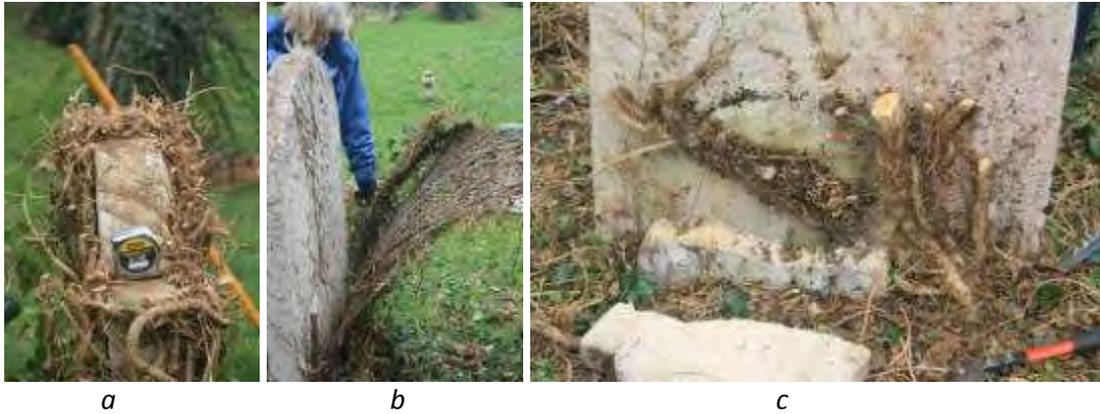
Figure 7.4 Ivy removal – *a*. removal of material from top of stones, *b*. peeling ivy away from gravestone surface, *c*. removal of main stump and root.

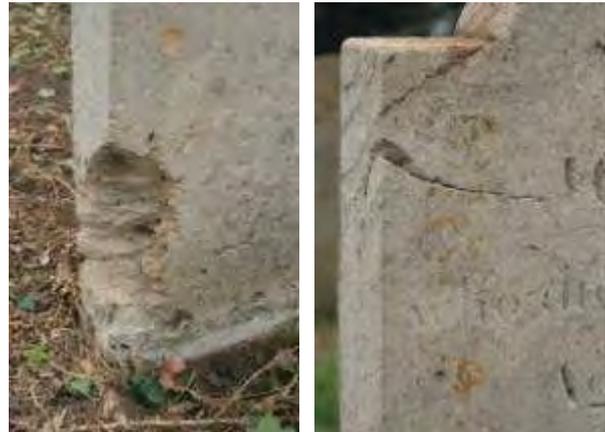
Figure 7.6 Uncovered damage on gravestones.

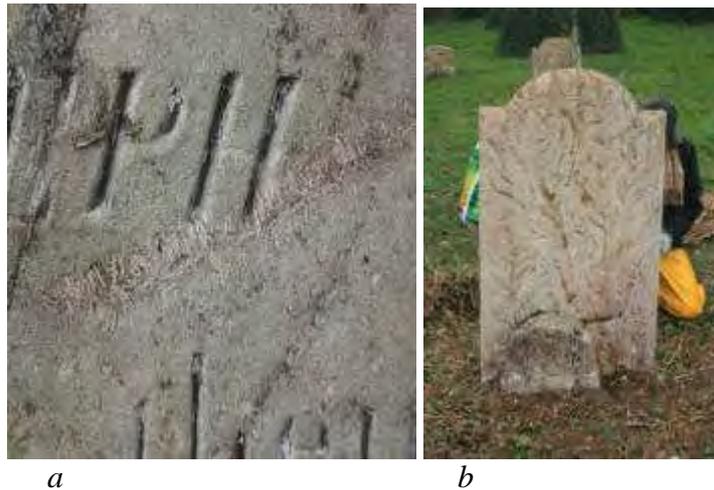
Figure 7.7 Aerial root marks (a) and brown staining (b) on gravestones.

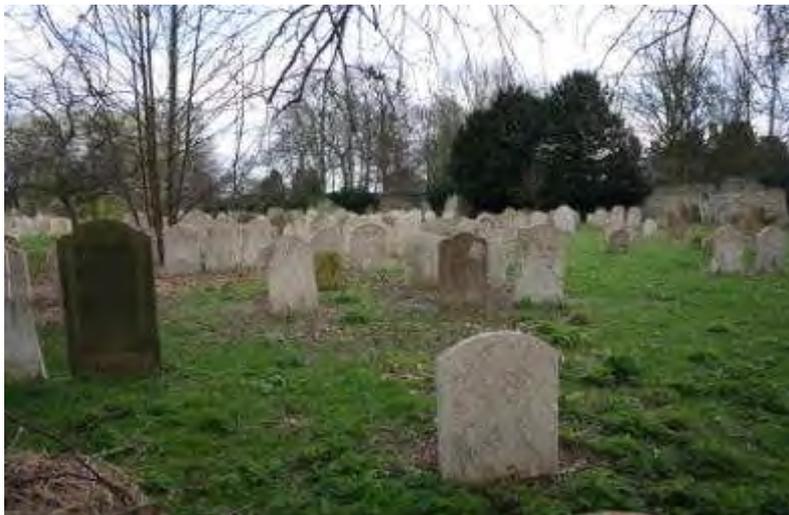
Figure 7.9 Ramsey Churchyard after complete ivy removal, March 2010.

removed ivy from all remaining gravestones (Figure 7.9). All stones appeared in good condition, thus confirming our observations.

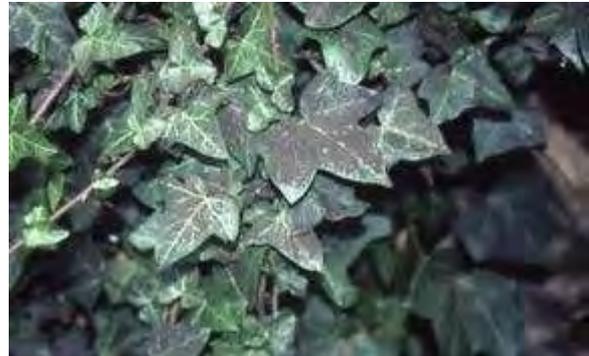
Airborne pollutants can be trapped

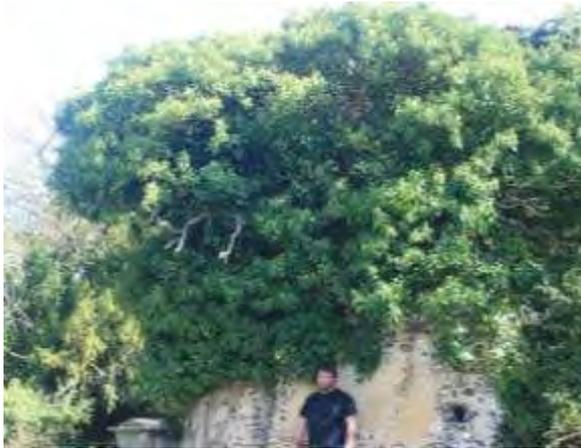
Assessing the condition of structures is difficult

1. It is difficult to carry out a condition survey on a structure covered in ivy
2. Ivy is able under certain conditions to root into – rather than cling onto – some structures and when this happens damage will occur
3. It has ecological disadvantages
4. It may not assist the presentation of all sites

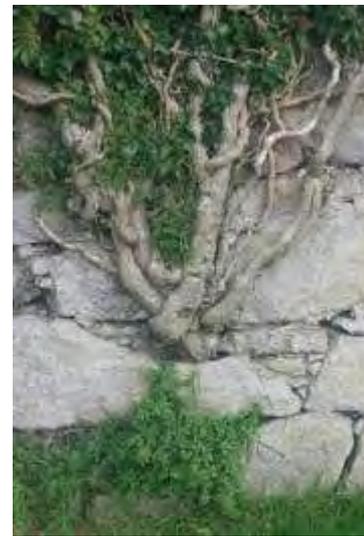
Where it occurs, rooting into the structure is damaging

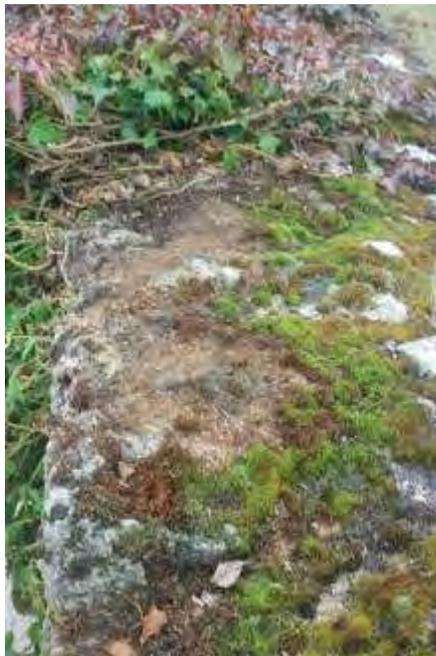
Removal of encroaching ivy from this walltop shows that covering of ivy allows no other vegetation to survive

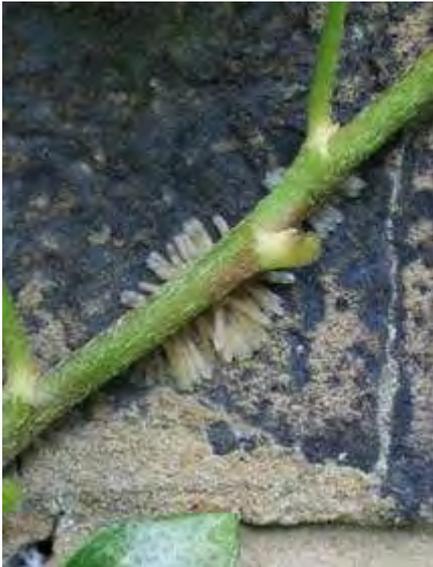
Figure 10.3 Example of root attachment on stone surface. The mechanism by which aerial roots cling on to the surface and whether this damages the surface is still being investigated

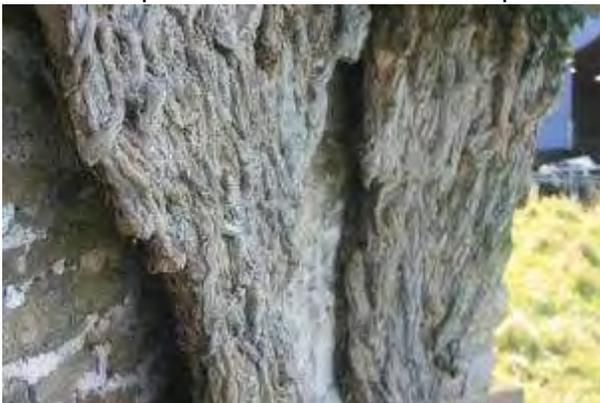
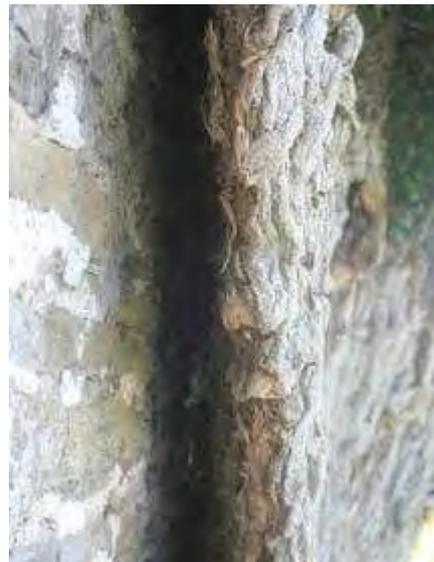
Above and right: a close look at an old ivy stem reveals that it is barely touching the wall and certainly not rooted in. Removal may not be necessary

Note: the curious shield like flattening of the stems was probably caused by grazing animals

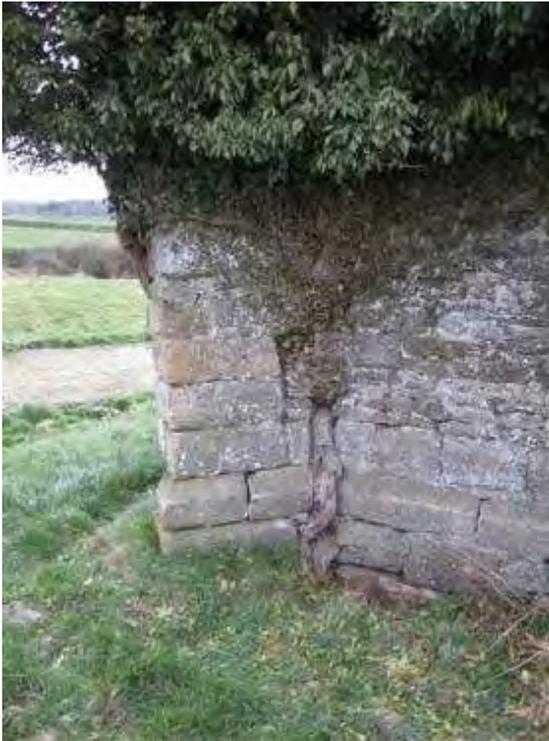
a

a) A clear case where ivy growth will cause increasing problems and should be removed

In both cases removal of the ivy would have to be followed by structural repair

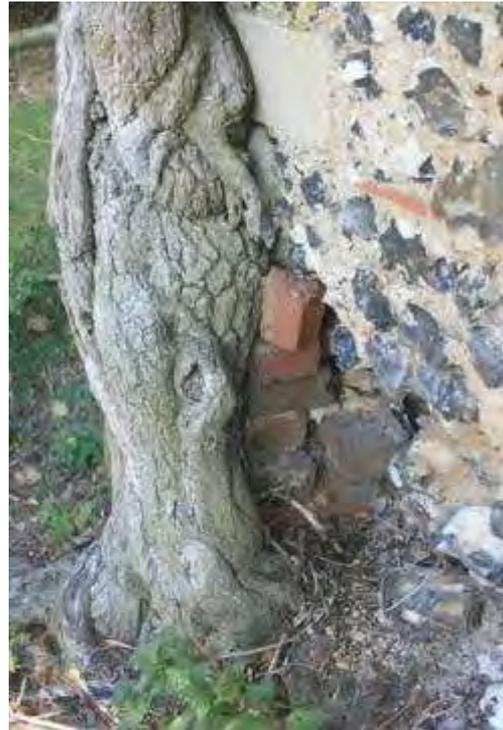
b

b) Here the case is not so clear cut, the ivy may be preventing damage getting worse

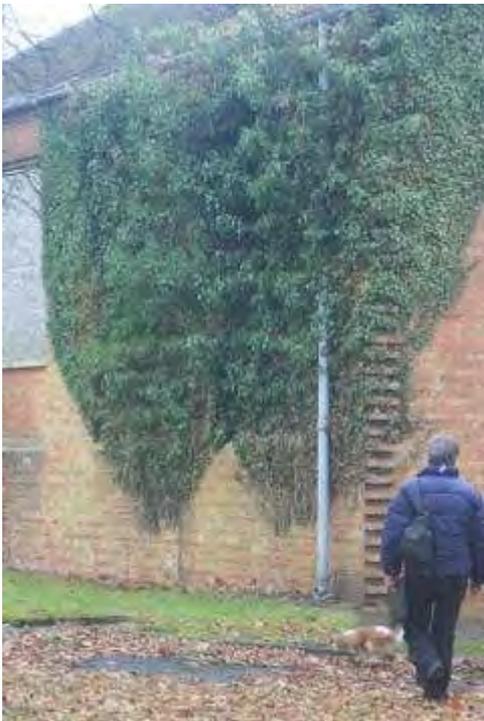
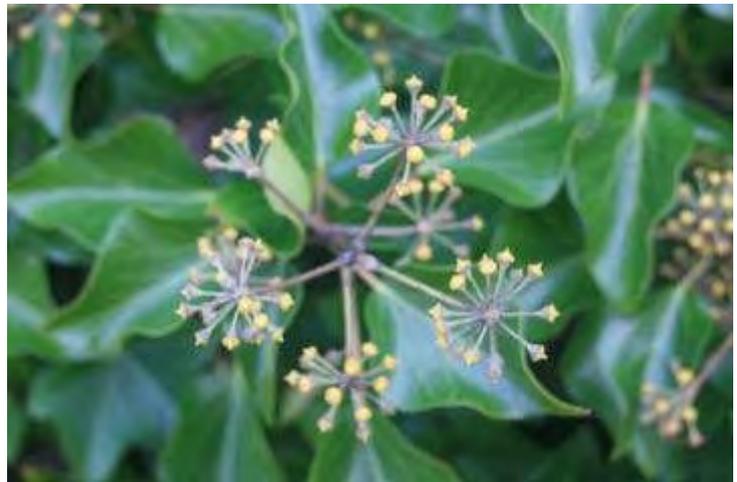
Above: Always consider the ecological advantages and disadvantages of ivy removal

Left: On complete structures keep ivy out of roofs and gutters

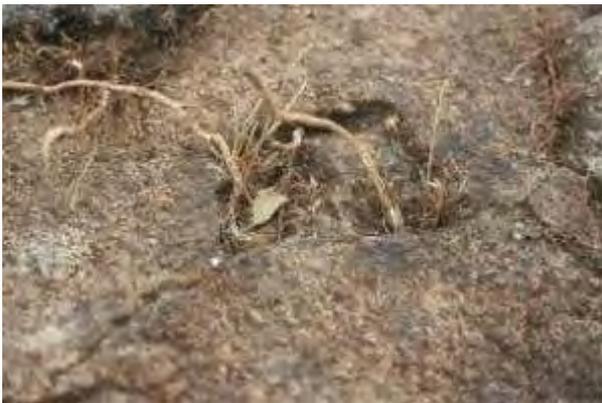
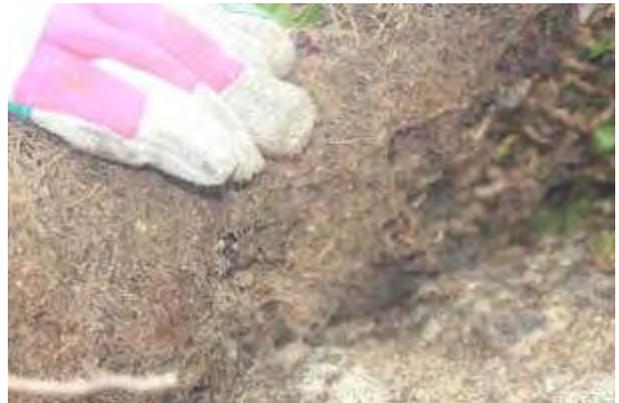
If removal is necessary, remove a trial section to assess likely difficulty. If ‘proper’ roots (above left) rather than just aerial rootlets (above right) are found then greater care should be taken to avoid further damage to the fabric.

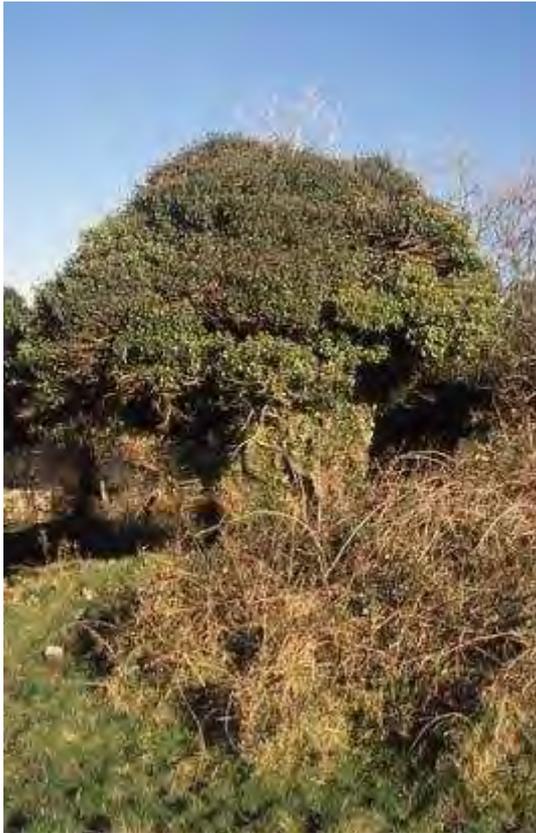
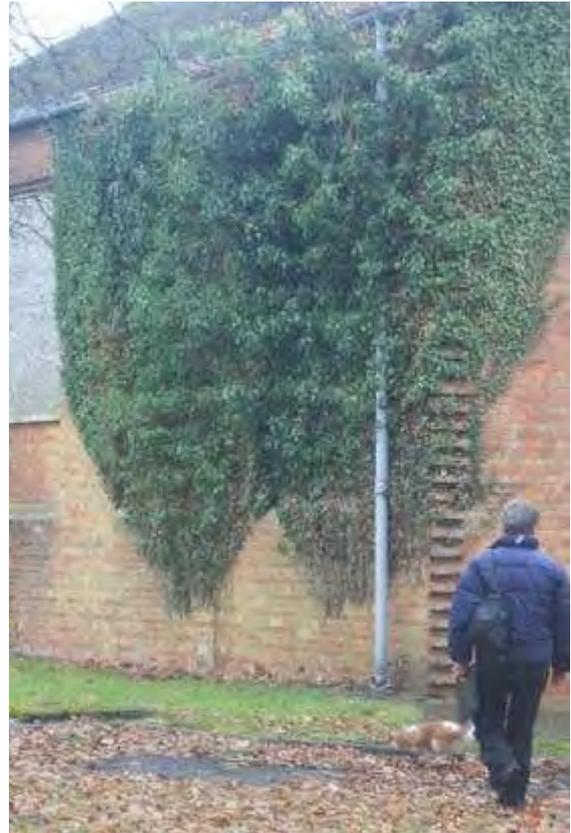
Above left: Consider the 'windsail' effect of large amounts of arboreal growth – especially on unsupported sections of masonry

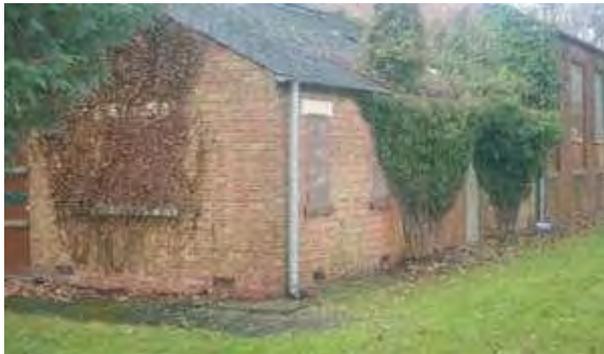
Left and above right: Cutting ivy at the base and leaving to die may be successful (end wall, photo left) but seems to be a major driver behind rooting into walls – photo above shows ivy on the same site, cut at the same time and clearly still alive.

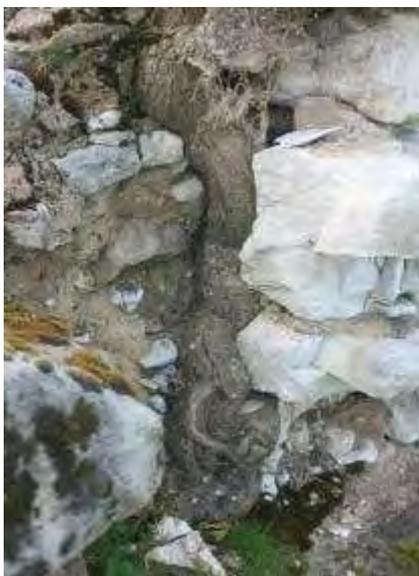
Left: Ivy rooted into or growing through a wall should always be removed – ideally before damage occurs.

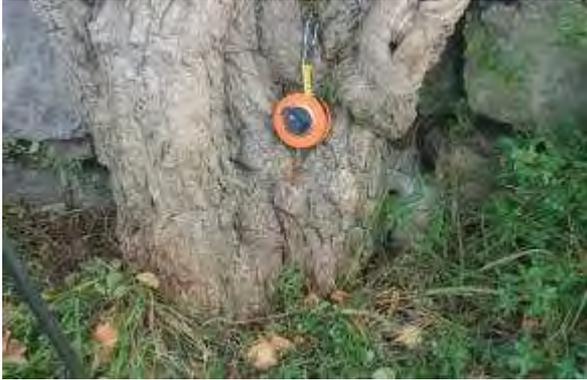
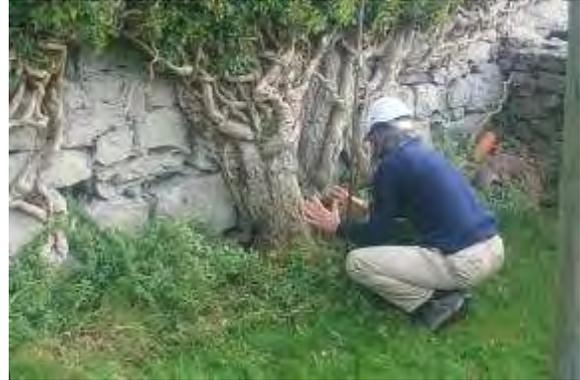
Ivy stem in Cumbria – 1 metre in diameter at ground level. Fortunately, in this case, it was rooted into the ground and not the wall.
