Heritage at **Risk**

Historic England

East of England Register 2015

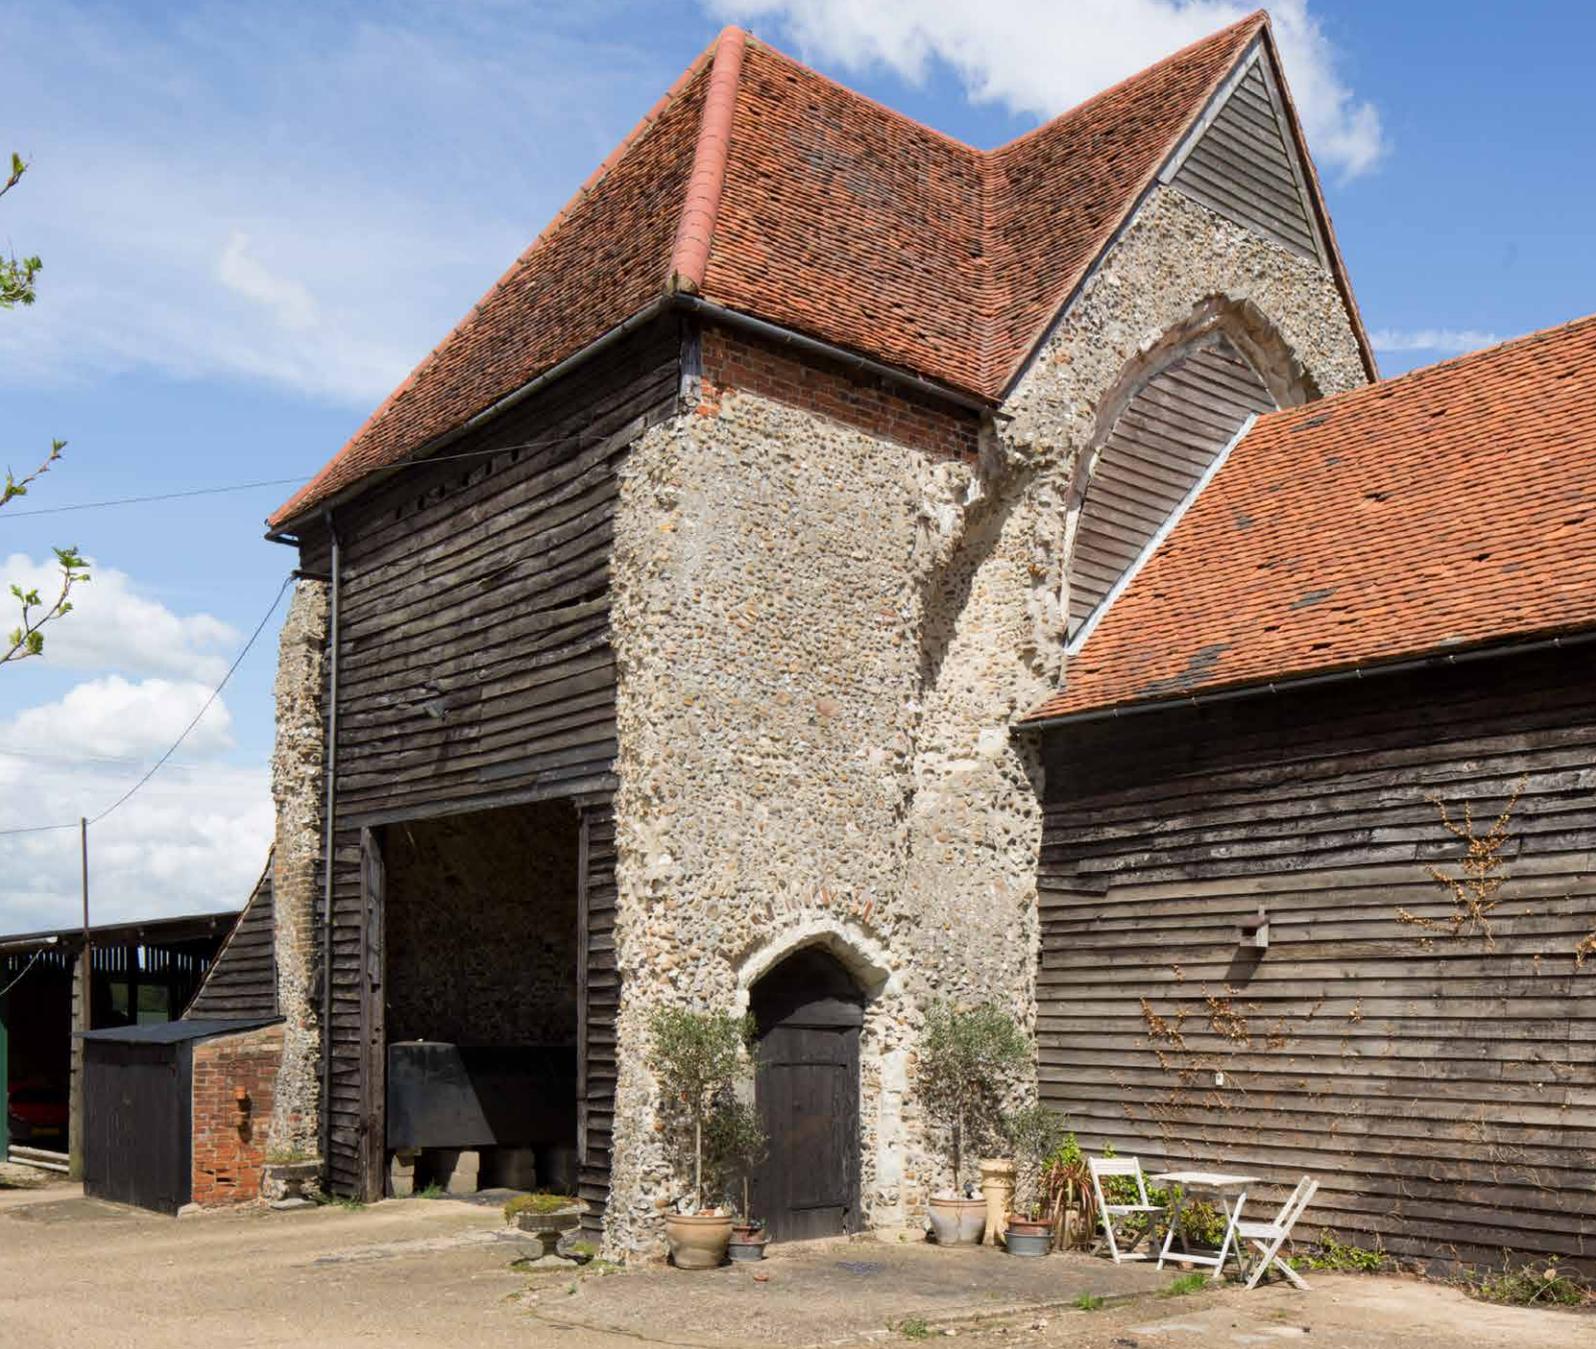
Cover image: The remaining built elements of the **Latton Priory**, a 12th century Augustinian monastic house, now a scheduled monument surviving within a series of timber-framed barn structures. Roof tile fixings have rusted, and tiles have been lost over recent years. Water ingress is leading to decay of important 14th century fine ashlar stone. There is concern about the progressively worsening condition of the fabric. Historic England has provided £114,000 towards the cost of repairs with completion due by March 2016.

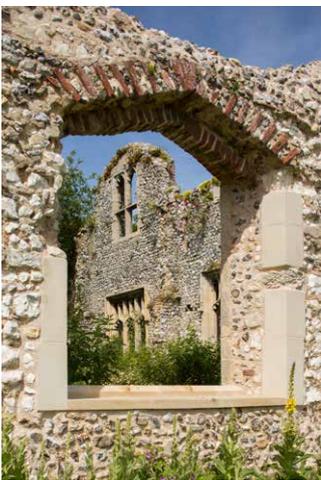
St Mary's Friary **Walsingham, Norfolk**

The remains of St Mary's Friary, founded in 1347, comprise the most complete surviving example of a medieval Franciscan monastic house in the country. The friars would have ministered to and drawn income from pilgrims who flocked

The site has long standing problems and has been on the Heritage at Risk Register since 2008. Works funded by Natural England, the Walsingham Estate and Historic England since 2010 have seen the little cloister, the guest house and chapter house repaired and consolidated. These works have been a model of cooperation between statutory agencies, grant awarding bodies, conservation professionals including skilled masons, and private owners. The prioritised works have been completed to a very high standard and the site was removed from the Register in 2015.

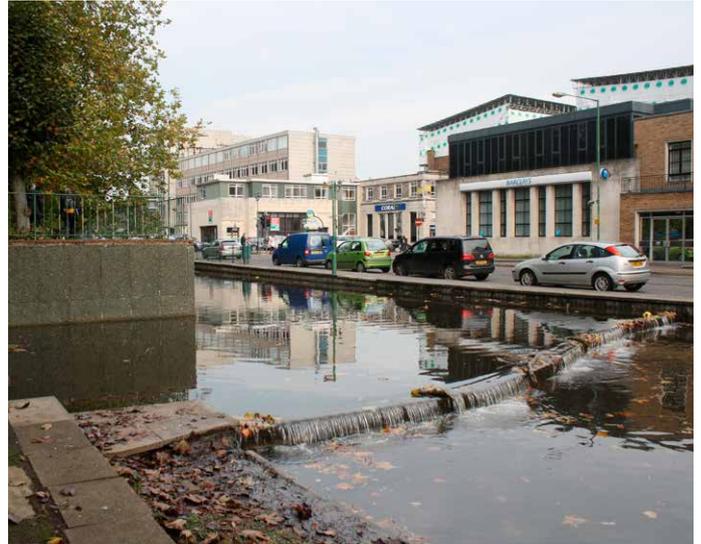
Over the years the gardens have been well used but the original concrete structures now need urgent repair. Comprehensive refurbishment is proposed, including structural repairs to bridges, balconies and other key elements. The planting scheme will be renewed in keeping with the original design and the impact of later additions will be reduced.

The registered Water Gardens were placed on the Heritage at Risk Register in 2013.

Dacorum Borough Council achieved a successful Heritage Lottery Fund bid and works are due to commence in 2015. Historic England offered extensive pre-application advice and an appraisal of a detailed master plan. Historic England also advised on the setting of the gardens in relation to the wider townscape redevelopment.
