Heritage at **Risk**

Historic England

East Midlands Register 2015

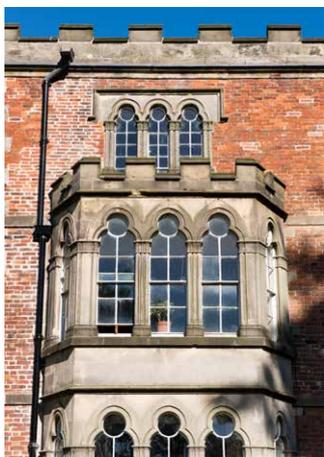
Stydd Hall **Yeaveley, Derbyshire**

Stydd Hall became a farmhouse, but its condition gradually became so bad that it was placed on the first national Buildings at Risk Register in 1998.

Historic England has provided grant aid and technical support to the Averys. The leaking roof has now been re-slatted. Structural timbers have been repaired and rainwater dispersal has been improved. All are critical concerns for the well-being of a building and its occupants!

Further repairs began in the summer of 2015. More will be required, but we are confident that Stydd Hall will soon be removed from the Heritage at Risk Register, its future secure.

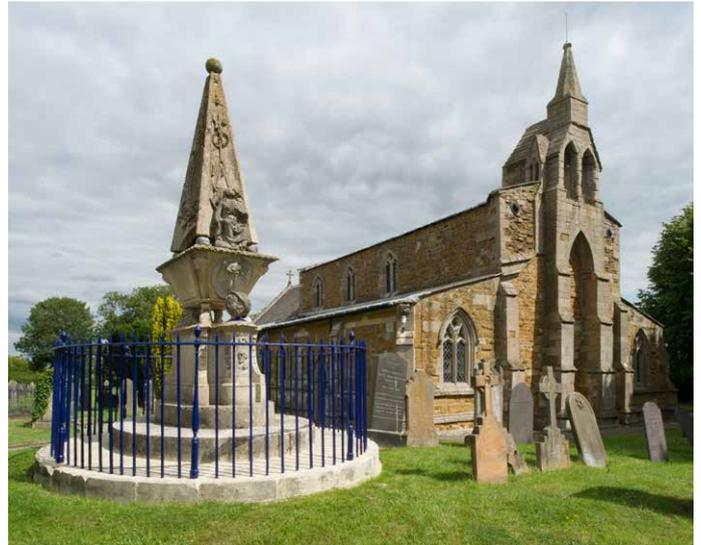
Squires' Monument entered the Buildings at Risk Register in 1998. Stonework was decaying and architectural detail was being lost. It has now been repaired and has been removed from the Heritage at Risk Register.

the monument therefore passed to the District Church Council. Repairs commenced in 2014 with grants from Historic England and Melton Borough Council.
