Heritage at Risk

There are **302** assets on the **North East** Register, three more than 2014

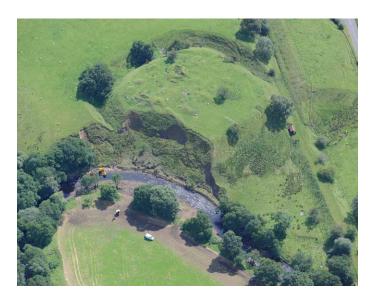
The castle has been on the Heritage at Risk Register since 2009. A combination of river erosion and groundwater pressure is destabilising the upper levels of the castle mound, causing it to slide towards the river. An engineer's report in 2013 concluded that structural failure will increase in the future with the resultant loss of archaeological deposits.

Today, the fortified house is largely visible as a

grassed-over mound. An archaeological evaluation has helped to clarify the nature of the surviving, threatened archaeological deposits. Whilst engineers have concluded that failure will increase, a number of options are being considered to stabilise the mound and protect the vulnerable archaeology.
