2. ARCHAEOLOGICAL SURVEY RESULTS: CHESHIRE

2.2 Neston and Burton Marsh (Map Figures 2.12 and 2.13)

2.3 Stanlow Point (Map Figure 2.21)

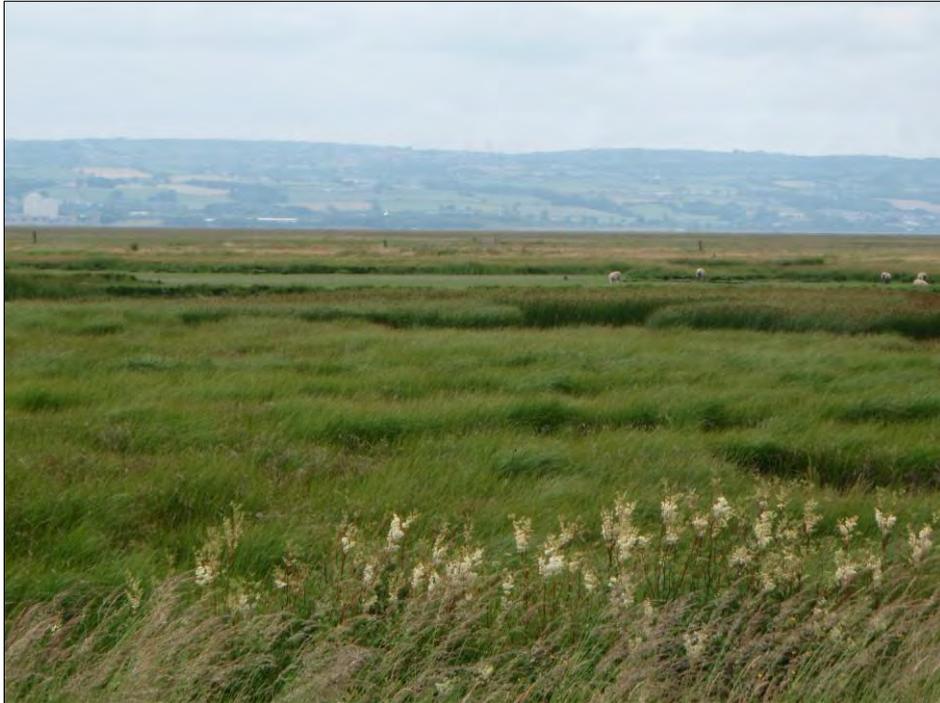
Figure 2.2 Stable salt marsh at Burton Marsh in the Dee Estuary south west of Neston, Cheshire, looking west.

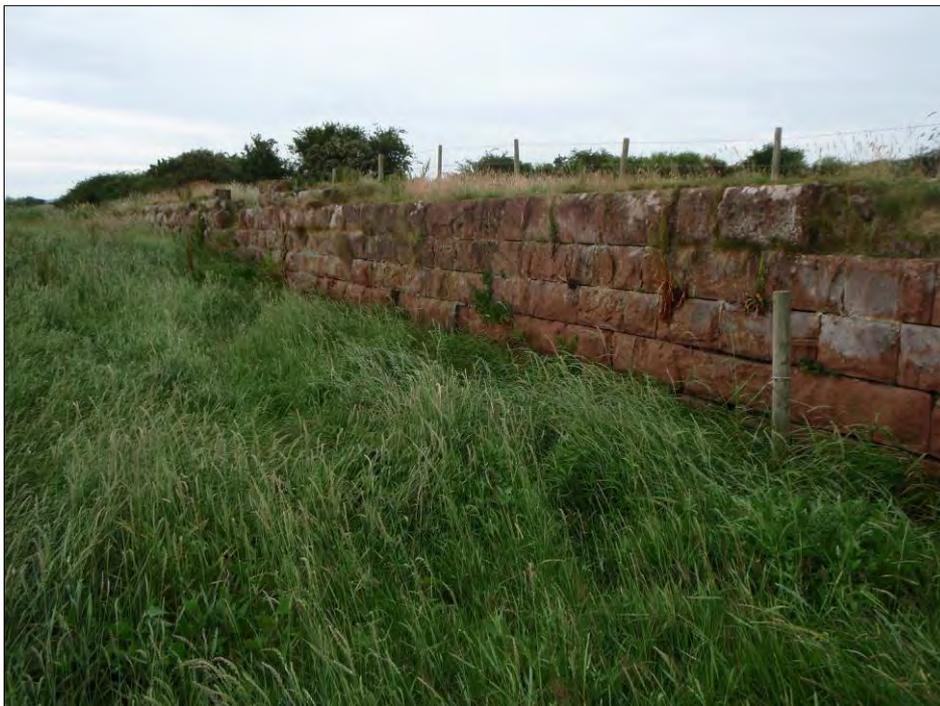
The field survey recorded several stone walled features as the remains of the Old Quay or walling associated with it (154). The best preserved portion consists of a $\approx 69\text{m}$ length of Red Sandstone walling surviving to $\approx 1.8\text{m}$ in height (Figure 2.3). At right angles to this, on the southern side, a further $\approx 30\text{m}$ length of walling is traceable as standing remains to a height of $\approx 1\text{m}$ in places, and buried remains in others. A river channel runs inland alongside this southern extent. The junction between the two walls is heavily eroded, or has been stone-robbled (see Section 2.2.9).

Figure 2.3 Neston Old Quay: Red Sandstone seawall surviving to $\approx 1.8\text{m}$ in height.

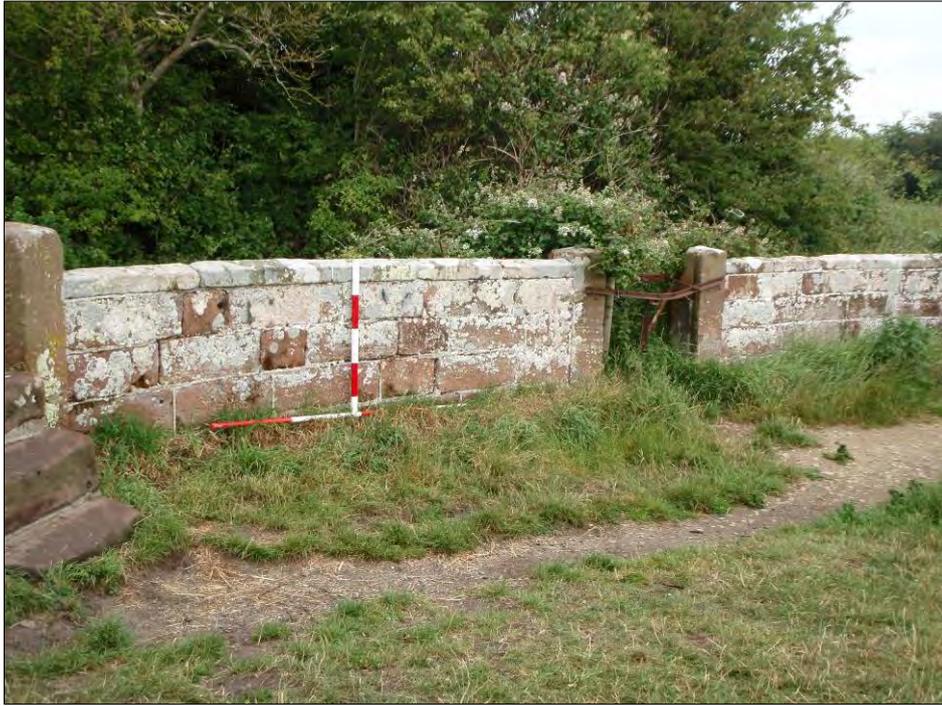
To the south of this area, further Red Sandstone walls, standing to a height of $\approx 1.2\text{m}$, were recorded that may be related to the remains of the quay. On the east side of the public footpath, these appear to have been remodelled and incorporated into garden walls for an adjacent house, however the gateway into the garden is a reused sluice gate (Figure 2.4). On the north and west side, the walls appear to be original. The west side contains a curved section of walling standing only a few courses high that juts out into the marsh and may be the corner of a section of seawall. The north side consists of a section of original walling with two inserted gateways containing chiselled stone gateposts. The northern side of this walling also contains the springing line of an arch, suggesting that a water channel ran past this section of wall and inland (Figure 2.5).

Figure 2.4 Remains of Red Sandstone walling, possibly associated with Neston Old Quay, remodelled and incorporated into garden walls. (scale = 1m x 2m).

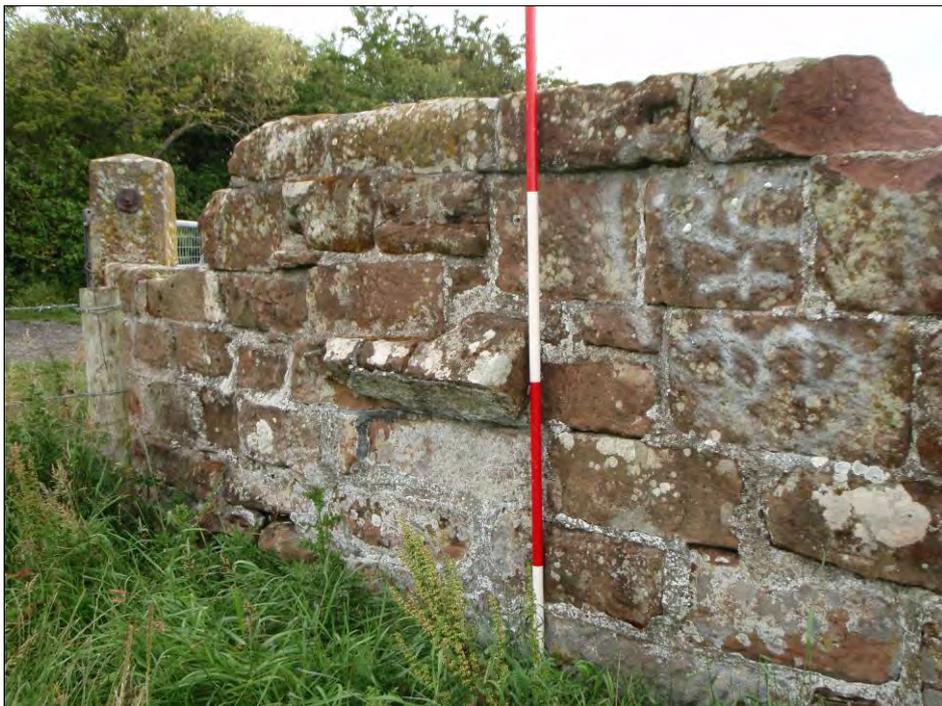
Figure 2.5 Springing line of an arch, possibly showing the location of a former water channel (scale = 2m).

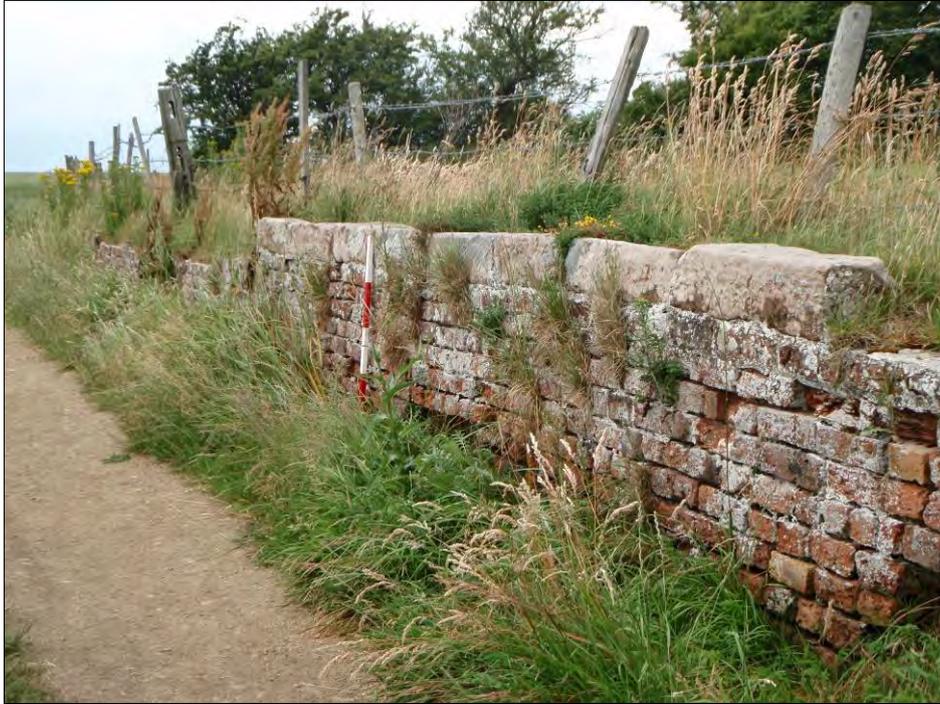
Other features noted during the walkover survey were two sections of handmade brick walling (c.27m and c.25m in length) with sandstone copings located to the south-west of the remains of the quay (Figure 2.6). The ground behind these walls is substantially higher than the salt marsh, so these may represent retaining walls or revetments. These are unlikely to be associated with the quay. The brick type and size can, however, be

partly dated. The bricks are handmade and measure 9”x3½”x2¼”, and therefore pre-date 1803 when a standardised brick size of 9”x4½”x3” was introduced following the brick tax (Cunnington 2002, 147; Iredale and Barrett 2002, 22). Assuming the bricks have not been reused, therefore, these retaining walls pre-date 1803.

Figure 2.6 Handmade brick retaining wall with sandstone copings (scale = 1m).

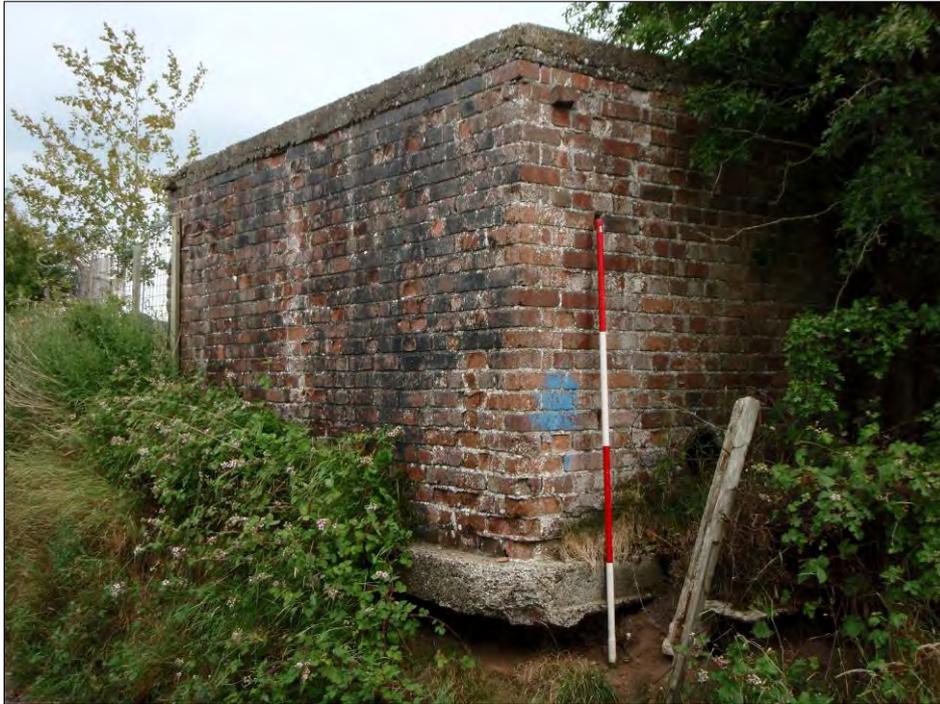
Field survey of this structure (155) confirmed that it is most likely to be a control building associated with the bombing decoy site on Burton Marsh, 650m east-south-east. The building is brick-built with a flat concrete base and roof which is typical of decoy

control buildings (Lowry 1996, 64). It is approximately 8m long x 3m wide x 2m high, built into the side of a low mound at one corner of a privately owned field (Figure 2.7). The building is overgrown with trees and shrubbery and the mound on which it stands is undergoing natural erosion as a result of slippage, not connected with coastal erosion. This is undermining the structure and may lead to subsidence and/or collapse in the future.

Figure 2.7 Bombing decoy control building on the edge of Burton Marsh. Note ground erosion at the base that may lead to subsidence (scale = 2m).

Erosion and the risk of future subsidence were noted at the bombing decoy control building (155), however this was not caused by coastal erosion processes and will not be affected by SMP2 policies, or equivalent.

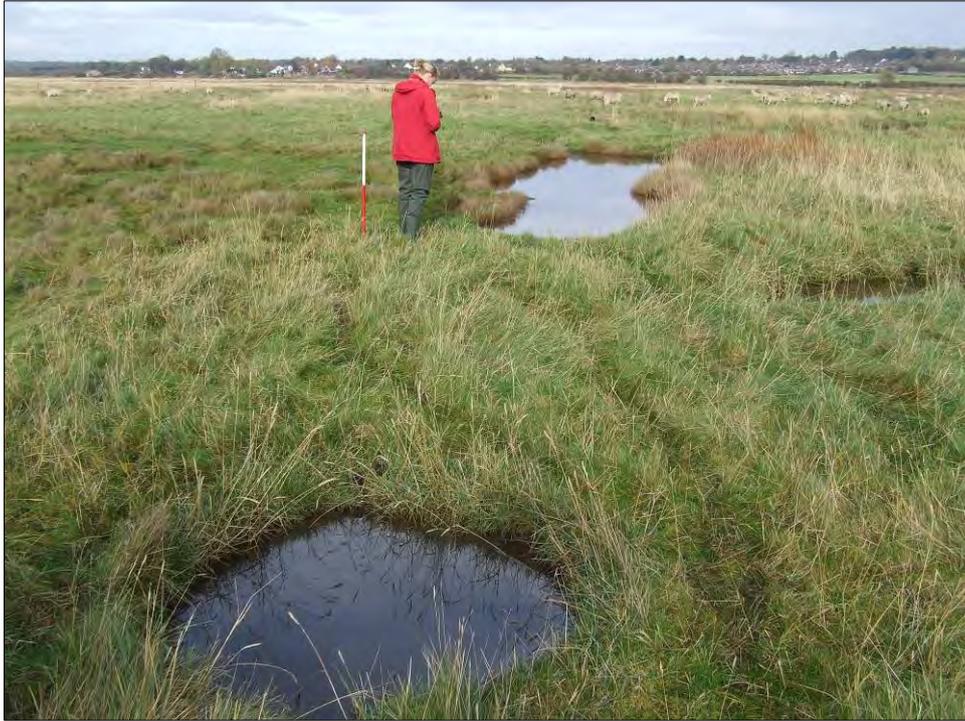
The bombing decoy site is located on land owned by the MOD and falls within the danger area of Sealand Rifle Range. The field survey identified the remains of the decoy as consisting of a series of water-filled cut features (201). The most prominent of these were two rectangular cuts (c.16m x 3m) each with an associated small square cut (c.2m x 2m) running alongside a long curving cut feature (Figure 2.8). These water-filled channels would have been arranged in such a way as to mimic the docks at Garston on a smaller scale; the long curving feature possibly mimicking the curve of the River Mersey (this feature was only mapped for a portion of its length owing to safety concerns). At night, lights would be shone on the water to draw attention to the decoy in preference to the real life docks on the other side of the Wirral. Several bomb craters were noted in the vicinity of the decoy site during the Phase 1 aerial photography transcription, possibly attesting to its success in drawing fire away from Garston and Liverpool.

Figure 2.8 Water-filled cut features in Burton Marsh interpreted as the remains of the Second World War bombing decoy site for Garston Docks (scale = 1m).

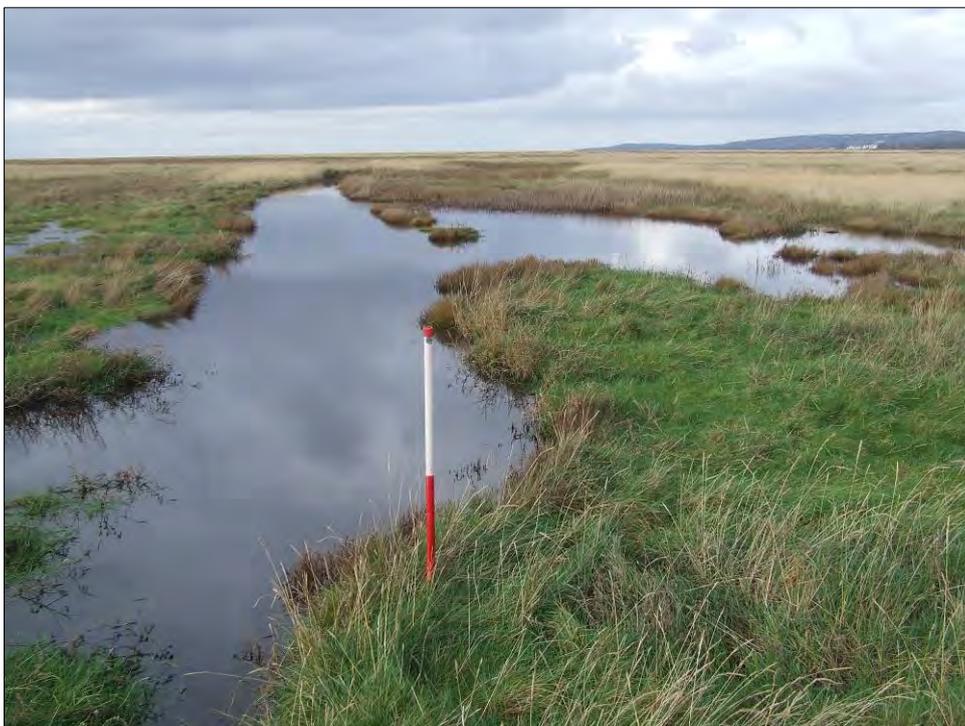
Further water-filled pools were identified as possibly relating to the decoy site, however these were more eroded making their identification as man-made features more problematic (Figure 2.9). Two bridges crossing channels in the marsh were also recorded

Figure 2.9 Possible further remains of the Second World War bombing decoy site (scale = 1m).

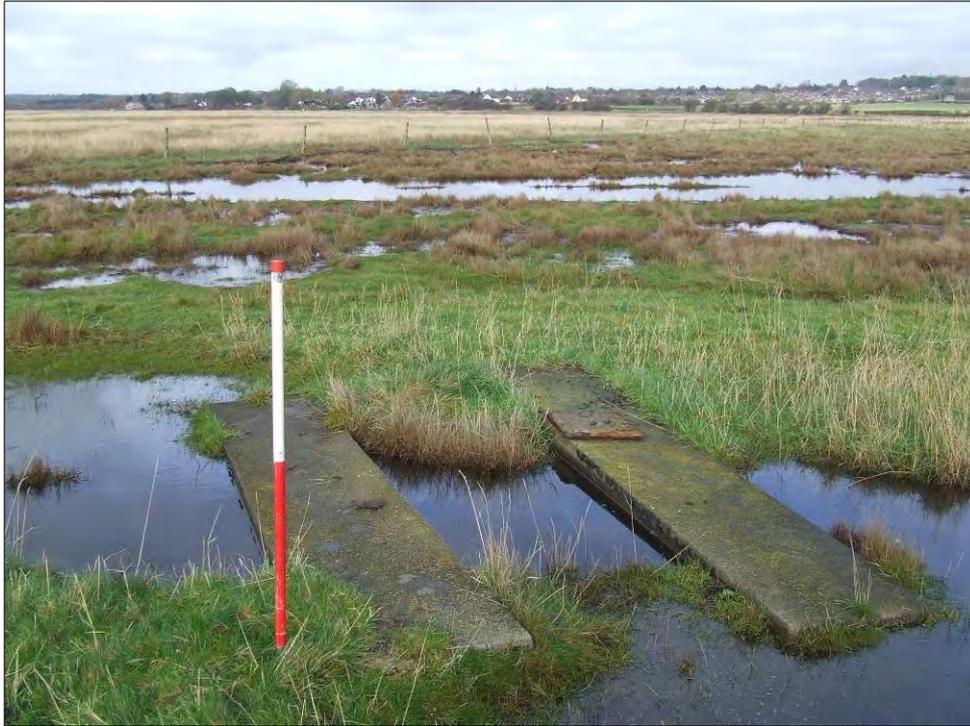
in association with the decoy, as these were constructed of rough concrete slabs typical of the Second World War period. However, these may not be in their original locations (Figure 2.10).

Figure 2.10 Possible remains of the Second World War bombing decoy site that appear to form a small bridge (scale = 1m).

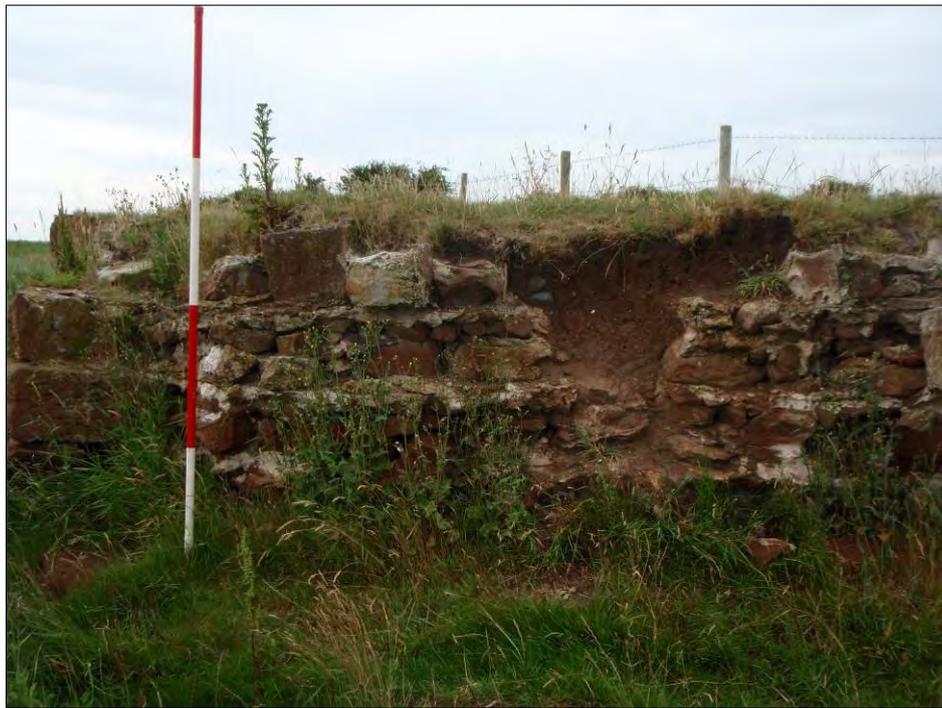
Figure 2.11 Erosion/stone robbing at Neston Old Quay (scale = 2m).

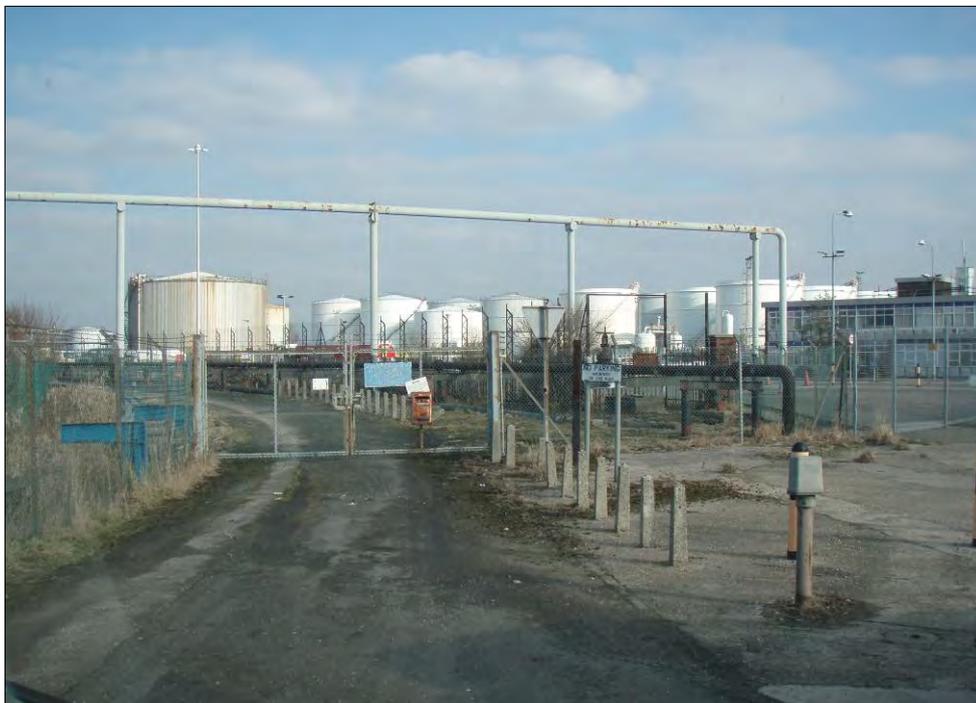
Figure 2.14 An entrance to Shell's Stanlow Oil Refinery and Petrochemicals Plant showing the built-up nature of the area south of the Manchester Ship Canal.

Stanlow Point became isolated from the mainland by the construction of the Manchester Ship Canal on its southern extent in the late 19th century (Ainsworth 2010). This has essentially turned Stanlow Point into an island. Industrialisation of the southern banks of the shipping canal, with Shell's Stanlow Oil Refinery and Petrochemicals Plant, has seen Stanlow Point become further isolated (Figure 2.14). There is now no public access to the 'island' which is currently owned by Peel Ports.

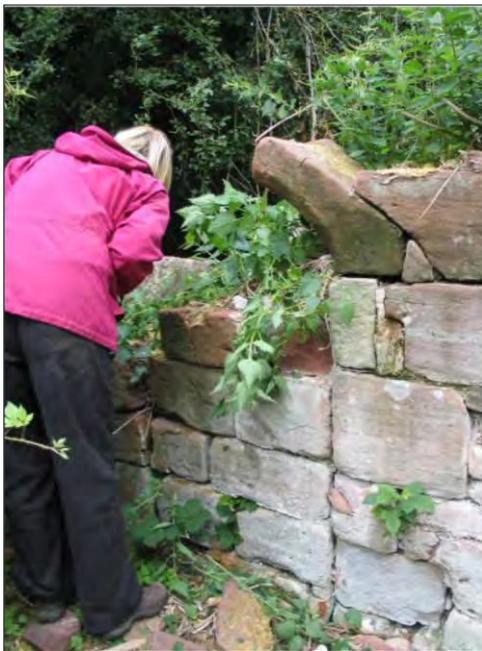
Figure 2.15 *In-situ* medieval doorway
(Ainsworth 2010, © English Heritage)

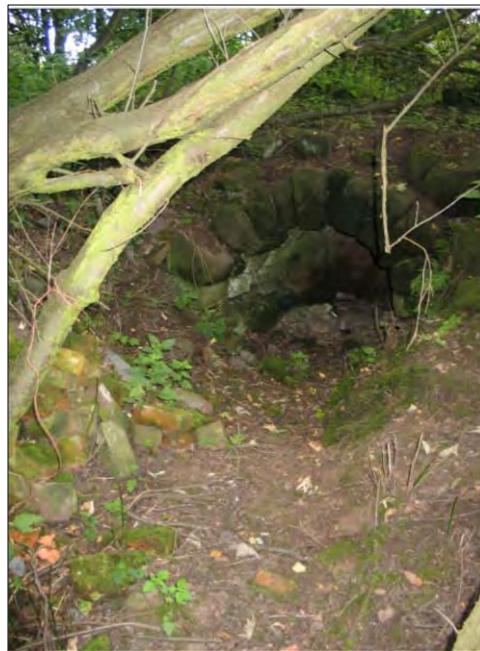
Figure 2.16 Remains of monastic drain
(Ainsworth 2010, © English Heritage)

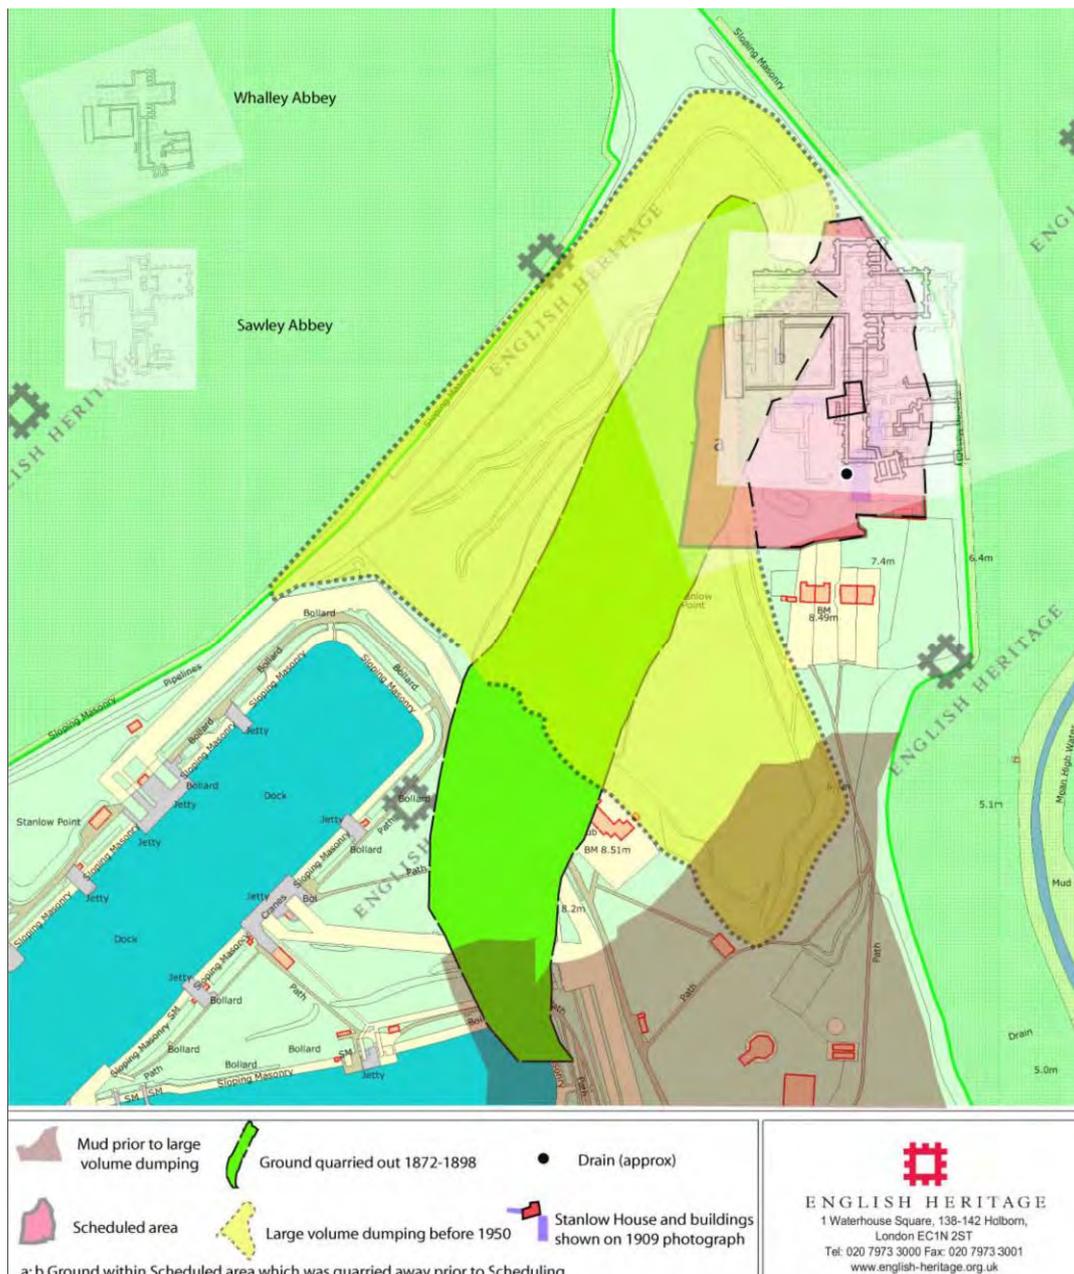
Based on his observations Ainsworth proposes two possible arrangements for the abbey buildings, which in Cistercian houses were of a fairly standardised plan form (Coppack 2006, 50). The second of Ainsworth's possible arrangements is reproduced as Figure 2.17, as this is the arrangement in which he places the most faith, albeit tentatively (Ainsworth 2010, 7). He states in this scenario, a significant part of the main conventual buildings may have been lost to quarrying in the late 19th century, including the lay brother's dormitories, western part of the cloister and most of the nave. However, the transepts, presbytery and east end of the church may have survived complete destruction (Ainsworth 2010, 7).

Figure 2.17 Possible arrangement of buildings at Stanlow Abbey overlaid on map of the modern landscape and its historical development. (Ainsworth 2010, © English Heritage)

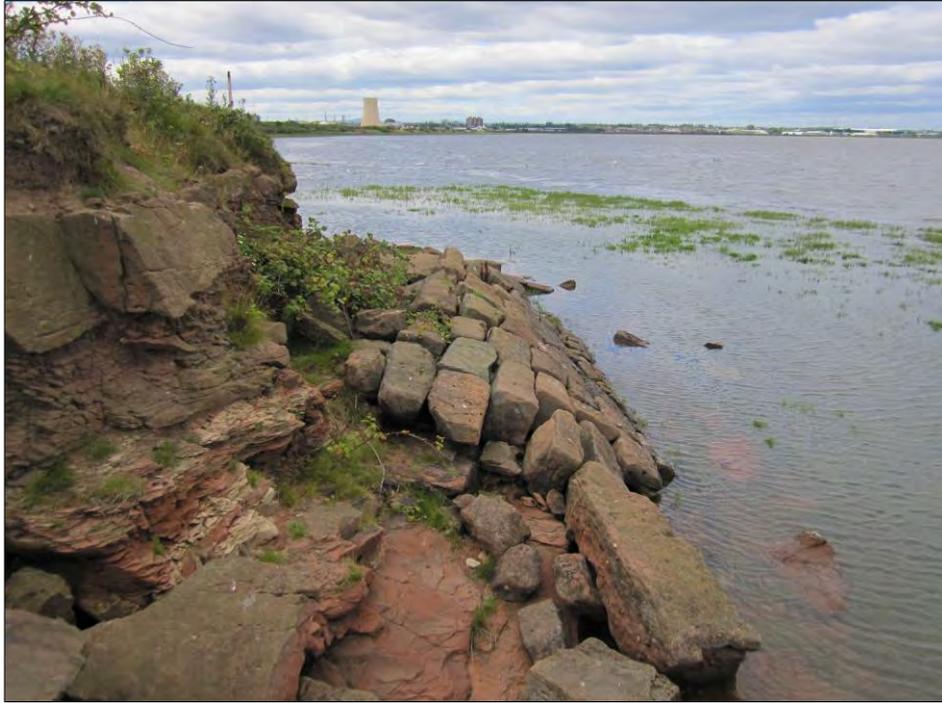
The current flood defences at Stanlow were erected in the Victorian era and are already failing in places (Figures 2.18 and 2.19) causing flooding in the abbey's courtyard area (Ainsworth pers. comm.). The responsibility for maintenance of these defences under a 'Hold the Line' policy for the next 100 years would usually lie within the public sector. The SMP2 states, however, that 'the economic viability of the policy may depend on knock-on benefits from flood defence function of the Manchester Ship Canal which lies between the Estuary and a large flood risk area at Stanlow and Ince Marshes. Protecting the industrialised hinterland and avoiding potential contamination...policy delivery in the noted frontages may be compromised by funding prioritisation due to low Benefit Cost Ratio, and therefore opportunities for co-funding need to be investigated.' This investigation is proposed under action reference 2.3 and is scheduled for 2015-2018 (Halcrow 2011). Given the economic and environmental risks of flooding the Stanlow Oil Refinery, it is unlikely that this investigation will prove to be unsuccessful. It should be noted, however, that the impetus to maintain defences will not be the protection of

Figure 2.18 Victorian defences on the north and north-west end of Stanlow Point (© Robert Edwards, Cheshire West and Cheshire Council)

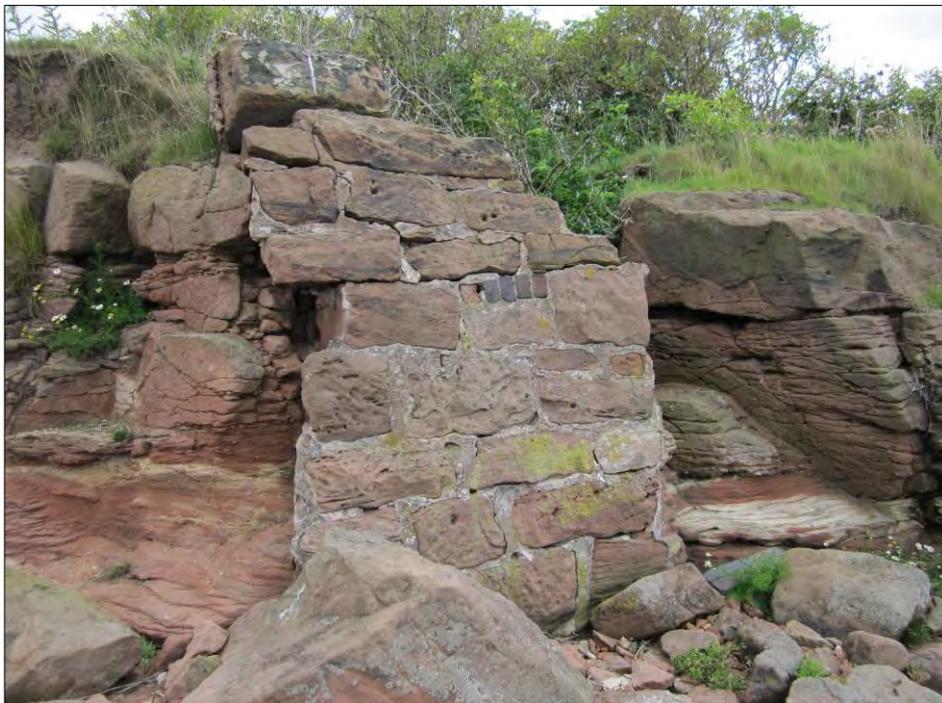
Figure 2.19 Failing Victorian defences on the north and north-west end of Stanlow Point (© Robert Edwards, Cheshire West and Cheshire Council)

Based on the current policy of 'Hold the Line', the remains of the Cistercian Abbey at Stanlow are not considered to be at immediate or long-term threat of coastal erosion. That being said, the delivery of the policy is reliant upon an agreement between government bodies and the private sector and the details and outcomes of this agreement may have the potential to negatively impact upon the known upstanding and unknown buried remains. As the site has never been fully recorded, any groundworks associated with the maintenance and erection of seaward defences will have the potential to impact on archaeologically sensitive deposits. Recommendations for a full survey have been produced as Ainsworth's assessment report concluded with a five-stage survey strategy. This would see the site undergo ecologically-sensitive clearance and recording to Level 3 standard (Ainsworth *et al* 2009) under contract, with input from English Heritage and Cheshire West and Cheshire Council (Ainsworth 2010, 9). His recommended survey area is reproduced as Figure 2.20. At the time of writing, this survey strategy has yet to be implemented and it should be marked as a priority for future work.

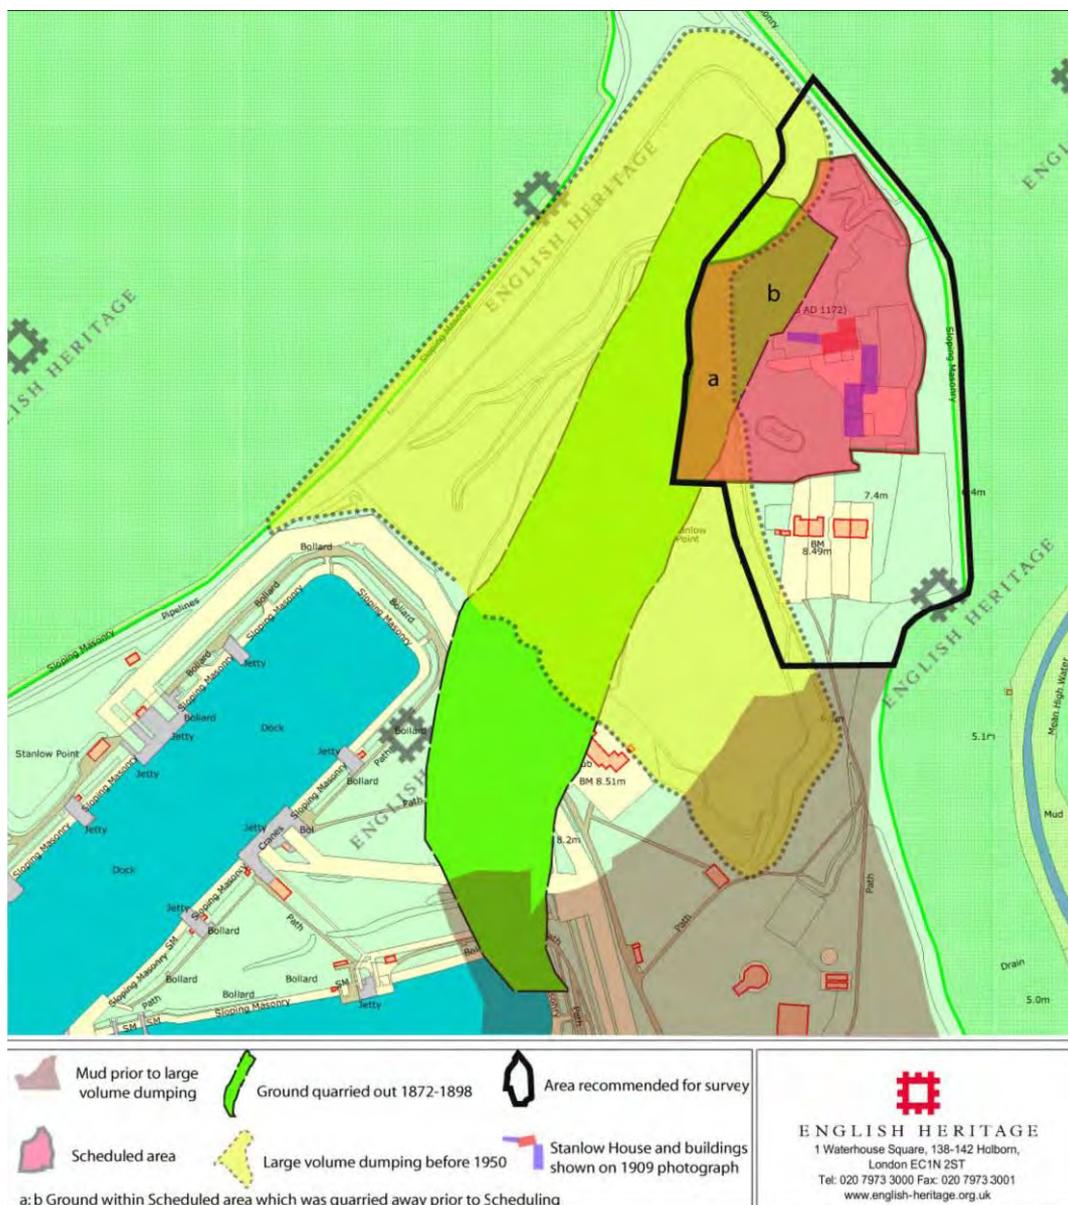
Figure 2.20 Recommended survey area (Ainsworth 2010, © English Heritage)
