5. ARCHAEOLOGICAL SURVEY RESULTS: CUMBRIA

5.1 Introduction

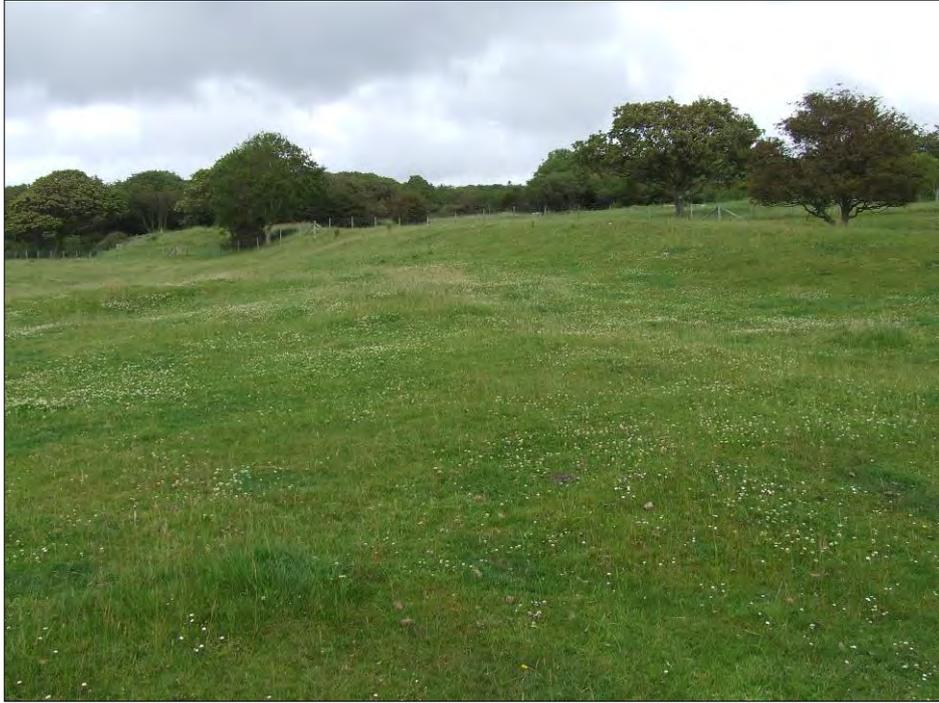
Figure 5.3 Medieval lynchet at Far Arnside

The Phase 2 survey recorded the remains of medieval lynchets (32) and an enclosure (33) at Far Arnside. The lynchets (32) consisted of the typical series of parallel earthen banks and have been ground-truthed through the Phase 2 survey (Figure 5.3). The earthwork remains are well-preserved in an area currently used for stock grazing.

According to these predictions, the medieval sites (32, 33) recorded at Far Arnside will not become under threat of coastal erosion in the next 100 years. They are therefore not considered to be at immediate or longer term risk of coastal erosion. It should be noted, however, that the area polygon mapped as part of the Phase 1 aerial photography transcription will be impacted upon within the next 100 years and this may therefore impact upon previously unrecorded, buried archaeological remains.

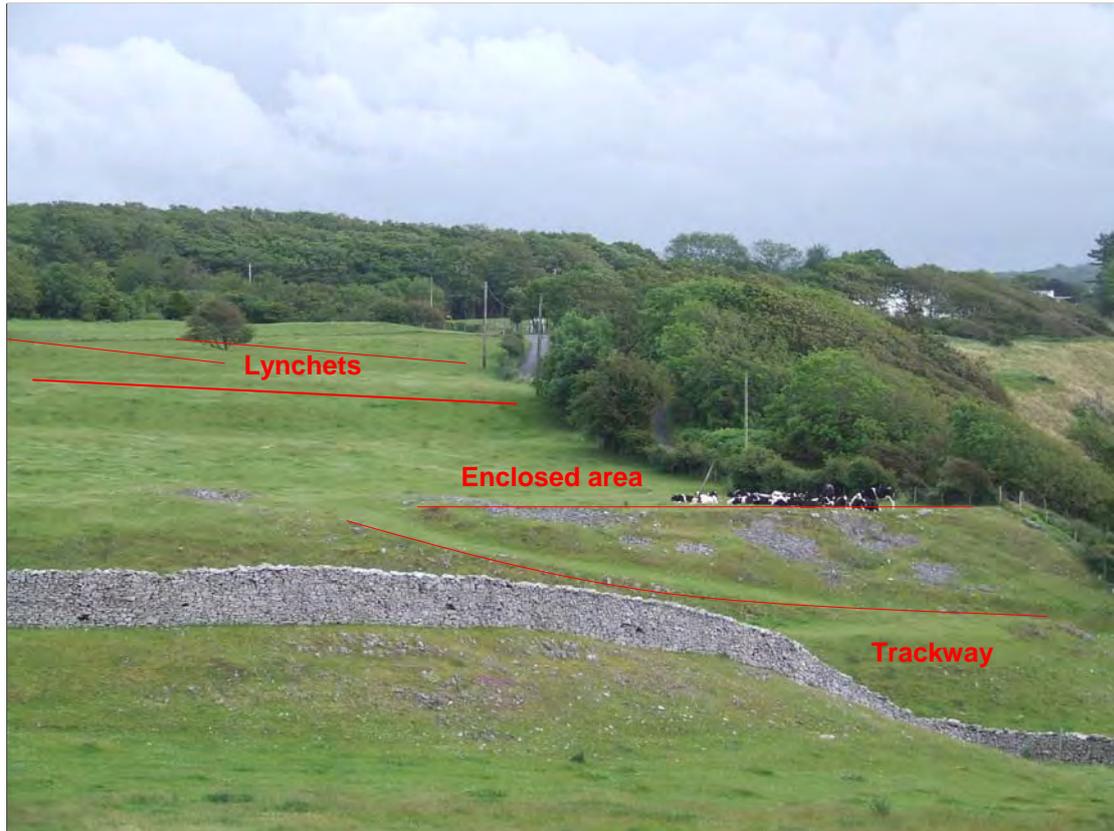
Figure 5.4 Medieval enclosure and lynchets at Far Arnside.

The enclosure (33) was recorded as the possible remains of collapsed stone walls, now partially embanked. These formed two sides of an artificially levelled, rectilinear enclosure measuring $\approx 22\text{m}$ north-south x $\approx 30\text{m}$ east-west (Figure 5.4). It was noted that the earthwork survival was less apparent than that on the aerial photography. A banked, ramped trackway was also recorded extending from the enclosure towards the current road and shoreline. This may be a modern feature, but could mirror the position of the original access to the site. No evidence of the proposed building foundation/long house foundation was recorded during the survey.

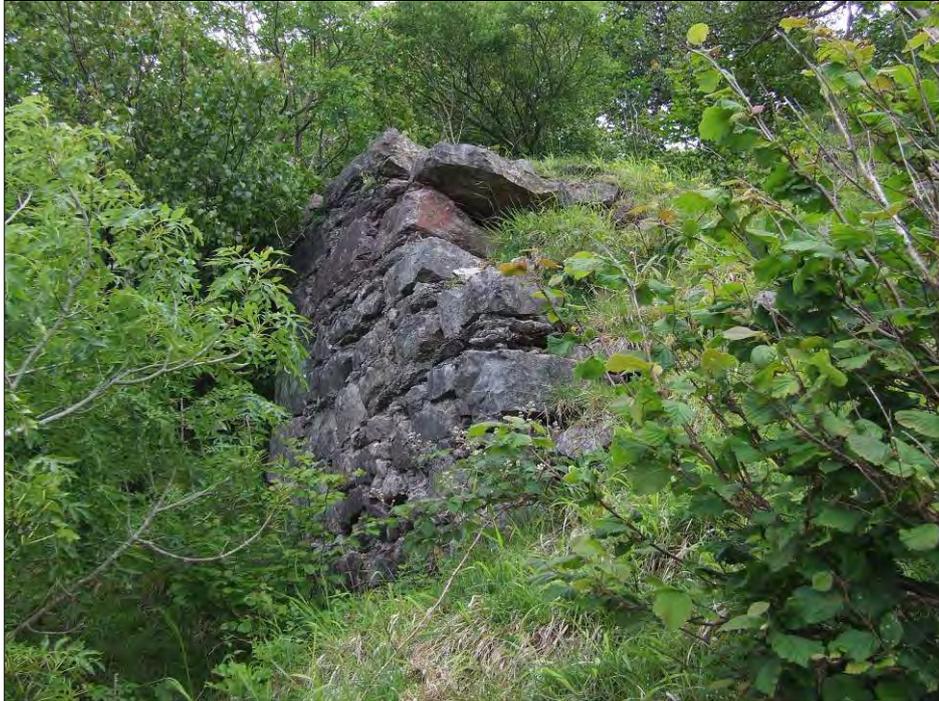
Figure 5.5 Overgrown limekiln at Blackstones, looking southeast.

The Phase 2 survey recorded the remains of the limekiln (34) as a largely ruinous, filled in structure that contrasts sharply with the well-maintained example recorded at Silverdale ≈ 3.5 km to the southeast (see Section 4.9.5). The level of vegetative growth at the site precluded a detailed study of the monument (Figure 5.5), however it was noted that the remains currently sit above the line of coastal erosion on the foreshore.

The limekiln (34) recorded at Blackstones Point will be at risk of long term coastal erosion under existing predictions (that is within 100 years) and both the structural fragment (35) and the possible jetty (40) lie in the inter-tidal zone and are undergoing active erosion. These sites will not be protected under current SMP2 policies and are therefore considered to be at immediate and long term risk of coastal erosion.

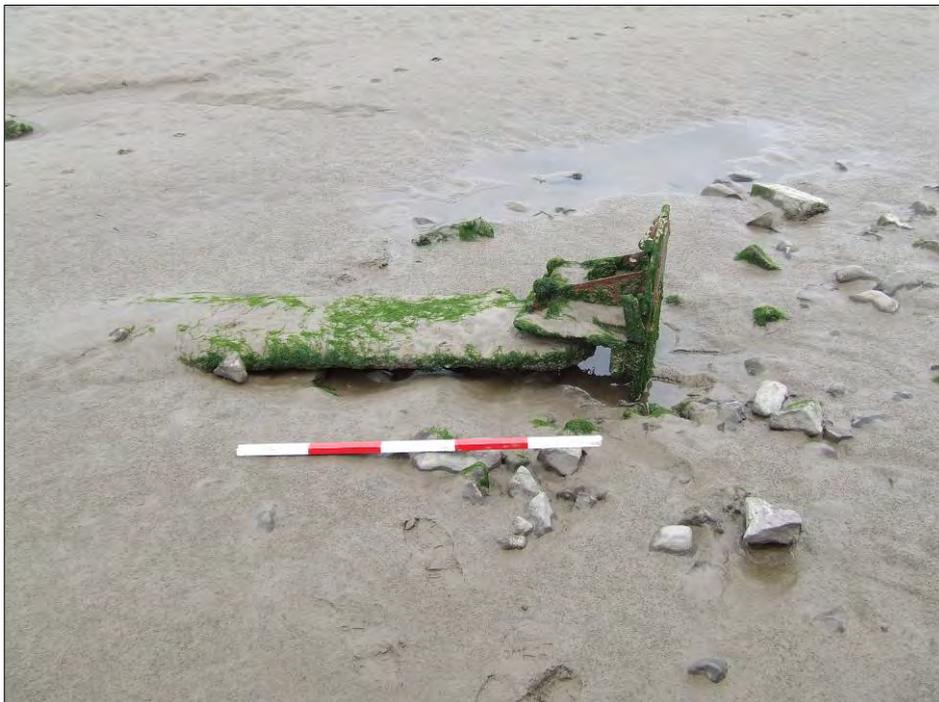
Figure 5.6 Structural fragment on the beach at Arnside (scale = 1m).

Around 380m northeast of the remains of the limekiln, the survey recorded a fragment of steel or cast iron (35) on the beach which appeared to be a structural element consisting of a riveted and hinged bracket and attached girder (Figure 5.6). This may have been from an offshore shipwreck, or may represent the only surviving element of a dump of building materials on the beach frontage. The function of the object is unknown.

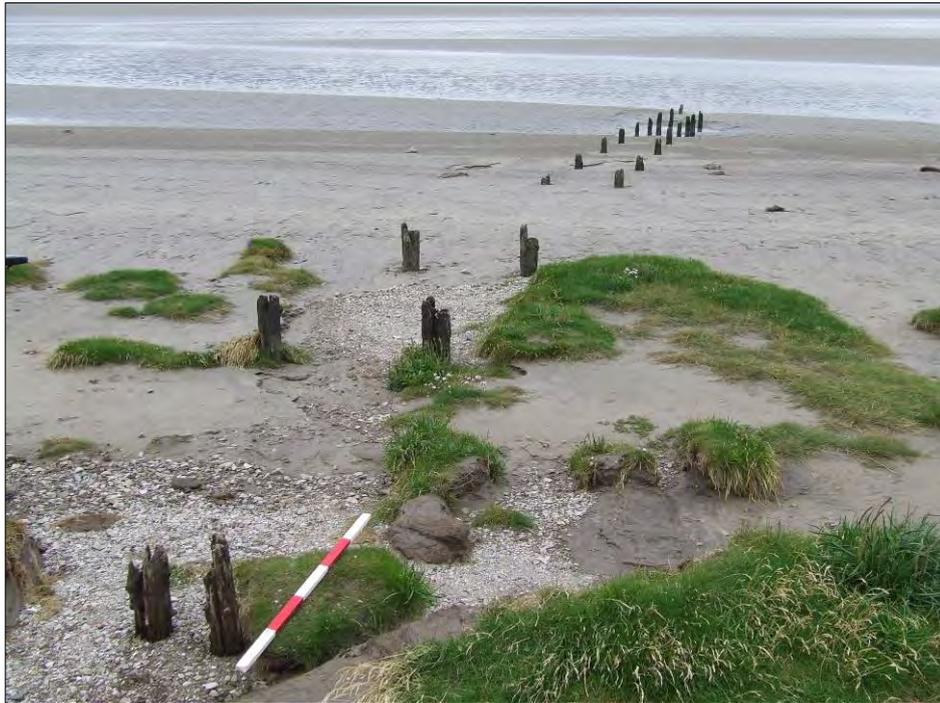
Figure 5.7 Possible jetty or pier, south of the Arnside Viaduct, looking northwest (scale = 1m).

The final site recorded in this area was the remains of a small jetty or pier (40) immediately to the south of the Arnside Viaduct. This feature appears on Ordnance Survey mapping for the first time in 1898 and consisted of a linear alignment of two sets of upright timber posts running for a length of c.27m out into the inter-tidal zone (Figure 5.7). Shipping would have been an important outlet for the products of industry around Arnside and several of these small piers must have existed along the coastline in this area.

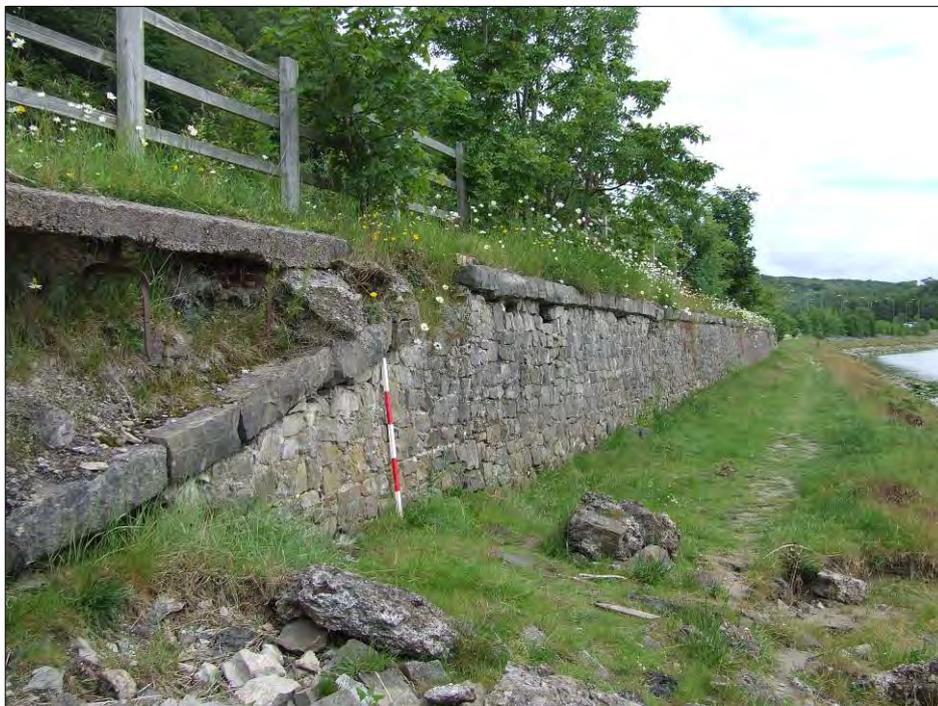
Figure 5.10 Disused railway platform at Greenodd (scale = 1m)

The remains consisted of a section of roughly coursed limestone walling standing to a height of \approx 1.5m, below a platform constructed of roughly cut limestone blocks. The platform tapers to the ground at each end, though the northern end is in a ruinous condition, either through the action of erosion and weathering, or through stone-robbing. The platform extends for a length of \approx 68m aligned roughly north/south (Figure 5.10).

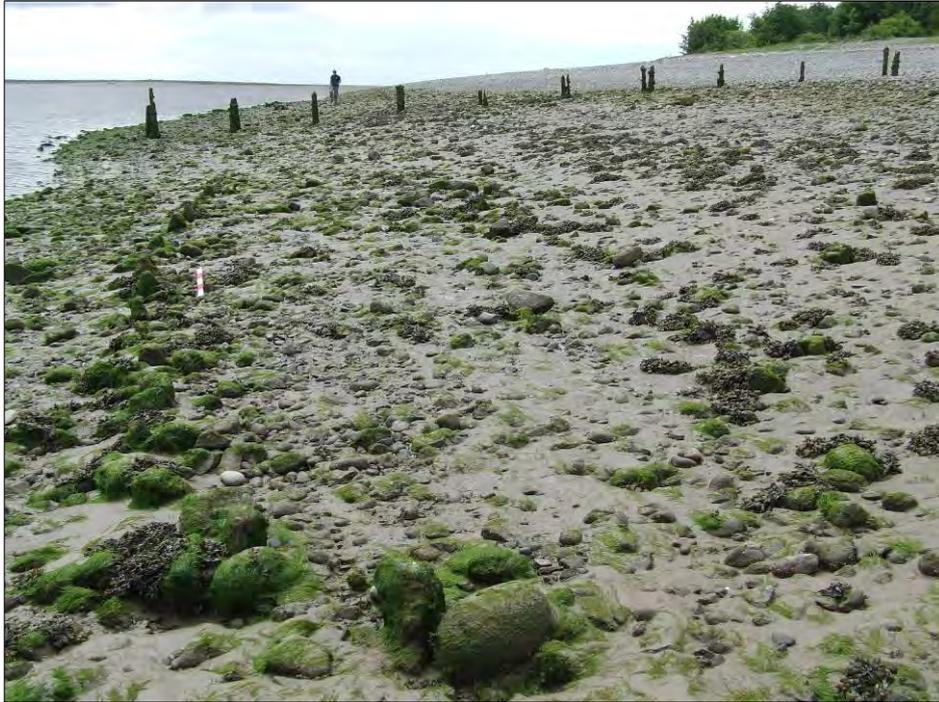
Figure 5.11 Surviving remains of quayside at Ulverston (Conishead Priory), looking south (scale = 1m).

At Ulverston the surviving remains of a jetty or landing stage (37) were recorded on the shoreline east of Conishead Priory. These consisted of two linear alignments of timber posts running roughly east-west for a length of c.24m, adjacent to two further linear alignments of less well-preserved posts running roughly north-south for a length of c.13-16m (Figure 5.11). The arrangement forms a T-shaped structure, the head of which runs parallel to the shoreline. The marked difference in the levels of preservation of the two sets of timbers may indicate either a difference in date between the two structures, or it may indicate that the east-west aligned structure remained in use longer than the north-south aligned structure.

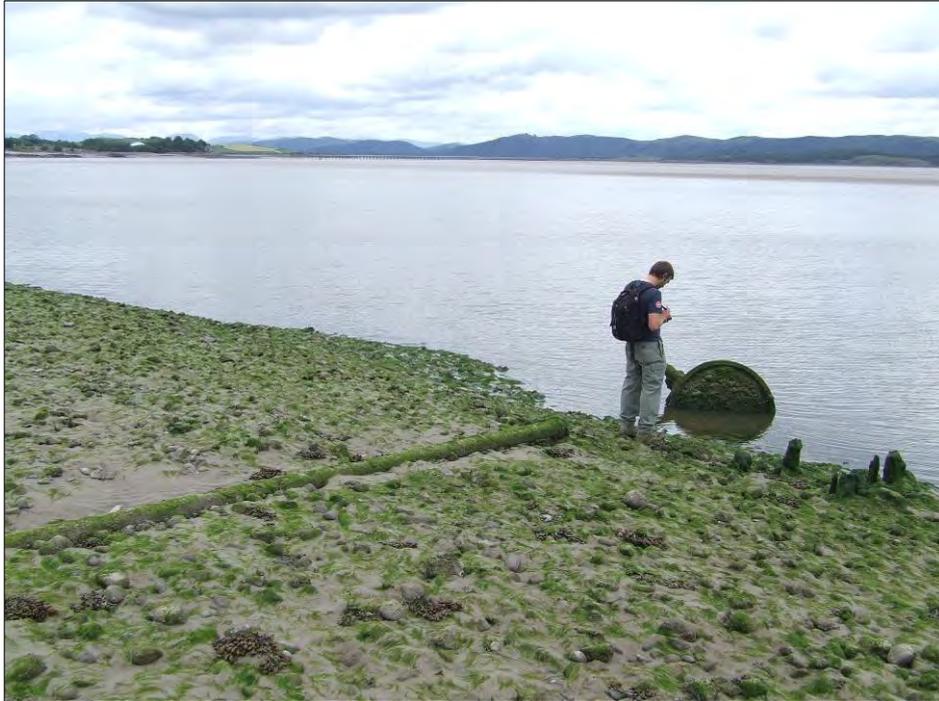
Figure 5.12 Surveying the remains of an iron object and associated timber structure and pipe.

Around 250m north of the quayside the survey also recorded the location of an iron object (Figure 5.12) and associated pipe and upright timbers (38). The iron object is clearly not *in situ*, but appears to have fallen off a timber base located immediately to the south. A nearby pipe may also have been related to the object, though this could not be confirmed during the survey. This purpose of this feature is unknown, but it may represent the remains of an industrial boiler although its location in the inter-tidal zone is puzzling.

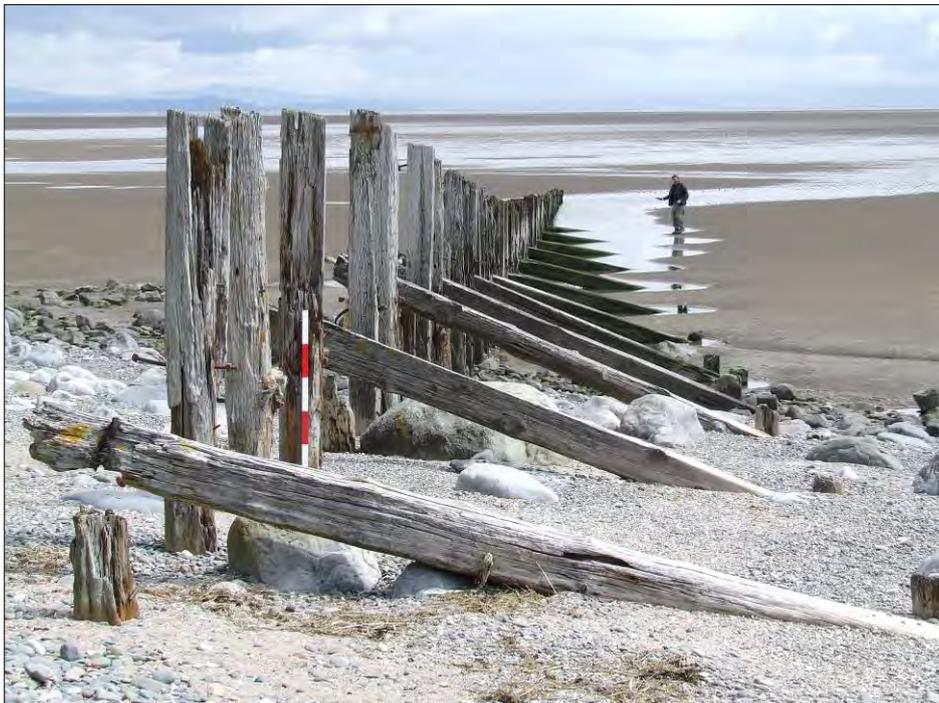
Figure 5.13 Surveying the possible remains of Baycliff Quay, looking east (scale = 1m).

At Baycliff, ≈ 5 km south of Ulverston, the Phase 2 survey recorded the remains of a timber structure that may have formed part of the quay (39). The remains consist of a timber structure extending perpendicular to the shore for a length of ≈ 77 m on an east-west alignment (Figure 5.13). The structure consists of a row of upright timber posts surviving to a height of ≈ 2 m onto which diagonal supporting posts are attached with the use of large iron fixings. The diagonal posts are ≈ 2 m in length and their opposite end is

The possible jetty at Baycliff (39) is predominantly an inter-tidal feature, however the westernmost portion of the asset will currently only be under water at extreme high tides and storms. NCERM predicts a shoreline retreat of between 20 and 40m at this location under the 'No Active Intervention' scenario, this means that the jetty will come under increasing, unmanaged damage from coastal erosion that will ultimately lead to its complete destruction in the next 100 years. It is considered to be at high risk of coastal erosion.

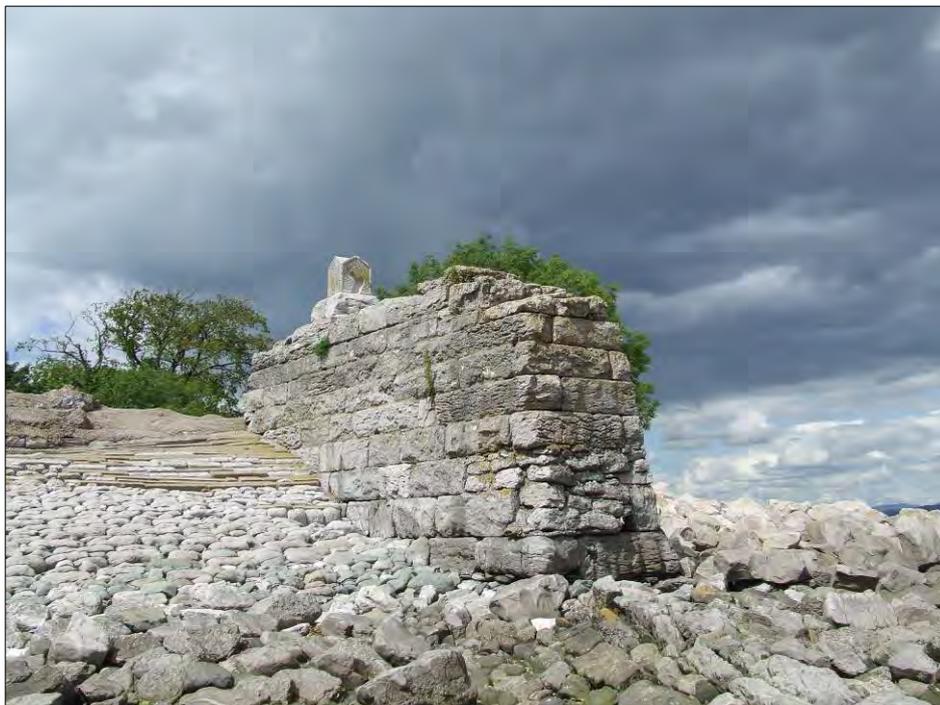
Figure 5.14 Remains of a pier at Wadhead Scar (42) and associated seawall (43), looking west.

Around 200m to the north of pier 42 the survey recorded a further pier (44). This was also constructed of well-coursed limestone masonry and was fronted by a limestone seawall of similar construction to that recorded to the south (43) (Figure 5.15).

The piers (42, 44) and seawall (43) at Wadhead Scar also show evidence of damage caused by coastal erosion. The shoreline in this area is thought to be stable, however these heritage assets are providing the current shoreline protection, rather than being protected themselves. For this reason, the sites recorded at Wadhead Scar are also considered to be at immediate and longer term risk of coastal erosion.

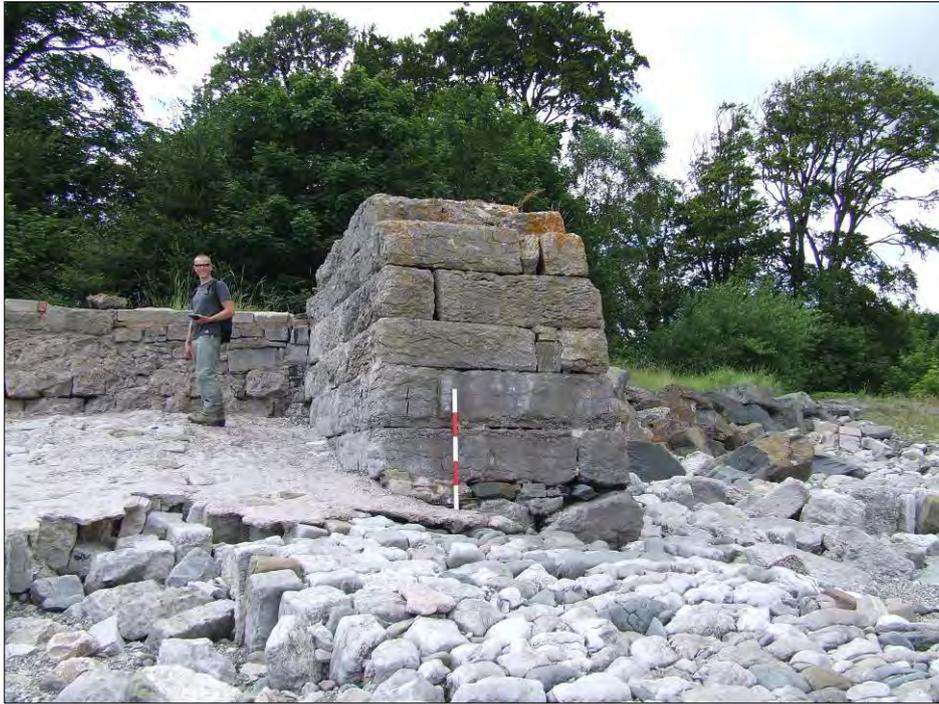
Figure 5.15 Recording the remains of a second pier (44) at Wadhead Scar, looking west (scale = 1m).

Both piers (42 and 44) and the seawall (43) are depicted on the Ordnance Survey 1:2500 map of 1889 and the seawall originally linked the two piers suggesting that these were in fact a single quayside with a north and south pier.

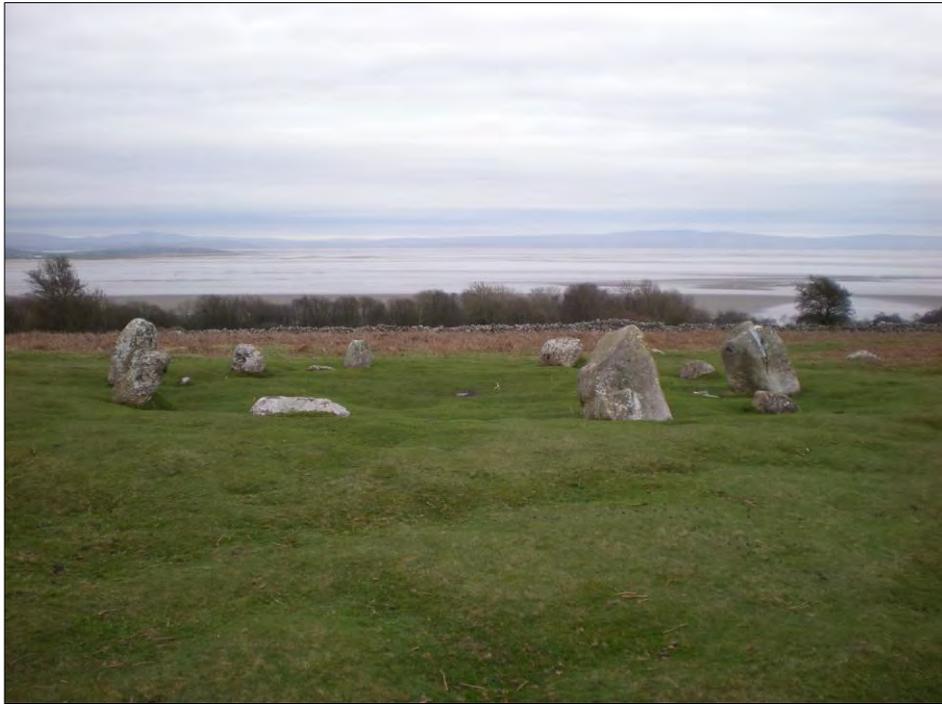
Figure 5.18 The inner circle of the Druid's Temple, Birkrigg, looking southeast.

The Phase 2 survey recorded the remains of the stone circle (215) as consisting of two concentric rings of upstanding and recumbent stones forming the inner and outer circles (Figure 5.18). The inner circle was more apparent than the outer circle which was partially obscured by bracken. The site sits on a grassed flattened platform which shows signs of the previous excavations in the form of undulations within the inner circle and around its stones. The Phase 1 aerial photography transcription recorded the remains of an earthwork of uncertain date next to the stone circle (NRHE: 1487837). This feature had the appearance of a hollow way leading up to, and past, the stone circle site (Figure

The significant rate of erosion at Aldingham clearly threatens the majority of the sites recorded in this location. Only the stone circle at Birkrigg (215) can be considered to be free from the threat of coastal erosion, owing to its location on high ground over 500m from the shore. This being said, Birkrigg is under threat of damage from other sources, such as vandalism, unmanaged bracken growth and footpath erosion.

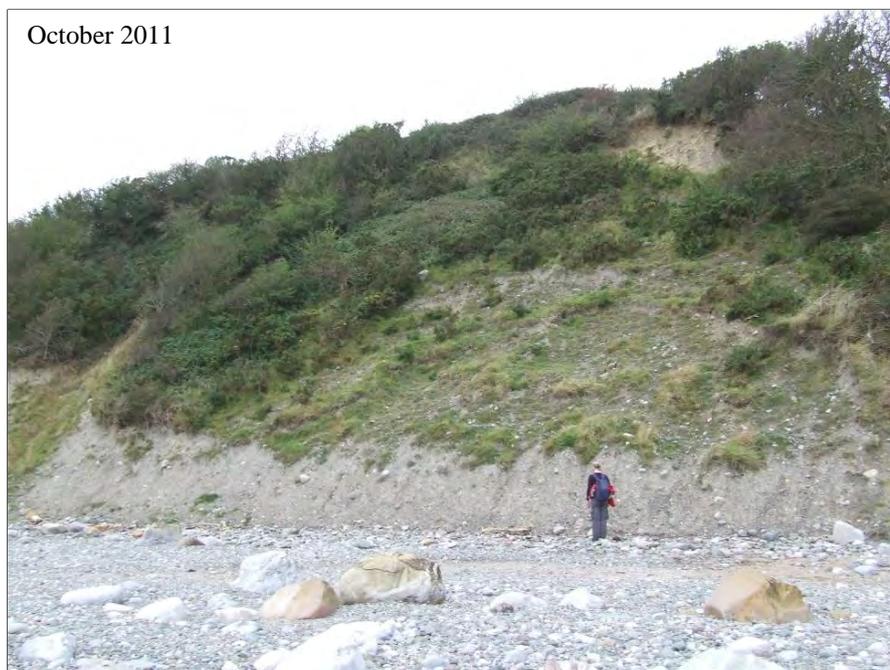
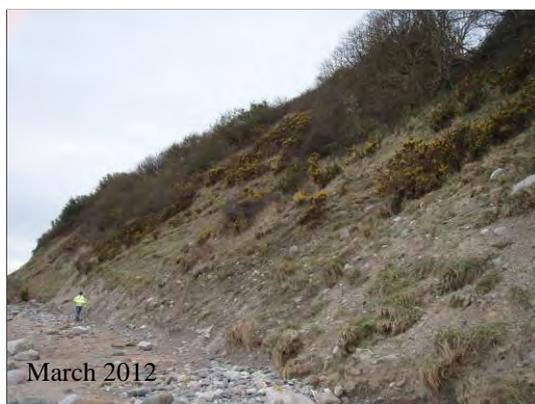
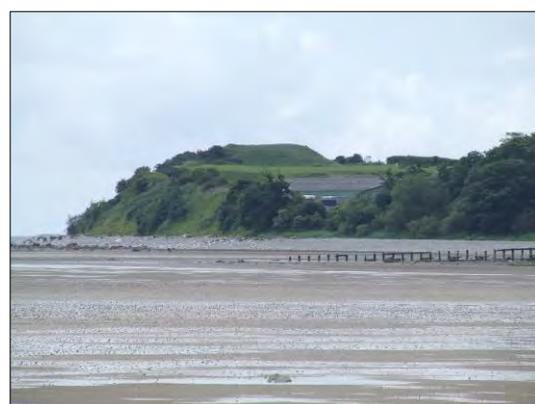
Figure 5.20 Aldingham motte and bailey showing the eroding cliff face and its situation in the landscape.

The Phase 2 survey recorded the remains of the motte and bailey as consisting of a motte with encircling moat and slight raised bank, together with an outer ditch interpreted as the bailey fosse (Figure 5.20). The erosion scar along the base of the till cliff, on which the motte and bailey sits, was surveyed on two occasions; in July 2011 (41) and March 2012 (236). The base of the cliff had shifted *c.*1m eastwards towards the shore by March 2012, presumably as a result of the slumping of material from the top of the cliff face to the base. This testifies to ongoing erosion at the site. Two points of significant erosion were also recorded (237, 238) and these corresponded with the points where the moat around the base of the motte meets the cliff edge (its entire eastern arm having eroded previously). Water from the surrounding fields drains into the moat which in turn channels this water over the cliff face, exacerbating cliff face erosion at these locations.

The most significant site at risk of erosion in this location is clearly Aldingham Motte and Bailey (41) which has already lost a substantial proportion of its total area to coastal erosion and rescue excavation. Whilst the excavations have been informative about the morphological development of the site, they were less informative on the presence or absence of buildings within the complex, did not include the castle bailey and failed to investigate the relationship between the developments taking place within the castle and the establishment of the nearby moated site. The results of the excavation have never been fully published and a more rigorous analysis of the dating of the phases of construction may provide some clarification as to who was responsible for its initial construction. The site retains large amounts of undisturbed archaeological deposits and there are clearly questions about the site and its wider significance that remain unanswered.

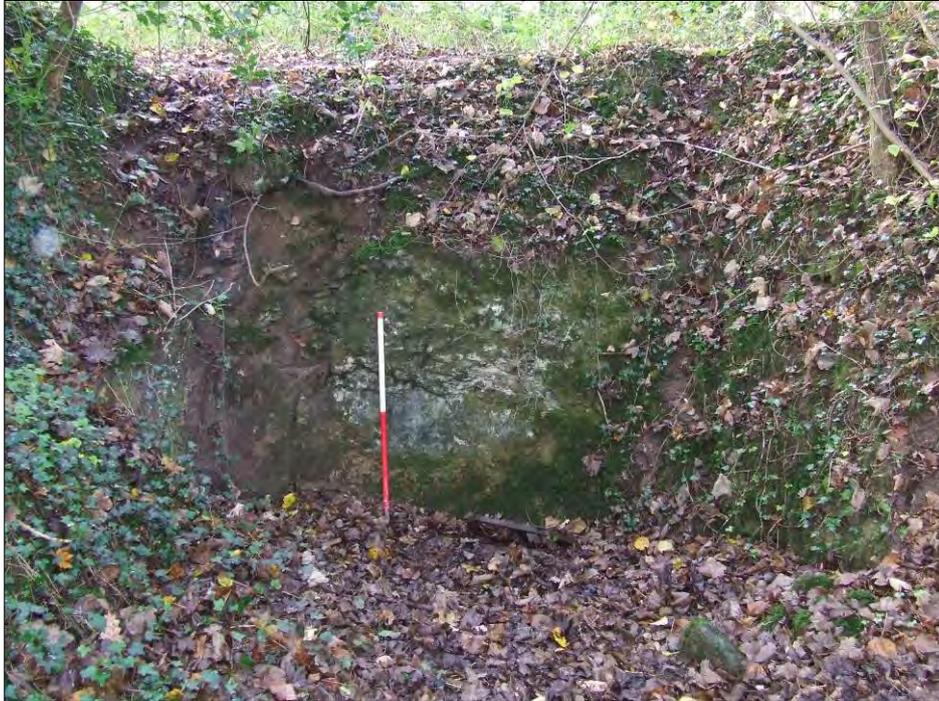
Figure 5.22 Entrance to Sea Wood Copper Mine, looking west (scale = 1m).

The Phase 2 survey recorded the location of the entrance to this shaft (214) as consisting of a small, sheet-metal lined opening of $\approx 0.5 \times 0.4\text{m}$ at the foot of a quarried out section of the surrounding limestone outcrop (Figure 5.22). The shaft is disused and allegedly flooded to the roof due to the silting up of Morecambe Bay (David Coward pers. comm.). There are several remains of quarries, spoil heaps and mine shafts (HER: 5580; 18078; 18079; 18095; 18098) along the eastern edge of Birkrigg Common that give some semblance of the past industrial character of this area.

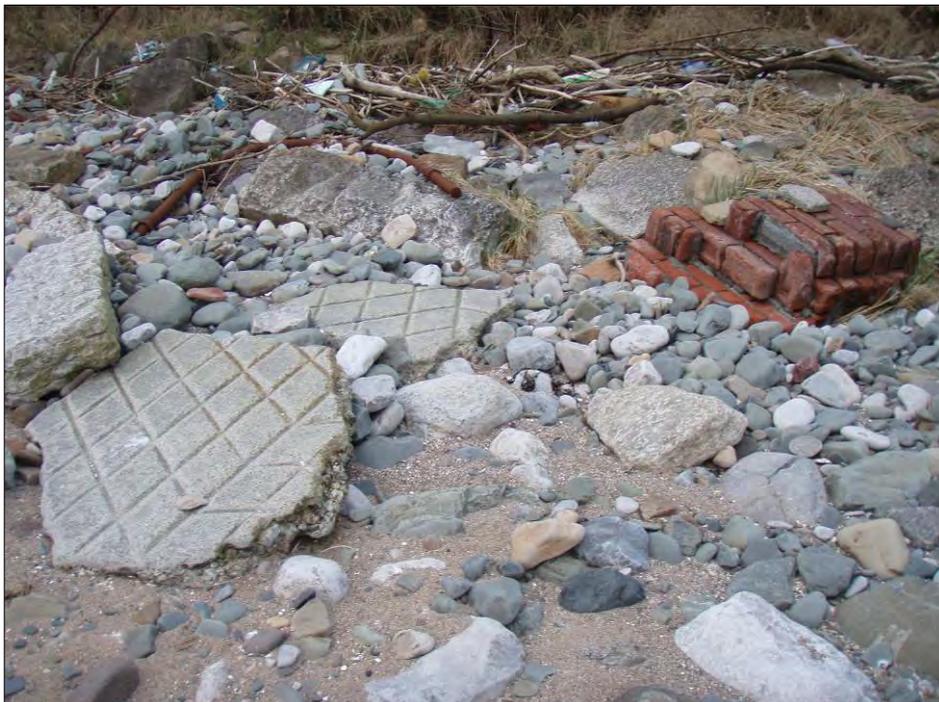
Figure 5.23 Remains of possible Second World War structure at Aldingham.

the entrance to Morecambe Bay. The Phase 2 survey recorded the remains of a demolished structure of presumed Second World War date (235) on the foreshore at Aldingham, c.250m northeast of the motte and bailey. The remains covered an area of c.135m² and consisted of concrete and sections of bonded brick walling (Figure 5.23). These remains were most likely brought to this location from elsewhere.

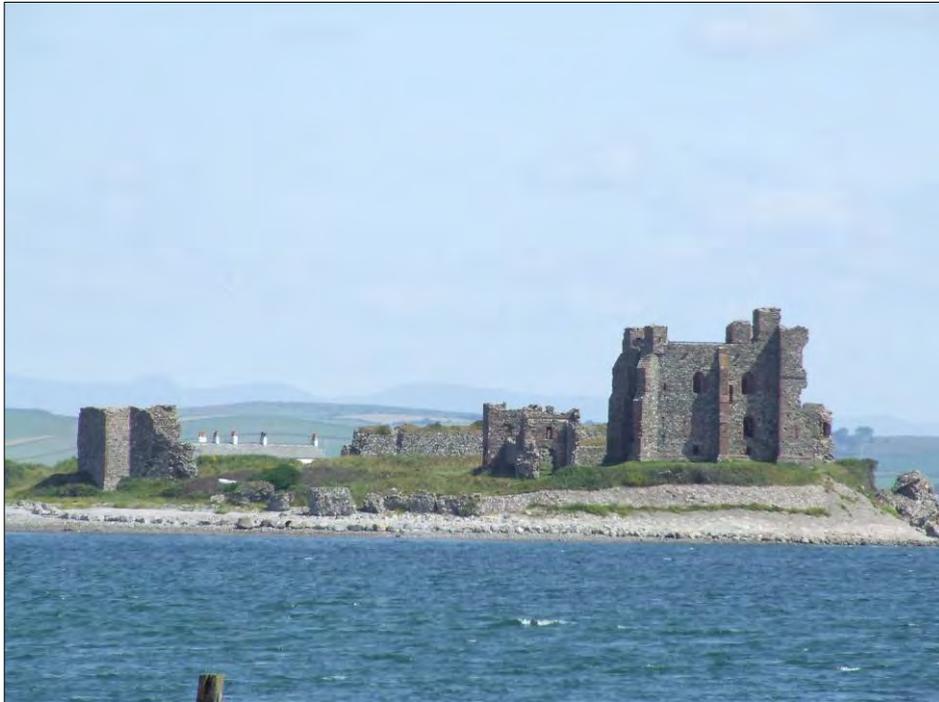
Figure 5.27 Piel castle viewed from the south of Walney Island, looking north.

The Phase 2 survey recorded the remains of the castle as described in the Scheduled Monument and Listed Building descriptions (Figure 5.27). The specific aim of the survey was to further assess the action of erosion at the site. As stated, the shoreline is currently protected by a patched sea wall of cobbles and concrete. This is carried at an angle up the cliff edge around the southeastern corner of the island. The sea wall is showing some signs of decay, but is generally sound and is monitored regularly by English Heritage (Figure 5.28). The Phase 2 survey mapped the eroding shoreline in June 2011 (72). This will act as a benchmark against which future erosion can be measured.

The erosion risk at Piel Castle is currently managed by English Heritage and previous erosion has been mitigated by consolidation works and detailed recording (Newman 1987; 1996). Despite this, if measured from the existing eroding shoreline (72), a loss of between 3.4 and 6.6m will impact upon the standing remains of the castle and any previously unknown buried archaeological deposits. The English Heritage Coastal Estate Risk Assessment noted the erosion of earthwork remains in the castle's environs. For this reason the castle and its immediate vicinity are considered to be at long term risk of coastal erosion, that is within the next 100 years. Halcrow's assessment of erosion at this site states that 'its location of Piel Island means there is a high risk from flooding and coastal erosion' (Halcrow 2011). The SMP2 does indicate that consent could be available for localised defence schemes to allow for the management of Piel Castle as a nationally important monument (Hunt 2011, 91).

It is noted that the consolidation works carried out in the late 1980s were designed to stabilise the remains for the following half century (Newman 1996, 121). This indicates that the work should come under review in 25 years time, by which point NCERM predicts that between 0.68 and 1.32m of ground will have been lost to coastal erosion (NCERM 2012). This review may provide an opportunity to measure the actual loss against the predictions and formulate future erosion risk management plans accordingly.

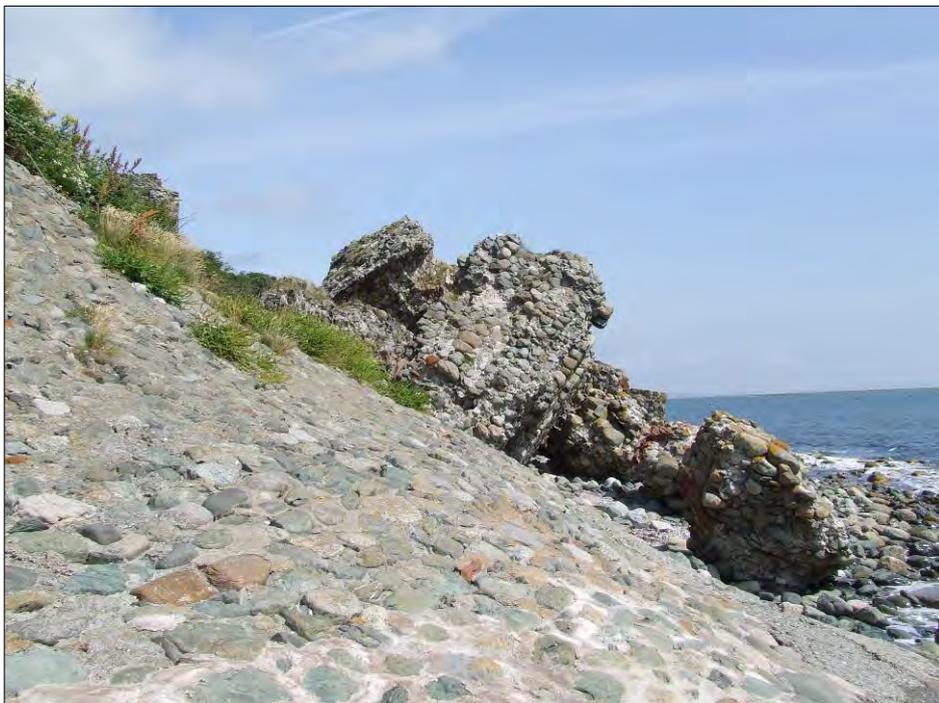
Figure 5.28 Sea wall and collapsed castle masonry on the southern shore of Piel Island.

Several large fragments of the castle have collapsed onto the beach and are actively eroding (Figure 5.28). These were recorded at 1:50 scale by The Cumbria and Lancashire Archaeological Unit in 1987 as part of consolidation works and are thought to comprise fragments of the inner and outer northeastern towers and the southern curtain wall (Newman 1996, 129-30). These largely collapsed in the 18th and early 19th century (Hunt 2011, 94).

Piel Island (Figure 5.28) lies within SMP2 policy unit 11c13.5, which recommends 'No Active Intervention' for the next 100 years. This states 'Limited defences present, allow natural processes to continue. However, localised defences may be permitted subject to consent, e.g. at Piel Castle' (Halcrow 2011).

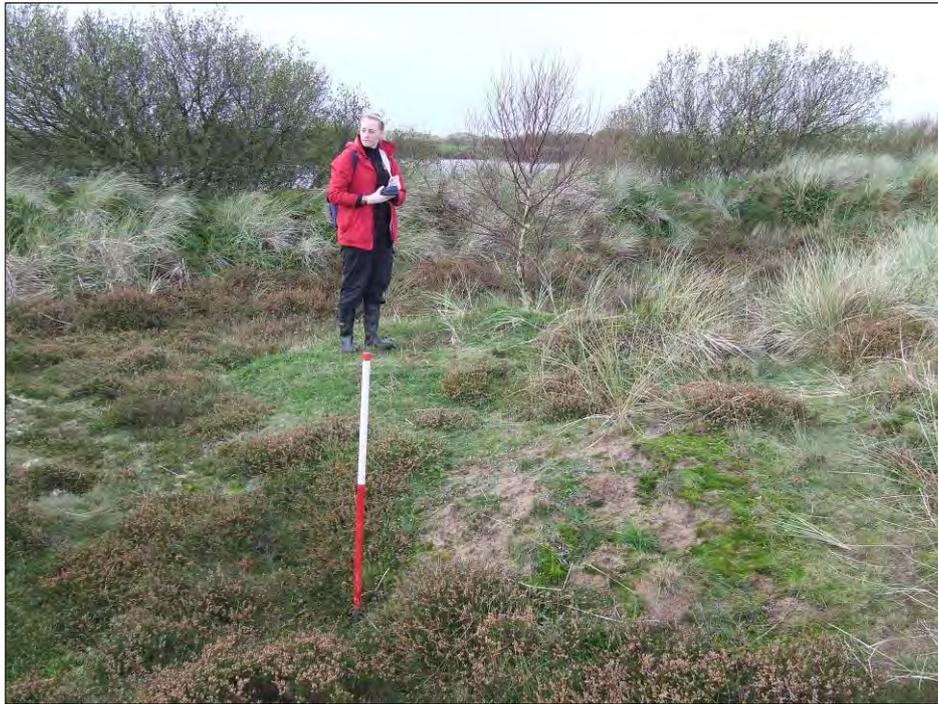
Figure 5.31 Recording the low mound of uneven ground, interpreted as a possible hearth site (scale=1m).

The first site recorded (203) was a low uneven mound (Figure 5.31) said to contain shells and fire-cracked basalt rocks (David Coward *pers. comm.*). This is described in the Cumbria HER as the site of a possible hearth (HER: 41881) and lies about midway between the west and east shores of the island, c.300-450m from the sea.

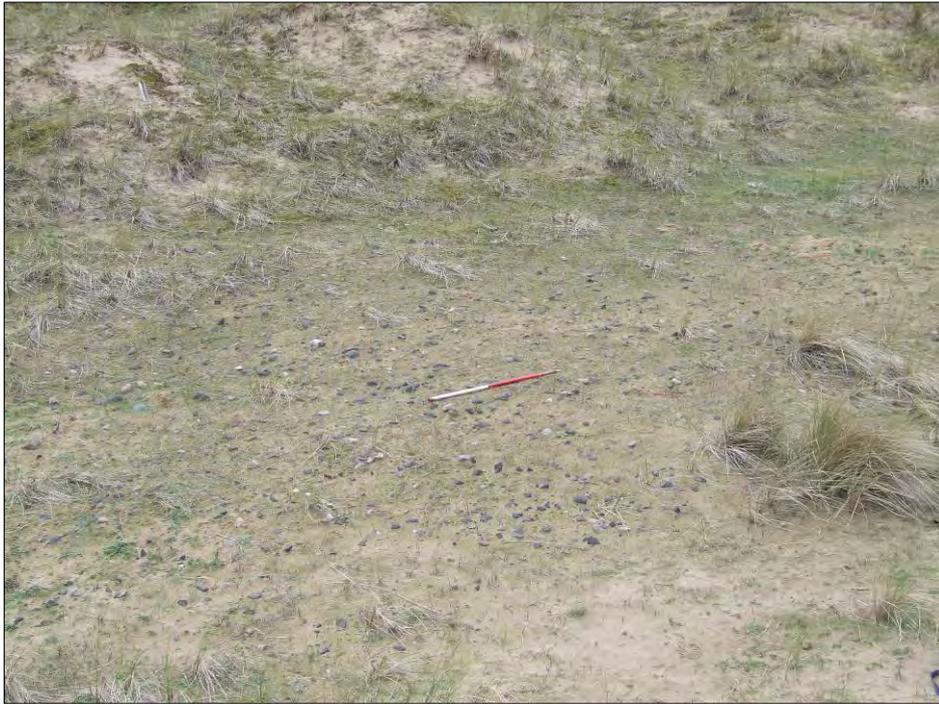
Figure 5.32 Large open area containing possible fire-cracked basalts (scale=1m).

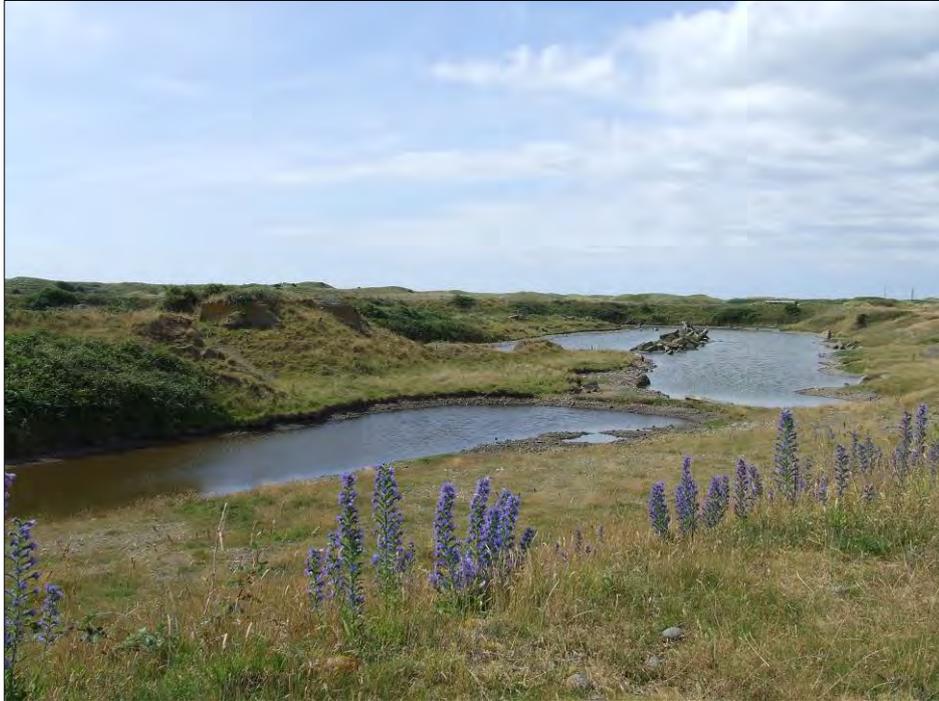
The Phase 2 survey recorded the remains of the saltworks (64) as consisting of extensive earthwork remains and large water-filled pools (Figure 5.35), as well as the remains of the timber pier used for salt exportation. The earthworks and pools appear to have been sculpted as part of the South Walney Nature Reserve and provide important diverse habitats for local wildlife. The history of the site is outlined in a dedicated interpretation

Figure 5.35 Remains of salt working industry on the south of Walney Island.

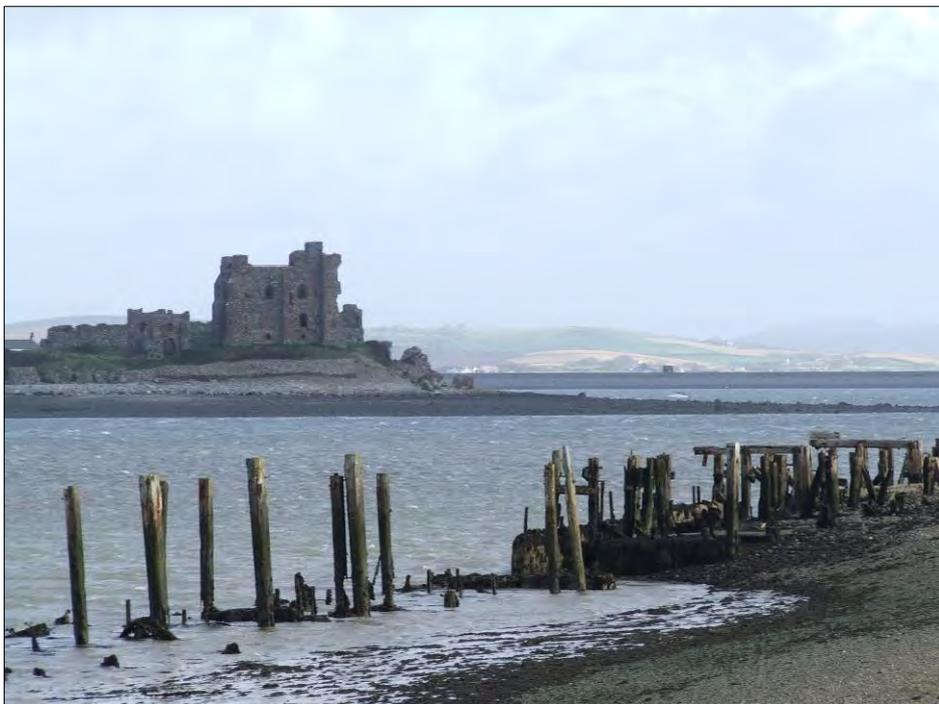
panel. The timber pier lies in the inter-tidal zone and is in a ruinous state consisting of a series of upright timber posts and a few horizontal beams (Figure 5.36). There appeared to be stone footings along the seaward face of the timbers, however more detailed survey was not possible as access to the shore was restricted.

Figure 5.36 Remains of the 1870s timber pier used to export salt and gravel from South Walney.

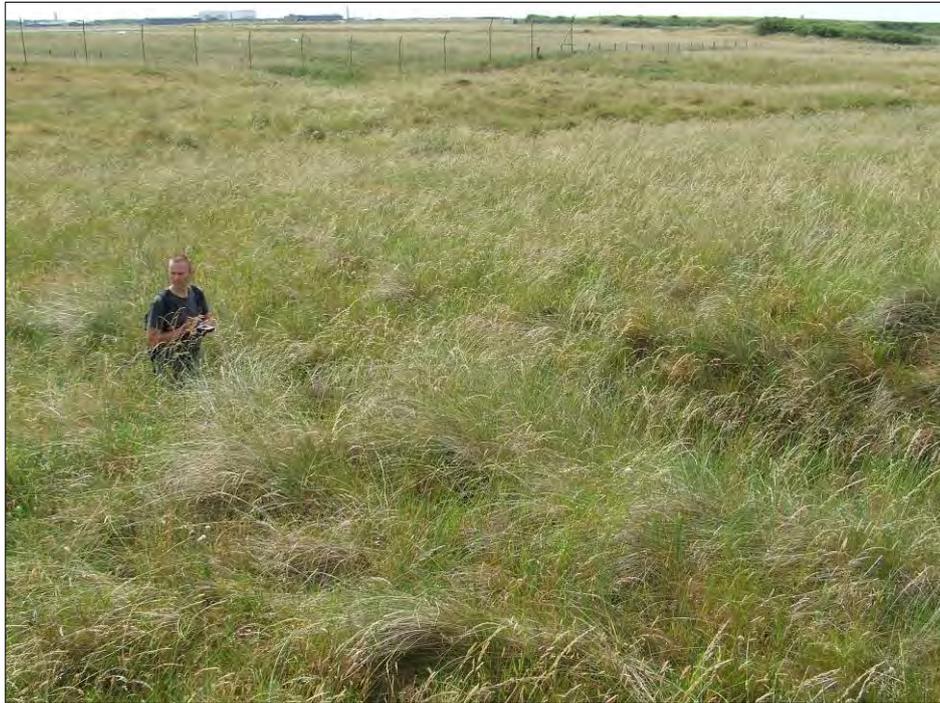
In the north of the island, the Phase 1 aerial photography transcription mapped a series of possible WW1 practice trenches (NRHE: 1488706) which look like crenellations in plan rather than the more common zig-zag trenches of World War Two (Lowry 2002, 26). One stretch of trenches was recorded during the Phase 2 survey as consisting of graded earthworks of box trenches (54, 55, 58) slit trenches (56) and mounds of upcast material (55, 57, 59). The line of box trenches (54) was partially obscured by long dune

grass, but was still discernable and recorded for a length of *c.*95m (Figure 5.38). As mapped, the recorded remains follow a crenellated plan form. Two further small box trenches were recorded at each end of these remains, immediately behind the first line (55, 58). These were accompanied by slit trenches (56) and mounds of upcast material (59), and may have formed a secondary redoubt or gun mounting position. These associated features were not mapped as part of the Phase 1 aerial photography transcription.

Figure 5.38 Recording the remains of possible First World War practice trenches in North Walney (surveyor is within the trench which runs diagonally across the photograph).

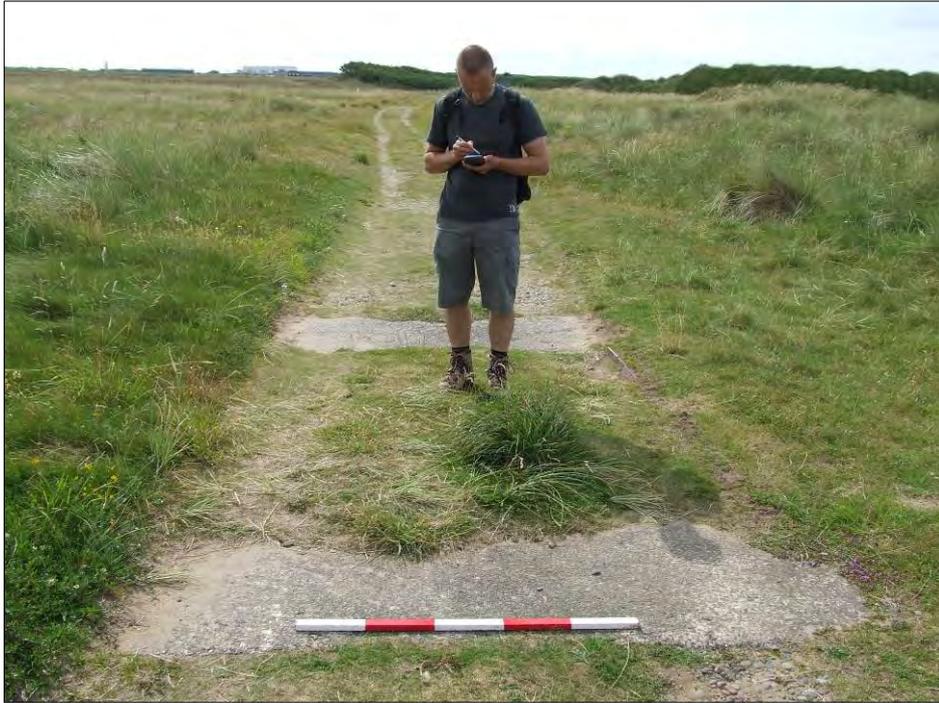
The Phase 2 survey did not record Walney airfield (HER: 15626) as it is still in use and is privately owned by BAE Systems. However, one feature possibly associated with the airfield was recorded during the survey, consisting of a concrete platform (53) measuring *c.*2m x *c.*5m (Figure 5.38). This was located along the line of a barbed wire obstruction, forming the outer limit of the airfield, that was mapped as part of the Phase 1 aerial photography transcription (NRHE: 1383764). No remains of the barbed wire obstruction have survived, however the concrete platform may mark the location of an access point through the wire, for troop movement that avoided the other defensive features of the airfield. This would date the platform to the Second World War.

Figure 5.39 Recording a concrete platform possibly associated with Walney airfield (scale = 1m).

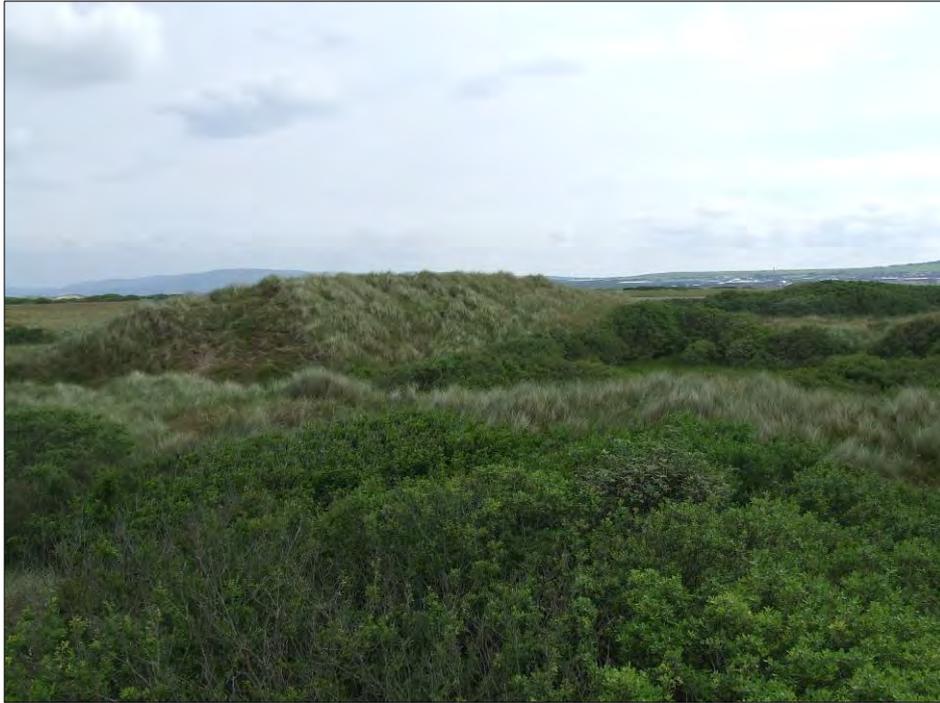
The purpose of the northern embankment (Figure 5.40) was to collect discharged ammunition, which would have been fired from the south at targets placed above the southern embankment. The southern embankment had a concrete retaining wall along its north face, the western side of which was covered with modern graffiti. This graffiti was extended between the Phase 2 site visits of July and November 2011 showing that the site is visited, at least occasionally.

Figure 5.40 The northern embankment of the Second World War firing range at North Walney.

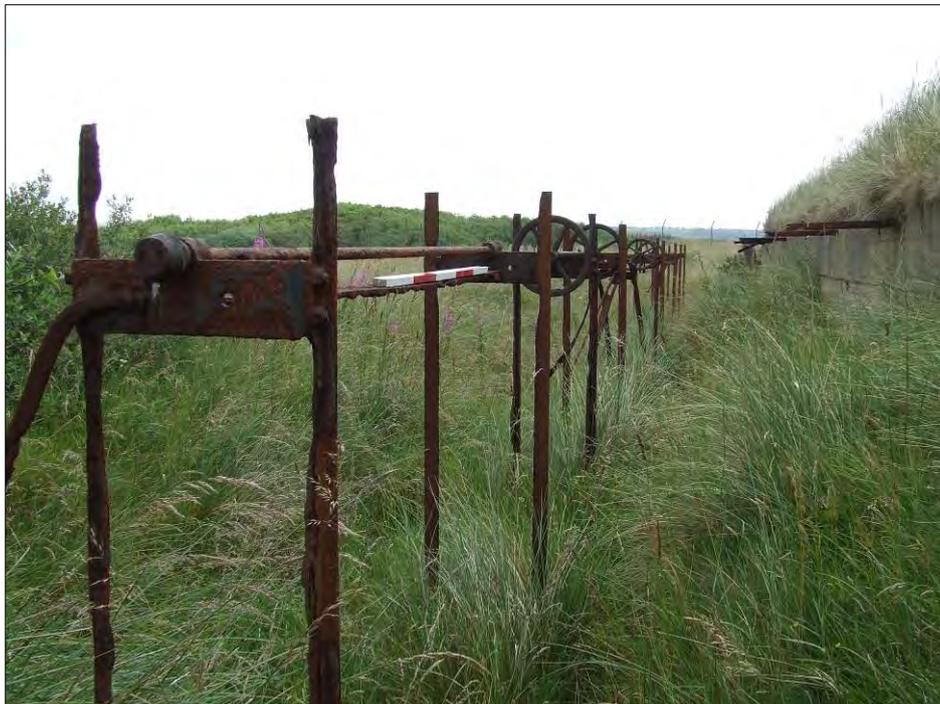
The wrought iron rotary mechanisms for raising targets above the southern embankment ran parallel to this retaining wall. These consisted of a series of frames, each with two pulley wheels (one at either end) connected by a horizontal shaft. These may have been powered by a second line shaft carried on wrought iron arms projecting from the concrete revetment behind, however no evidence of a second shaft survives. The frames are in a rusted deteriorating condition and none of the targets survive (Figure 5.41).

Figure 5.41 The southern embankment of the Second World War firing range at North Walney showing the concrete revetment and wrought iron mechanism for raising the targets.
