5. ARCHAEOLOGICAL SURVEY RESULTS: CUMBRIA

5.1 Introduction

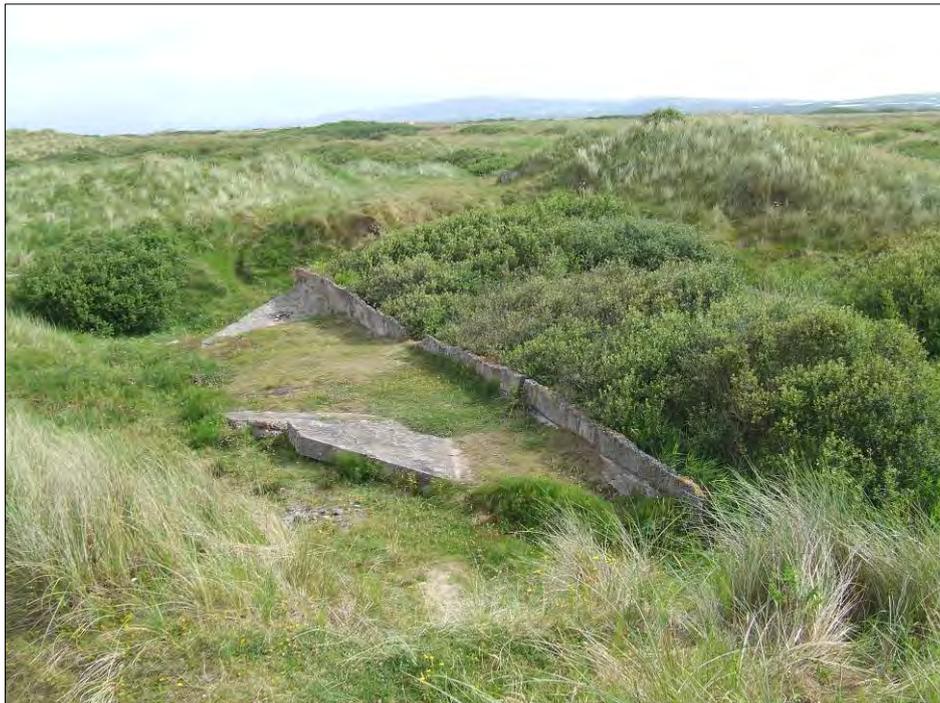
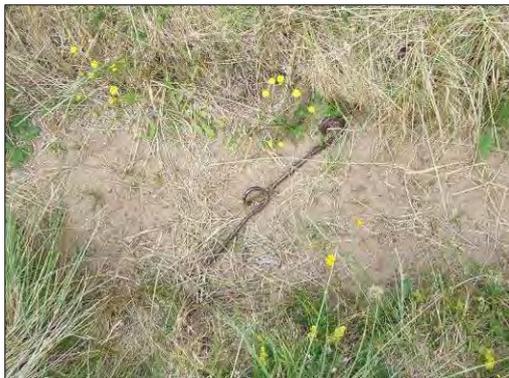
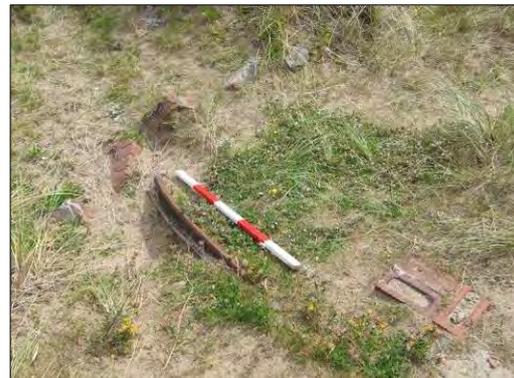
Figure 5.42 Remains of the air gunners range on North Walney; the ruined concrete remains of the target area (49), the metal fixing for a barbed wire fence (50) and the curving metal gunners' rail (51) (scale = 1m).

Two further points were recorded marking the location of the remains of a wire fence (50) found protruding from the sand dunes, and the remains of a possible trackway (51). The fence (50) took the form of a partially buried run of metal fixings which would have had wire fencing or barbed wire attached to form a barrier, presumably marking the outer extent of the air gunners range (Figure 5.42). Whilst the trackway (51) consisted of the partially buried remains of a curving metal rail and brick structure. This rail would have encircled the target area (49) and would have a mounted machine gun allowing the trainees to fire down into the target area, whilst moving along the rail. This therefore simulated firing upon a fixed target from a moving aircraft.

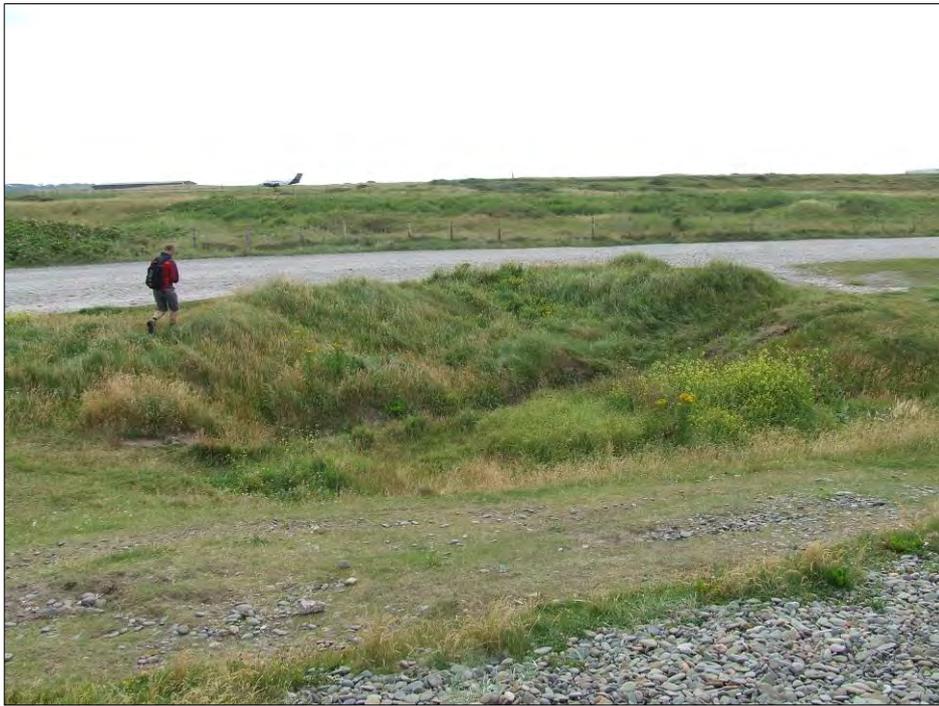
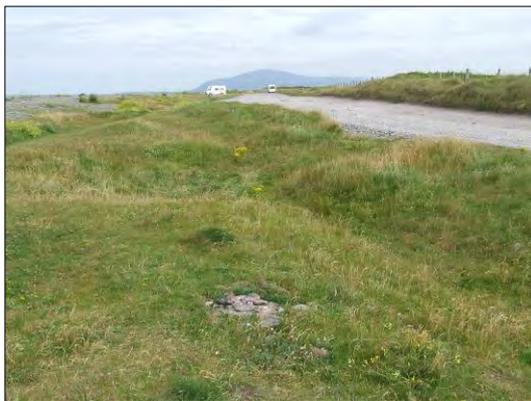
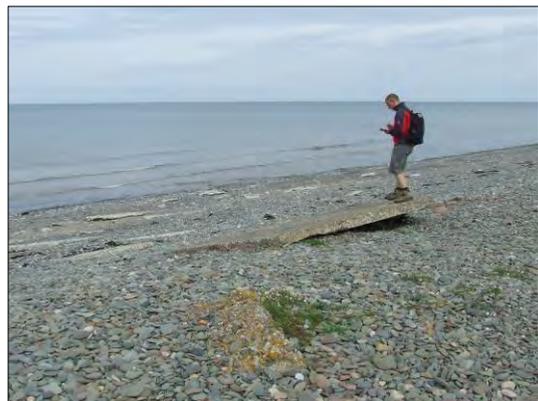
Around 700m south of the air gunners range a further concentration of Second World War features was recorded as part of the Phase 2 survey (Figure 5.43). These were most likely associated with the defence of Walney airfield and consisted of two large probable weapons pits (46, 47), a possible gun emplacement (45) and a trench (48). The weapons pits consisted of large hollowed-out areas that could be a natural feature of the dune system, but may also be man-made features. The larger of the two pits (46) had a diameter of $\approx 16.5\text{m}$. The trench recorded lies to the north of these pits and was much degraded. It ran for a length of $\approx 19\text{m}$ with a maximum width of $\approx 2\text{m}$. The possible gun emplacement consisted of a ruined concrete platform similar in appearance to known gun emplacements recorded in the south of the island (see below). It is surrounded by other building remnants of possible wartime date.

Figure 5.43 Features of Second World War date, possibly for defence of Walney airfield, consisting of weapons pits (46), a trench(48) and a possible gun emplacement (45) (scale = 1m).

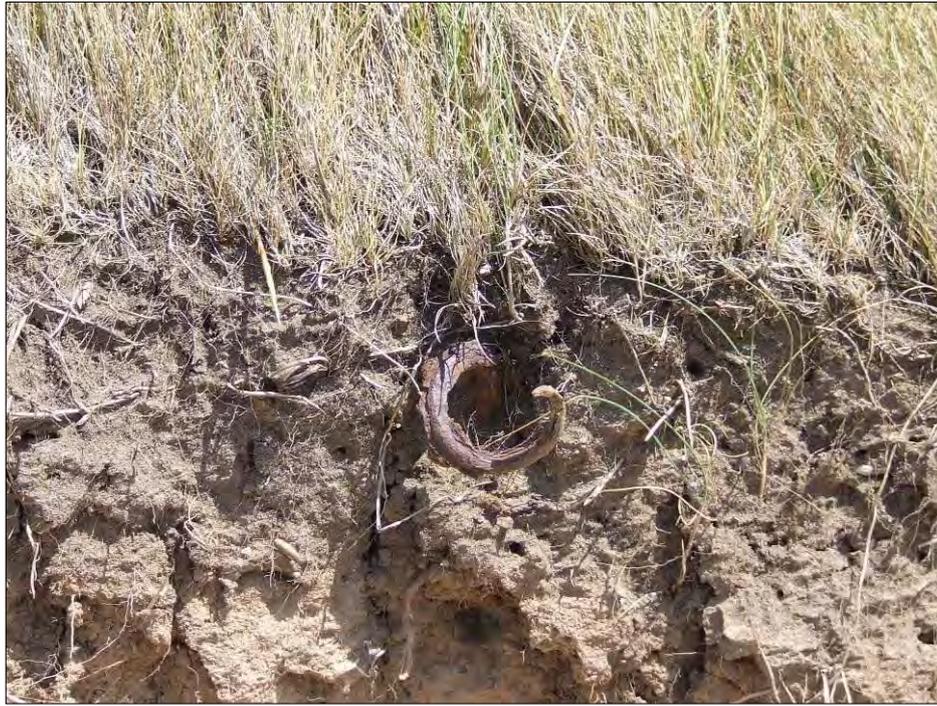
Figure 5.44 Remains of picket wire or barbed wire fence in the eroding till cliff edge on South Walney.

The Phase 2 survey recorded the remains of a possible picket wire or barbed wire fence (70) along the western shore in the south of the island. This consisted of metal fixings seen eroding out of the till cliff edge. The remains may be in-situ but could also have been moved from elsewhere and used as a field boundary. The metal was corroded and only a small section of the fixing was visible in the cliff face (Figure 5.44).

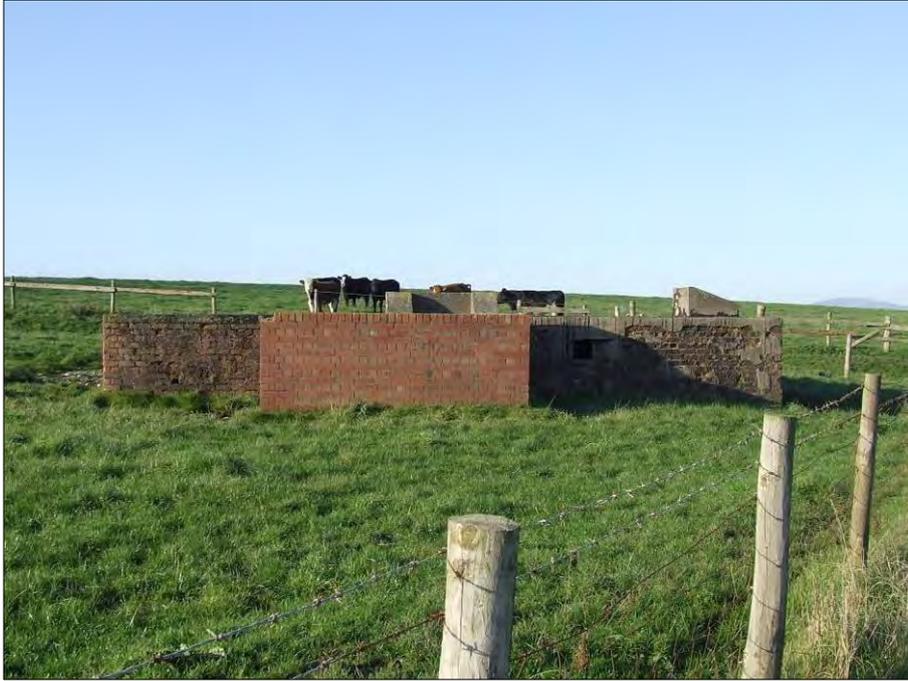
This building is recorded in the Cumbria HER (HER: 19872) and consisted of a T-shaped brick structure with a flat concrete roof (Figure 5.45). There was a circular aperture on the west elevation and square gun port on the southeastern elevation, facing towards the decoy site. This is an unusual feature for a control building and suggests that the structure also served as a pillbox. The building was also fitted with an escape hatch in the roof accessed via an internal ladder.

Figure 5.45 Second World War decoy control building on South Walney

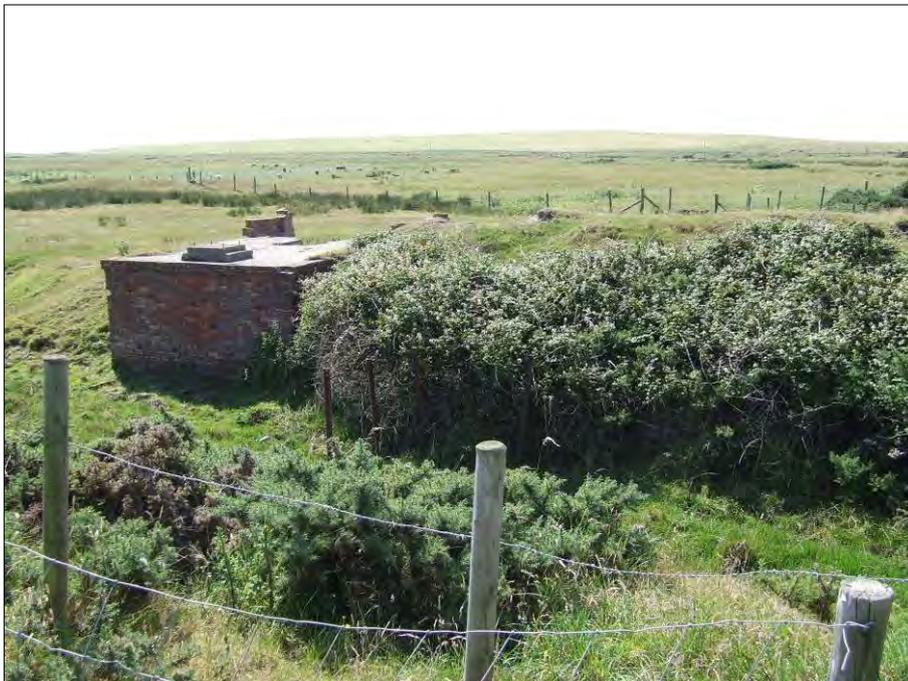
Around 1.3km southeast of the bombing decoy control building, the Phase 2 survey recorded the remains of a possible Second World War bunker (69). This consisted of a square brick-built structure laid to English garden bond with two projecting brick-built wings on the west elevation (Figure 5.46). The roof was constructed of flat concrete and appears to incorporate the footing for an attached gun position. To the north side of the possible bunker a man-made embankment may house an underground extension of this structure, though access could not be gained for inspection. This may also have been associated with the bombing decoy site on Wylock Marsh to the northwest.

Figure 5.46 Possible Second World War bunker on South Walney.

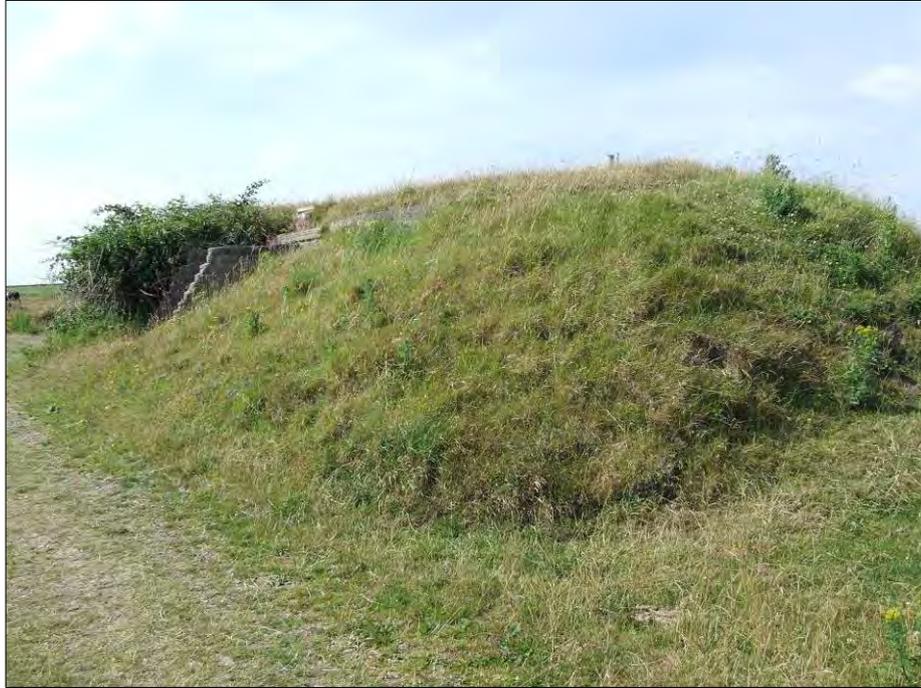
Around 1km south of the bunker a further Second World War air-raid shelter (62) was recorded as part of the Phase 2 survey. This consisted of a large earthen embankment surrounding a concrete structure measuring $\approx 20\text{m} \times \approx 12\text{m}$ (Figure 3.47). The entrance to this structure is now blocked, but was composed of concrete blockwork which projects from the east face of the embankment. The structure was provided with two brick-lined escape hatches in the roof, both of which are now blocked.

Figure 5.47 Possible Second World War air-raid shelter on South Walney.

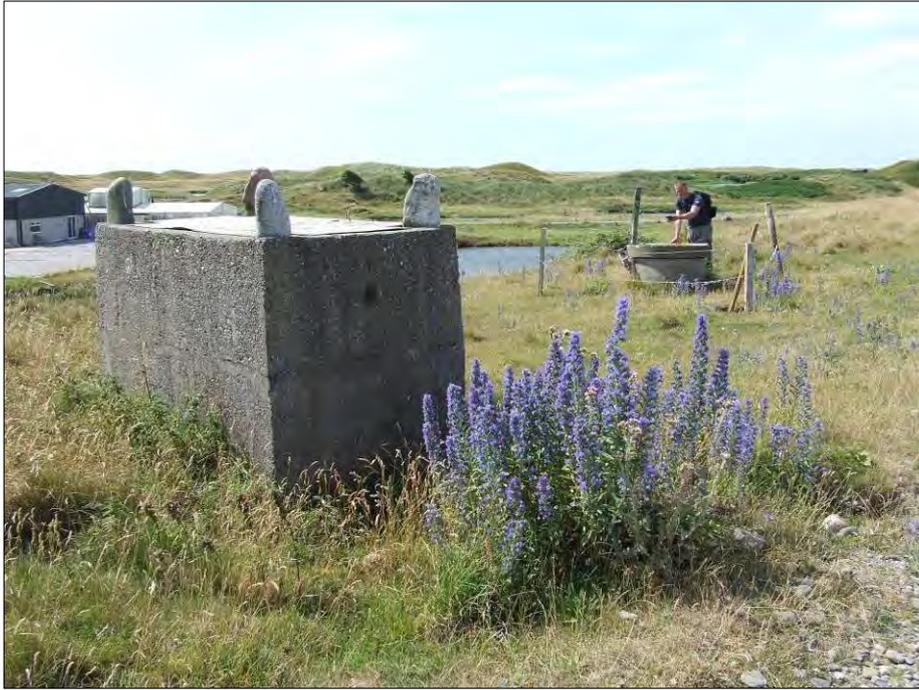
Around 1.5km southeast of the shelter, the survey also recorded two entrances to underground shafts (63) which appeared to be of wartime construction (Figure 5.48). The first shaft was cylindrical and constructed of concrete with iron fixings for a cover on the top. It had internal iron steps leading to a water-filled chamber. The second shaft, $\approx 9.5\text{m}$ away, was square, constructed of concrete and on first inspection looked very similar to an anti-tank block. It retained the metal fixings for transportation on each of its four corners, however these were encased with concrete. The block was hollow with a permanently fixed metal cover on the top. The purpose of these shafts is not known.

Figure 5.48 Recording two possible wartime shafts on South Walney, looking west.

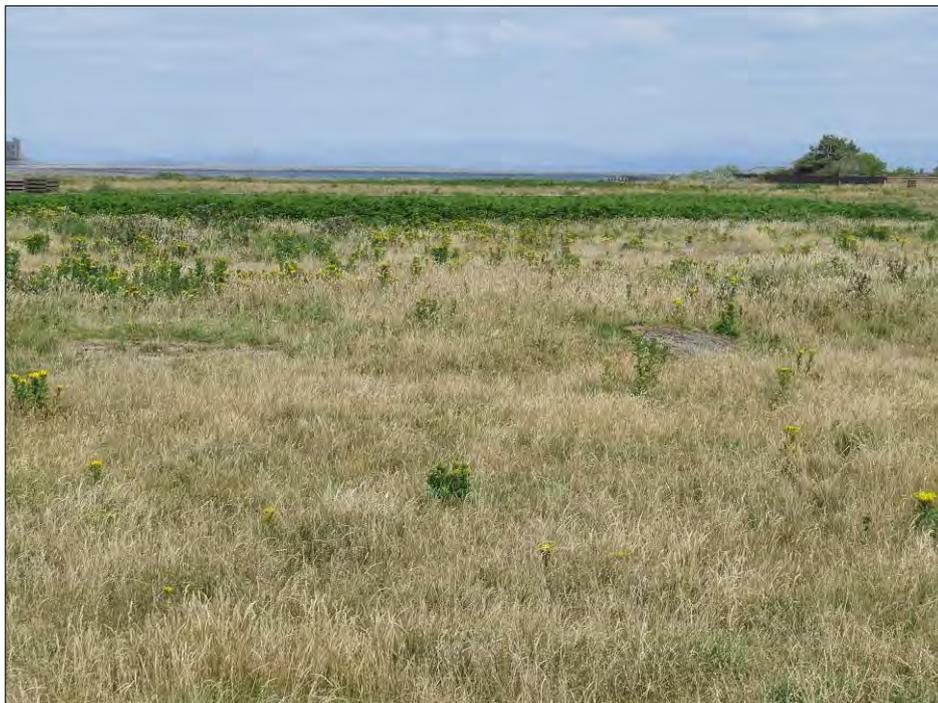
The Phase 2 survey recorded the remains of the H5 battery as consisting of a military camp (68), a control building (67d) and three gun emplacements (67a, 67b, 67c). The military camp (68) consisted of earthwork remains and concrete footings for demolished buildings (Figure 5.49). These were largely overgrown and the full extent of the remains, as mapped during Phase 1, could not be established on the ground. No standing structures survived, and this is a common feature of domestic camp sites which tend to have been cleared, leaving only the concrete hut bases to mark their former location (Lowry 2002, 104). The command post for the coastal battery consisted of the ruined remains of a flat-roofed concrete structure which appeared to have had internal brick partitions (Figure 5.50). Again, it was common for command posts to be deliberately destroyed after the war in order to render the battery unusable and this appears to have been the case at the H5 battery. The damage incurred cannot be explained by coastal erosion or other natural processes.

Figure 5.49 Concrete bases of dismantled buildings forming a Second World War Military camp.

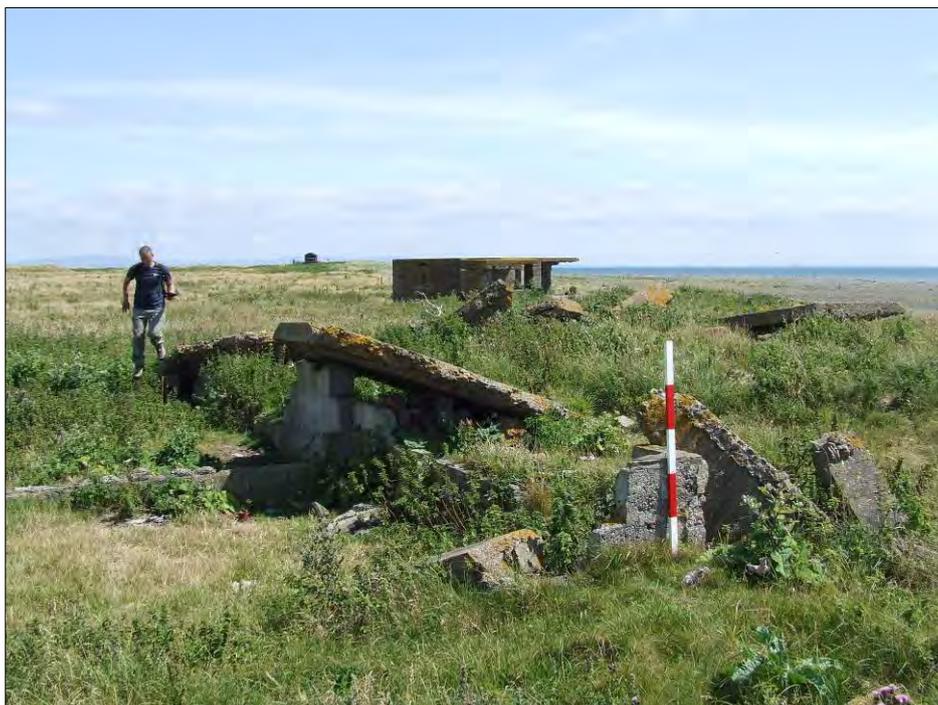
Figure 5.50 Demolished command post for the H5 battery, looking southeast (scale = 1m).

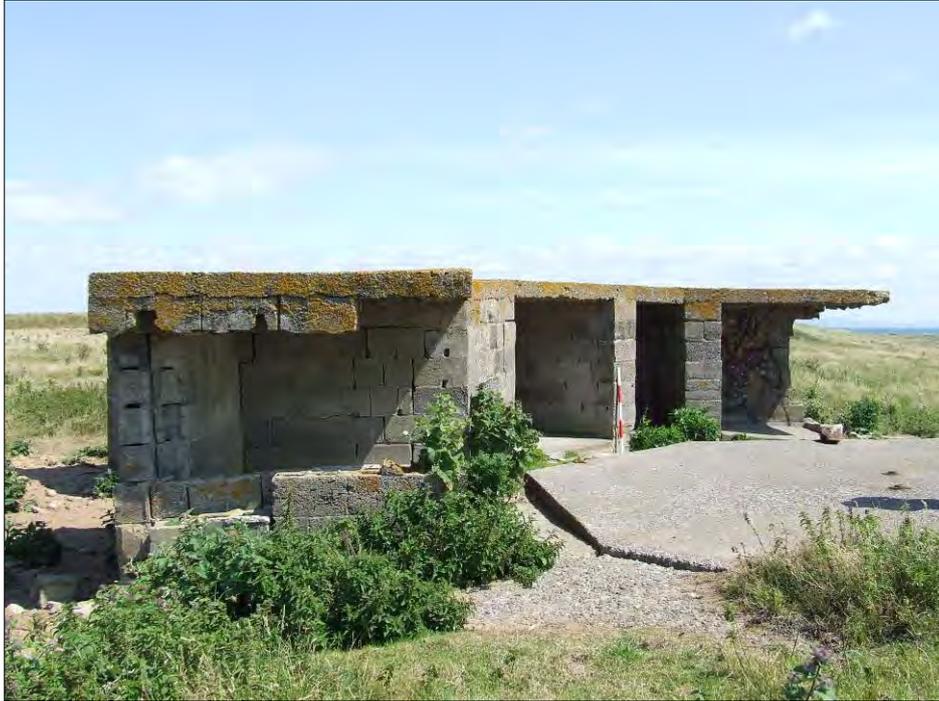
The gun emplacements recorded as part of the Phase 2 survey (67a, 67b, 67c) are only the most inland three of an original four emplacements at this location. The fourth, most seaward gun emplacement appears to have either been completely destroyed, or partially destroyed and buried beneath a shingle ridge on the beach front. The three surviving gun emplacements are in varying degrees of disrepair as a result of coastal erosion. The best preserved emplacement (67a) consisted of an octagonal concrete base with metal gun holdfast points in the centre. Along the northern side of the base there were three surviving ammunition lockers (Figure 5.51). There may once have been at least two more of these and a roof with only the coastal side of the gun emplacement open to allow firing, although the original form of this gun emplacement is difficult to discern. The remains of ruined ammunition lockers were noted in the vicinity of the structure. The other two gun emplacements survived as octagonal concrete bases with gun fixing positions only. The most seaward gun emplacement has been displaced and was lying at an angle partially buried in a large shingle ridge (Figure 5.52).

Figure 5.51 Best preserved gun emplacement on the H5 battery with surviving ammunition lockers, looking southeast (scale = 1m).

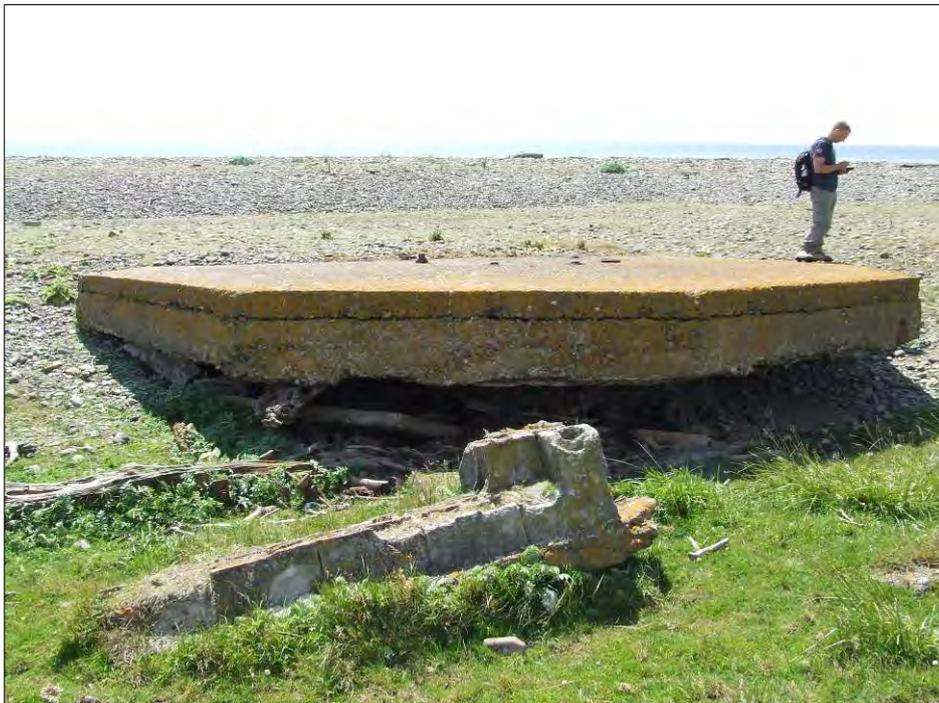
Figure 5.52 Recording the remains of the most seaward gun emplacement on the H5 battery surrounded by the demolished remains of ammunition lockers, looking southwest.

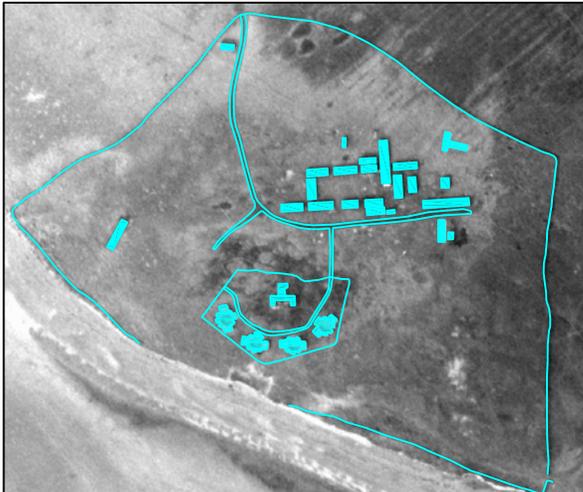
RAF 106G/UK/1334 5401 29-MAR-1946 English Heritage (NMR) RAF Photography

1946 - Immediately post-war the HAA Battery is almost completely intact, including the associated camp with road network and the barbed wire perimeter. Notably a length of this perimeter is missing along the shoreline, suggesting it was lost to coastal erosion.

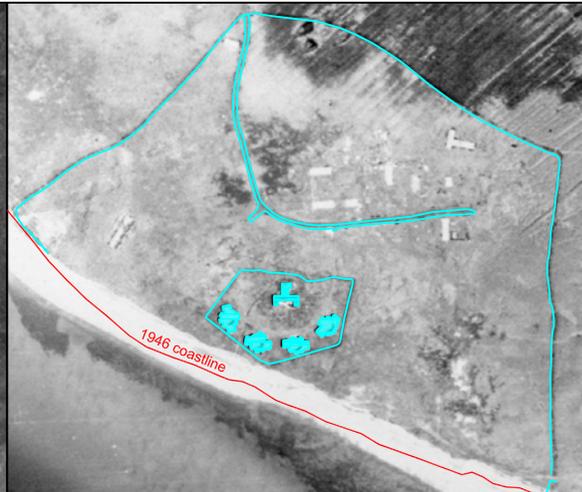
RAF 541/522 3047 12-MAY-1950 English Heritage (NMR) RAF Photography

1950 - Four years later the camp buildings have been demolished, and part of the trackway has been removed or overgrown. The battery itself remains fully intact with the barbed wire perimeter. Notably the shoreline has eroded over 20m losing more of the outer fence.

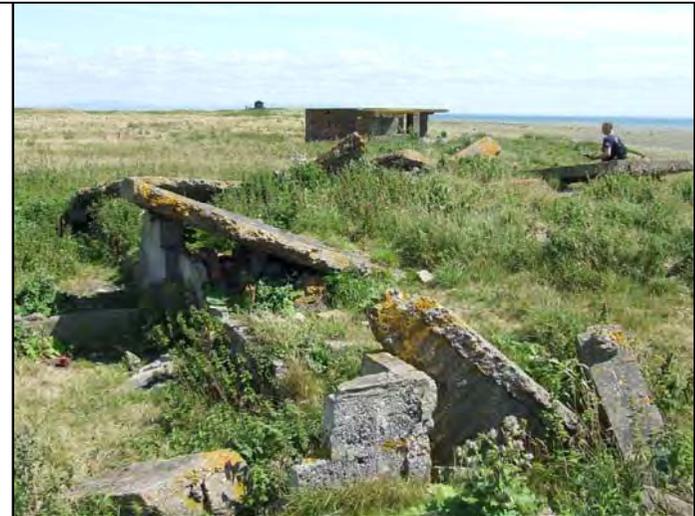
2011 - The overgrown ruins of the battery command post in the foreground, with the only in-situ gun emplacement behind. This gun position only retains the rear ammunition lockers. The others have collapsed through coastal erosion.

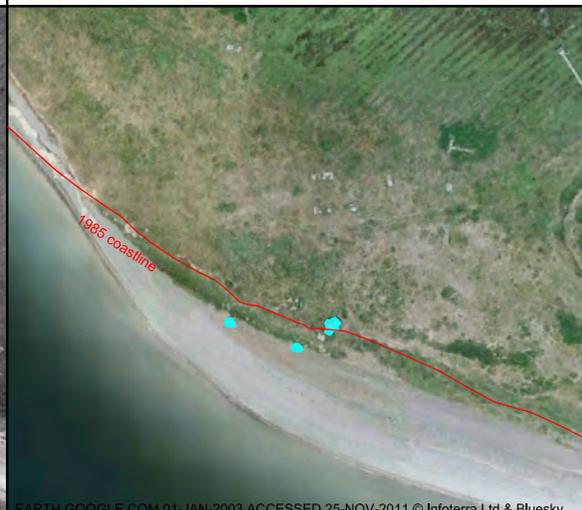
EARTH.GOOGLE.COM 01-JAN-2003 ACCESSED 25-NOV-2011 © Infoterra Ltd & Bluesky

2003 - A period of stability has seen a slight reclamation of the dunes for up to 22m. The command post has largely been covered. One of the emplacements has either been destroyed or buried under the storm beach.

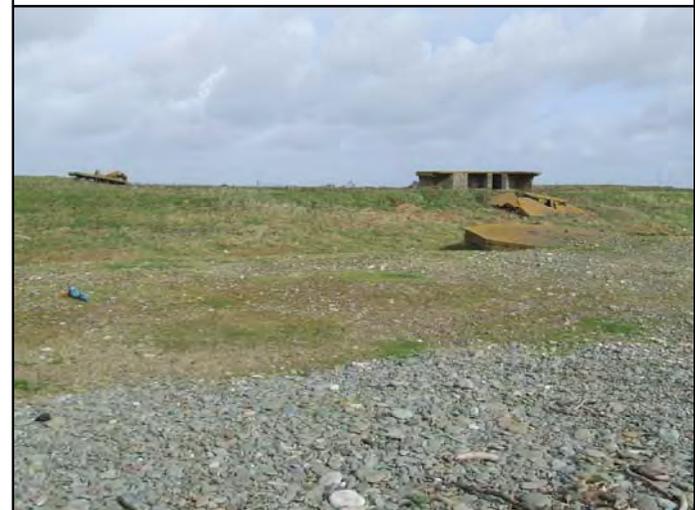
2011 - The command post to the left, and surviving gun position on the summit of the old coastline with the collapsed ammunition lockers in front. Part buried in the beach is the footing of a second gun emplacement. A third should be visible in the immediate foreground, but has either been completely destroyed or is buried.

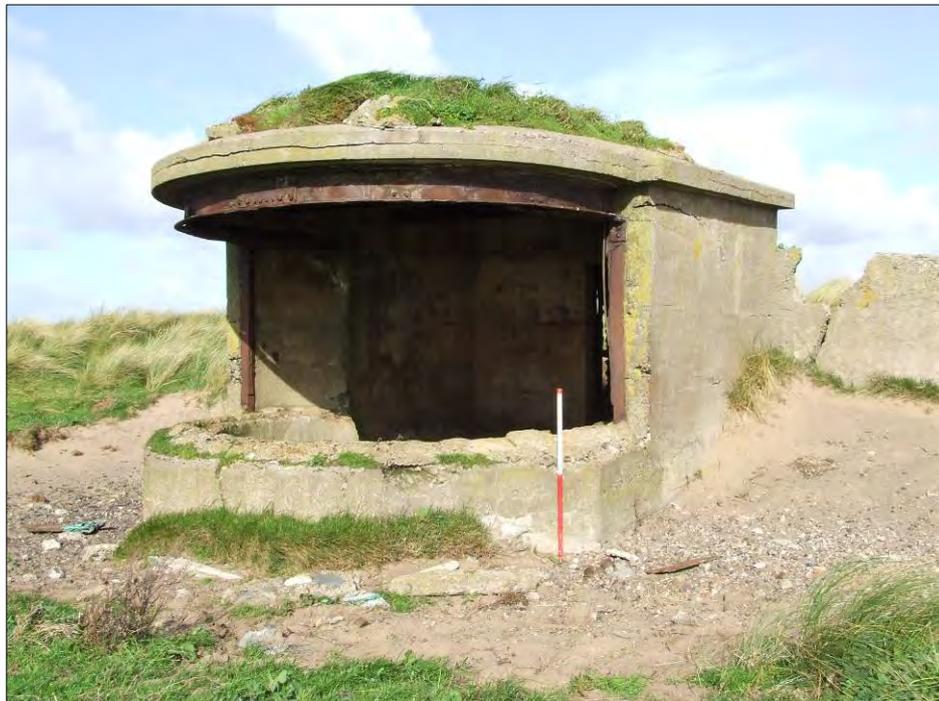
Figure 5.54 Searchlight 65a at Hिल्psford Battery, South Walney, looking north (scale = 1m).

The two searchlight positions recorded (65a, 65i) were in a remarkably well-preserved state consisting of concrete square-shaped structures with D-shaped open fronts framed by wrought iron (Figure 5.54). The framing would have held sliding iron shutters, some panels of which still survive internally. The entrance was via an iron door in the rear of the structure. Searchlight 65a had a length of ruined concrete walling projecting from its northwestern corner suggesting that the battery was once enclosed. This wall does not survive elsewhere. The roof of this structure was also overgrown and this vegetation could eventually undermine the structural integrity of the building.

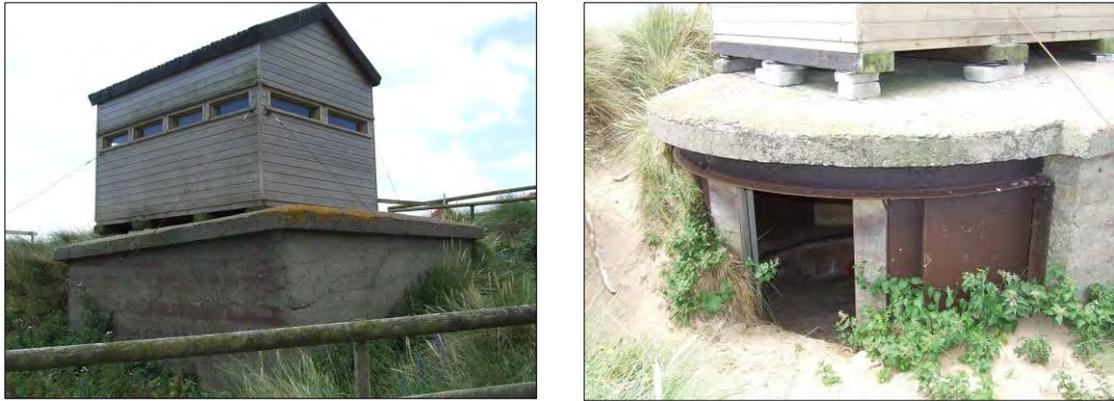
Figure 5.55 Searchlight 65i at Hilpsford Battery, with Groyne Hide on the roof.

Searchlight 65i had the interesting addition of a timber bird-hide on its roof, but was otherwise in a good state of repair with well-preserved internal iron fixings and shutters (Figure 5.55). The level to which the dune sands have partially buried the structure testifies to some accretion in this area since the 1940s and this is attributed to the now redundant groyne system along the western shoreline on the south of the island (Halcrow 2011).

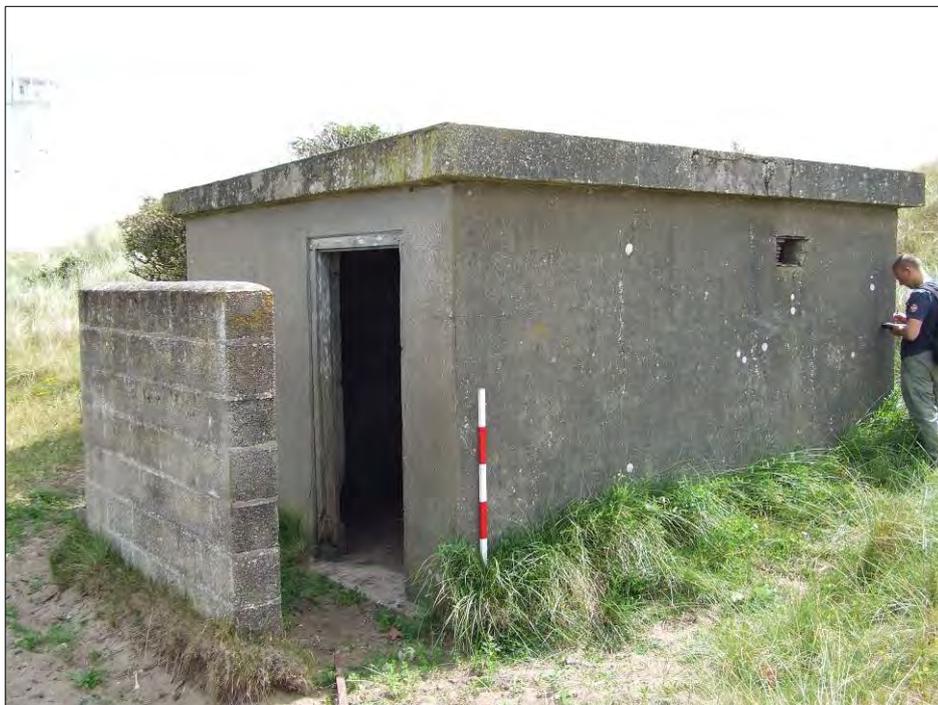
Figure 5.56 Recording shelter 65b at Hilpsford Battery, South Walney (scale = 1m).

The two shelters recorded (65b, 65c) were also well-preserved. These were constructed of regular concrete blockwork with external concrete render and a flat roof (Figure 5.56). Each had an external, detached blast wall constructed of concrete blocks in front of the entrance, which was a simple doorway. Ventilation openings were present in each side wall, but the structures were otherwise windowless.

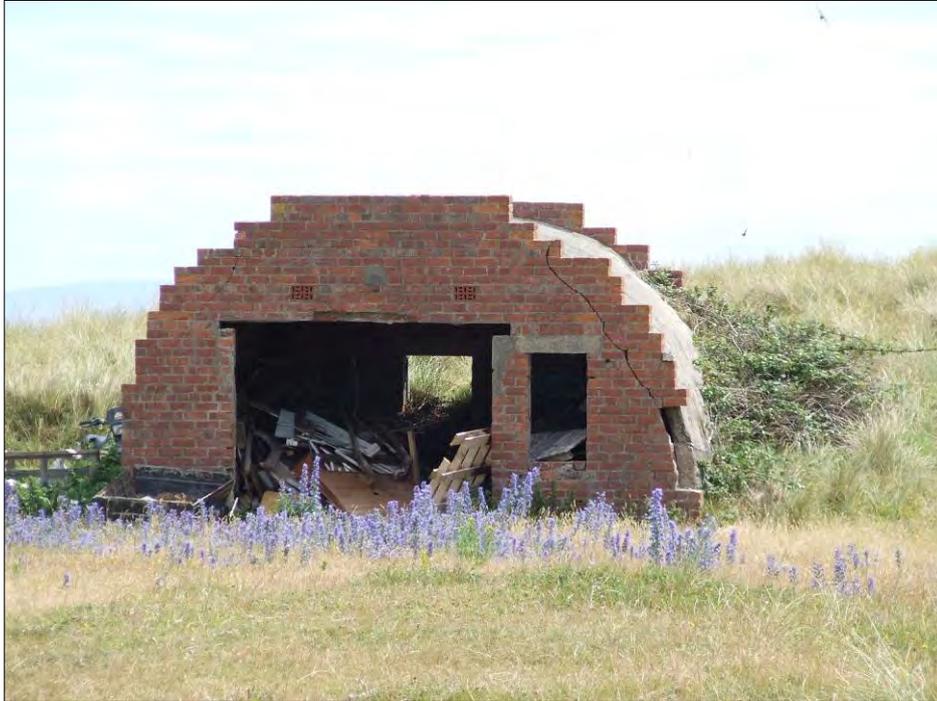
Figure 5.57 Possible gun store 65d at Hilpsford Battery, South Walney (scale = 1m).

Located $\approx 50\text{m}$ east of shelter 65c, was a brick and concrete ‘nissen hut’ style structure that has been interpreted as a possible gun store (Figure 5.57). It had brick-built front and end walls with a wide front opening, and adjacent window, and an entrance to the rear. The main body of the structure was constructed of concrete with a semi-circular section. This building was on private land and was not accessible for a more detailed survey.

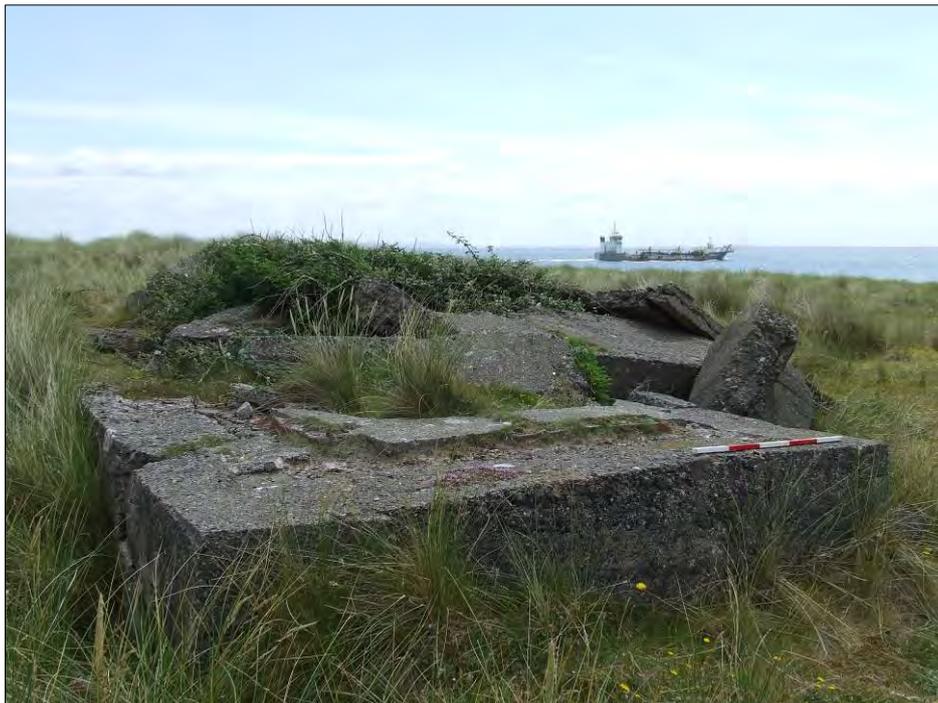
Figure 5.58 Possible ancillary gun emplacement 65e, looking southeast (scale = 1m).

The three gun emplacements recorded (65e, 65f, 65h) are all in a ruinous condition, particularly site 65e which consists of the rubble remains of a concrete and brick structure (Figure 5.58). It was identified as a possible ancillary gun position although emergency batteries usually consist of only two gun emplacements (Osborne 2004, 25). This structure may also be the remains of the battery’s command post, similar to that seen at the H5 battery to the west (see Figure 5.49).

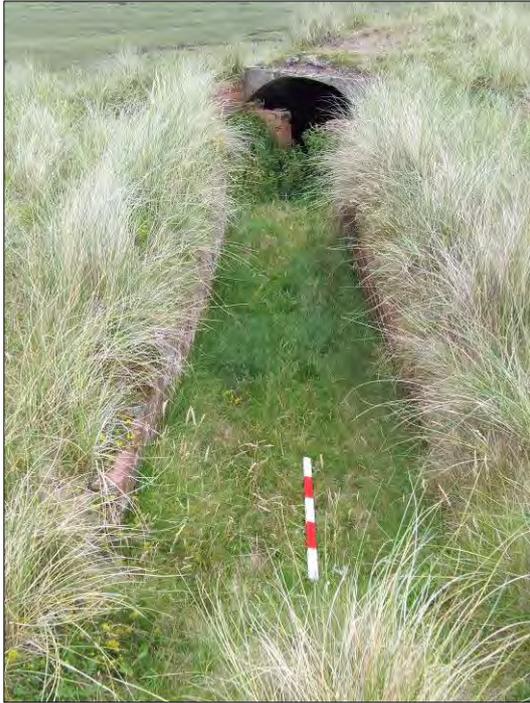
Figure 5.60 Magazine attached to the rear of the gun emplacements at Hilspsford Battery, South Walney (scale = 1m).

The two gun emplacements were connected to the rear to a shared magazine (65g) for the storage of ammunition (Figure 5.60). This consisted of a brick-built passage, now roofless, leading down to two long underground chambers of semi-circular section. The chambers had brick front and end walls with the main body constructed of pre-fabricated steel of ‘nissen hut’ style, rendered with concrete to a flat roof surface.

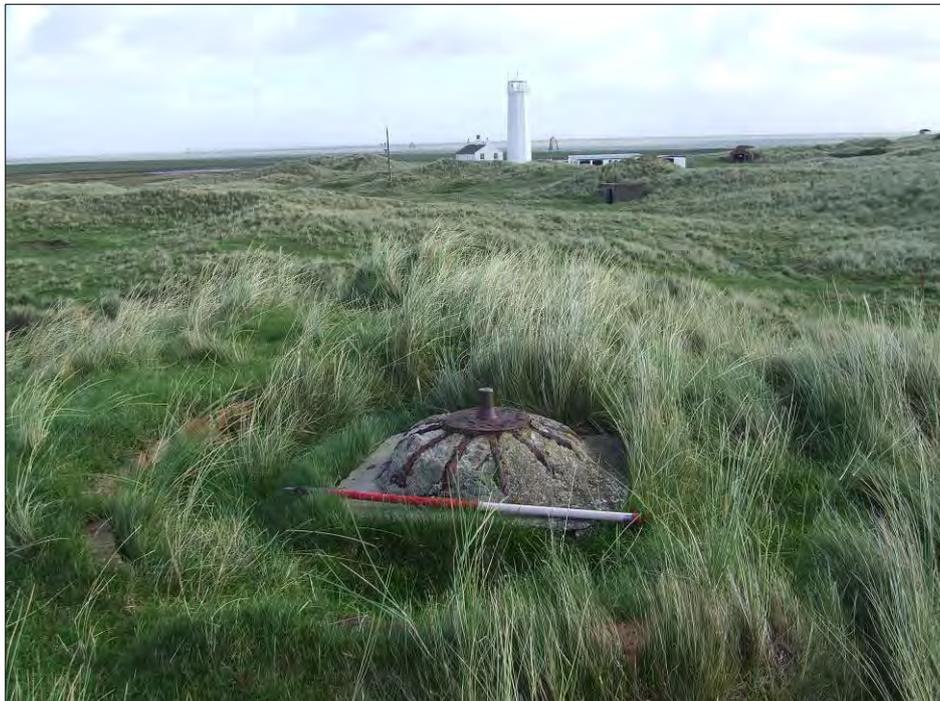
Figure 5.61 Spigot Mortar in the foreground with Walney lighthouse and other features of the Hilspsford Battery in the background, looking east (scale = 1m).

The final feature recorded as part of the Hilspsford battery was a spigot mortar located inland from all of the other remains. This was built upon a high dune to afford good views of the surrounding area. The remains were partially buried, however the concrete drum, or thimble, steel spider and stainless steel pivot were all visible, together with an outer ring of brick walling (Figure 5.61). Spigot Mortars had a range of $\approx 365\text{m}$ and are commonly found flanking coastal batteries (Lowry 2002, 91).

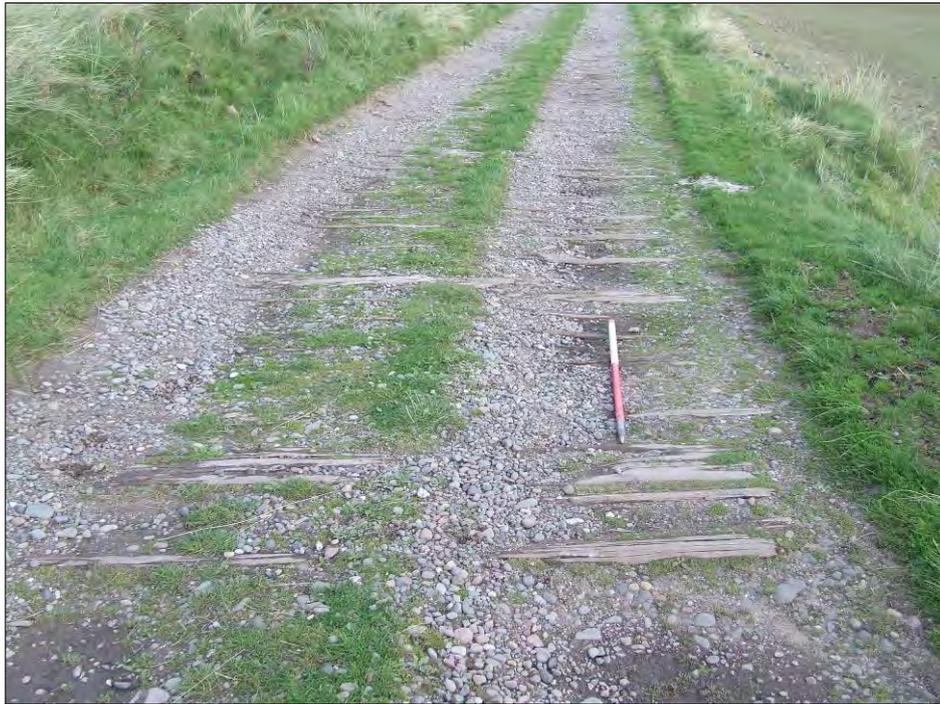
Figure 5.62 Second World War timber railed trackway leading to Hilpsford Battery (scale = 1m).

Other features associated with the coastal battery were observed during Phase 2, such as the remains of the original trackway (Figure 5.62) leading up to the battery (preserved as the driveway to the lightkeeper's house) and the lighthouse itself which almost certainly performed the function of a Battery Observation Post. These would usually be purpose-built structures unless a suitably high structure was located in the vicinity (Osborne 2004, 27). The present lighthouse was built in 1804 and is recorded in the Cumbria HER (HER: 18992), copies of photographs taken at the end of the Second World War show the lighthouse camouflaged in paint (Figure 5.63). Neither of these features was considered to be at risk of coastal erosion.

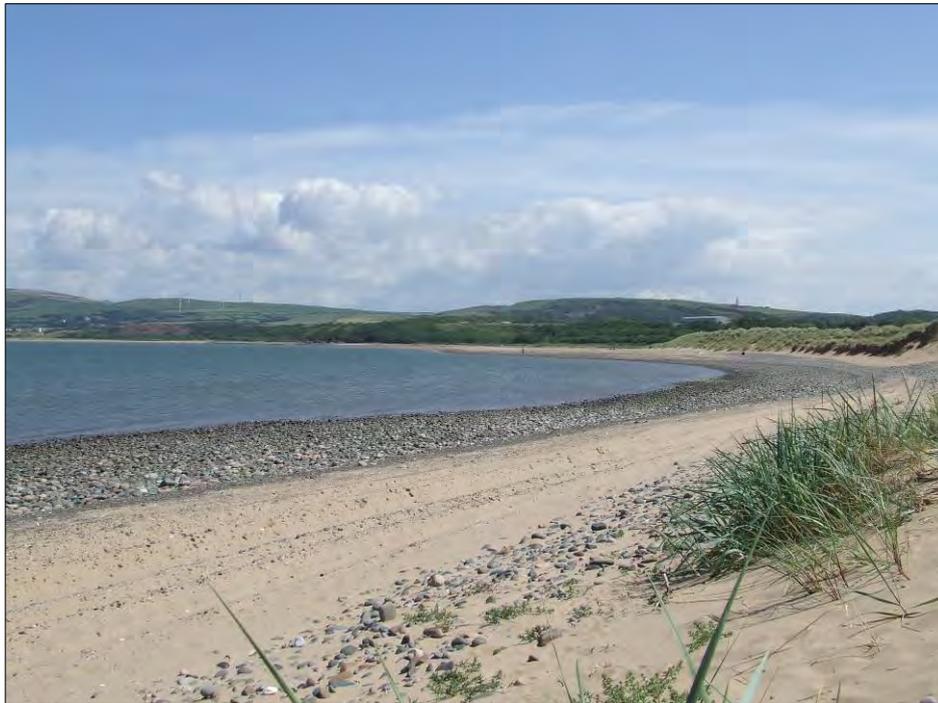
Figure 5.67 Undefended coastline at Roanhead at the mouth of the Duddon Estuary, looking east.

The Duddon Estuary is orientated southwest to northeast and was probably formed during the Tertiary period and then modified during the last glaciation (Yasin 1991). It has a complex geological sequence characterised by Silurian Sedimentary Units in the upper reaches, Carboniferous Limestone in the middle reaches and Permian and Triassic Sandstones at the estuary mouth (Johnson 2011, 25). The superficial geology is dominated by blown sands at the estuary mouth around Sandscale, Diamicton Till at Millom and Quaternary Clay, Silt and Sand further up the estuary (BGS 2008). The superficial geology appears to influence the principal soils within the estuary which are composed of Dune Sand around Sandscale, Seasonally Wet Deep Silt around Millom and some saltmarsh accumulation on the western shores of the inner estuary. These soils will support a range of land uses including grassland, cereal cultivation and pasture (Farewell 2007). Much of the estuary shoreline is undefended (Figure 5.67).

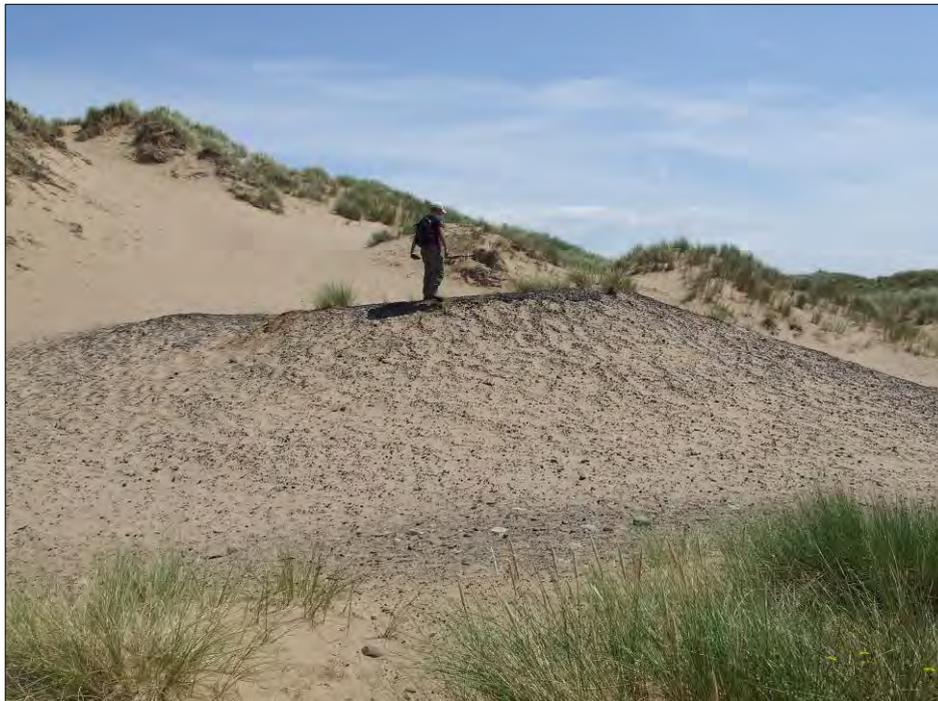
Figure 5.68 Recording the location of the excavated Late-Neolithic-Early Bronze Age occupation site at Roanhead, note the mound of dumped slag waste.

The survey recorded the accurate location of the excavations conducted in 2003 (71) which are now covered with a deliberate dump of slag waste, charcoal, brick and glass fragments (Figure 5.68). This has been put in place in an attempt to stabilise the dune system and protect the remaining part of the occupation site that was not excavated in 2003 (David Coward pers. comm.). This man-made mound covers an area $\approx 30\text{m}$ in diameter and at present it appears to be successful in protecting the eroded remains.

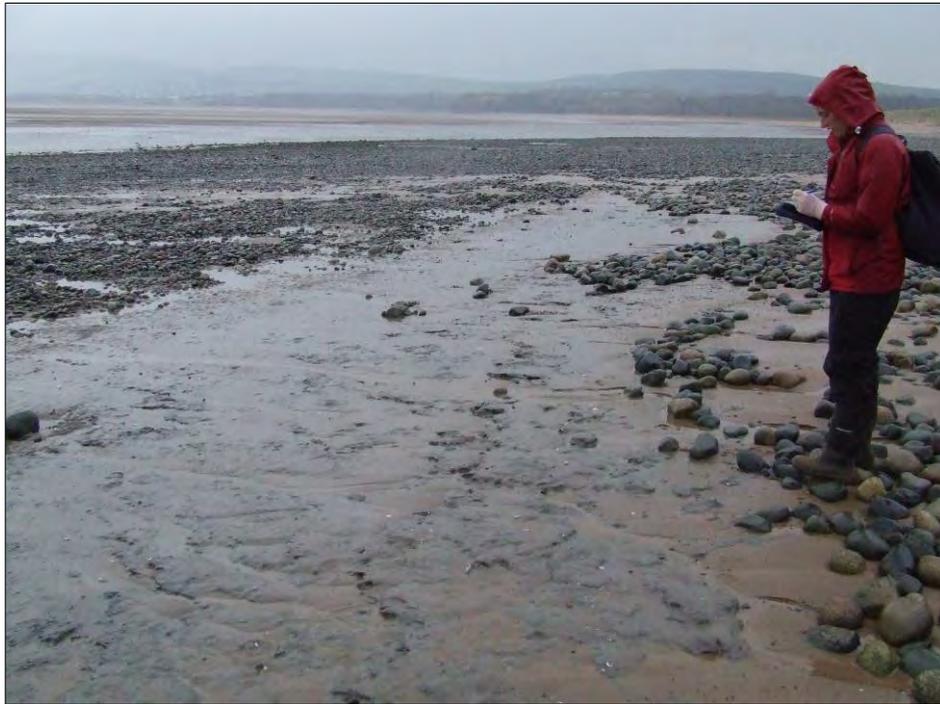
Figure 5.69 Recording a marine silt and clay exposure at Sandscale, looking east.

The survey also recorded an exposure of blue/grey marine silty clay (206) of presumed Holocene date in the inter-tidal zone (Figure 5.69). This extended for a length of $\approx 34\text{m}$ and had a maximum width of $\approx 8.4\text{m}$. It did not appear to have high organic content, however it may prove to be an important indicator of the sequential development of this coastline, should a more extensive sequence be found elsewhere. Previous exposures of similar material have included evidence of vegetation and hazelnuts (David Coward *pers. comm.*), however none of this was evident at the time of survey.

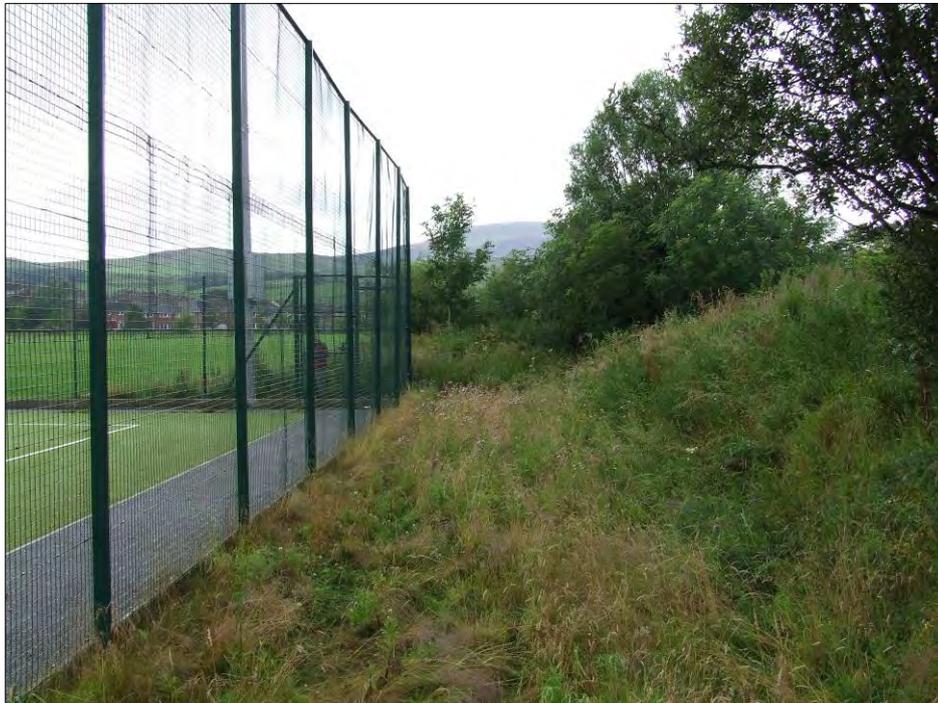
Figure 5.70 Remains of a possible sleeching mound at Millom School (right of the photograph).

Cranstone identified a possible sleeching mound and salt working site at Salthouse Farm in Millom (Cranstone 2006, 103), located along the backslope of the current saltmarsh. The Phase 2 survey has added to this with another possible sleeching mound to the south of the farm at Millom School (85). This consisted of a mound of material running for a length of $\approx 18\text{m}$ beside the school playing fields (Figure 5.70). This record extends the potential saltworking evidence further south in Millom and this is in keeping with the documentary evidence where Cranstone notes that the St Bees saltworking holdings in Millom were particularly extensive, indicating production on an industrial scale (Cranstone 2006, 103).

The identification of this site as a medieval sleeching mound is based upon the known presence of salt working in this area and the fact that it appears to have been man-made.

It is therefore noted only as a possible sleeching mound and further investigation would be required to ascertain its true nature. It may for instance represent landscaping associated with the nearby school.

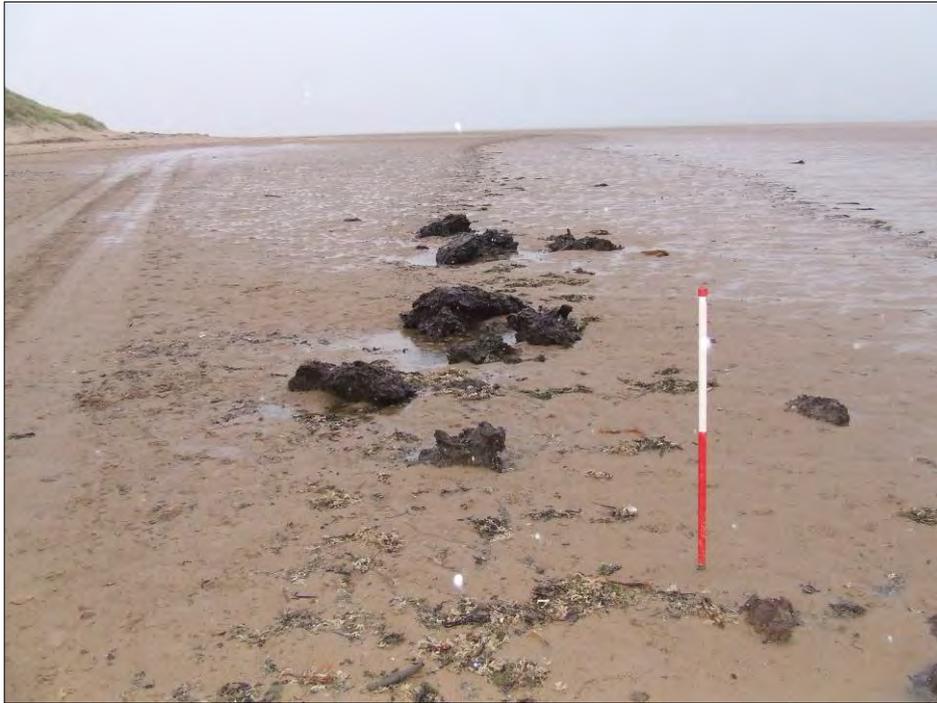
Figure 5.72 Iron production waste, possible evidence of a shipwreck, looking west (scale = 1m).

Evidence of a probable timber shipwreck site (207) was recorded at Sandscale as consisting of a spread of iron production waste in the inter-tidal zone (Figure 5.72). This appears to be the remains of a small ship's cargo, the remainder of the ship having been re-used or otherwise destroyed. The cargo covers a distinct area of $\approx 52\text{m}^2$.
