5. ARCHAEOLOGICAL SURVEY RESULTS: CUMBRIA

5.1 Introduction

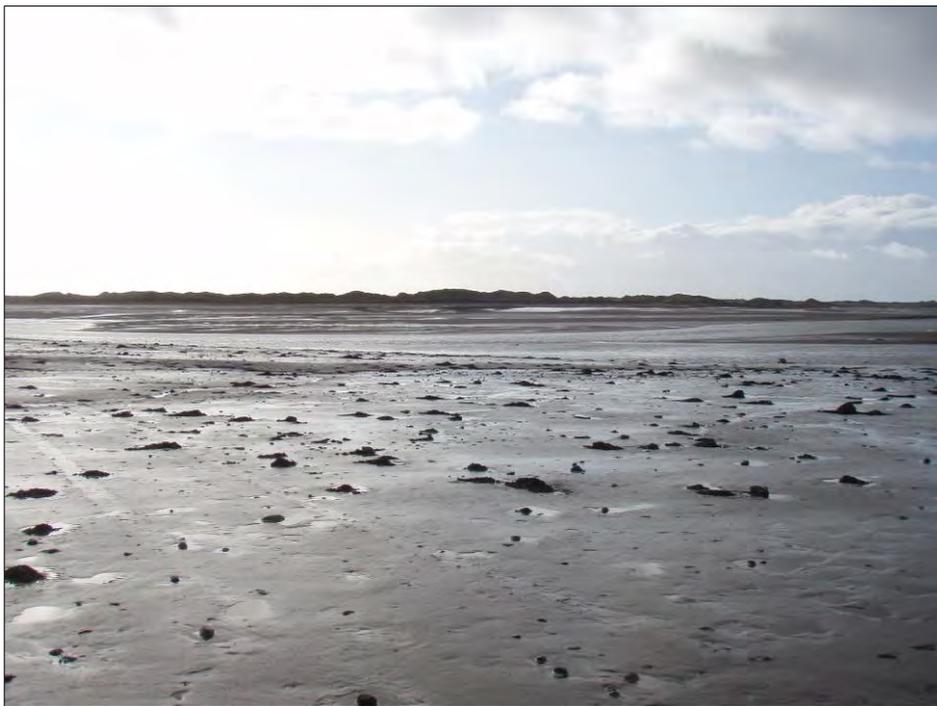
Figure 5.74 Inter-tidal sand and mud flats at Ravenglass, looking south towards Eskmeals spit.

The Rivers Irt, Esk and Mite converge to form a single channel as they exit into the Irish Sea between Drigg spit to the north, and Eskmeals spit to the south. The Solid geology of the area is predominantly Calder Sandstone Formation with a superficial geology of Blown Sands around Drigg and Eskmeals and Devensian Diamicton Till inland at Ravenglass (BGS 2008). The principal soils in the area vary between Seasonally Deep loams and clays and dune sands on the Drigg and Eskmeals spits. These are suited to a varied regime of recreation, cereal production and stock rearing (Farewell 2007). The inter-tidal zone is predominantly sand and mud flats with some saltmarsh accumulation near Saltcoats (Figure 5.74). Saltcoats has also been provided with shoreline protection as has a localised section of the Ravenglass to Eskdale railway. The remainder of the coastline in this area is unprotected.

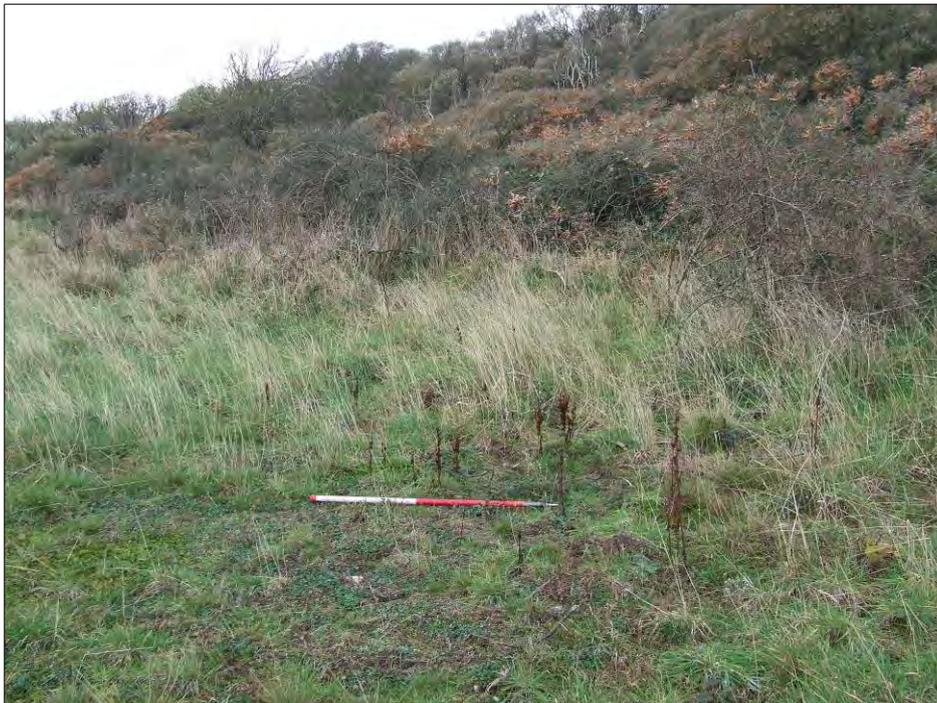
One cleared area containing similar ‘fire cracked’ stones to the prehistoric occupation sites on Walney Island (see Section 5.6.4) was noted during the survey and recorded as an area polygon (216). This covered an area *c.*25m in length and *c.*12m in width (Figure 5.75). It may represent the location of a buried prehistoric occupation site, which at this elevation would be expected to date to the Bronze Age (Cherry and Cherry 1986, 14).

Figure 5.75 Possible prehistoric occupation site at Eskmeals (scale = 1m).

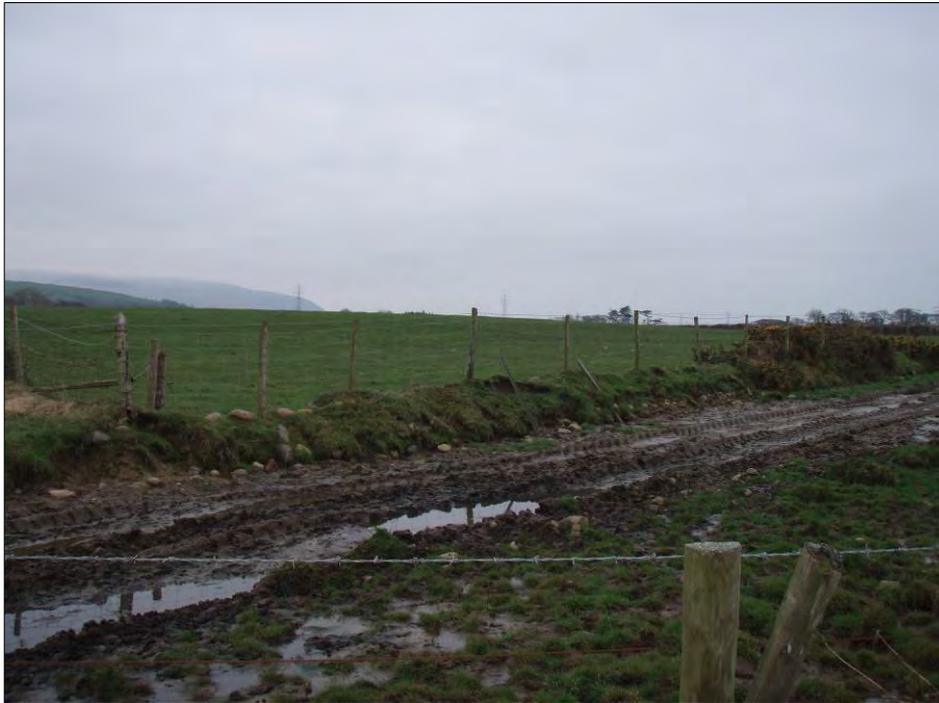
The location of this alleged excavation was recorded as part of the Phase 2 survey (222) with the site situated on the southern shore of the River Esk, behind an area of saltmarsh accumulation. No evidence of the excavation or any prehistoric occupation was apparent at the time of survey, however a natural ridge in the landscape may represent the palaeobeach described (Figure 5.76).

Figure 5.76 Site of alleged excavation of prehistoric hut sites, looking southeast.

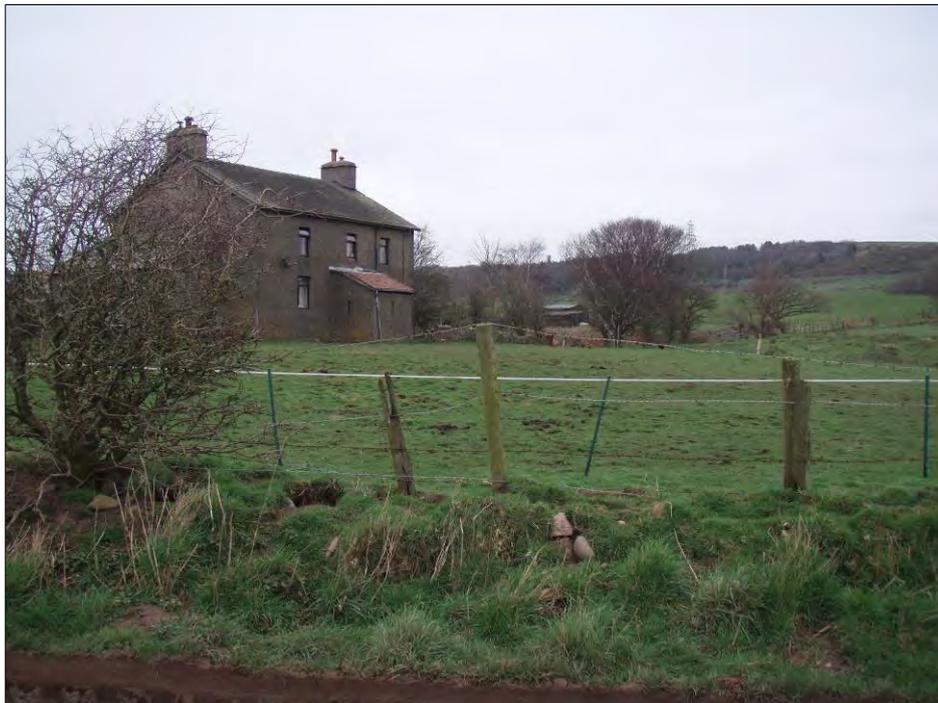
The phase 2 survey investigated the sites of the 'lozenge-shaped' enclosure and 'doughnut-shaped' anomaly, neither of which were particularly evident as surface features. The site of the 'lozenge-shaped' enclosure (223) was evident as an area of slightly elevated, flatter ground than the surrounding terrain, however this could not be definitively identified as a man-made feature (Figure 5.77), whilst the site of the 'doughnut' shaped anomaly (225) showed no surface expression. The location of both anomalies was recorded as part of the survey since future intrusive investigation may reveal significant archaeological remains in this area and this should be noted in the HER for future planning enquiries.

Figure 5.77 Brighthouse Farm sitting within the 'lozenge-shaped' enclosure noted as an area of slightly elevated flatter ground than the surrounding terrain, looking southeast.

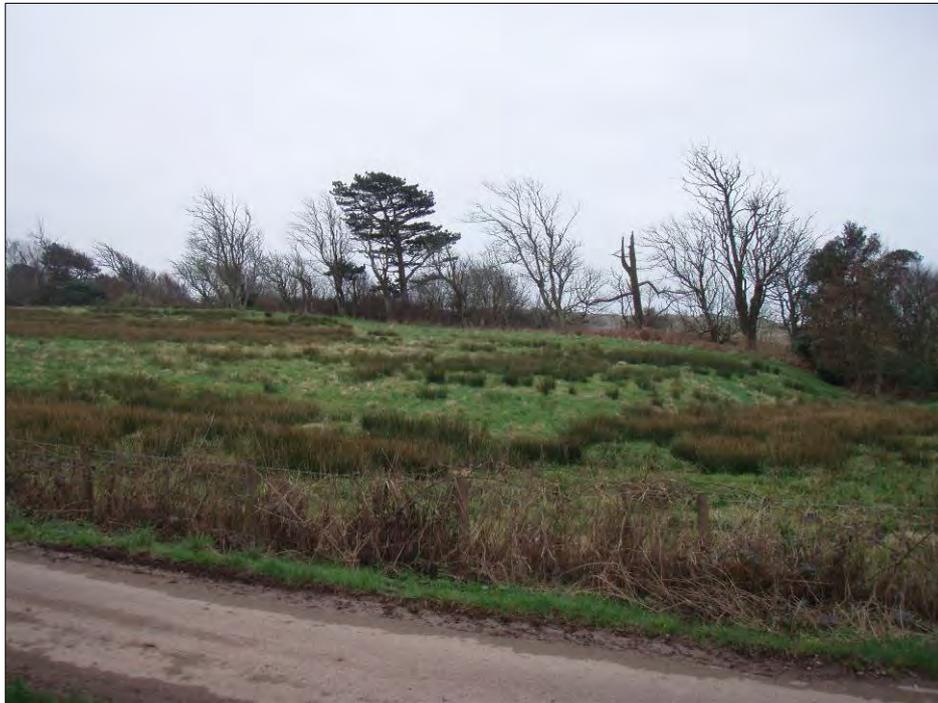
The earthwork survey of Ravenglass Fort refers to the area east of the railway as being covered in dense woodland (Blood 1998, 9). This is no longer the case as clearance must have taken place in the intervening period allowing the remains to be fully appreciated. There did not appear to be significant earthwork remains within the fort, but its extent and outer ditch was discernable (Figure 5.78).

Figure 5.78 The eastern section of Ravenglass Roman Fort showing the northern ditch and location of the railway line marked by tree growth, looking west.

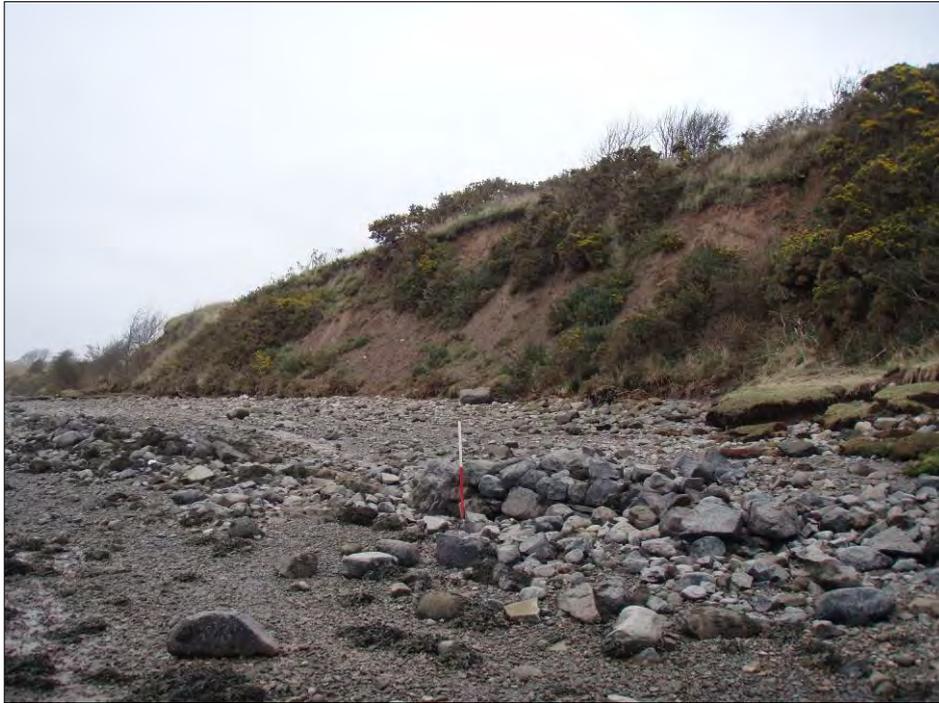
Figure 5.79 The western section of Ravenglass Roman Fort showing the extent of erosion. The remains of a wall in the foreground are allegedly a former retaining wall for the fort that was in use \approx 30 years ago, looking north (scale = 1m).

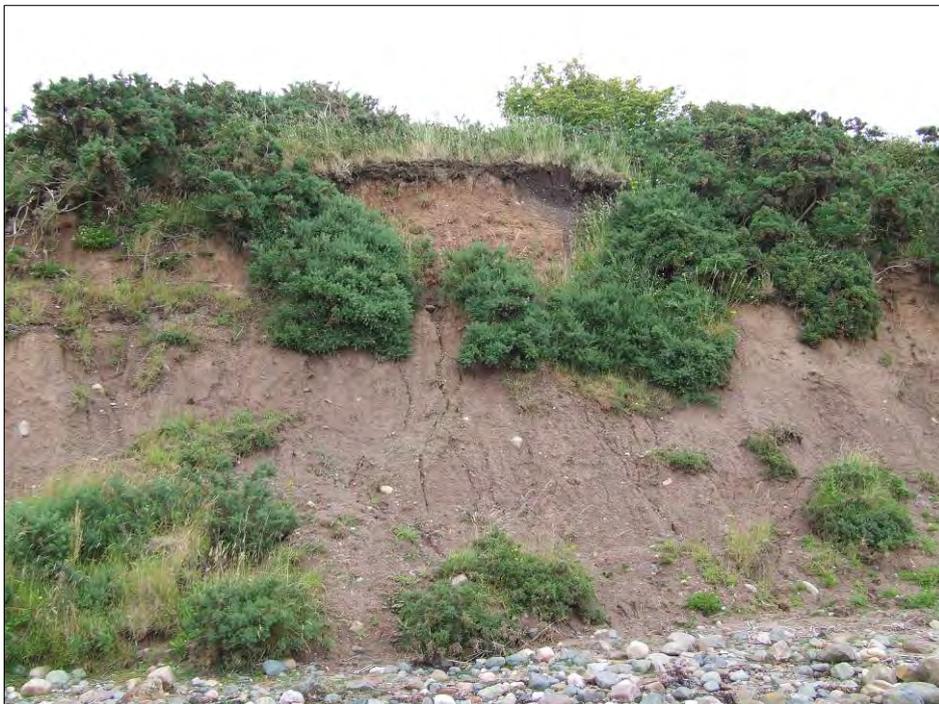
The remains of the western section of the fort are clearly visible from the shoreline at Ravenglass where the truncated remains of the outer ditch demarcate the northern and southern extent of the fort's interior (Figure 5.79). The Phase 2 survey measured the present line of the base of the eroding till cliff in order to provide a measured benchmark against which future erosion can be measured (74). An old retaining wall was noted c.10m in front of the eroding face and according to local knowledge this wall used to retain the fort c.30 years ago (Clifford Jones *pers comm.*). This suggests a loss of 10m of the fort in the past 30 years. Significant archaeological features were noted eroding in section at the top of the till cliff face, including structural remains and a cut feature towards the southern end of the fort (Figure 5.80).

Figure 5.80 Eroding archaeological deposits at the southern end of the fort, looking east.

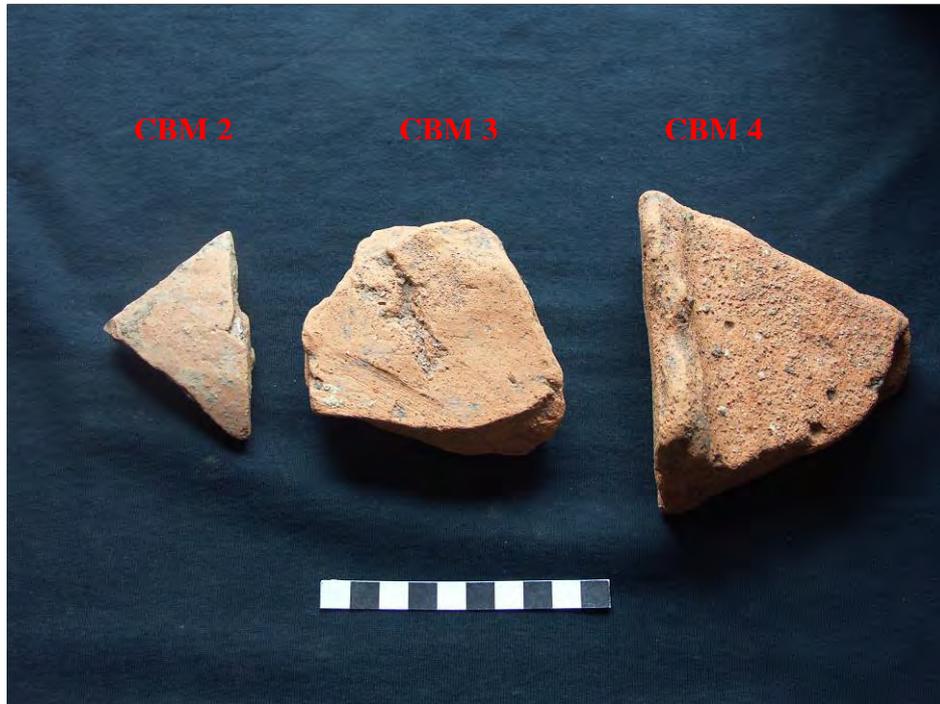
The fort was visited in July 2011 and March 2012 and on both occasions eroding artefacts were recovered from the base of the cliff face (75). These have been analysed by Ruth Leary and Gwladys Monteil and consist of building material, pottery sherds and Samian Ware generally dating to the 2nd and 3rd centuries AD (Figure 5.81 and 5.82). The full reports are reproduced below. The presence of these eroding artefacts and features indicates that the rescue excavation, although extensive, has not recovered all of the available information on the western portion of the fort.

Figure 5.81 Ceramic building materials recovered from Ravenglass Roman Fort (scale = 0.1m).

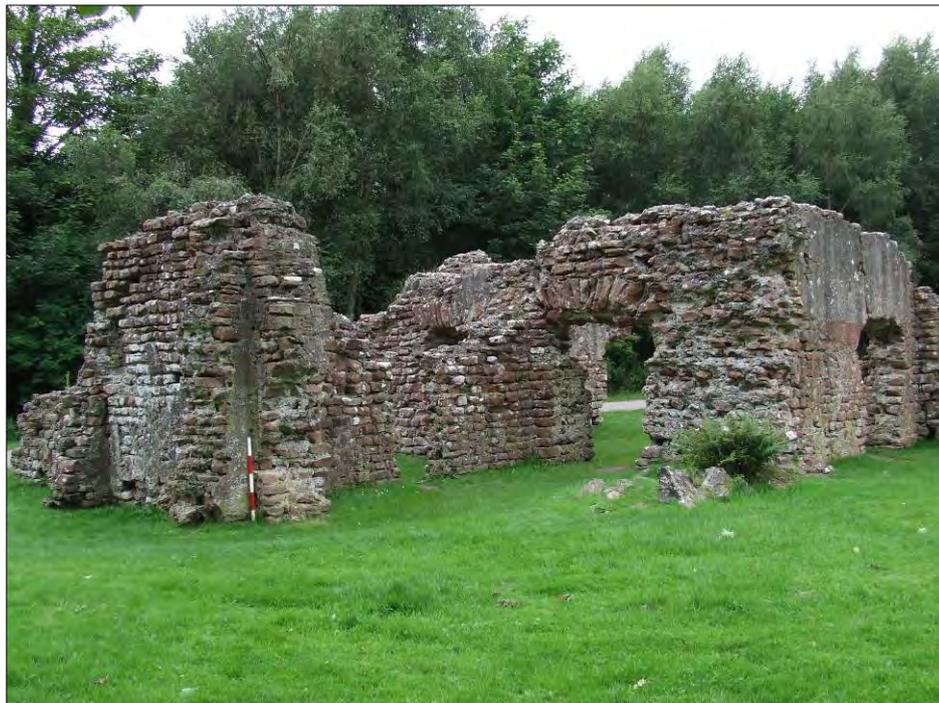
Around 30m northeast of the fort site, the Phase 2 survey recorded the remains of Ravenglass Roman bathhouse, known as Walls Castle (73). This is a Scheduled Monument (13570) and lies within the 'Frontiers of the Roman Empire (Hadrian's Wall)' UNESCO World Heritage Site. The walls are among the tallest surviving Roman remains in Britain and are managed by English Heritage, and are open to public free of charge. The bathhouse was excavated in the late 19th century and surveyed in 1985, both of which concluded that it was once more extensive than the existing remains. It would have extended beyond the present field boundary, making it larger than the bathhouse at Hardknott Fort to the east (Shotter 1998, 348). The Phase 2 survey recorded the remains as consisting of well-preserved and well-maintained sandstone walling (Figure 5.83). All door and window surrounds have been robbed out, however an internal niche for a statue survives giving some indication of the opulence of its interior.

Figure 5.83 Remains of Ravenglass Roman bathhouse (73), looking northwest (scale = 0.1m).

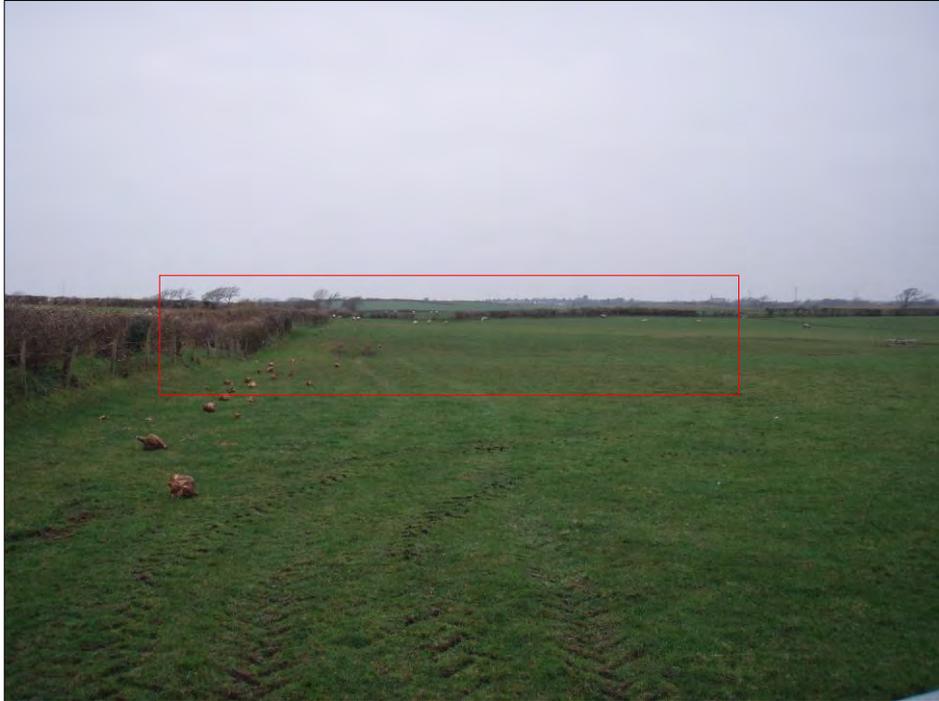
as Ravenglass and possibly beyond (Potter 1979, 18). The Phase 2 survey recorded the location of the suspected fortlet, which was discernable as a slight rise (232) in the pasture field where it was located (Figure 5.84). This could not be definitively identified as a man-made feature however.

Figure 5.84 Remains of a possible Roman fortlet, looking northwest (Clifford Jones pers. comm.).

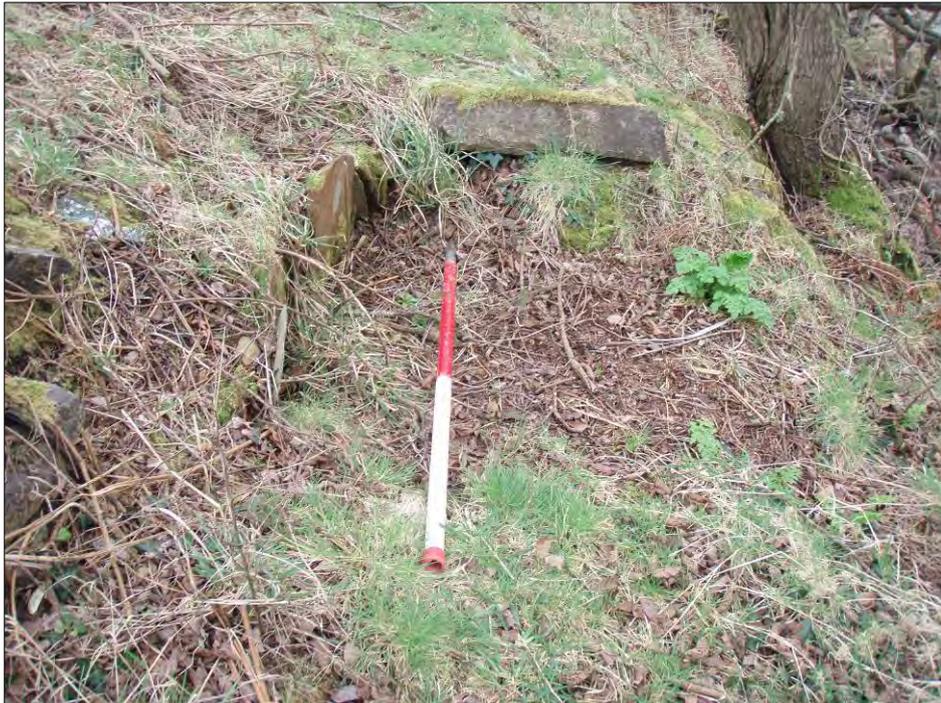
The Phase 2 survey recorded the remains of a possible cist (228) *c.*170m south of the fort, which may therefore date to the same period as the excavated example. The remains were located on the top of the eroding till cliff, obscured by trees. The railway line at this point is closer to the cliff edge than at Ravenglass fort, and the possible cist was essentially sandwiched between the railway line and the cliff edge. It consisted of irregular slabs of stone and slate arranged to form three sides of a stone-lined trough (Figure 5.85). This measured *c.*1.25m in length but appeared to have been truncated along one side by erosion of the till cliff on which it stands. There was a depression in the centre of the trough suggesting that it may have undergone excavation previously, an assumption which is further corroborated by the presence of a neatly stacked pile of stones to the side of the feature. There is no modern record of this excavation, or of the possible cist feature which is not recorded in the Lake District National Park HER.

Figure 5.85 Remains of possible cist south of Ravenglass Roman Fort, looking south (scale = 1m).

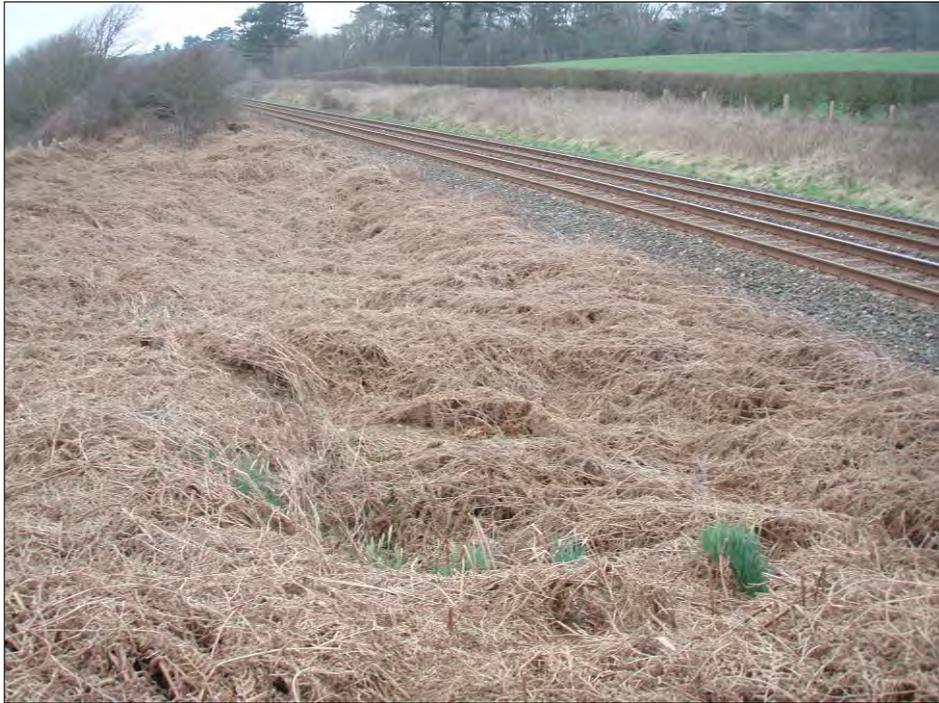
A further 'pit' feature (231) was recorded in the Brighthouse area *c.*200m southeast of the possible cist and it was thought to correspond to a record from the construction of the railway line in the mid 19th century. This states that a pit had been discovered containing some 'old bones and cloth' which were not considered to be of any value (Clifford Jones *pers. comm.*). The pit recorded at Brighthouse could not be accessed for detailed study as it lay in a fenced off area close to the railway line. It consisted of a relatively large square-shaped 'dip' in the natural terrain partly obscured by grasses, but appeared man-made on initial assessment (Figure 5.86). Its identification as the pit described by the railway workers is open to debate, more so because it does not appear on Ordnance Survey mapping until the National Grid 1:2500 map of 1971.

Figure 5.86 Possible pit feature at Brighthouse, looking north.

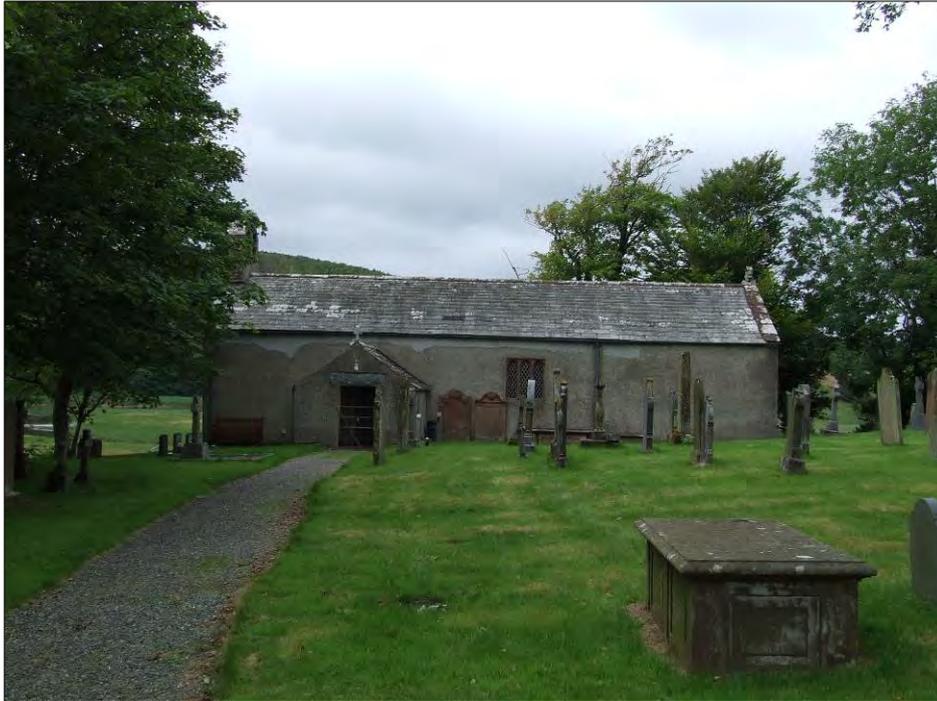
The Phase 2 survey recorded St John's Church (77) as described in the Listed Building Description. It was well-maintained and still in use as a Parish Church (Figure 5.87). The church sits within a raised platform with a stone built retaining wall, similar to the church at Beckermet to the north (see Section 5.10.4). At Beckermet the platform is thought to be the remains of an Anglo-Saxon church with the later Norman church built in the same location, using the platform as the churchyard.

Figure 5.87 St John's Church, Waberthwaite looking north.

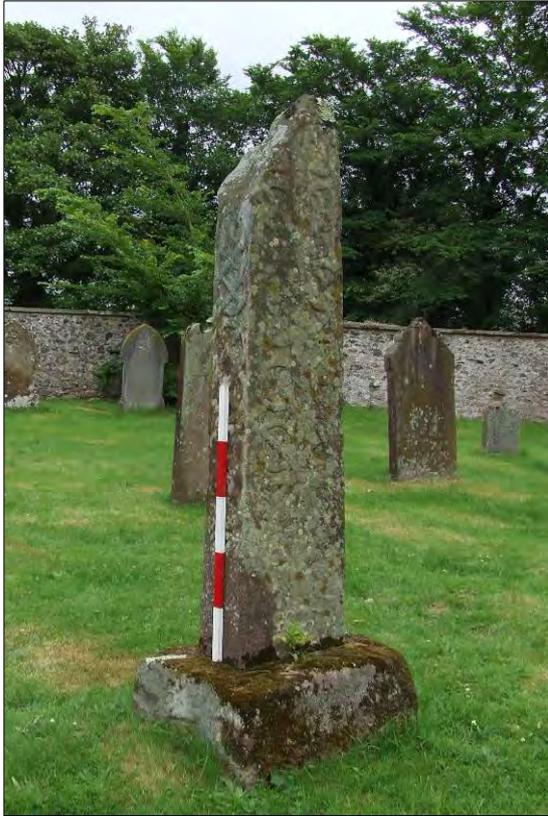
The Phase 2 survey recorded the remains of the cross shaft (230) as being largely as described in the Scheduled Monument Description, except that the bird-like head is actually on the wider east face of the cross shaft, rather than the south face which is a side panel containing interlace carving only (the same as the north face). The east face also contains the carving of a horse surrounded by interlace in the mid-section. Only three of the four panels on the east face are decorated, the basal panel containing interlace carving (Figure 5.88). Collingwood, who also provides a drawing of the shaft, describes these features as dating to the mid-10th century (Collingwood 1927, 152-3). The shaft is suffering from erosion and lichen growth that is damaging the decorative panels

and its outdoor location leaves it susceptible to the damaging effects of freeze-thaw action.

Figure 5.88 Cross shaft at St John's Church, Waberthwaite showing the west and north faces (scale = 1m).

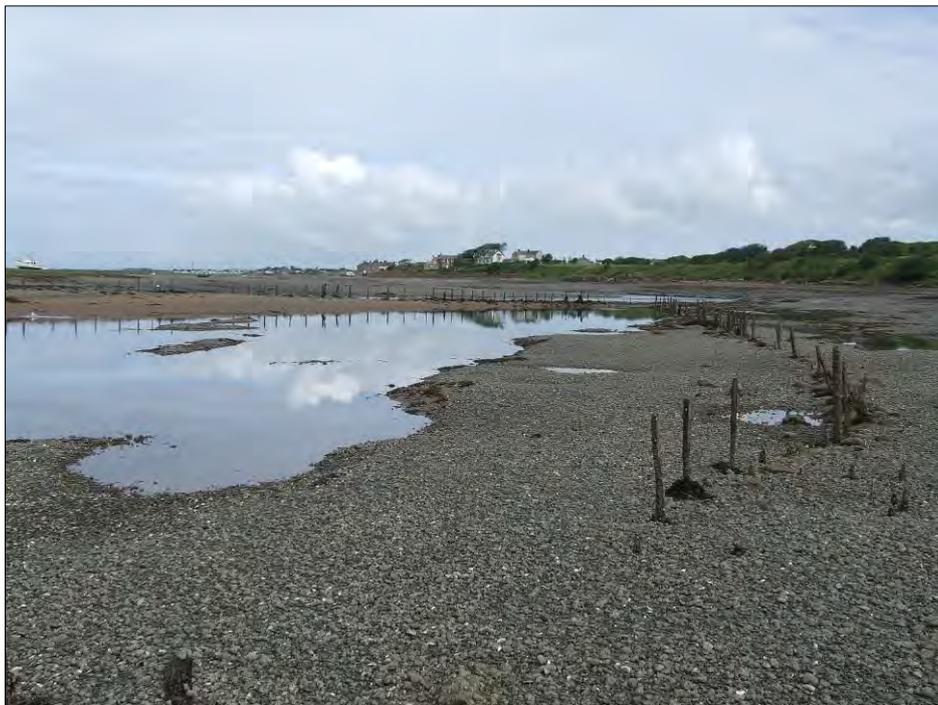
this point. It has a total length of c.350m and contains two narrow ‘eyes’ where trapped fish would be collected, probably in wicker baskets (Jecock 2011a, 3). The degraded remains of these traps survive at the ‘eyes’ (Figure 5.89) and would likely have been similar to those recorded at Morecambe (see Section 4.8.4, Figure 4.65). In places traces of timber wattling also survives on the river bed which would have been weaved between the posts to form the barrier.

Figure 5.89 Fish trap on the River Esk at Ravenglass with a degraded trap at the ‘eye’ on the right, looking north.

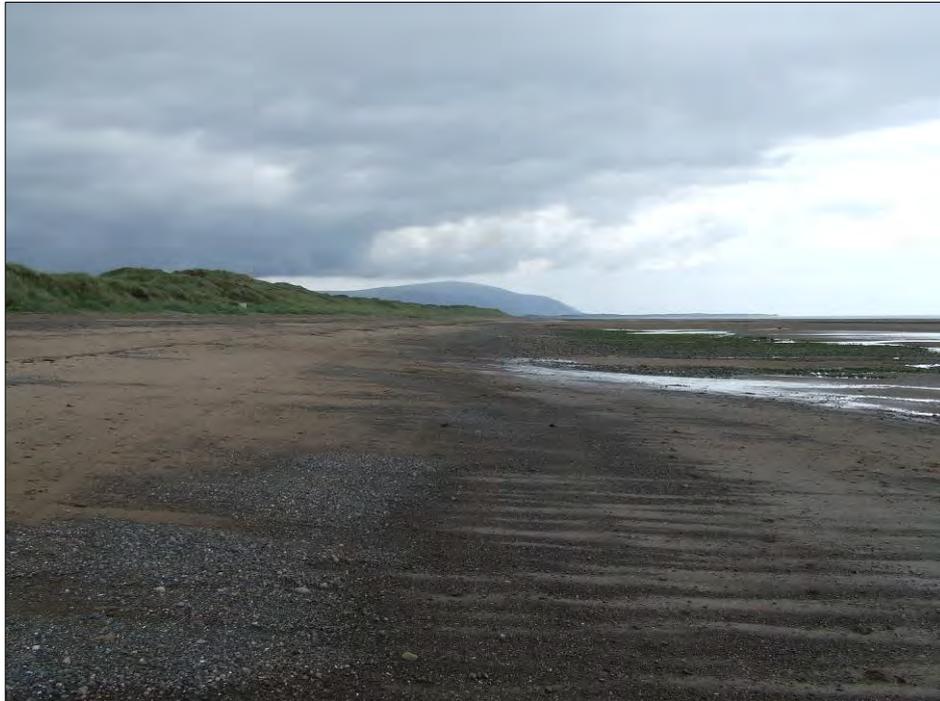
Drigg spit has a solid geology of Calder Limestone formation with a superficial geology of Blown Sand (BGS 2008). It forms the mouth of the Ravenglass Estuary Complex discussed in Section 5.8.2. The principal soil in this area is Dune Sand suited to recreational uses (Farewell 2007) and the shoreline is composed of a narrow shingle beach fronted by wide inter-tidal sand and shingle flats (Figure 5.91). It is not provided with shoreline defences.

Figure 5.91 The inter-tidal zone at Drigg spit, looking south.

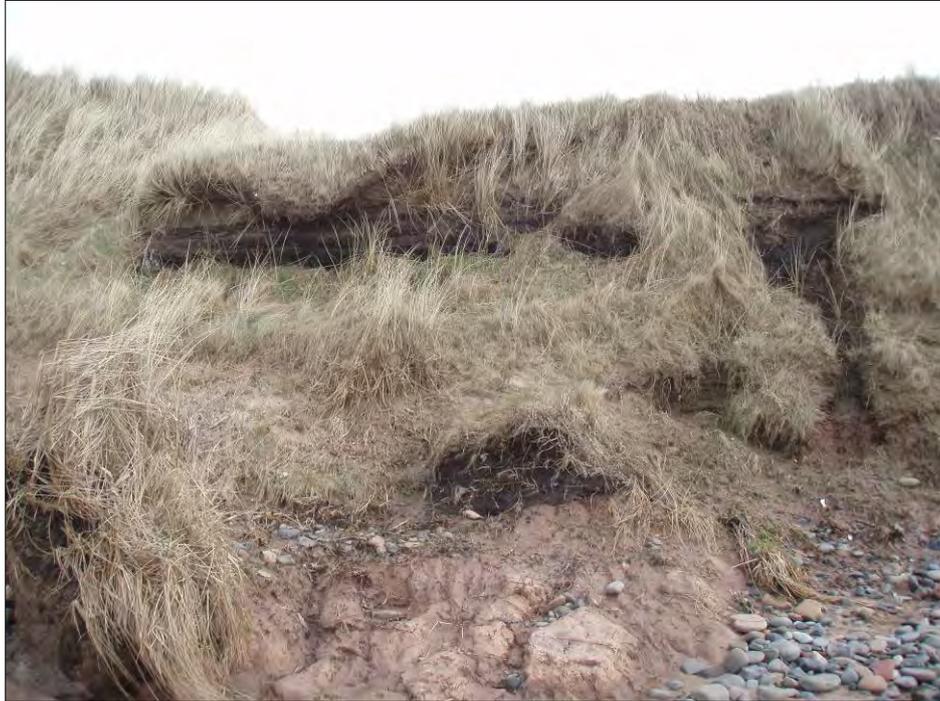
The organic band described by Cherry (1982) and Croft (2000) was clearly visible in the eroding cliff section and extends beyond the area of the suspected burnt mound (Figure 5.92). It was measured (212) and sampled for pollen analysis and radiocarbon dating as part of this project and the results are presented in Chapter 6.

Figure 5.92 Eroding organic band and site of the excavated burnt mound (cut section to the left of the photograph) at Drigg, looking east.

Some uncertainty remains in the interpretation of this site as a burnt mound as the excavations in 2000 failed to recover any evidence of prehistoric human intervention, save for the presence of charcoal bands within the peat deposits. Whilst the most likely explanation for the charcoal is anthropogenic, the possibility that it was formed through natural forest fires or clearance activities some distance from the site cannot be discounted. The palaeoenvironmental survey also suggested that the site may actually be a kettlehole deposit that has been misinterpreted as a man-made feature (Ian Boomer *pers. comm.*). The exact nature and significance of the site will therefore need to be established prior to the development of suitable management plans, if indeed these are necessary.

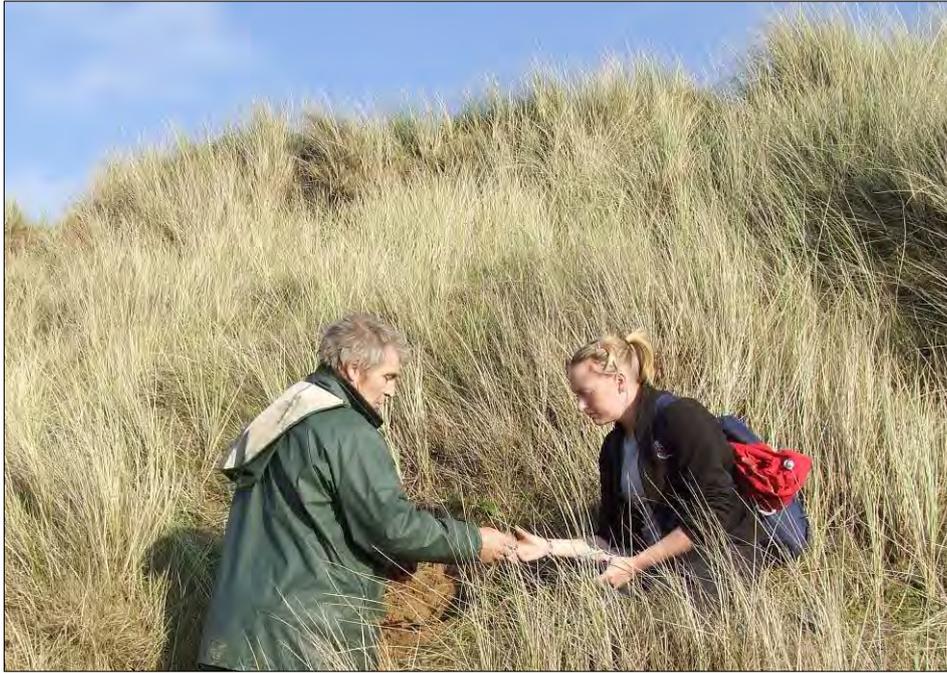
Figure 5.93 Investigating the site of the second suspected burnt mound with David Coward.

The site of a second suspected burnt mound was also recorded as part of the survey (211), c.60m north of the previous site. This was seen eroding from the cliff edge whilst the excavations of the southern burnt mound were being undertaken in 2000 (Croft 2002, 19). This consisted of similar ‘fire cracked basalt’ as identified by Cherry to the south (David Coward *pers comm.*). The erosion of this cliff section has stabilised, at least temporarily, and the remains are grassed over (Figure 5.93). No surface features associated with a burnt mound were recorded during the survey, but its location was accurately recorded to aid future management.

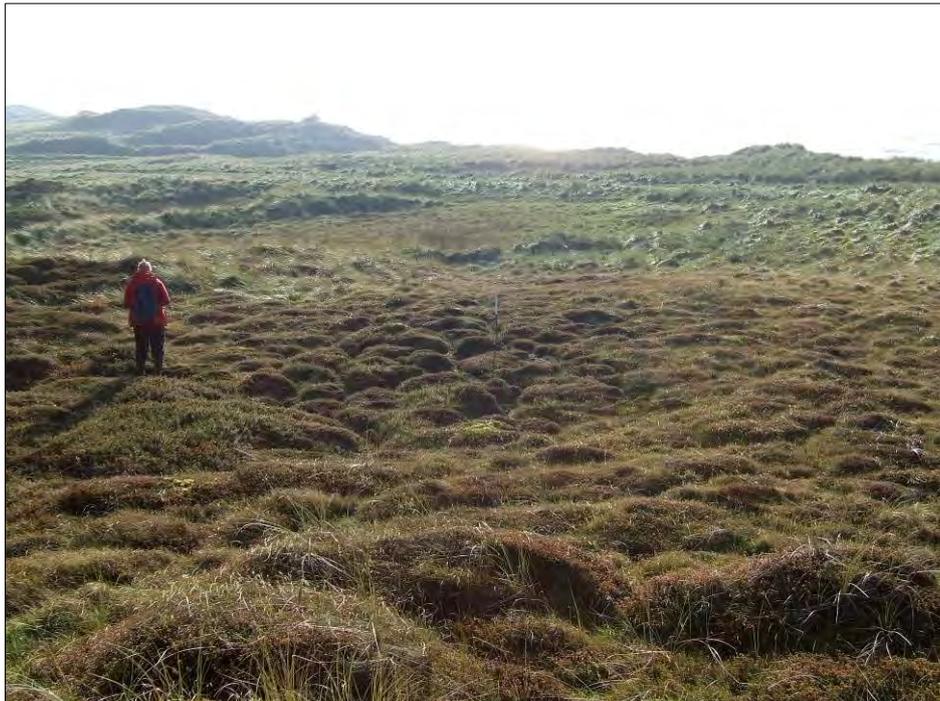
Figure 5.94 Recording the location of a suspected flint working site identified by Cherry, looking southeast.

The Phase 2 survey also recorded the location of a possible flint working site (210) identified by Cherry within the dune system. Cherry recovered a large number of flint artefacts from fieldwalking in the dunes and noted this location as having a particular concentration, possibly representing a production site (David Coward *pers. comm.*). This site was known to David Coward but is not recorded in the Cumbria HER. No artefacts or features of prehistoric date were recorded at the time of survey, as dune erosion has stabilised and vegetation has become established (Figure 5.94). The area of previous dune erosion is marked by the change of vegetation in this area.

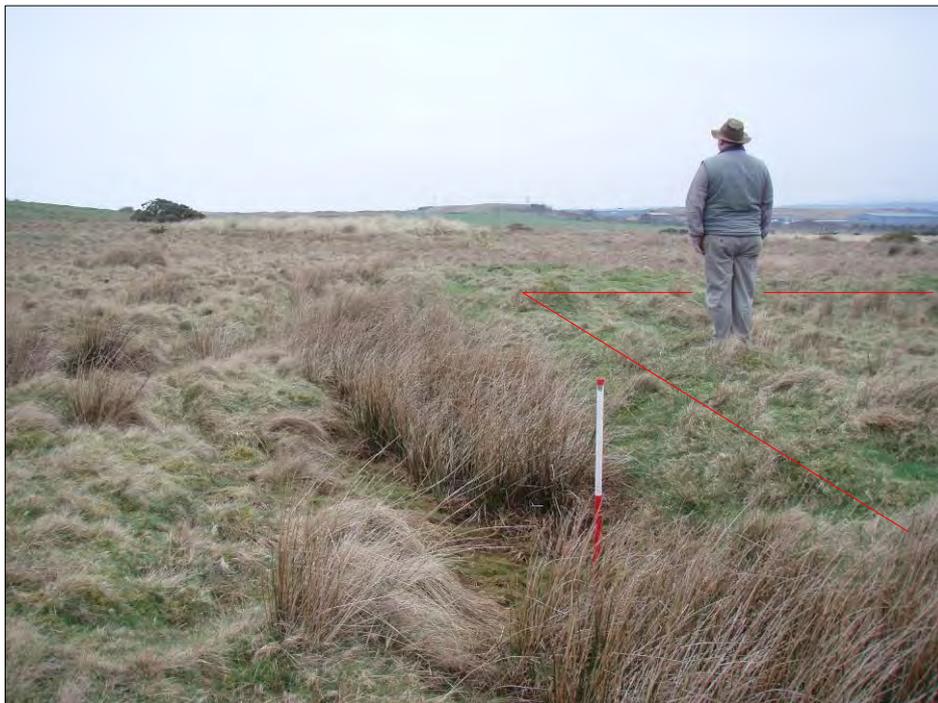
Figure 5.95 Earthwork remains of rectilinear enclosure at Drigg showing the external ditch with reed growth and the bank where Clifford Jones is standing, looking north (scale = 1m).

The Phase 2 survey recorded the remains of a large enclosed area (227) at the back of the dune system in an area used as pasture fields. This consisted of a large rectilinear enclosure, measuring $\approx 235\text{m} \times \approx 60\text{m}$, demarcated by a raised bank and external ditch (Figure 5.95). A possible entrance into the enclosure was noted in the northeast corner as an area without the bank and ditch feature, though it may have been truncated at this point at a later date. The purpose of this feature is unknown, however Clifford Jones believes that it may be connected with oyster farming and pearl processing at Drigg in the 19th century (Clifford Jones *pers. comm.*).

The assessment of these remains as being of post-medieval date is linked to the level of preservation of the remains, as well as the shape and size of the feature. It bears similarity to a post-medieval field system, though the enclosure is certainly not a simple post-medieval field boundary.

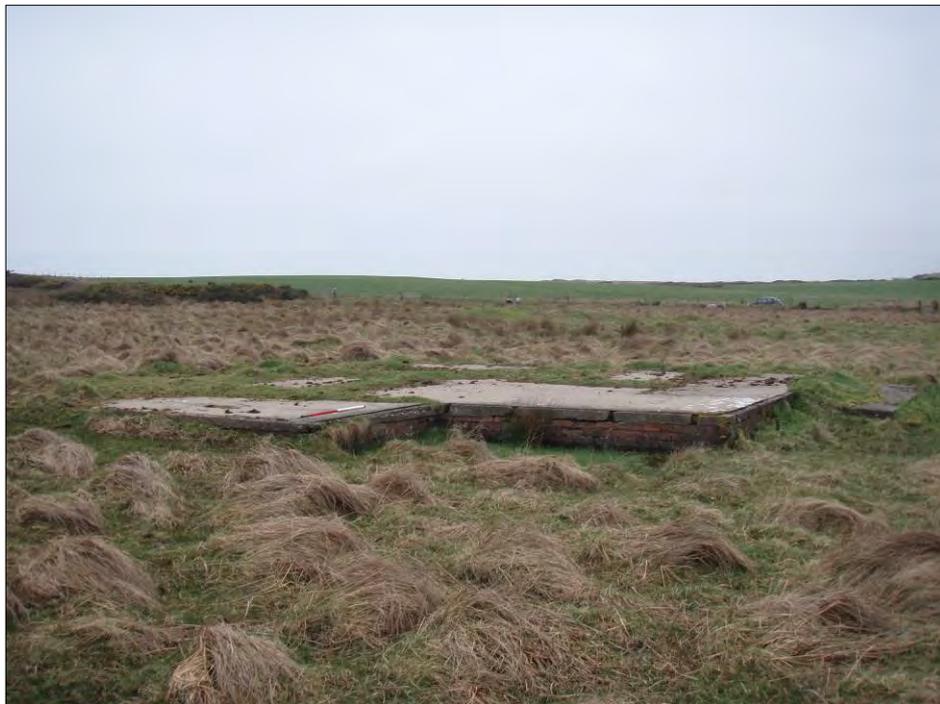
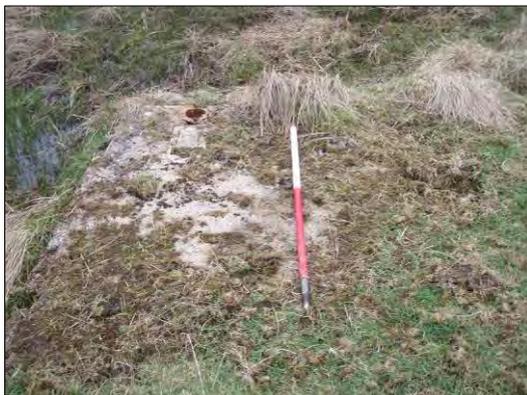
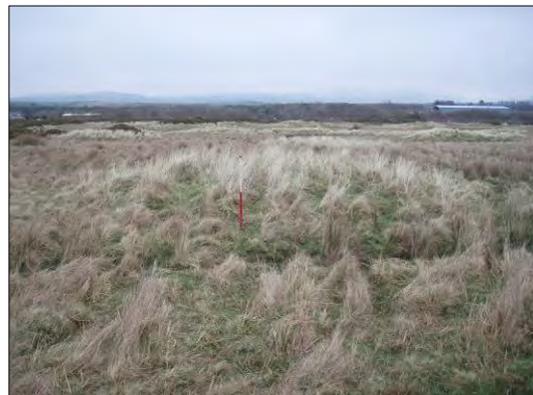
Figure 5.96 Remains of a military camp (226) at Drigg consisting of brick and concrete building platforms, remains of toilet blocks and dome-shaped raised earthwork platforms (scale = 1m).

Around 175m to the north of the possible post-medieval enclosure, the survey recorded the remains of a Second World War military camp (226) not mapped during the Phase 1 aerial photography transcription. This consisted of the brick and concrete footings for a number of buildings, within which remains of drainage systems indicated the position of former toilet blocks (Figure 5.95). Trackways were also recorded linking the building platforms together. The survey recorded remains covering an area $\approx 80\text{m} \times \approx 65\text{m}$, though it is probable that further remains exist at the site that were not mapped. To the south of the concrete footings, the earthwork remains of a series of domed platforms were also recorded (Figure 5.96). Seven platforms were recorded as part of the survey although further platforms were observed, but were too extensive to map. The purpose of these raised platforms is not known and their mapped extent does not follow any logical pattern. They may simply be dumped building materials from the demolition of the military camp, but they could be underground bunkers. Further investigation of these features would be required in order to determine their purpose and significance.

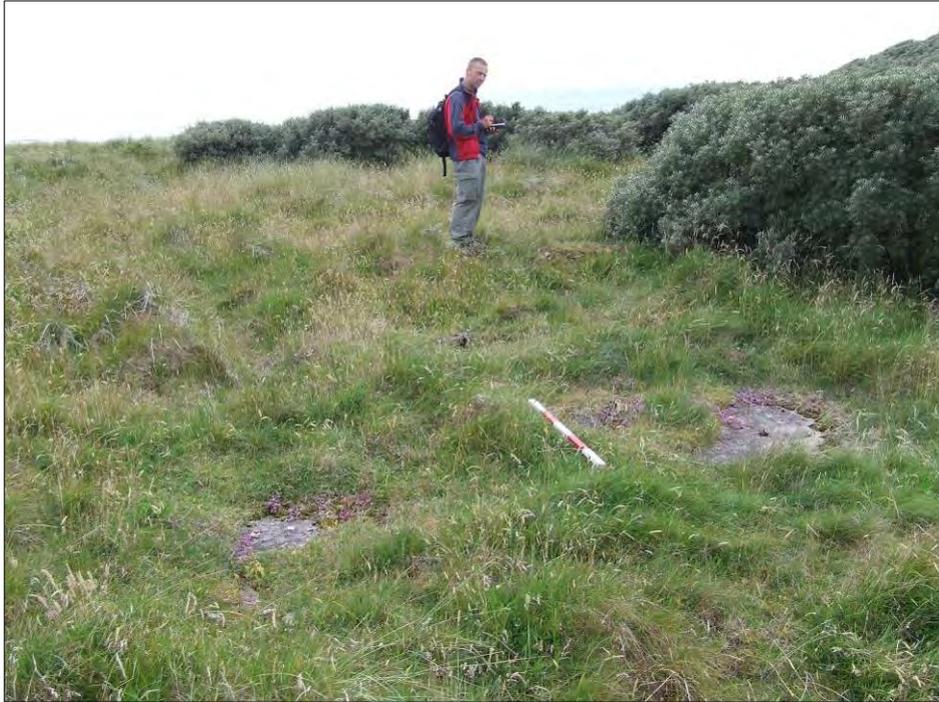
Figure 5.97 Recording the remains of a military camp (82) at Drigg consisting of concrete building platforms, (scale = 1m).

A further Second World War military camp (82) was recorded within the dune system to the northeast of the burnt mound site. Again the remains consisted of concrete footings for a number of buildings spread across large areas of the dunes (Figure 5.97). These footings were not as well preserved as those recorded at the back of the dunes (226) and the lack of stock grazing in this area also meant that they were more overgrown. No specific functions for the structures could be identified.

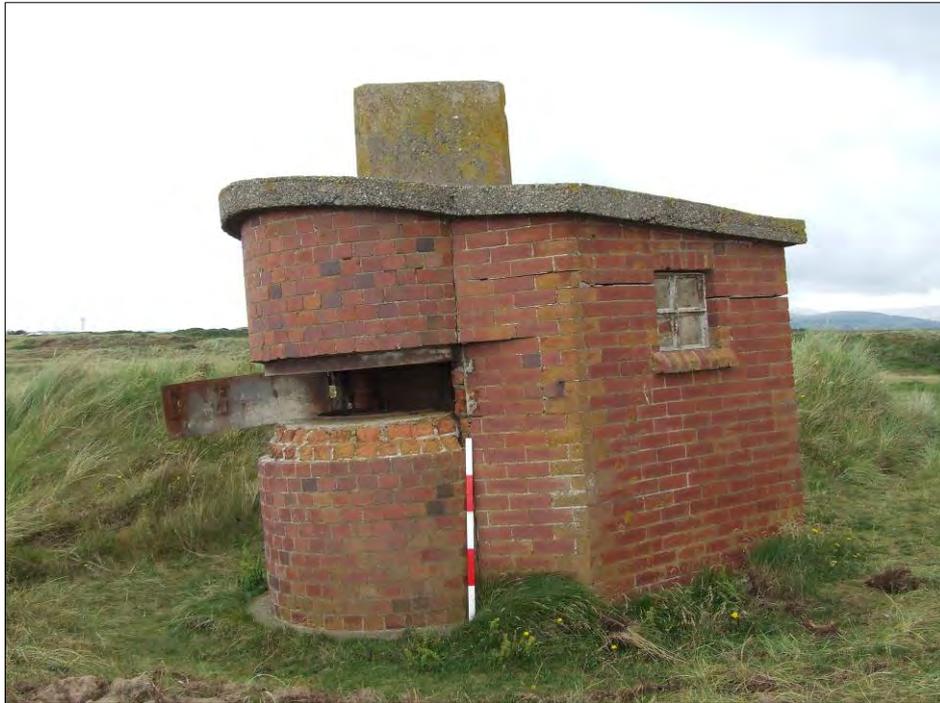
Figure 5.98 Northernmost brick-built pillbox (79), looking northeast (scale = 1m).

Around 350m south of the military camp, the survey recorded the remains of a brick-built pillbox (79), together with an identical pillbox located *c.*1.4km further south (81). The northernmost pillbox lies within the remit of Cumbria County Council and is recorded in the Cumbria HER (HER: 16875). That in the south lies within the Lake District National Park and is not recorded in the HER. The similarities in form between the two structures suggest that they should be viewed and managed as a pair, regardless of them being located within different local authority areas.

The pillboxes consisted of small brick-built structures with flat concrete roofs. They were square in plan with half-round front projections containing wrought iron, shuttered, horizontal gun ports (Figure 5.98). The buildings appear to have been disguised, both by the use of false four-paned windows in each of their side walls and by the addition of a concrete projection on the roof. These features, together with the plan form of the buildings, combine to give them the appearance of small boats or ship wrecks, thus deterring enemy attack (Figure 5.99). The northernmost pillbox was in a better state of preservation than that to the south which was partially buried in dune sand and which has suffered from subsidence. Both pillboxes had significant cracks three to four courses beneath the roof.

These structures have been interpreted as pillboxes, however they may be the remains of quadrant towers associated with an artillery range (Osborne 2006, 198), and as such they would be used to plot the exact angle that ammunition hits the water. Drigg dunes was an important training centre for soldiers during the Second World War and the purpose of these structures may therefore be related to that, rather than the active defence of the coast.

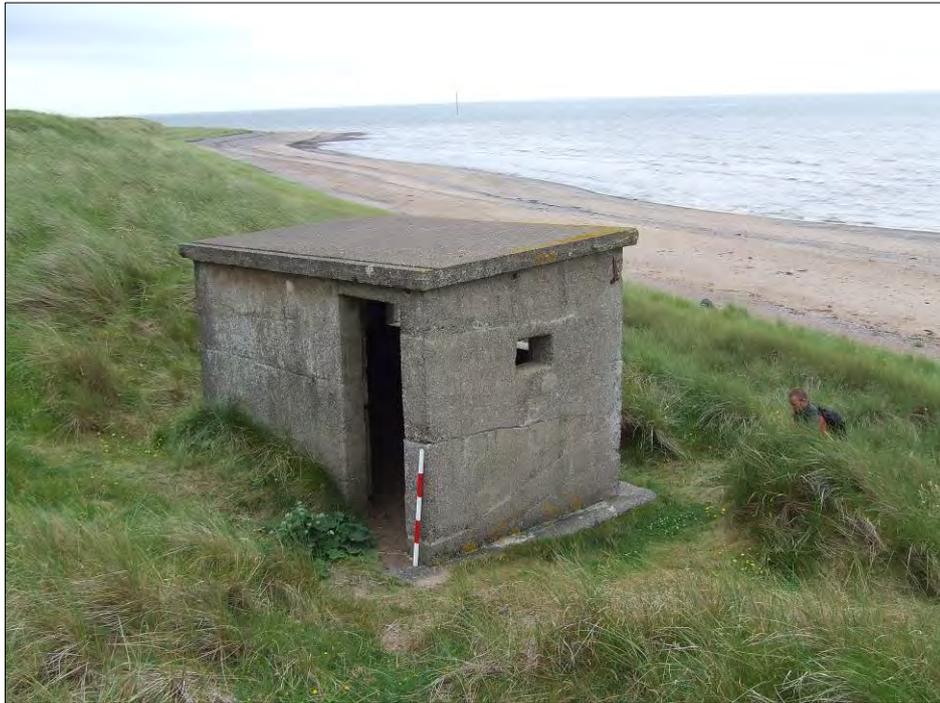
Figure 5.100 Recording the remains of a concrete pillbox overlooking the location of a Second World War firing range, looking southwest (scale = 1m).

A further pillbox (83) was recorded $\approx 530\text{m}$ to the north of the military camp. This was a very simple concrete square-shaped structure with a flat roof (Figure 5.100). It has a wide gun port on its western elevation, small ventilation openings on each side wall and an entrance to the rear, eastern elevation. This feature may have been associated with a Second World War firing range that was mapped as part of the Phase 1 aerial photography transcription directly in front of this structure (NRHE: 1413082). No remains of the firing range were identified during the Phase 2 survey.

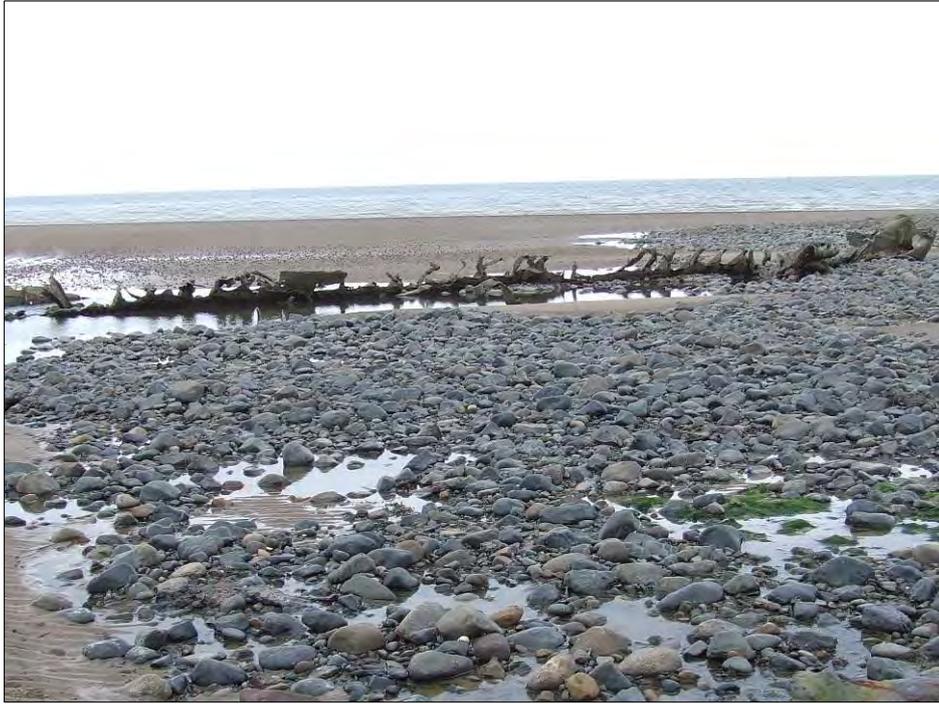
Figure 5.101 Iron-hulled wreck in the inter-tidal zone at Drigg, showing the sheared and twisted nature of the ribs, looking east (scale = 1m).
