5. ARCHAEOLOGICAL SURVEY RESULTS: CUMBRIA

5.1 Introduction

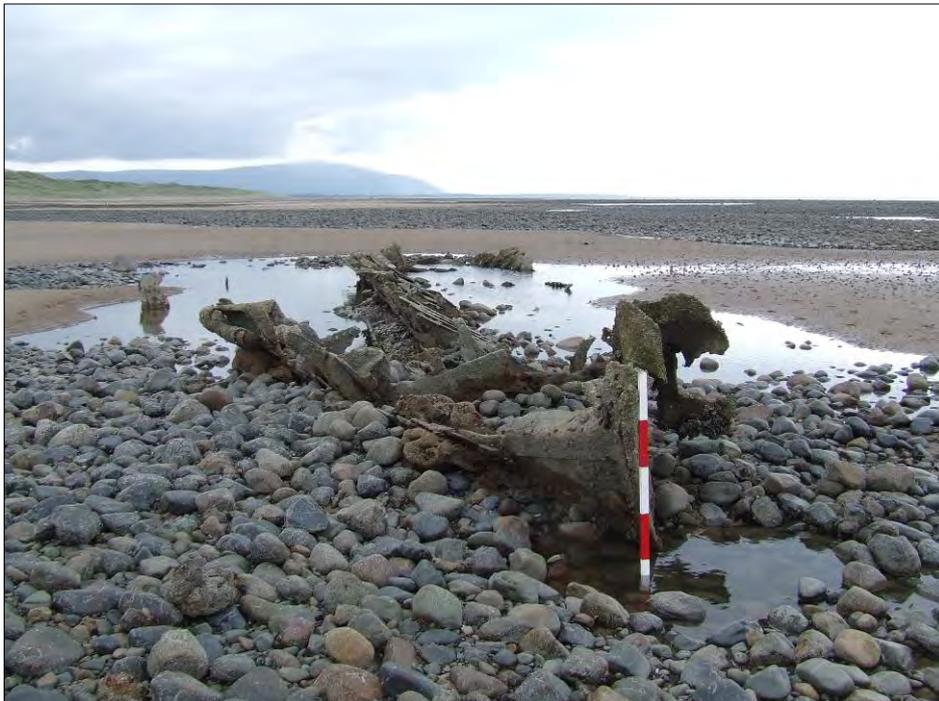
Figure 5.102 Iron-hulled wreck in the inter-tidal zone at Drigg, looking south (scale = 1m).

In the inter-tidal zone, $\approx 560\text{m}$ southwest of the concrete pillbox, the survey recorded the remains of a shipwreck (80), or gunnery target, of probable wartime date. The remains of the iron-hulled wreck were spread across an area of $\approx 300\text{m}^2$, with the main body of the ship covering an area of $\approx 170\text{m}$. The wreck had sustained significant damage to the ribs which were twisted with shear breaks (Figure 5.101). This may have been caused by the wreck having rolled onto the beach during storm conditions, or it may have been fired upon as part of the training exercises taking place in Drigg dunes. Enough of the wreck survives to appreciate its original form and further research would undoubtedly identify the type and date of the vessel (Figure 5.102).

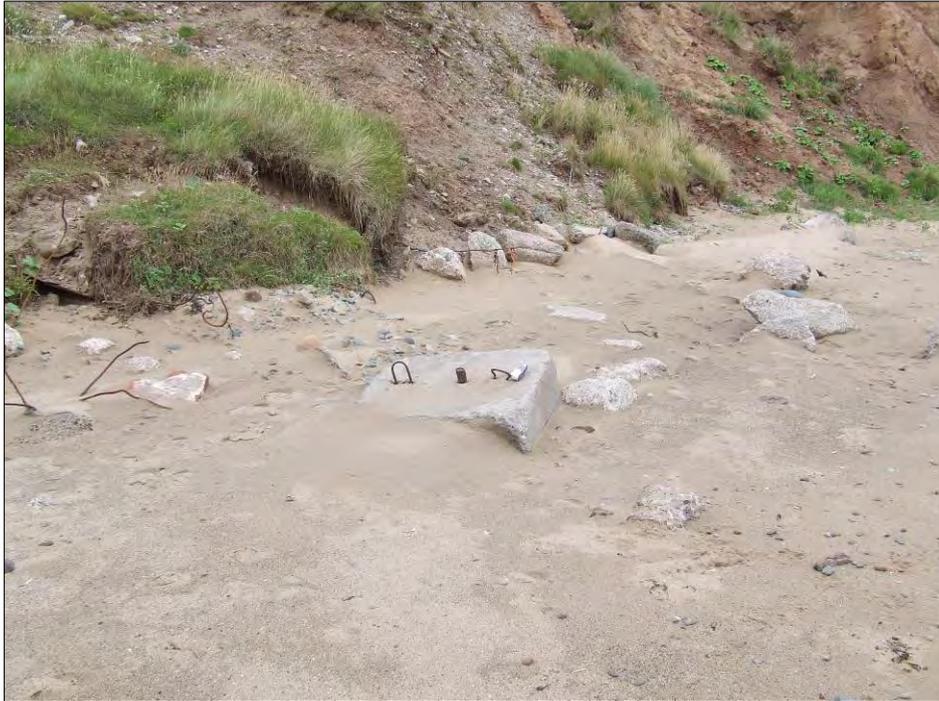
Figure 5.103 Remains of possible gun emplacement or pillbox (84), looking east.

Also on the beach front, the survey recorded the remains of a ruined pillbox or gun emplacement (84) consisting of a concrete block with a iron pivot, or gun mounting position (Figure 5.103). This was surrounded by further concrete and iron remains. This site may have been destroyed through coastal erosion.

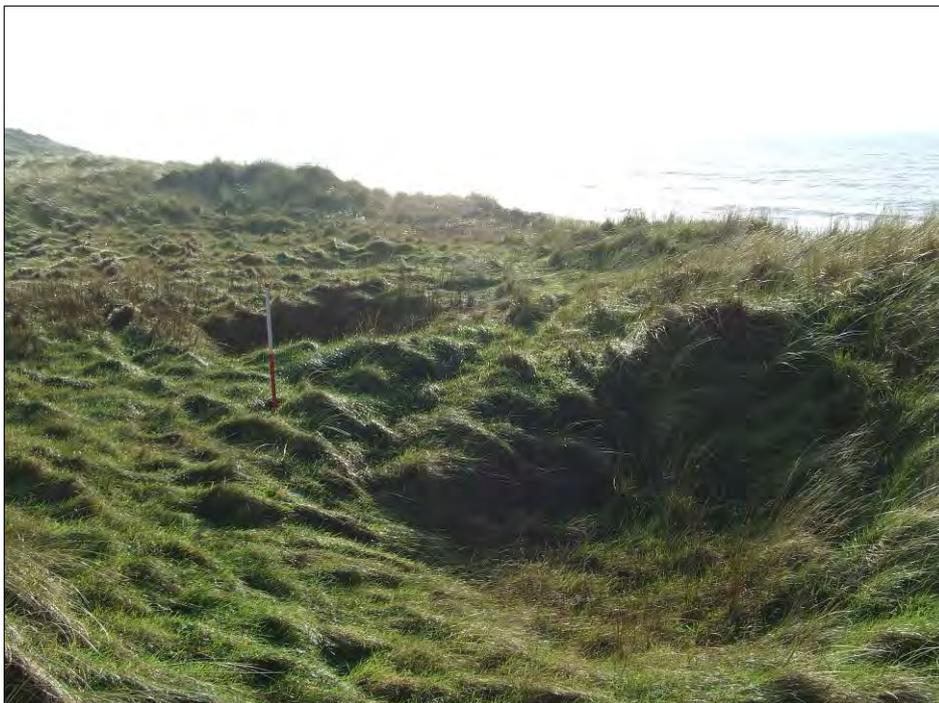
Figure 5.104 Remains of a minefield in the dune system at Drigg, looking southwest (scale = 1m).

In the dune system $\approx 180\text{m}$ south of this feature, the survey recorded the earthwork remains of a minefield (209) that was mapped as part of the Phase 1 aerial photography transcription as running for a length of $\approx 2.5\text{km}$ along the coast (NRHE: 1492518). The remains recorded consisted of two craters covering an area of $\approx 160\text{m}$ (Figure 5.104). These were mapped as an area polygon to give some idea of the character of these remains. Further remains of the minefield are likely to survive along the coast, but were too extensive to map as part of this project.

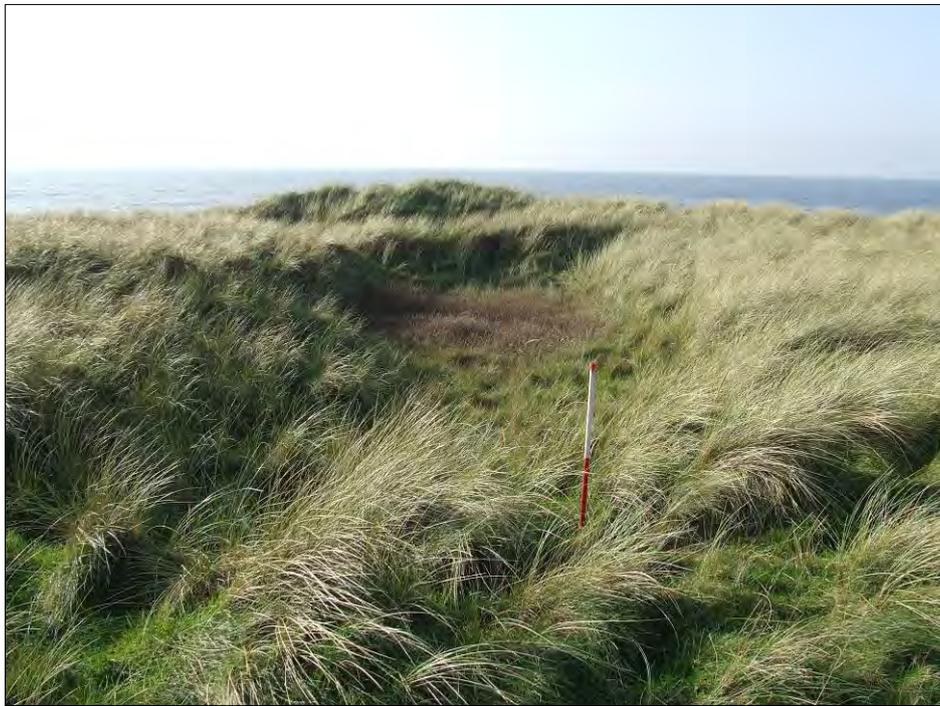
Figure 5.105 Remains of a trench in the dune system at Drigg, looking west (scale = 1m).

A further earthwork depression in the dune system was recorded immediately to the north of the remains but appeared to be a rectilinear cut feature, rather than a mine crater (Figure 5.105). This was interpreted as a Second World War trench (208).

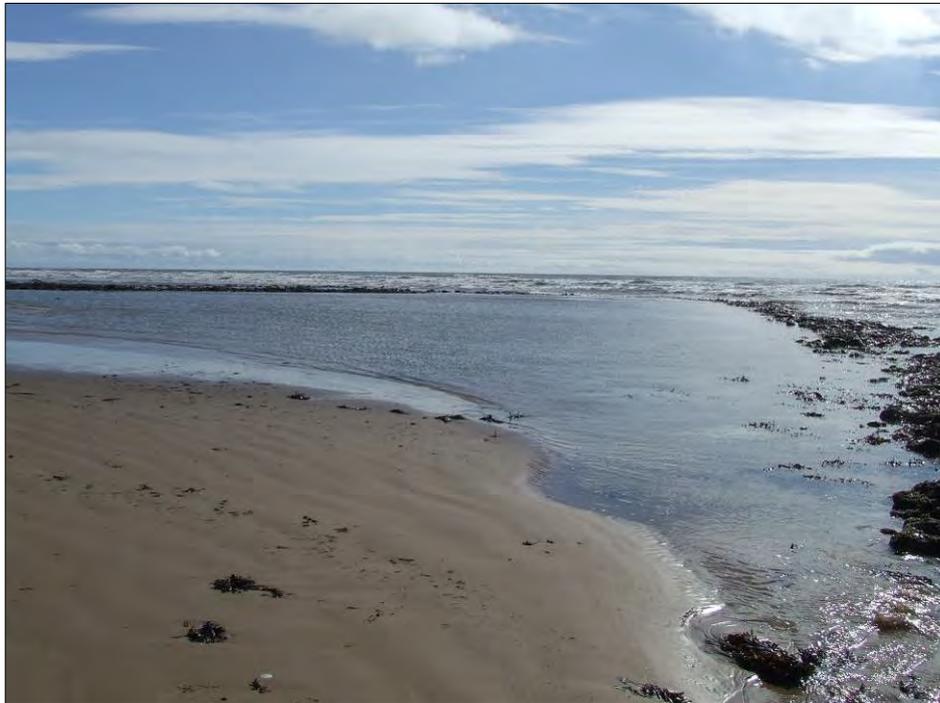
Figure 5.108 V-shaped, stone-built, medieval fish trap at Nethertown, looking southwest.

The Phase 2 survey at Nethertown was assisted by Peter Murphy of English Heritage. It recorded the remains of the medieval fish trap (139) as consisting of a well-preserved, rubble-built, V-shaped fish trap with concave sides (Figure 5.108). The side arms of the trap extended for c.105m into the inter-tidal zone and were designed to trap fish at the apex or 'eye' during the ebb tide.

The stone-built nature of this fish trap contrasts sharply with the fish traps recorded so far along the North West Coast as part of the Phase 2 survey. These have universally been built of upright timber posts designed to carry wattle side walls (see for example Section 4.8.4). Jecock states that fish weirs constructed entirely of rubble walls seem confined to the South West Coast of England and Wales (Jecock 2011a, 3). If this trap was originally built entirely of rubble walling, therefore, this may be a significant site type in this region.

All of the sites recorded in this section are significant for various reasons. The most at risk of coastal erosion is clearly the inter-tidal fish trap at Nethertown which is apparently a rare example of a stone-built fish trap in this location. Its possible association with the ecclesiastical establishment at St Bees, c.5.5km to the north, also gives it added significance. It is undergoing active erosion and therefore considered to be at immediate and long term risk of coastal erosion. Should there be any buried timber elements at this site, a radiocarbon date could prove useful for establishing the development of this fish trap and its chronological relationship with those recorded in other areas along the North West Coast.

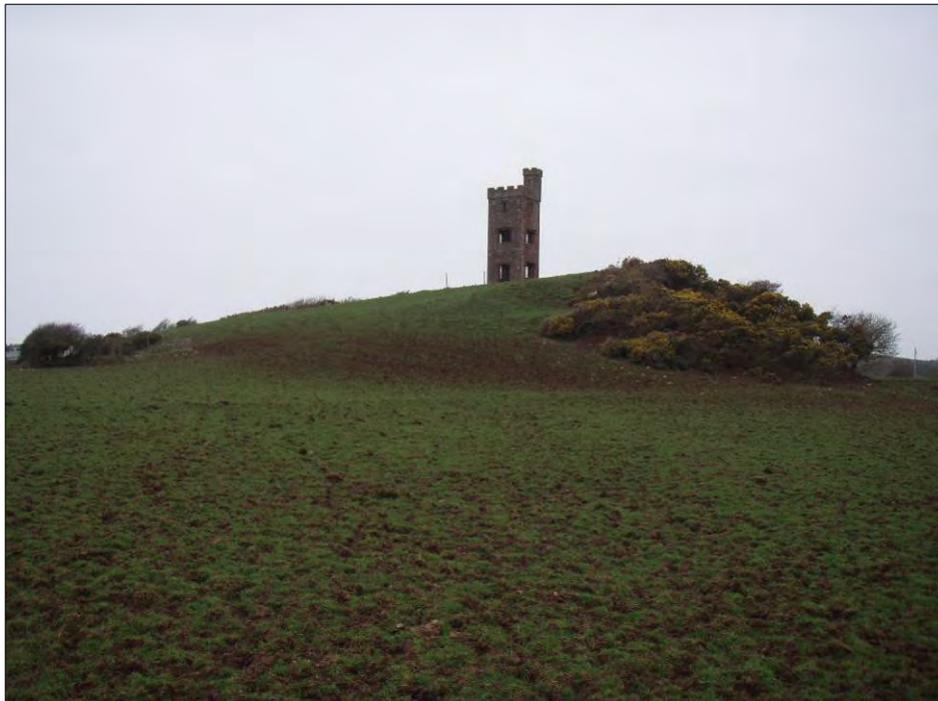
Figure 5.109 Natural spur possibly used as a Norman motte with Braystones Tower on the summit, looking north.

The Phase 2 survey recorded the remains of the motte and Braystones Tower (234) as consisting of a large, probably natural mound, topped by a 19th century battlemented tower of red sandstone (Figure 5.109). The tower was as described in the Listed Building description with no major damage or subsidence problems noted at the time of survey.

The suspected motte appears convincing from the north, east and west approaches alongside the canalised river, however from the landward southern side it takes on the appearance of a natural raised spur. Whilst this may indicate that the bailey was located on this site, there is no evidence of an associated bailey enclosure and even then the motte would normally be cut off from the bailey by a water-filled moat. That the site is not a man-made mound, however, does not necessarily mean that it was not used by the Normans in a similar fashion, as medieval castle sites generally made use of natural topography where possible. The location of the site on raised ground next to a possible river crossing would make it a desirable location for the establishment of a castle and past landscape evidence may even show that the spur was cut off by water during high tide as the surrounding land is a low lying infilled estuary. Further research on documentary sources and limited excavation work could elucidate some of these points, and would allow for more informed and appropriate future management of the site.

Owing to their distance from the shoreline, the suspected motte at Braystones and the Anglo-Saxon church of St Bridget's in Beckermet are not considered to be at immediate or longer term risk of coastal erosion. However, their location within an infilled estuary leaves them at risk of flooding with the surrounding land being particularly low lying. Both sites lie within the Environment Agency's Coastal Flood Risk Area for extreme events.

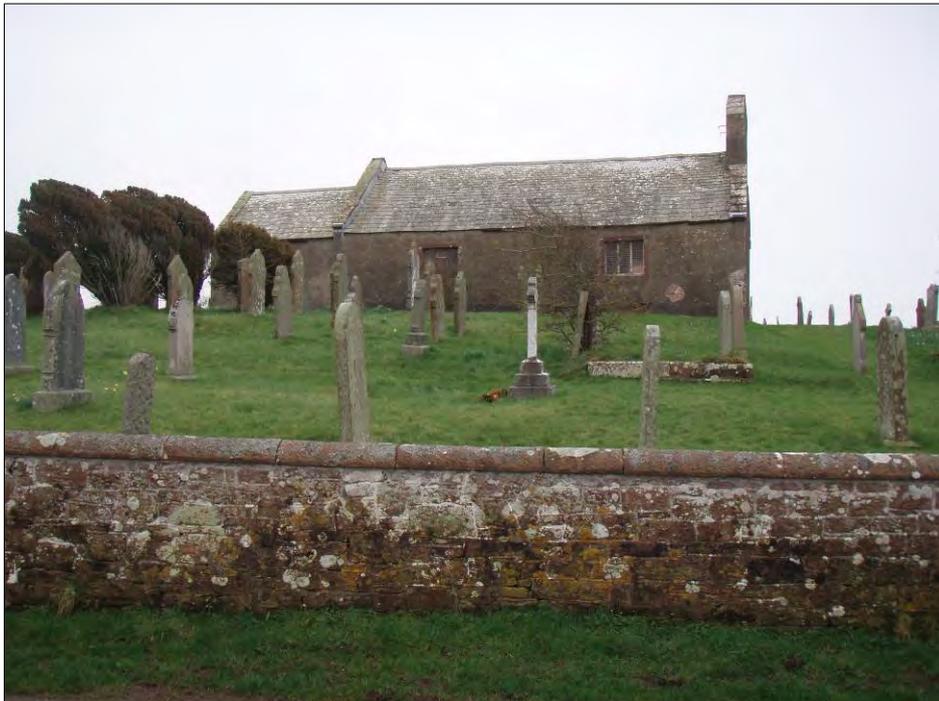
Figure 5.110 St Bridget's Church, Beckermet sitting on a raised platform within its churchyard, looking south.

St Bridget's Church in Beckermet is a Grade II* Listed Building (76363) described as the remains of a medieval church with some 17th century alterations. It is currently on the Heritage at Risk Register due to water ingress and stone decay. It is recorded in the Cumbria HER as a Norman church with an Anglo-Saxon foundation and a pair of Anglo-Saxon cross shafts in its churchyard (HER: 1259). The cross shafts together form a Scheduled Monument composed of a 9th century Anglian cross and a late 10th/early 11th century Anglo-Scandinavian cross (23784). The churchyard is believed to be of Anglo-Saxon origin with the Norman church replacing an earlier ecclesiastical building in this location.

The Phase 2 survey of St Bridget's recorded the remains of the church, the churchyard and the two cross shafts (233). The church was as described in the Listed Building Description and lay within a raised churchyard with a stone-built retaining wall (Figure 5.110). This is a similar arrangement to that recorded at the Parish Church of St John in Waberthwaite (see Section 5.8.6) which is also considered to be an Anglo-Saxon foundation. The presence of two cross shafts within the churchyard lends further weight to the argument that this was an important ecclesiastical area prior to the Norman Conquest.

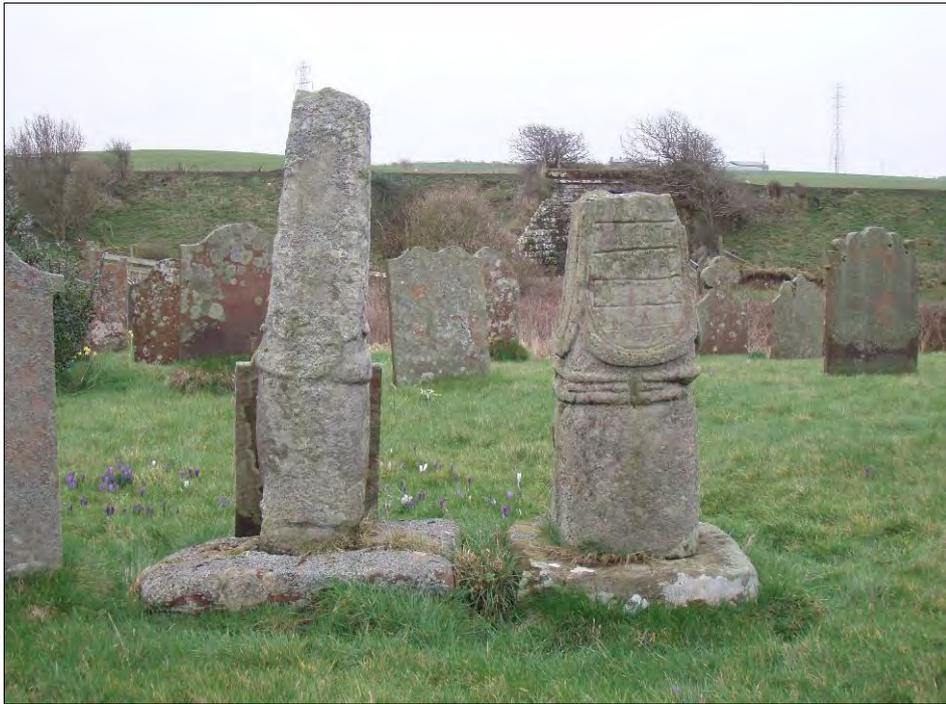
Figure 5.111 Two cross shafts in the churchyard at St Bridget's Church, Beckermet. Late 10th - early 11th century cross on the left and 9th century cross on the right.

The earlier of the two cross shafts is described in the Scheduled Monument Description as being carved in yellow sandstone with a circular profile to the base and a square profile with rounded corners to the shaft. This is similar to the famous cross at Gosforth, c.6km to the southeast (Collingwood 1927, 6). An inscription on the west face of this shaft has not yet been deciphered, and the language in which it was written has not yet been identified (Scheduled Monument Description). This earlier shaft has been illustrated and described by Collingwood (Collingwood 1927, 6 and 147). The later cross shaft is constructed of red sandstone and has a similar profile with a circular base below a rectangular shaft.

The Phase 2 survey recorded the cross shafts as described in the Scheduled Monument Description (Figure 5.111). The shafts are within socket stones but are most likely not in their original location as their proximity to each other would allow very little space between the shafts for the side arms of the crosses, if these had survived. One, or both, of the cross shafts is likely to have been moved to its present location after the crosses had been broken. Both shafts are suffering from erosion and lichen growth that is damaging the decorative panels and their location outdoors leaves them susceptible to the damaging effects of freeze-thaw action.

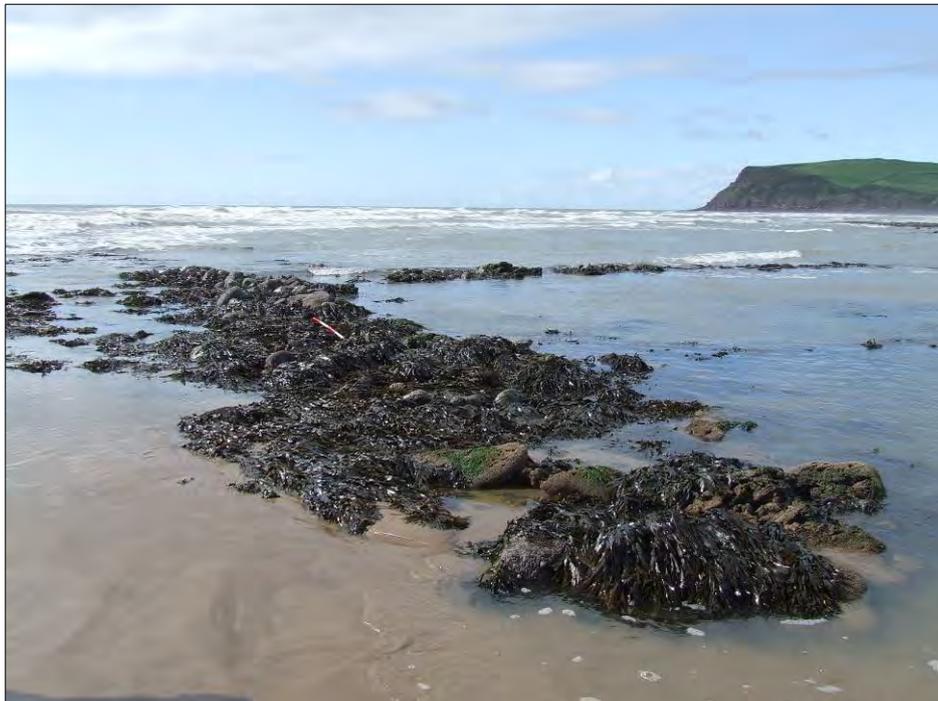
The Phase 2 survey at St Bees was assisted by Peter Murphy of English Heritage. It recorded the remains of the medieval fish trap (138) as consisting of a reasonably well-preserved, rubble-built, fish trap extending for a visible length of $\approx 15\text{m}$ seaward before turning at a roughly 90° angle and continuing for a length of $\approx 20\text{m}$ (Figure 5.114). This section of visible fish trap represents only the mouth of what was a very large, probably V-shaped, structure mapped from aerial photography and extending for a length of $\approx 80\text{m}$ into the inter-tidal zone. The remainder of the fish trap is likely to survive but was not observed due to tidal conditions.

Figure 5.114 Stone-built, possibly medieval fish trap at St Bees, looking northwest (scale = 2m).

Similar to Nethertown, these stone-built fish traps are a rare feature outside the South West Coast of England and Wales and as such they are significant survivals of past fishing practices (Jecock 2011a, 3).

The definite fish trap (138) lies within SMP2 policy unit 11d 5.7 which recommends 'Hold the Line' for the next 100 years, whilst the possible fish trap (137) and peat and marine clay exposure (246-7) lie within the SMP2 policy units 11d 5.6 and 11d 6.1 respectively, both of which recommend 'No Active Intervention' for the next 100 years.

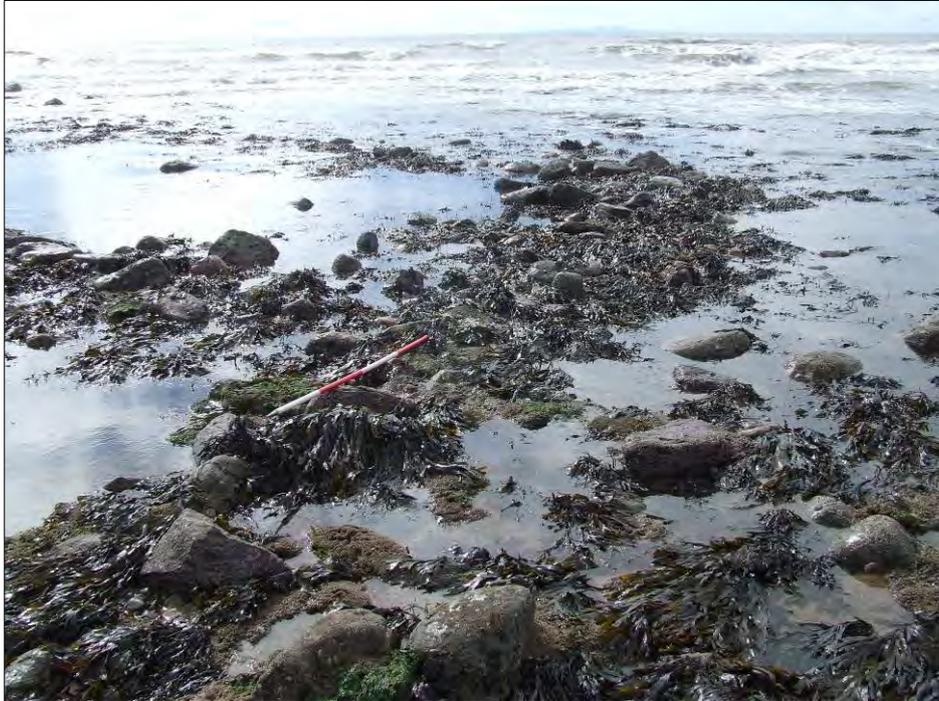
A second possible rubble-built fish trap (137) was recorded $\approx 80\text{m}$ to the south of this feature. It consisted of a possible man-made alignment of stones extending for a visible length of $\approx 10\text{m}$ out into the inter-tidal zone (Figure 5.115). Further study of this feature would be necessary in order for it to be classified with certainty.

Figure 5.115 Possible fish trap at St Bees, looking west (scale = 2m)

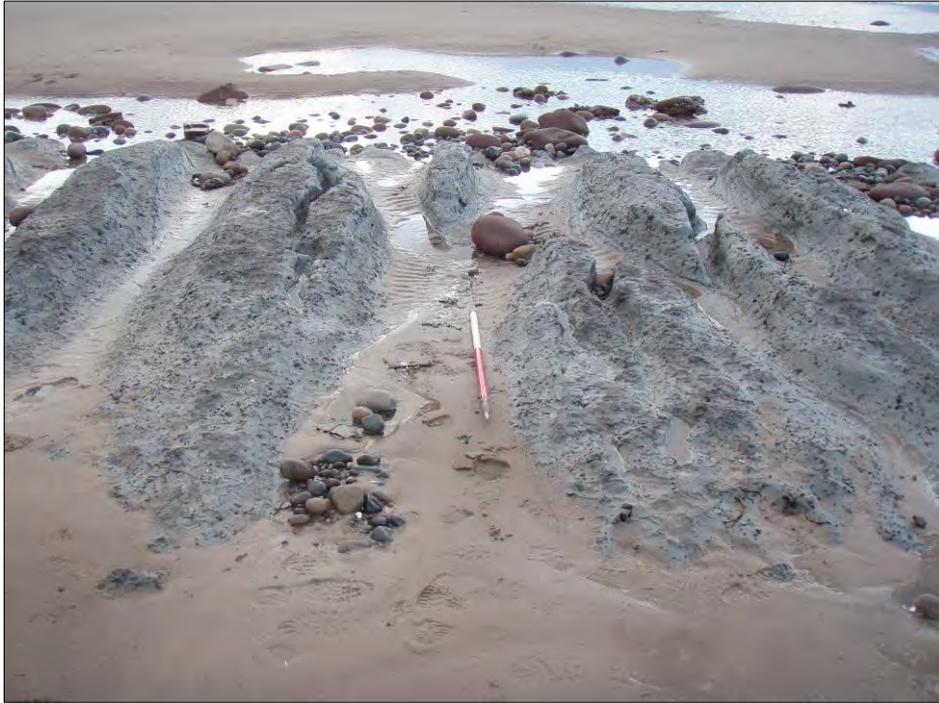
Figure 5.116 Effects of draw down on the exposed marine clay in the lower beach section at St Bees, looking west (scale = 1m).
