Conserving War Memorials

Case Study: Surface Treatment of Bronze Statuary

First and Second World Wars Memorial, Tottenham, Haringey, London

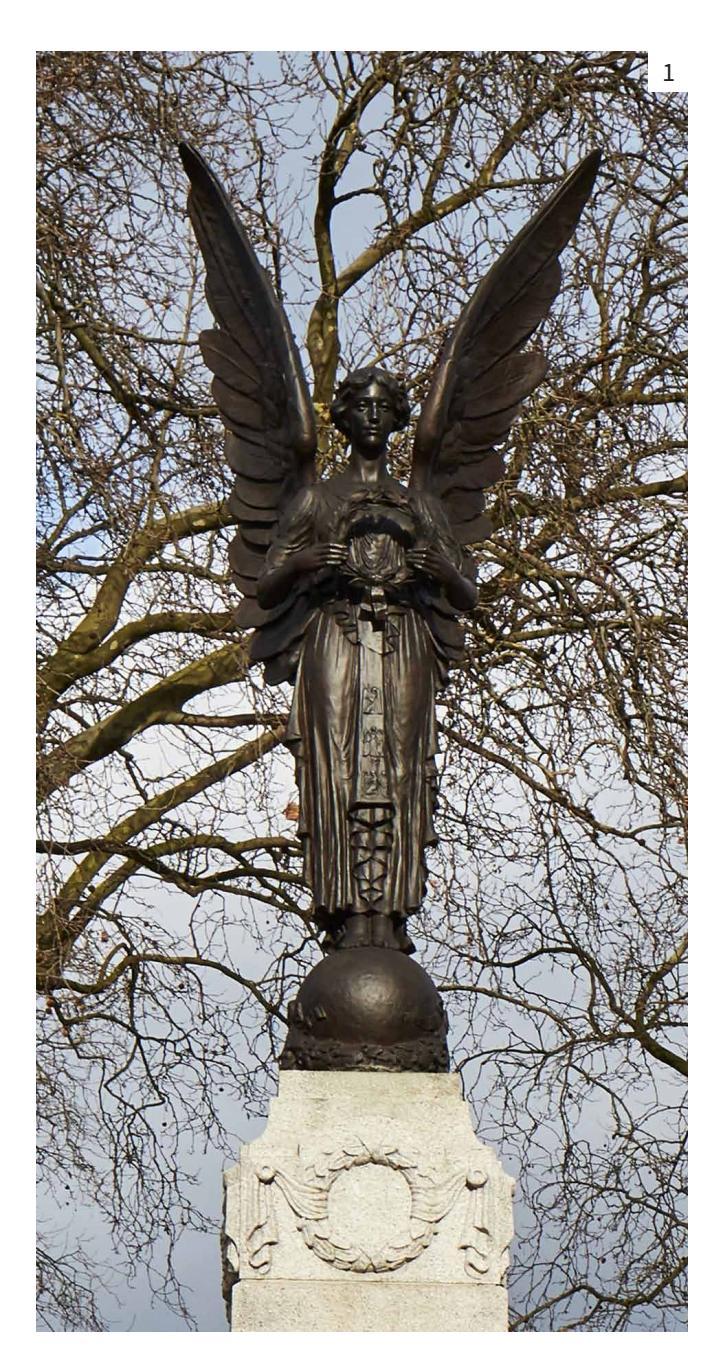
¹ The statue of Peace wears a laurel crown and holds a wreath. She stands with outstretched wings on a half-globe. The pleated front of her gown is decorated with angels in relief.
