# SPAB Building Performance Survey 2012

Interim Report October 2012

Dr Caroline Rye, Cameron Scott and Diane Hubbard Society for the Protection of Ancient Buildings Supported by Historic England

# The SPAB Building Performance Survey 2012 Interim Report

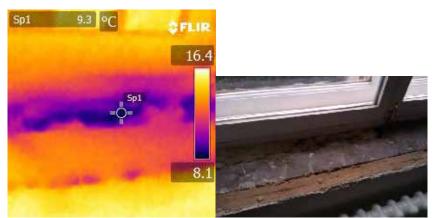
On the first floor, there was evidence of air ingress where areas of the building fabric were yet to be completed (shown in Figures 10 & 11).

Figure 11. 116 Abbeyforegate, Shrewsbury – first floor, south wall, window cill

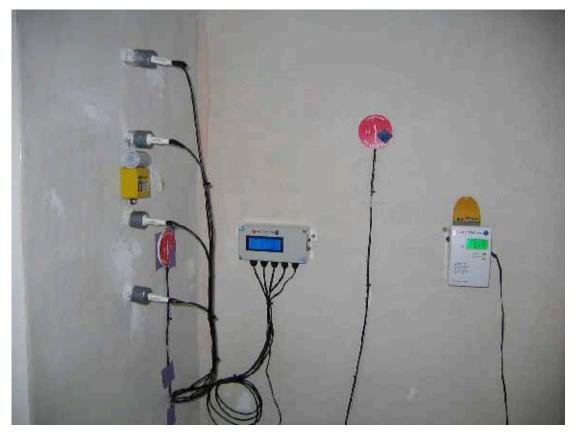
Figure 17. Interstitial, U-value and IAQ monitoring set up at Abbeyforegate, Shrewsbury, 2012.

Temperature and moisture measurements are being made through a section of south-facing brick wall of the living room at Abbeyforegate (Fig. 17). Combined temperature and relative humidity sensors are located at four points within the wall at the heights and depths given in Table 8 coupled with sensors to record internal and external conditions. Data from all these sensors, for the period 17th February - 13th April 2012, has been collected and used as the basis for the following analysis. The position of these sensors correspond with those of the pre-refurbishment monitoring carried out between 28th January - 11th February 2011

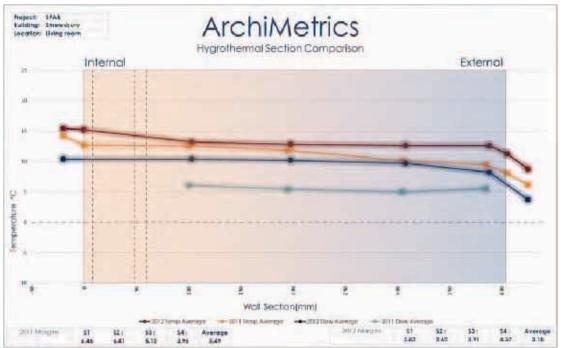
Figure 19. 2011 and 2012 Temperature and dewpoint gradient comparison for Abbeyforegate, Shrewsbury.

The comparison graph, Figure 19, shows the raised temperature on the internal side of the wall for the 2012 data and the drop of this gradient between the insulating layer and the first interstitial sensor node to a temperature of 12-13°C which roughly coincides with that recorded in the previous year. Temperature measurements from the remaining three sensing nodes, however, show the flatten gradient previously noted and are higher than those record pre-refurbishment the previous year. The 2012 raised temperature gradient is not necessarily a result of improved thermal performance, it maybe more a function of milder winter weather and the extending period of 2012 monitoring which continued into warmer months and therefore raised the average temperature for this wall in general. In addition to the flattened temperature gradient seen in the 2012 measurements, an examination of the comparison chart, Figure 19, shows another significant difference between the 2011 and 2012 data, this time for interstitial moisture. This concerns the dewpoint margins, that is the temperature difference between the temperature gradient and the dewpoint gradient plotted for both wall sections. In 2011, the margin averaged across all four wall measurement nodes was 5.49°C and 3.96°C when calculated for just the fourth node in

isolation which is sited close to the external surface. Therefore, in 2011 the wall would have required an overall temperature drop of 5.49°C, or 3.96°C at the outer node, in order for condensation to occur over the monitoring period. Following refurbishment, as can be seen in Figure 19, this dewpoint margin has narrowed and been reduced to 3.18°C when averaged across all four nodes. This is possibly as a result of the masonry part of the wall fabric being cooled by the presence of an internal insulating layer which now prevents some of the heat from the room entering the original masonry part of the wall structure (hence also the flatter temperature gradient and the lower, refurbished, U-value measured for this wall). However, it is interesting to note that the same reduction in the 2012 dewpoint margin is not found when the outer node is looked at in isolation. Here the margin has increased from 3.96°C to 4.37°C. It was noted in the previous Building Performance Survey report, SPAB Research Report 2: 2011, that the dewpoint gradient measured for this wall in 2011 did not conform to the more standard pattern found elsewhere within the survey, where dewpoint and temperature gradients converge towards the exterior face of the wall. The report provided a commentary on the condition of the south-facing brick wall as an explanation for this anomaly, where it was suggested that the poor condition of the pointing had the effect of drying the air within the wall structure either due to air movement and/or air exchange. The external condition of the south-facing wall at 116 Abbeyforegate remained unchanged in 2012, however, within the body of the wall, lower masonry temperatures are now the dominant factor that determine the dewpoint margin for the majority of the masonry but this influence decreases as we move towards the exterior face of the wall where, closer to the exterior surface, the wall continues to experience significant air movement and this leads to an increased dewpoint margin for just this particular location.

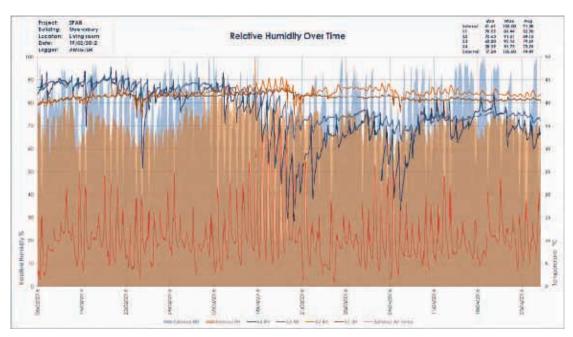
Figure 20. Plots of interstitial RH, internal room RH and external RH and temperature, Abbeyforegate, Shrewsbury, 2012.

By plotting levels of external air temperature, external and internal RH, as well as RH recorded at the interstitial sensors within the wall at Shrewsbury over time it is possible to see the evidence for the behaviour of moisture as vapour within the wall (Fig. 20). Conditions within the wall are affected by the external conditions (temperature and RH) and unsurprisingly this influence is most profound at the most extreme exterior sensor, sensor 4, whilst the responses from other sensors diminish as we move further back into the body of the wall away from these drivers. Of note is the switching of the RH plots for sensors 3 and 4 with those of sensors 1 and 2 which occurs during the week beginning 7th March 2012. Sensors 3 and 4 are sited within the external leaf of the solid wall whilst sensors 1 and 2 are further back towards the interior face. Levels of %RH at sensors 3 and 4 begin a steep decline during this week and from this point remain below those found towards the interior leaf of the wall for the rest of the monitored period shown. This occurs as a result of the temperature increase which occurs between 7th - 21st April which inevitably causes reduced atmospheric RH which is matched by a similar reduction, over time, in levels of RH recorded at sensor 4 and is mirrored, in a less profound way, at sensor 3. This period of warm weather seems to have dried the exterior leaf of the wall to the extent that following this event RH levels towards the exterior

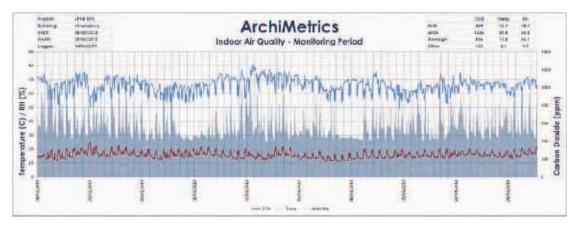
Figure 21. Indoor Air Quality (CO<sub>2</sub>, temperature and RH) Abbeyforegate, Shrewsbury, 2012.

Figure 21 plots temperature, RH and CO<sub>2</sub> levels for the living room at 116 Abbeyforegate between the period 18th February - 2nd May 2012. Table 9 provides a summary of the indoor room conditions. The figures represent average values recorded during both the pre (2011) and post-refurbishment (2012) phases. The data that constituted the 2011 averaged values was collected over a two week period therefore averages for a two week period have been extracted from the 2012 data set and provided along with values for the extended monitoring period in order to provide an improved comparative base.

There would appear to be a trend in the 2012 data towards slightly warmer internal temperatures and a rise in RH. The improvement in room temperature may reflect a reduction in fabric and ventilation heat losses as a result of the addition of internal wall insulation and secondary double-glazing to this room or it may just reflect warmer external temperatures during the 2012 monitoring period (or a combination of both these influences). The air pressure tests suggest that the addition of secondary glazing has made a difference to levels of air infiltration for the property as a whole (reducing the air flow under a 50 Pa pressure differential by 170  $m^3h^{-1}$ , see Table 7). This reduction in infiltration may explain the rise in levels of RH between the two measured years, however, values recorded for levels of CO<sub>2</sub> post refurbishment are lower than those recorded in the previous year and are closer to those commonly found for external air (between 350 - 450 ppm). This suggests that the quantity of external air present in the living room (which accommodates a large, uncapped chimney flue) has not altered significantly and therefore the increase in RH cannot be explained by reduced infiltration. The raised level of RH could, however, be explained by the nature of the refurbishment work that had recently taken place in the room, in particular the application of 8mm of lime plaster as a finish for the woodfibre board insulation. The higher levels of RH recorded during 2012 probably reflect moisture introduced into the room as a result of this plaster finish drying through evaporation. It is likely that over the extended period of monitoring that is currently in place at Abbeyforegate we can expect to see RH reach an equilibrium, once this plaster has dried out, which more properly reflects current levels of occupation and external/internal air balances.

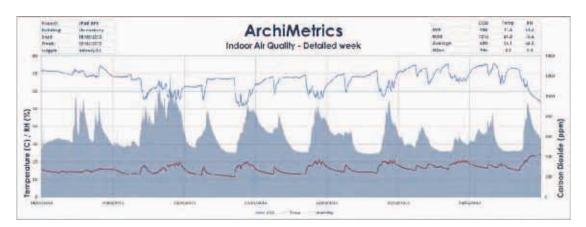
Figure 22. Detail - Indoor Air Quality (CO<sub>2</sub>, temperature and RH) Abbeyforegate, Shrewsbury 18th - 24th February 2012.

A 'detailed' week, 18th - 24th February 2012, has also been plotted from the data gathered post-refurbishment (Fig. 22). From the plot of temperature (in red) it is possible to identify the heating cycle and the corresponding reduction in RH as the higher temperatures reduce the saturation percentage of the air. The  $CO_2$  levels recorded map occupancy of the room at 116 Abbeyforegate during the week and from these it is also possible to see that the heating cycle is well-matched with the use of this room. As previously discussed, the  $CO_2$  levels in Figure 22 also shows the significant influence of the open flue on room conditions; the rapid exchange of internal with external air as a result of the flue is shown, as following occupancy  $CO_2$  levels rapidly return to background levels of  $CO_2$  close to ambient external conditions.

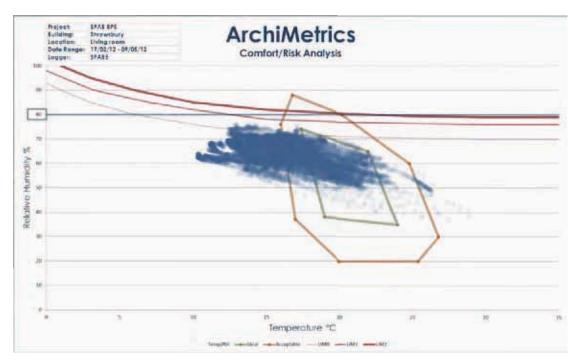
Figure 23. Comfort/Risk Analysis for Abbeyforegate, Shrewsbury, 2012.

ideal zone (Fig. 23). The 1 - 2°C increase in room temperature has placed the living room within more standard bounds of human comfort, although these temperatures may yet be on the low side for some individuals. This increase in temperature, as has been previously noted, has also been accompanied by raised levels of RH previously explained as the residual effect of the wet finishes applied to the wall surfaces in this room. Plots of 2012 temperature and RH are therefore also lifted within the graph up the vertical RH scale and now begin to intersect with one of the limiting isopleths for mould, (LIM 0 - ideal culture medium). They do not, however, intersect with the isopleths that indicate the potential for damage to timber or masonry fabric (LIM 1 and LIM 2).

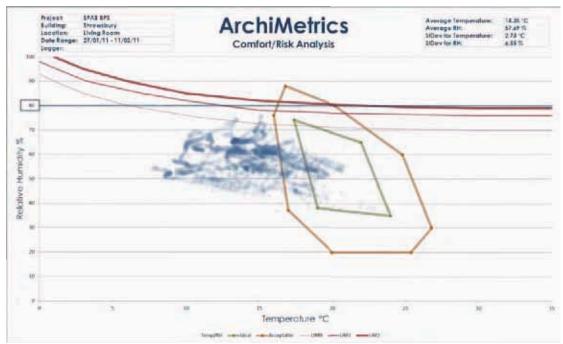
Figure 24. Comfort/Risk Analysis for Abbeyforegate, Shrewsbury, 2011.

In 2011, pre-refurbishment, the majority of the temperature/relative humidity measurements fell outside of the parameters deemed ideal for human comfort and mostly outside of the polygon that described acceptable limits (Fig. 24). In 2012, post-refurbishment, the balance of the graph has changed as temperatures have shifted up the horizontal temperature scale and readings are now centred within the 'acceptable' zone and also occupy more of the

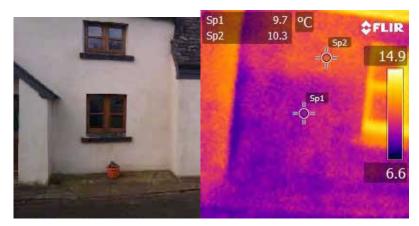
A thermographic survey of the exterior of Riddlecombe was carried out under ambient conditions. The south-facing façade showed some variations in temperature. In Figure 27, the variation is due to an area of wall being set back, whereas in Figure 28, there is no change in wall thickness. This cooler area does not correspond to the stone plinth visible from thermal images at the same location from inside the building shown in Figure 30.

Figure 28. The Firs, Riddlecombe – south-facing façade, flush.

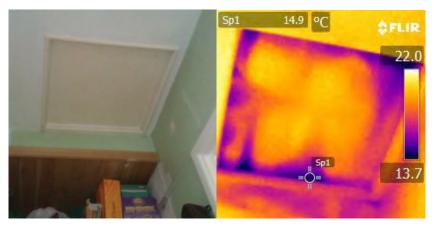
With respect to the later additions, the draught proofing to the rear door reduced the level of ingress, but some was still evident. At the time of survey the loft hatch in the rear passage had not been draught proofed and showed ingress (Fig. 32). It was also noted the missing areas of insulation in the rear bedroom ceiling remained visible under thermographic survey (shown in Fig.

Figure 32. The Firs, Riddlecombe – rear passage, loft hatch.

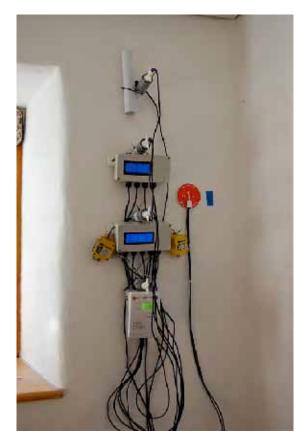
Figure 35. Interstitial, U-value and IAQ monitoring set up at The Firs, Riddlecombe, 2012.

Temperature and moisture measurements are being made through a section of south-facing wall of the office room at Riddlecombe (Fig. 35). Combined temperature and relative humidity sensors are located at four points within the wall at the heights and depths given in Table 15 coupled with sensors to record internal and external conditions. Data from all these sensors, for the period 7th February - 9th September 2012, has been collected and used as the basis for the following analysis. The positions of these sensors corresponds with those of the pre-refurbishment monitoring carried out between 25th February - 11th March 2011.

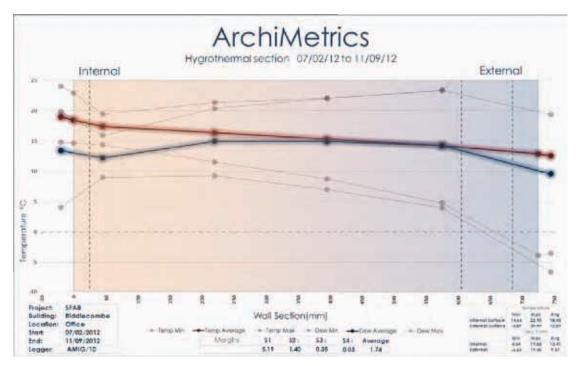
*Figure 36. Temperature and dewpoint gradients for The Firs, Riddlecombe, 2012.*

What is immediately of note from the 2012 graph in Figure 36 is the converging temperature and dewpoint gradients at both the third and fourth interstitial nodes and this pattern is repeated for the maximum values in this graph. The minimum values do not show converging plots of temperature and dewpoint this may indicate that at lower temperatures the wall does not seem to experience such high moisture responses to the extent that dewpoint saturation is not reached. More detail concerning the moisture vapour responses of the wall at Riddlecombe can be found in the section on Relative Humidity below.

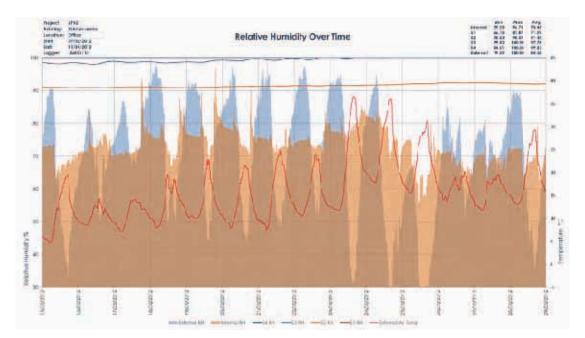
Figure 39. Detail - plots of interstitial RH, internal room RH and external RH and temperature, The Firs, Riddlecombe, 15th - 29th May 2012.

Figure 39 shows a detailed plot of the RH values for the wall at Riddlecombe between 15th - 29th May. It is during these two weeks that the level of RH measured at sensor 3 exceeds 100%. It appears that this occurs in parallel with rising external temperatures and a similar although somewhat delayed and less pronounced increase can be seen in sensor 2 readings (this increase is more visible in Figure 38). Significantly, following the rise in gradient on sensor 2, RH values do not return to previous levels when temperatures diminish. As has been noted previously RH continues to rise over the monitoring period. In contrast to the wall at Shrewsbury where interstitial RH more or less maps that of external temperature and RH i.e. when temperatures rise interstitial RH falls the opposite appears to be happening in the wall at Riddlecombe. RH increases with external temperature increase and continues to accumulate over time. This leads us to speculate that the raised temperatures are causing the moisture vapour in the wall to increase perhaps as some sort of hygroscopic effect as a result of heat and that the accumulation may be explained by the inability of the wall to allow enough of this vapour to evaporate overtime.

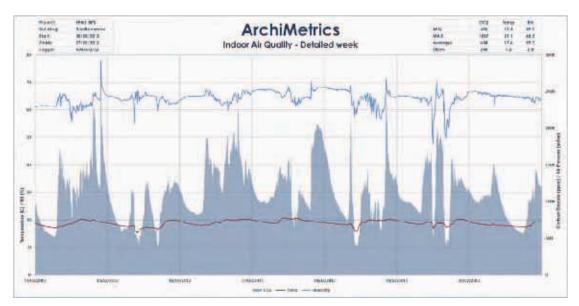
Figure 43. Detail - indoor Air Quality (CO<sub>2</sub>, temperature and RH) The Firs, Riddlecombe 14th - 20th February, 2012.

An examination of a 'detailed week', Figure 43, for Riddlecombe clearly shows purge ventilation (window-opening) in relation to undesirable levels of  $CO_2$  in the office. When  $CO_2$  levels peak above 2250 ppm this is often followed by a steep drop back down to background levels. This is similar to the pattern found at Shrewsbury but there the steep drops indicated an increase in air flow as the result of a large uncapped chimney flue which occupies a proportion of the living room space. In contrast to this at Riddlecombe we can also see a different more gently decay which occurs when the office ceases to be occupied but in the absence of purge ventilation on these occasions the return to background  $CO_2$  levels takes place over a longer period of time and hence shows as a more gradual decline.

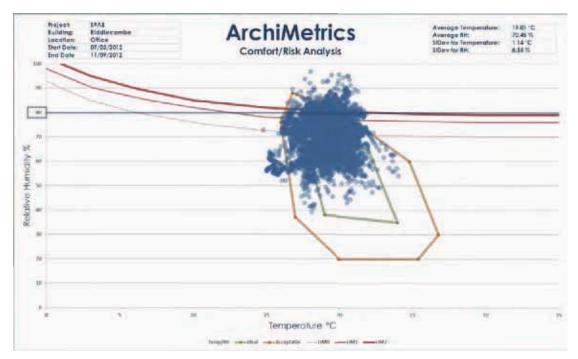
Figure 44. Comfort/Risk Analysis for The Firs, Riddlecombe, 2012.

Figure 45 from data recorded between 7th February - 11th September 2012 shows a different (and logically) much greater range of temperature and RH spread for the office in Riddlecombe. It also presents a very different picture to that contained within the short period of temperature and RH monitoring conducted as part of the indoor air quality (IAQ) survey taken in the earlier part of the year where temperatures were fractionally lower than previously record and RH only slightly raised. In 2011, again from monitoring conducted over a much shorter winter time period, conditions in the office had conformed well to the 'comfort index' as temperatures sat mostly within the 'ideal' polygon and apart from a short aberration RH was below all the limiting isopleths for mould growth. The 2012 graph would suggest, that for the majority of this monitoring period (which has included the spring and summer months) temperatures have stayed within this 'ideal' comfort zone. However, RH is raised with a proportion of readings lying above the limiting isopleths for mould growth for all three substrates. Of all the houses monitored in this study Riddlecombe has the highest occupancy level, 5 persons and one of the smallest overall areas, 86m<sup>2</sup>, therefore one could expect higher levels of RH to be found in such a building. Likewise, as has been previously noted, there seems to be raised moisture levels within the wall of the study and this too might have an influence on RH measurements in this room. This monitoring has taken place during the warmer part of an uncharacteristically wet year (even for the south-west). In order for a more complete picture of indoor room conditions to be drawn the continued monitoring at Riddlecombe will allow a year-long analysis to see how this spread is affected by the autumn and winter months. It is worth noting that the owner of the building reports that in general conditions in the house are more comfortable as a result of the refurbishment work.

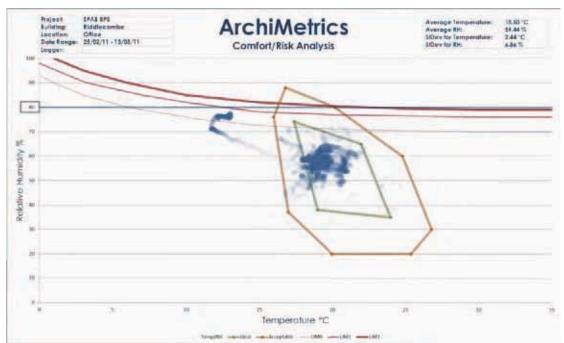
Figure 46. Comfort/Risk Analysis for The Firs, Riddlecombe, 2011.

The 2012 graph, Figure 45, plots data gathered over a much longer time period (7 months) than was the case in 2011 (15 days) hence the increased density of blue temperature and RH plots for this year.

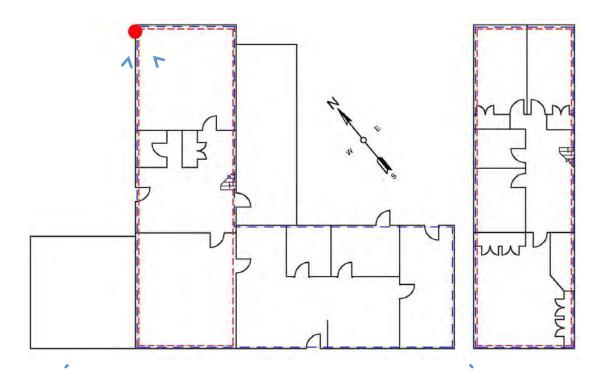
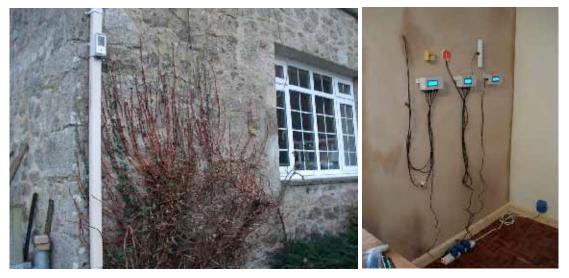
*Figure 48. Positions of in situ monitoring equipment at Mill House, Drewsteignton, 2012.*

Between 7th - 28th February 2012 an *in situ* U-value measurement was taken on the insulated west wall of the ground floor office room (Figs. 47 & 48). The result along with standard U-value calculations made following the BR 443 method are shown in Table 17 below. The 2011 *in situ* U-value given in Table 17 is taken from the measurement made at 1800mm above finished floor level as this equates with the position of the 2012 measurement.

The addition of 100mm of polyisocyanurate board (plus air gap and plasterboard) has made a significant difference to the heat loss measured as an *in situ* U-value for this section of wall, reducing it from the 1.20 W/m<sup>2</sup>K measured from the uninsulated wall in 2011 to 0.16 W/m<sup>2</sup>K, an 87% reduction. The 2012 measured U-value improves upon the calculated U-value for the equivalent wall build-up which is also the pattern normally found for most traditional walls in their existing condition i.e. pre-refurbishment. As has

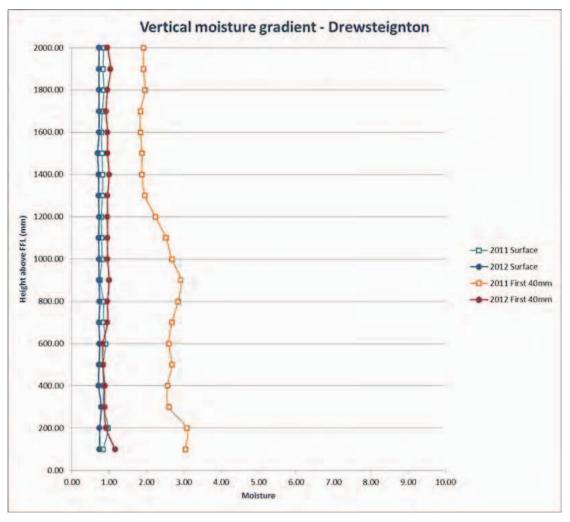
Figure 49. Pre and post refurbishment measurements of surface & subsurface moisture at Mill House Test Wall, Drewsteignton, 2011 & 2012

Rather like the graph for surface moisture at Shrewsbury, which was for a wall which had also been internally insulated, Figure 49 shows both 2012 surface and sub-surface measurements of the test wall at Drewsteignton to be at the 'dry' end of the nominal moisture scale. Here they are also accompanied by the measurements of surface moisture taken in 2011, whereas the sub-surface measurements from 2011 (40mm into masonry of wall) do show a more erratic gradient which indicates at least a slightly raised moisture level for this part of the wall below the height of 1200 - 1400mm. The changes

observed in these gradients following the application of internal wall insulation are perhaps not surprising when one considers the depth of measurements and materials now involved in the wall build-up. The depth of the wall has increased by around 140 mm and this increase has all been to the internal face of the wall, so like Shrewsbury the moisture-measuring instruments are no longer looking into the solid masonry part of the wall (where previously higher moisture levels were found) but are now providing readings of the new gypsum and plasterboard surface. The sub-surface capacitance reading is now measuring the wall about 25mm behind the plasterboard looking at levels of moisture found roughly at the air gap/polyisocyanurate board interface. These new materials, away from the sources of moisture that are potentially present in a pre-1919 solid wall, such as ground water and precipitation, mean that the internal surface and sub-surface of the test wall is found to be quite 'dry' although it maybe that different degrees of moisture are present in other, earlier, parts of the construction.

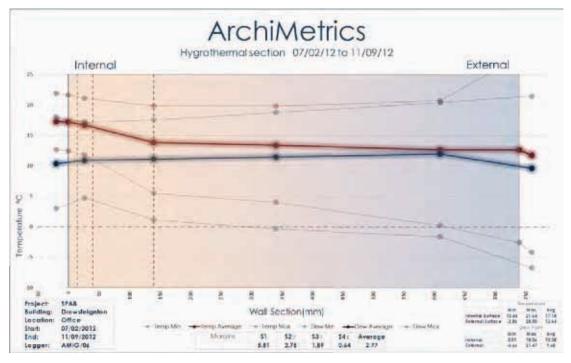
Figure 51. Temperature and dewpoint gradients for Mill House, Drewsteignton, 2012.

In a similar but more pronounced way to that found for the internally insulated wall at Shrewsbury, the steepest fall in the temperature gradient for the test wall at Drewsteignton occurs, appropriately enough, through the insulated portion of the wall build-up (Fig. 51). And following this, also in a similar way to Shrewsbury, the temperature gradient through the masonry part of the wall is virtually flat with only a few degrees of temperature difference between sensor 2 located behind the insulation and sensor 4 positioned behind the exterior face of the wall. A significant difference, however, between this graph and that produced for Shrewsbury can be seen in the plotting of the maximum values over the monitored period. The monitored wall in Shrewsbury is southfacing and on sunny days this showed a very pronounced reversal of heat flow from the exterior back into the wall, with the external surface temperature peaking at around 45°C. At Drewsteignton although it is possible to see a reversal of heat flow through the wall up to the point of insulation from the plot of the maximum values this is much less pronounced and the external surface

temperatures only peak at 28°C. This is due to the different orientation of this wall which faces west and therefore receives direct sunlight for a much shorter period of time on sunny days.

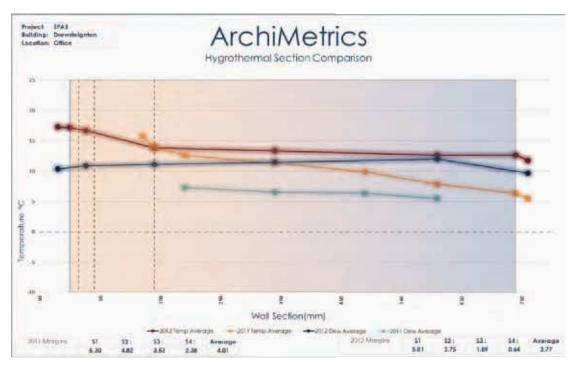
*Figure 52. 2011 & 2012 temperature and dewpoint gradient comparison for Mill House, Drewsteignton.*

Figure 52 allows a comparison to be made between the 2011 and 2012 interstitial hygrothermal gradient monitoring. As with the previous examples at Shrewsbury and Riddlecombe the generally raised temperature gradient through the masonry part of the wall seen in the 2012 readings is not as a result of the wall's improved thermal performance but is a factor of the duration of the monitoring which has been extended and now includes the warmer spring and summer parts of the year. One striking thing about Figure 52 is the change in dewpoint gradients between the two years. The 2011 data (drawn in pale blue and orange) conforms to an understanding of orthodoxy in terms of dewpoint behaviour, that is; temperature and dewpoint will tend to coalesce towards the colder exterior extremes of a building element. This pattern can be seen in the 2011 temperature and dewpoint gradients. It can also be seen in the gradients drawn from the 2012 monitored data, the difference being that, despite generally raised temperatures which might

improve the dewpoint margin, the dewpoint is also raised and begins to converge towards the temperature gradient around the 4th node. The dewpoint margin that was calculated across all four nodes in 2011 was 4.01°C, with the outer node in isolation calculated as 2.38°C. From the 2012 data the dewpoint margin across all four nodes has reduced by 31% to 2.77°C and by 73% for the fourth node alone, which at 0.64°C is moving towards saturation point.

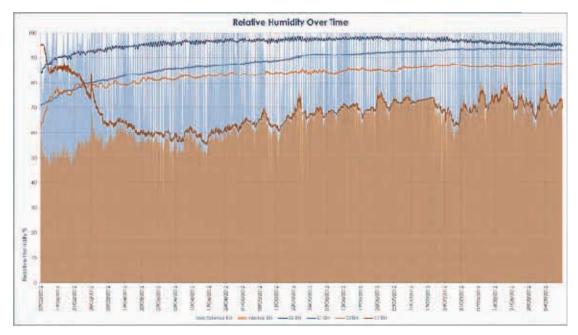
Figure 53. Plots of interstitial RH, internal room RH and external RH and temperature, test wall, Mill House, Drewsteignton 2012.

By plotting levels of internal and external RH as well as those recorded at the interstitial sensors in the test wall at Mill House over time it is possible to see a trend developing within the masonry part of the wall (Fig. 53). Sensors 2, 3 and 4 all show RH rising during the monitoring period. The exception to this is sensor 1 located in the air gap behind the plasterboard drylining. This initially had shown quite high levels of RH which have fallen away and by around 6th March 2012 start to come into a steady relationship with measurements of internal room RH. The RH gradient for sensor 1 can be explained by the drying of the moisture that was bound with the gypsum plaster skim which had

been applied to the interior surface of the plasterboard (this can be seen as patches of damp in Figure 50). It is interesting to note the length of time taken for this drying to occur. Also worthy of note is that, following this decline, the level of RH behind the plasterboard tracks that of internal room RH, suggesting that the drylining finish, complete with a coat of emulsion paint, is highly permeable and that the water vapour within the air in the room is easily able to move through the drylining into the air gap behind with the result that room and air gap RH are more or less equivalent. Sensors 2, 3 and 4 however are located adjacent to and within the original masonry part of the wall and these show a different picture where levels of RH are seen to mostly increase during the monitoring period.

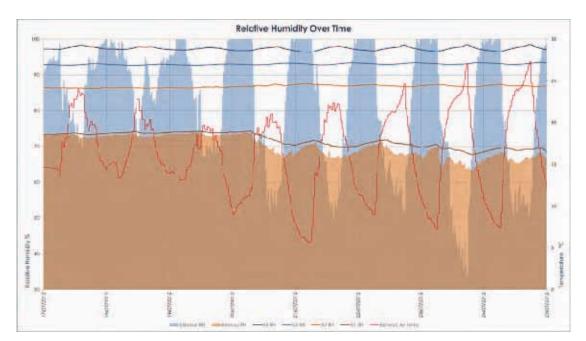
Figure 54. Detail - plots of interstitial RH, internal room RH and external RH and temperature. test wall, Mill House, Drewsteignton, 2012.

A plot of a 'detailed' week of RH data from Drewsteignton shows some interesting trends. Here again, like the wall at Riddlecombe, it is possible to see interstitial RH responding to raised external temperature, albeit without the accompanying accumulation in moisture vapour seen at Riddlecombe (Fig. 54). The peaks in RH shown from sensor 4 appear to be a direct response to spikes in temperature (these spikes are particularly pronounced and can be explained as the period of time during the day that the west-facing

wall received direct sunshine). It is also possible to see a similar but less pronounced response in RH at both sensor 3 and sensor 2 but this is offset in time, an echo of what has occurred nearer to the external surface, which maybe due to the heavyweight nature of the granite wall which results in a slow and flattened thermal response and as a consequence retards and diminishes the wall's deeper interstitial RH responses. Towards the end of the monitoring period shown in Figure 53 it can be seen that levels of RH, having increased at sensor 3 and 4 begin to diminish whilst those recorded at sensor 2 positioned directly between the insulation and masonry continue to increase. It will be interesting to observe the trends of the plots from the interstitial sensors within the wall at Drewsteignton as the monitoring moves from summer back to winter, this will be commented upon in future reports.

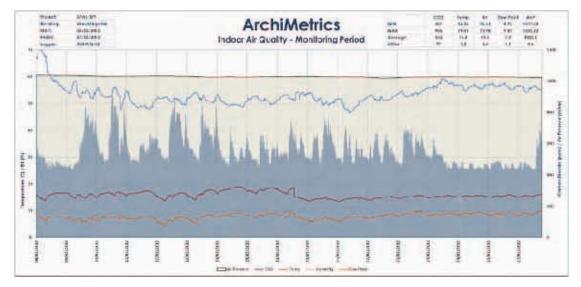
Figure 55. Indoor Air Quality (CO<sub>2</sub>, temperature, RH, dewpoint and air pressure) Mill House, Drewsteignton, 2012.

Figure 55 plots temperature, RH, CO<sub>2</sub>, dewpoint and air pressure levels for the office room at Mill House, Drewsteignton, between the period 8th February - 27th February 2012. Table 19 provides a summary of the indoor room conditions, the figures represent average values recorded in 2011 and 2012.

Given that no general refurbishment work has taken place in this particular room at Mill House it is perhaps not surprising there is very little difference between the values recorded in 2011 and those gathered in 2012. The insulated section of test wall measures only 5.6m<sup>2</sup>, roughly 13% of the overall external wall surface of the room, therefore there will be no general benefit to the air temperature of this room as a result of the addition of this insulation. In fact there is a slight dip in the average temperature found in 2012 which can

perhaps be explained by the fact that the 2012 measurements were taken somewhat earlier in the year, in February, so temperatures may have been somewhat cooler compared to those in March which was the period of the previous 2011 measurements. There is a slight rise in average room RH recorded in 2012 and this could be explained by the addition of a wet finish to the test section of wall which, as has been previously discussed, raised RH levels in proximity to this for a time.

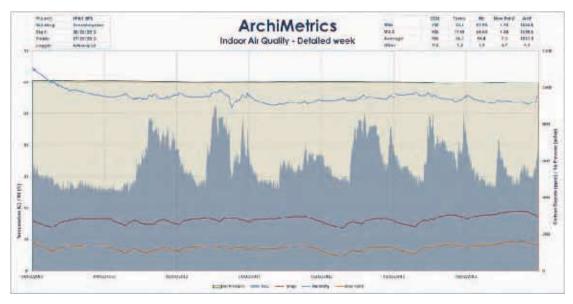
Figure 55. Detail - indoor air quality (CO<sub>2</sub>, temperature, RH, dewpoint and air pressure) 8th - 14th February, Mill House, Drewsteignton 2012.

Periods of occupancy of the study at Mill House can be seen in the raised measurements of  $CO_2$  for most days in the week 8th - 14th February (Fig. 55). There are occasional steep falls in  $CO_2$  which could be explained either by window opening or accidental purge ventilation or just high external wind speeds and then elsewhere there are rather more gentle decays as the room more slowly returns to its normal background levels of  $CO_2$ . The average  $CO_2$  for this detailed week remains on the low side at 585 ppm, within acceptable limits for good air quality and even the maximum value recorded for this week, of 906 ppm, remains below the ASHRAE recommended limit of 1000 ppm. There is very little change in RH in relation to occupancy, and this, as well as the reasonable  $CO_2$  levels measured at Drewsteignton are most likely as a result of the large overall volume of the room (88m<sup>3</sup>).

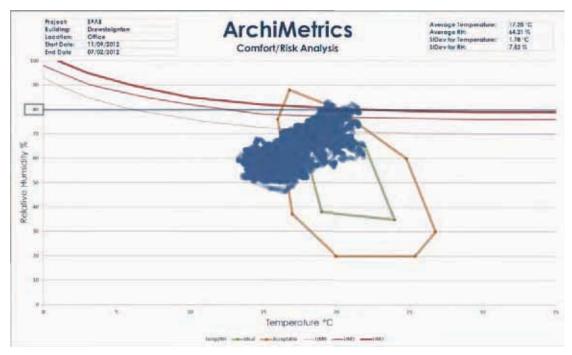
Figure 56. Comfort/Risk Analysis for Mill House, Drewsteignton, 2012.

The 2012 graph (Fig. 56) plots data gathered over a much longer time period (7 months) than was the case in 2011 (15 days) hence the increased density of blue temperature and RH plots for this year.

Figure 56 from the 2012 data shows that in comparison with the much shorter period of monitoring carried out in 2011 temperature and RH is in general higher. This maybe because the 2012 graph includes measurements that extend through the spring and summer and therefore incorporate what has been an unusually wet year. Figure 56 from 2012 places the temperature of the room mostly within the bounds of the 'acceptable' polygon that defines a range of temperatures for human comfort, whereas in the previous shorter winter monitoring of 2011 the majority of temperatures sat outside of this polygon at the colder end of the temperature scale. RH between the two years also shows very different levels for the reasons previously given, although it is interesting to note that over the extended 2012 period part of the RH record now does bisect the limiting isopleths for mould growth including peaking briefly above 80% normally regarded as the upper limit beyond which conditions become conducive for mould growth on both timber and masonry substrates.
