ENGLISH HERITAGE

HERITAGE AT  
RISK  
REGISTER  
2012

SOUTH WEST

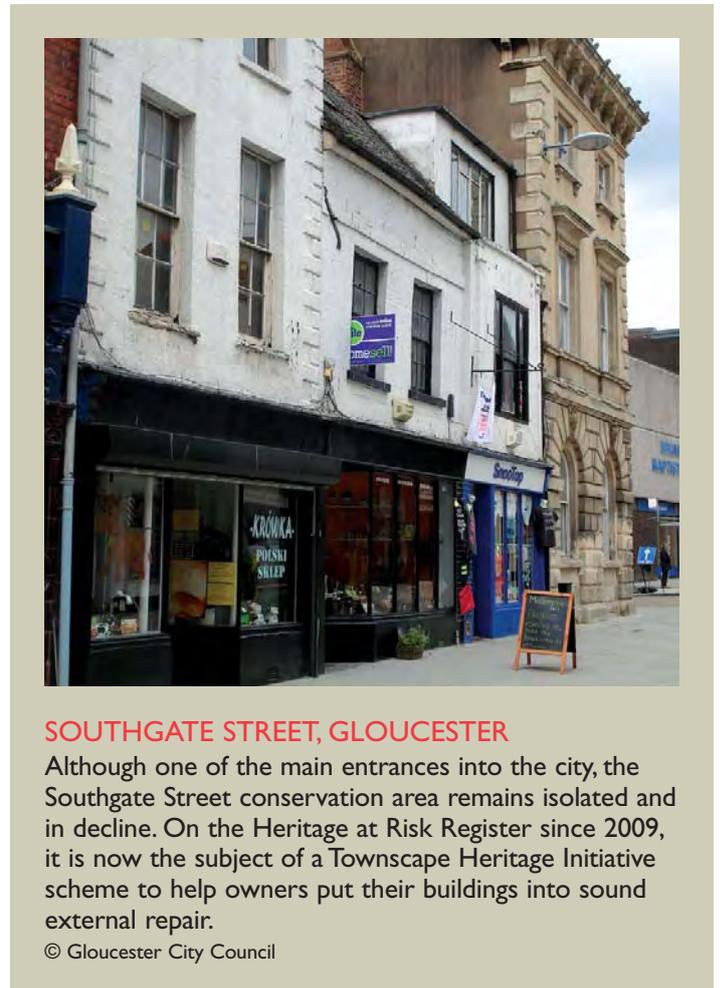
### SOUTHGATE STREET, GLOUCESTER

Although one of the main entrances into the city, the Southgate Street conservation area remains isolated and in decline. On the Heritage at Risk Register since 2009, it is now the subject of a Townscape Heritage Initiative scheme to help owners put their buildings into sound external repair.
