ENGLISH HERITAGE

HERITAGE AT
RISK
REGISTER
2013

NORTH EAST

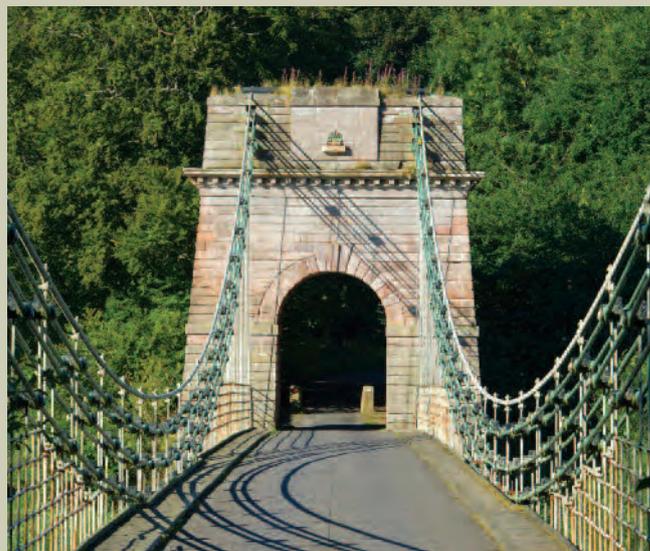
UNION SUSPENSION BRIDGE, NORTHUMBERLAND

The Union Suspension Bridge was the longest wrought iron suspension bridge in the world when it opened in 1820 with a span of 137m (449 ft). Listed grade I, the bridge spans the River Tweed and the border between Northumberland (England), and Scotland. It was designed and built by Captain Samuel Brown, a naval officer in the Napoleonic Wars and later a chain manufacturer, who patented his invention of the wrought iron bar-linked chain used in the construction of this bridge. This is a new entry on English Heritage's Heritage at Risk Register.
