ENGLISH HERITAGE

HERITAGE AT
RISK
REGISTER
2013

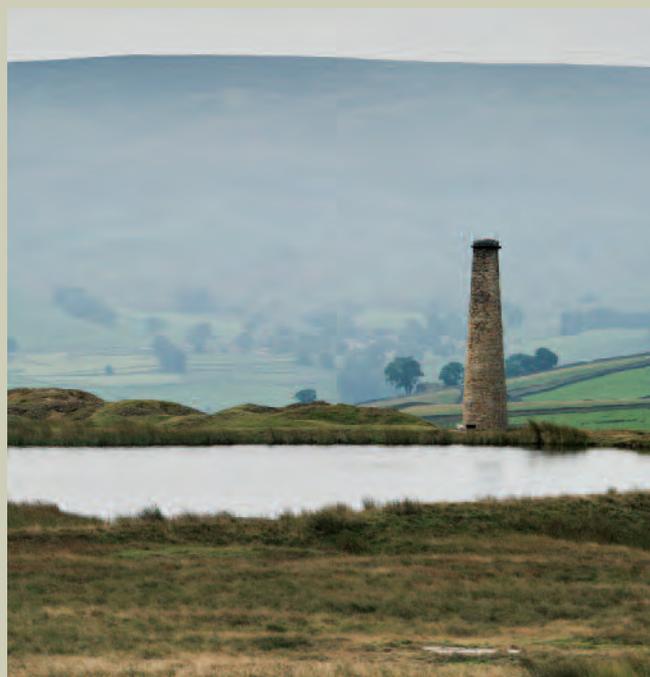
LEAD CUPOLA, FLUE AND CHIMNEY, GRASSINGTON MOOR, NORTH YORKSHIRE

The surviving remains of a lead processing plant stand high on Grassington Moor. On the Register since 1999, the ruins of this extraordinary system of flues, semi-sunken arched tunnels, condensing chambers, and chimney have now been repaired and removed from the Register with grant aid from English Heritage.

Lead mining has shaped the landscape of the Dales since Roman times and our successful partnership with the National Park has secured characteristic remains as evidence for future generations. Successes include the removal of Sargill Lead Mine, now monitored by a team of volunteers and the repair of the chimney and flues associated with lead smelting on Grassington Moor.

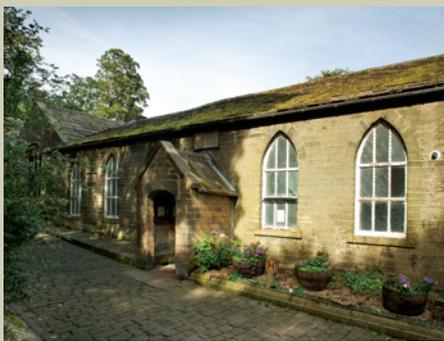
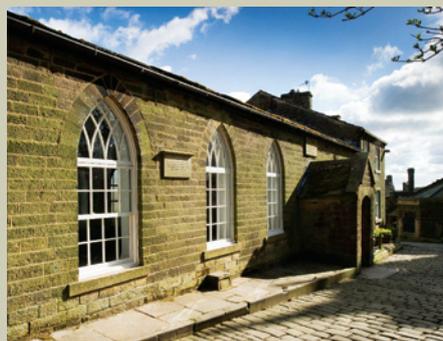
HAWORTH CONSERVATION AREA, WEST YORKSHIRE

reinstatement of original features including windows in the old school room (left, before and after) and shop fronts on Main Street, repair of the cobbled streets and repairs to the roof of St Michael and All Angels Church where Patrick Bronte was curate have all helped to restore the character of the village.

The work by residents, businesses, the local authority and English Heritage has helped Haworth to turn a corner, but there is still much to do. We've identified a series of further actions such as tackling the plethora of signage blighting Main Street and encouraging owners to follow our lead on building repairs so that Haworth continues to strengthen its identity as an iconic Yorkshire village showcasing Yorkshire's heritage to visitors from all over the world.
