Heritage at **Risk**

Historic England

West Midlands Register 2017

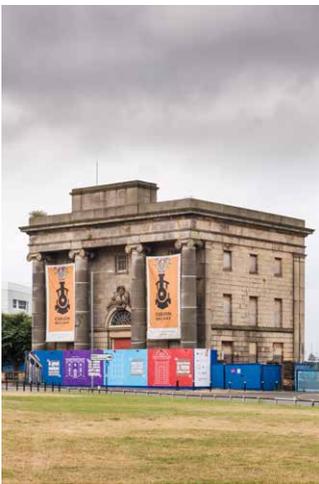
Curzon Street Station **Birmingham**

Curzon Street Station, the original terminus of the London to Birmingham railway, was built in 1838 and has been unused for over a decade. It has become isolated on the eastern side of the city, a proud and intriguing relic of Birmingham's 19th century civic pride, welcoming visitors to the city as their trains come

into Birmingham New Street Station.

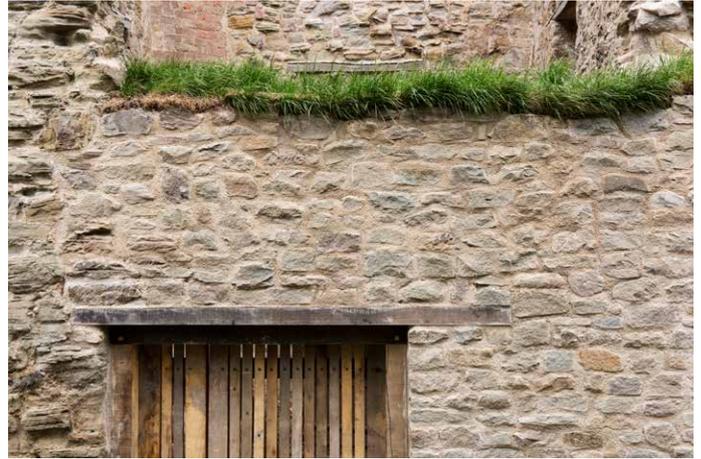
The Engine House is rectangular on plan, measures 6.3m x 4.7m and was originally covered by a pitched roof where the ridge was 9.5m above ground level. The walls are constructed in squared buff coloured rubble. Apart from the large stone base used to secure the engine cylinder, nothing remains of the steam engine and its component parts. The Engine House became disused in the middle of the 19th century.

A scheme to consolidate the masonry remains was carried out this year with grant aid from Historic England and facilitated by the Stiperstones & Corndon Hill

Country Landscapes Partnership. The works included rebuilding part of one demolished wall to ensure structural stability, stone renewal, repointing and soft capping of exposed wall heads. The works were concluded in April 2017 and the structure removed from the Heritage at Risk Register.
