Heritage at Risk	III
The Register	VII
Content and criteria	VII
Criteria for inclusion on the Register	VIII
Reducing the risks	Х
Key statistics	XIII
Publications and guidance	XIV
Key to the entries	XVI
Entries on the Register by local planning authority	XVIII
Greater London	I
Barking and Dagenham	I
Barnet	2
Bexley	5
Brent	5
Bromley Camden	6
City of London	20
Croydon	20
Ealing	24
Enfield	27
Greenwich	30
Hackney	33
Hammersmith and Fulham	40
Haringey	42
Harrow	46
Havering	50
Hillingdon	52
Hounslow	59 65
Islington Kensington and Chelsea	70
Kingston upon Thames	82
Lambeth	82
Lewisham	92
Merton	96
Newham	99
Redbridge	104
Richmond upon Thames	105
Southwark	107
Sutton Tower Hamlets	115 116
Waltham Forest	118
Wandsworth	125
Westminster, City of	128

2014

Heritage at Risk is our campaign to save listed buildings and important historic sites, places and landmarks from neglect or decay. At its heart is the Heritage at Risk Register, an online database containing details of each site known to be at risk. It is analysed and updated annually and this leaflet summarises the results.

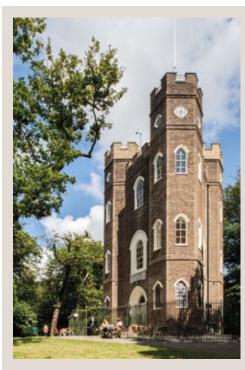
SEVERNDROOG CASTLE, GREENWICH

Towards the end of the 20th century Severndroog Castle fell into a state of disrepair. Its decorative plasterwork and joinery were damaged by water penetration and many features were damaged or stolen by vandals.

In summer 2014, Severndroog Castle opened its doors to the public for the first time in 25 years. The castle has been carefully restored. The decorative plasterwork has been repaired and re-gilded, the windows painstakingly overhauled and graffiti cleaned from the outer walls.

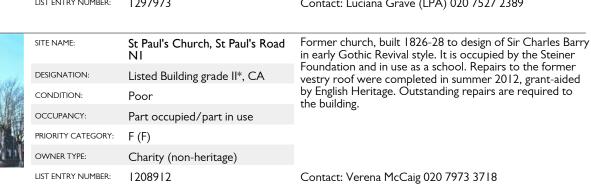
TH	SITE NAME:	Railings, Thornhill Square NI	Some repairs to the railings were completed in 2010, part
	DESIGNATION:	Listed Building grade II, CA	funded by English Heritage. The Council is proposing to apply to the Heritage Lottery Fund for a grant towards
TAT	CONDITION:	Poor	further repairs and landscaping. Discussions are ongoing regarding how best to repair or replace damaged railings.
1 State	OCCUPANCY:	N/A	regarding now best to repair of replace damaged railings.
	PRIORITY CATEGORY:	D (D)	
	OWNER TYPE:	Local authority	
	LIST ENTRY NUMBER:	1297982	Contact: Andy Rayner (LPA) 020 7527 4087

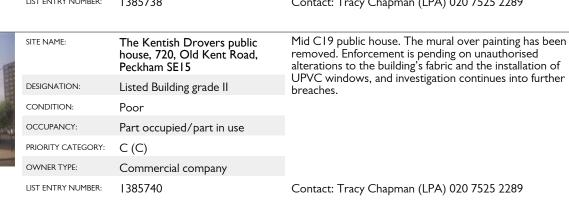
all 1	SITE NAME:	21 and 23, Park Street SEI	Pair of houses dating to circa 1820. Currently vacant and
	DESIGNATION:	Listed Building grade II, CA	suffering from significant structural problems. The northern flank wall to No. 23 is propped with scaffolding. The
1 THUR	CONDITION: OCCUPANCY:	Poor	houses have been sold and the new owners are in pre- application discussions with Southwark Council.
LAND		Vacant/not in use	application discussions with southwark Council.
ANT I	PRIORITY CATEGORY:	A (A)	
	OWNER TYPE:	Private	
And the state of the	LIST ENTRY NUMBER:	1385752	Contact: Tracy Chapman (LPA) 020 7525 2289
